1008 – Leapings View
Thurlstone

BS 5837:2012 Arboricultural
Report, Impact Assessment
and Method Statement

JG Pears Holdings Ltd

June 2024

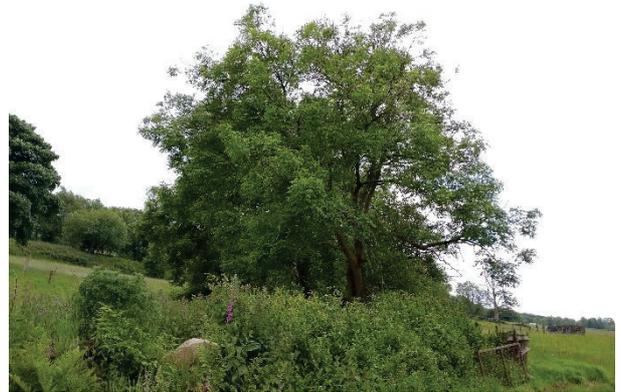
Photo 4: T012 from the north

- 5.15 A new hard surfaced footpath, a retaining wall and the terracing of an embankment are proposed at the edge of the RPA of T004, T012 and T022 respectively. In these instances, root growth from the trees will have been restricted in the direction of the proposed works by various existing site

features; including the partially collapsed dry stone retaining wall in the case of T004 and T012 and the steepness of the embankment and competing roots of surrounding vegetation in the case of T022.

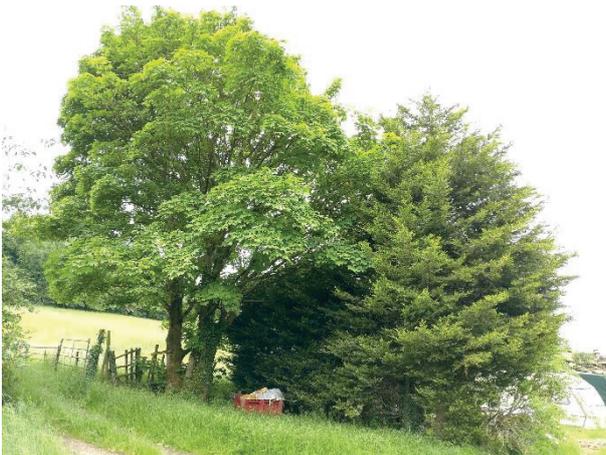
Photo 2: T004 and H005 from the north east

- 5.13 Existing hard surfaces lie within the RPA of the retained individual tree T004 and tree group G026, as shown on the Tree Impacts Plan at Appendix 3. While the hard surfaces and their sub-base will have created an inhospitable rooting environment, there is still the potential for roots to be present beneath them.

- 5.14 Therefore, if it is required to upgrade these surfaces, the works here should be carried out in a manner that precludes the likelihood of any root damage. This can generally be achieved by retaining the sub-base layer to build a new surface upon, and by avoiding compaction or contamination of the sub-base layer while it is temporarily exposed.

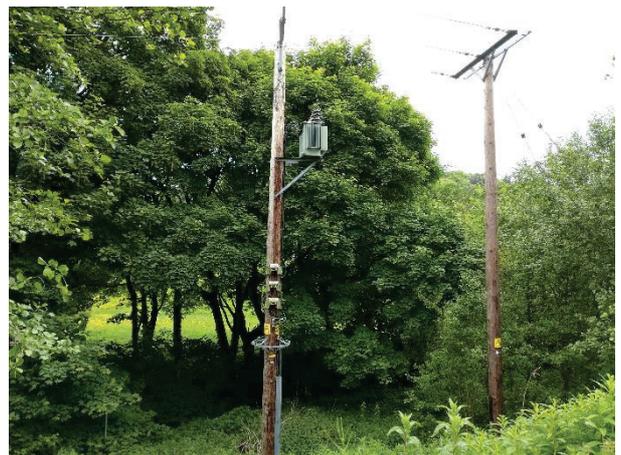
Photo 5: G014 from the south

G014	Sycamore (<i>Acer pseudoplatanus</i>)	15.0	>10	380 avg	See Plan				1.0	Early Mature	40+ Years	Good	Semi-mature to early mature group growing on bank of stream to north, inaccessible due to dense surrounding vegetation & various obstructions, generally single or twin stemmed, no significant defects		B1,2	-	-

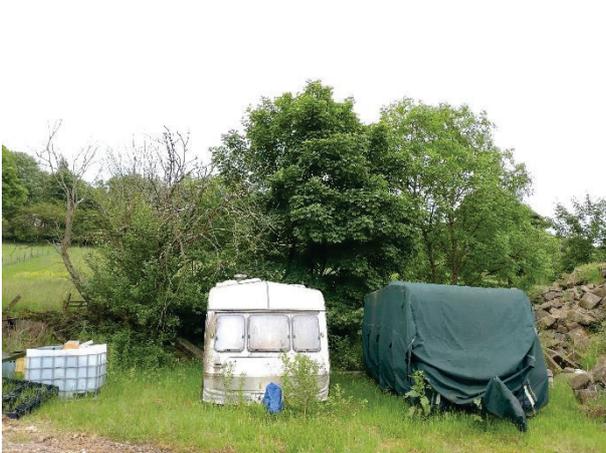
Photo 3: T006, T007 and T008 from the north west

4.9 The trees T006 and T023 have been categorised as retention category U, as they cannot realistically be retained in the current Site context for more than 10 years. In some circumstances category U trees can be retained for the short term amenity and ecosystem service benefits that they provide. However, in this instance it is advised that the trees are removed as soon as is reasonably practicable, as T006 is dead and large limbs of T023 are overhanging a public footpath.

T006	Willow (<i>Salix caprea</i>)	7.0	6	180 avg	3.0	3.0	3.0	3.0	1.0	Dead	Dead	Dead	Standing dead tree with some small stems re-growing from roots at base	<i>Removal advised regardless of development proposals</i>	U	-	-
T007	Sycamore (<i>Acer pseudoplatanus</i>)	8.5	1	240	4.0	3.0	3.0	3.5	1.0	Semi Mature	20+ Years	Good	Growing from base of dry stone wall, large stones piled at base, slight northerly lean		B1	2.9	26
T008	Ash (<i>Fraxinus excelsior</i>)	8.0	2	260, 200	3.0	3.0	3.5	4.0	1.5	Semi Mature	10+ Years	Fair	Growing from within large pile of large stones, twin stemmed at 1m, various branch stubs & minor deadwood throughout crown	Removal required as pile of stones will need to be removed for construction of adjacent dwelling	C1	3.9	48
T009 #	Sycamore (<i>Acer pseudoplatanus</i>)	6.5	3	140, 120, 110	2.5	2.5	2.5	2.5	1.0	Young	20+ Years	Fair	Multi-stemmed at base, growing amongst pile of large stones	Removal required for stabilisation of partially failed wall	C2	2.6	21

- 5.16 Fencing is proposed within the RPA of T007. Potential root damage can be avoided through the use of post and rail fencing and the avoidance of trenched footings. Post holes within the RPA should be excavated using hand tools only and re-positioned if significant roots are found.
- 5.17 All works beneath canopy spreads or within the RPA of retained trees have been detailed as part of the Arboricultural Method Statement (AMS) at Appendix 3.

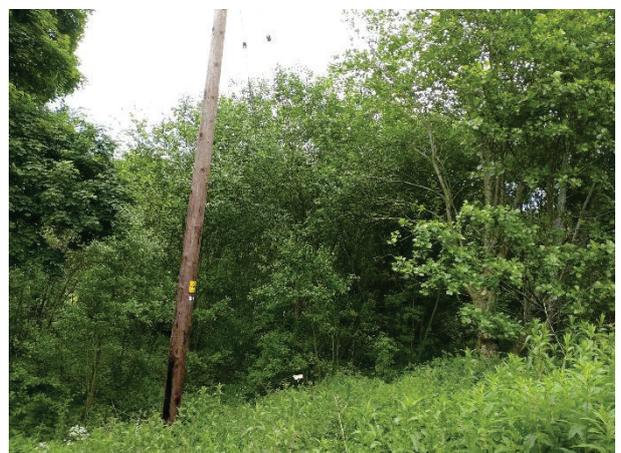
Photo 6: South western end of G015 from the south west

- 5.7 The loss of a high proportion of the tree group G015 will result in a minor loss of amenity value within the Site. However, the trees to be removed are of particularly low individual value. Their loss will open up views to the larger trees to either side of the River Don from within the Site and allow space for more suitable replacement planting.

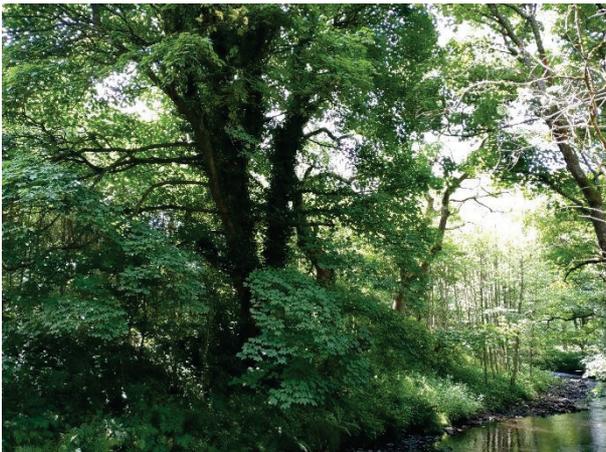
Photo 9: T020, T021 and T022 from the north east

- 4.6 The most significant tree included in the survey was the large sycamore, T022, located at the north of the Site, close to the southern bank of the River Don. Although somewhat sheltered from view by the surrounding vegetation, this tree provided a high level of amenity value to the site and surrounding areas.

T022	Sycamore (<i>Acer pseudoplatanus</i>)	18.0	2	650, 620	6.5	8.0	6.0	6.5	1.0	Mature	40+ Years	Good	Twin stemmed at base, ivy covered stems & lower crown, minor deadwood throughout		A1	10.8	366
T023	Ash (<i>Fraxinus excelsior</i>)	18.0	1	770	1.5	8.0	6.5	4.0	1.0	Mature	10+ Years	Poor	2x large stubs from previously failed limbs at 6m & 11m, large gaps in canopy & sparse upper crown due to these lost limbs, minor deadwood throughout, unsuitable for retention as it overhangs a public footpath	<i>Removal advised regardless of development proposals</i>	U	-	-
T024	Laburnum (<i>Laburnum anagyroides</i>)	7.0	2	170, 140 #	2.0	2.0	2.0	2.0	2.0	Semi Mature	40+ Years	Fair	No access & limited visibility due to dense surrounding undergrowth, minor deadwood throughout		C2	2.6	21
