TREE SURVEY RISK REPORT

***4 Mysten Croft,
Barnsley,
S75 1EP***

Prepared for: *Debbie Sanderson*

Reference: *AWA6720*

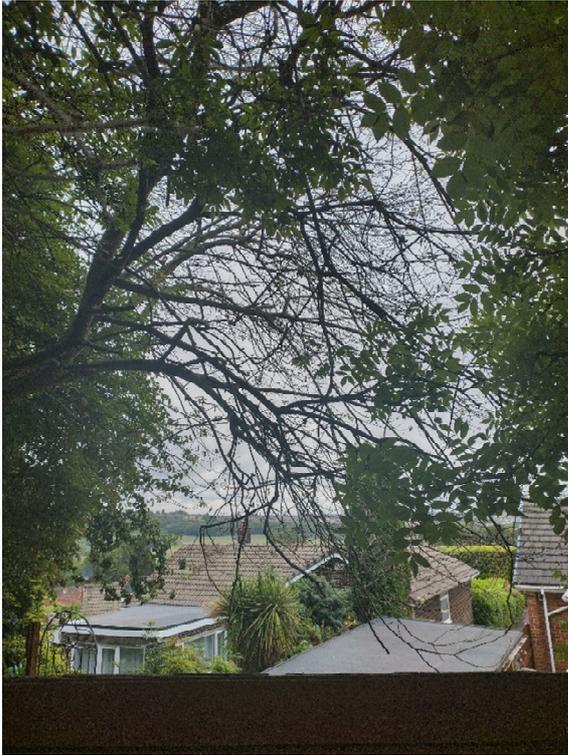
- 3.2.1 Of the surveyed trees or tree groups, 6 were identified as requiring some level of management.
- 3.2.2 **Tree Removals:**
- 3.2.3 Tree T4 was found to have an unacceptable level of risk and requires felling to ground level as a **Moderate** priority, highlighted in orange on the tree plan and data schedule.

Photo 1: Dead eastern crown of T4 overhanging adjacent garden

Tree ID	Tree Species		Measurements					Tree Condition		Risk Assessment							Works	Next Survey		
	Common Name	Latin Name	Maturity	Height (m)	Number of Stems	Stem Diameter (mm)	Spread Radius (m) (Average)	Vitality	Obvious Defects	Additional Comments	Assessed	Target Type	Multiple?	Target Range	Size Range	Probability of Failure			Reduced Mass (%)	Risk of harm/ Urgency
T4	Goat Willow	<i>Salix caprea</i>	Mature	13	3	510, 390, 360	6	Poor	Weak union. Crown dieback. Sparse crown. Branches causing obstruction. Leaning stem	Mature tree at edge of woodland TPO. Three stems at base, each with poor union and partially included bark. Most easterly stem has historically partially failed. Subsiding over adjacent garden to east. Gap in crown of 2m. Eastern stem with major dieback with very limited remaining foliage. Western two stems with poor union at base and tight unions at 1.5-2m. Minor dieback in crown with reduced vitality. Limited long-term prospects	Main Limbs	H: HUMAN	1	3	2	2		Unacceptable/ Moderate	Remove eastern stem. Reduce remaining crown by 2-3m - Alternatively, remove to ground level and replace with suitable specimen - Protected by Tree Preservation Order	3 years

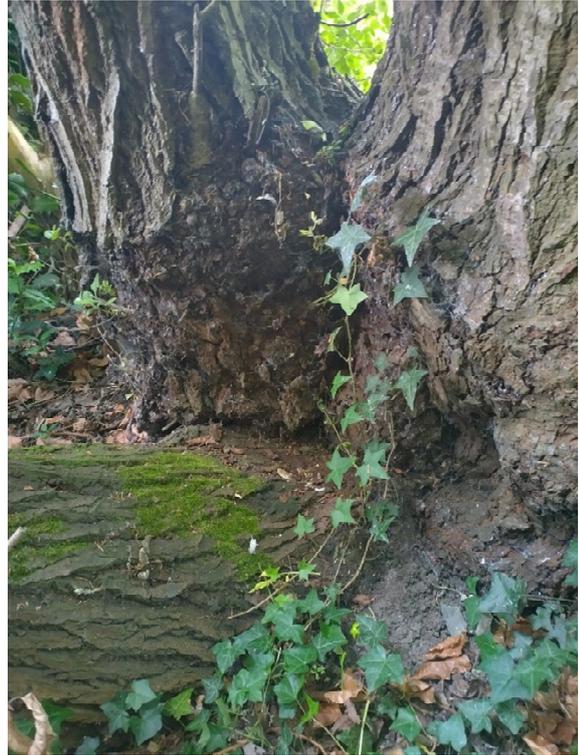
Photo 2: Poor unions at base of T4 including historically partially failed eastern stem

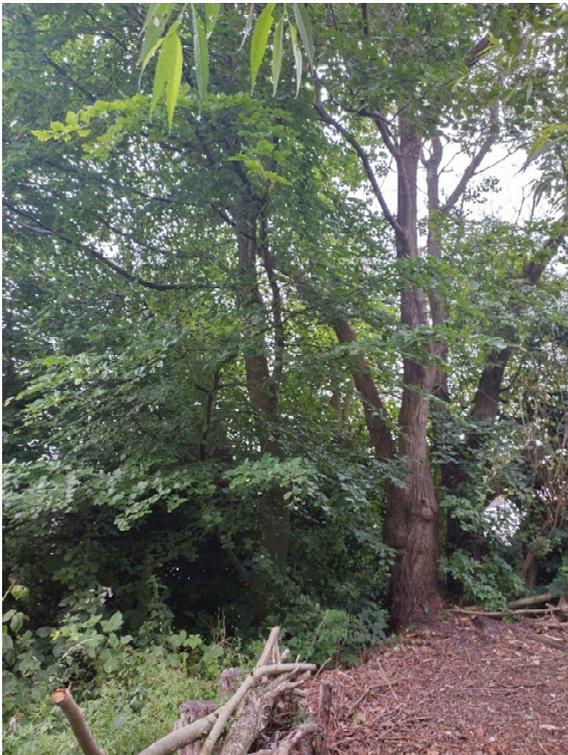
Photo 3: T4, T5, T6, and G16 looking east

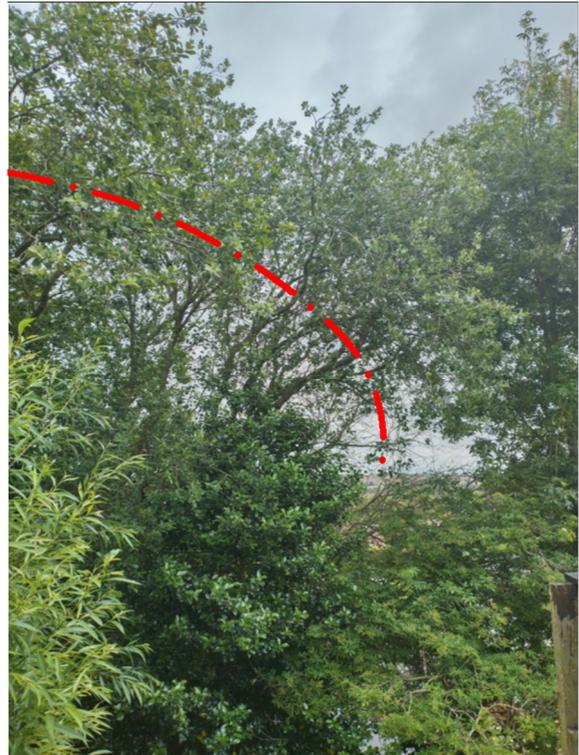
Photo 4: Suggested reduction of T4 following removal of eastern stem
