Annual Tree Health & Woodland Inspection.

Hawthorne Croft
1567
November 2025

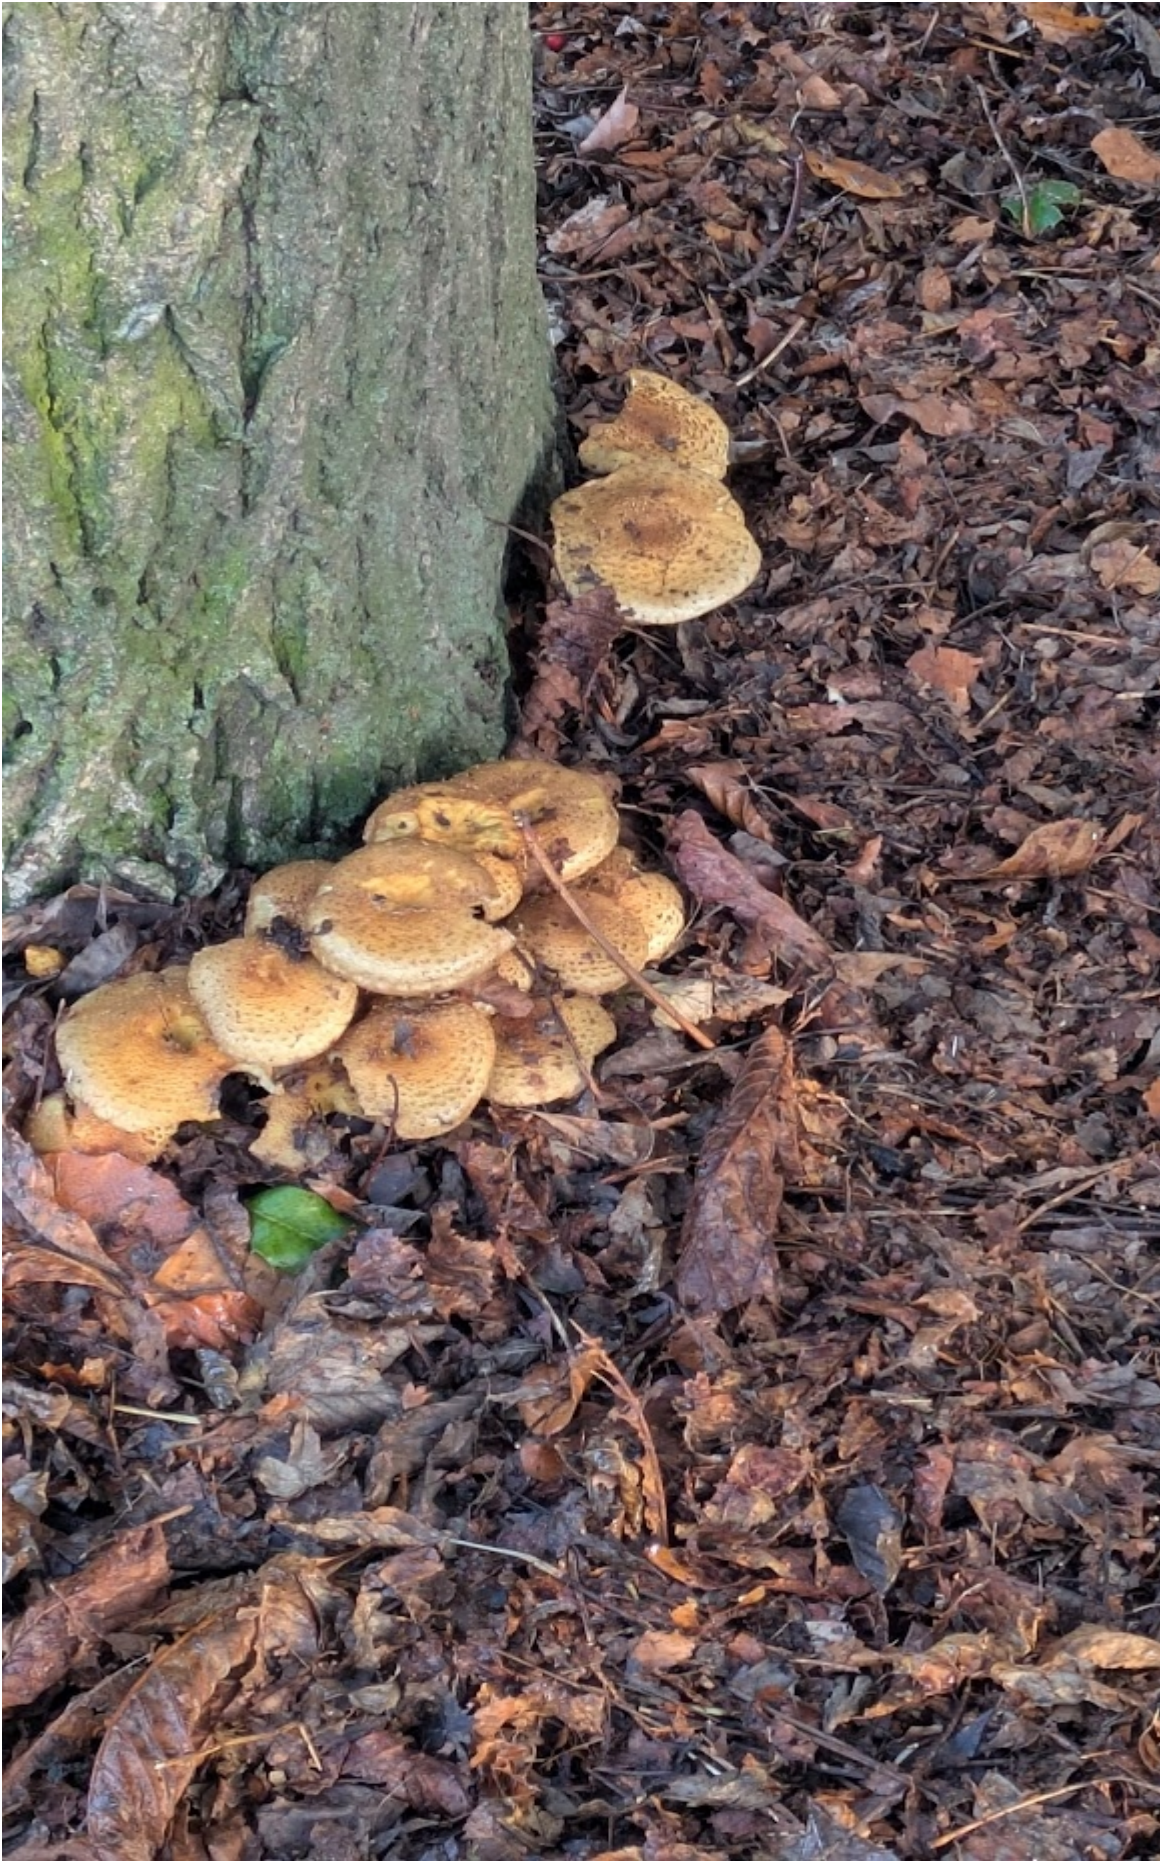
The ash tree hosts canopy deadwood, wood pecker holes indicating decay in the main stem, it has a pholioata colonisation around the base of the tree, there are inonotus colonisations on the tree, it is concerning as it causes heart decay, so close to the wood pecker activity, along with suspected ash dieback, the tree is in severe decline, photo attached, remove the tree within six months, and replant with a lime species tree.

Ash in A1, Pholiota at base.

Remove the ash and the chestnut in A1, the trees have blue dots on them, six month timescale, cut ivy at base of the trees.

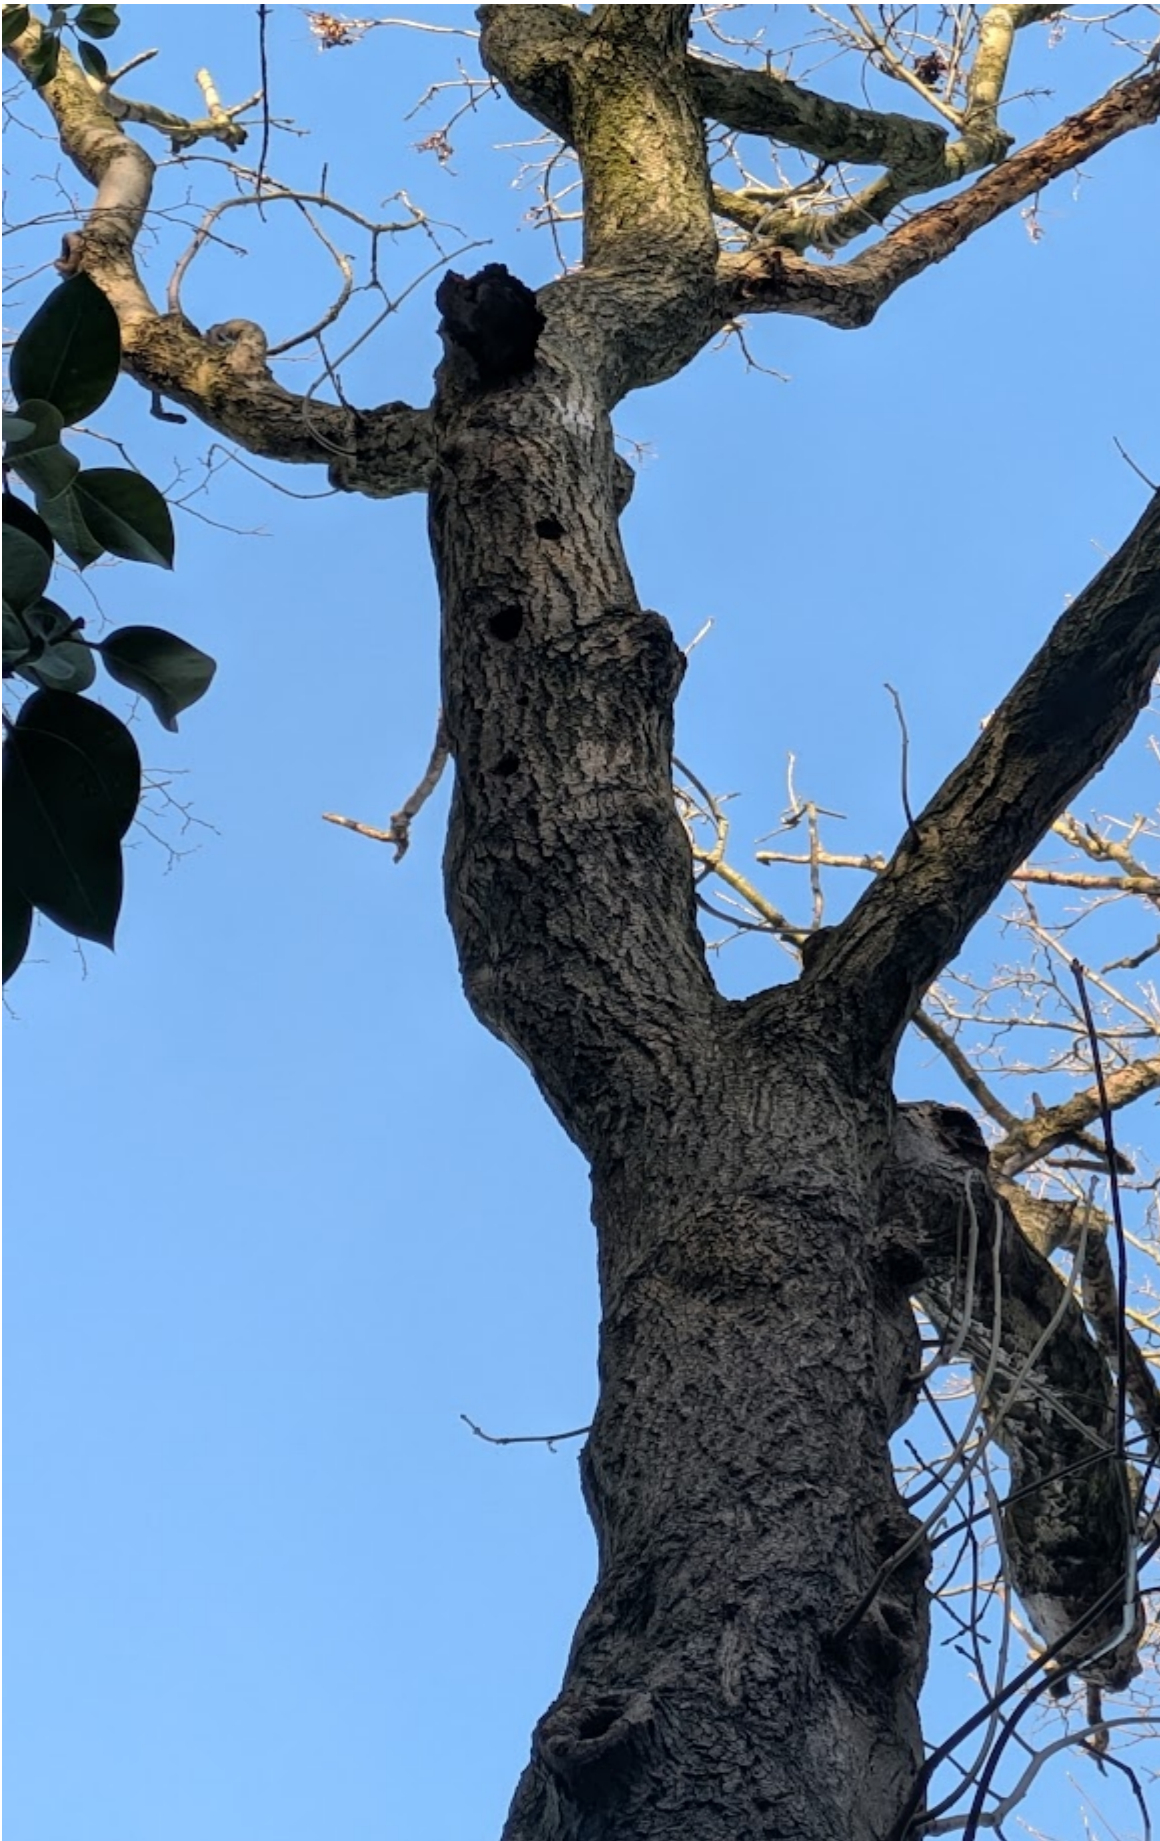
Ash in A1, wood pecker holes, and inonotus

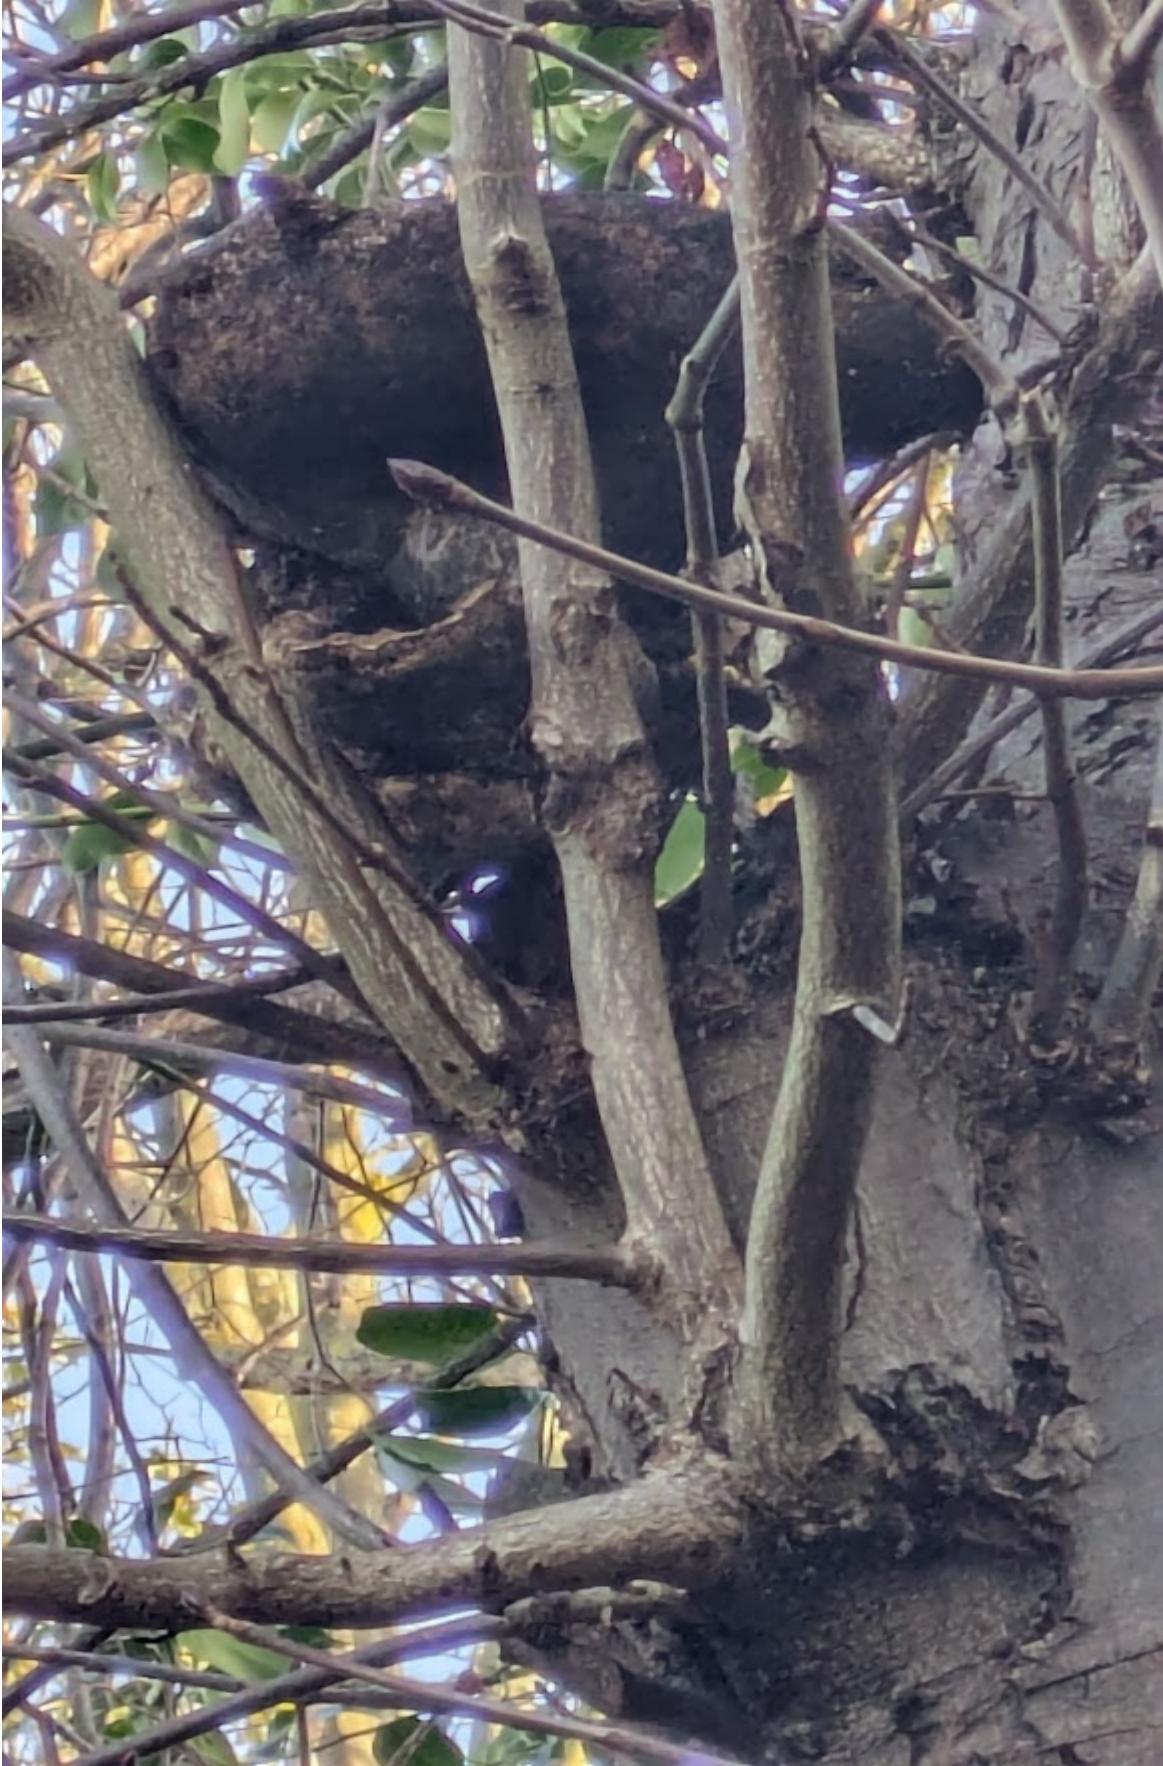
Twin stemmed chestnut, previously reduced, has giant polypore colonisations, decay in the main stem, observed is cambial necrosis, remove the tree within six months, replant with a fastigiate hornbeam or similar species.

Chestnut in A1, giant polypore colonisation.

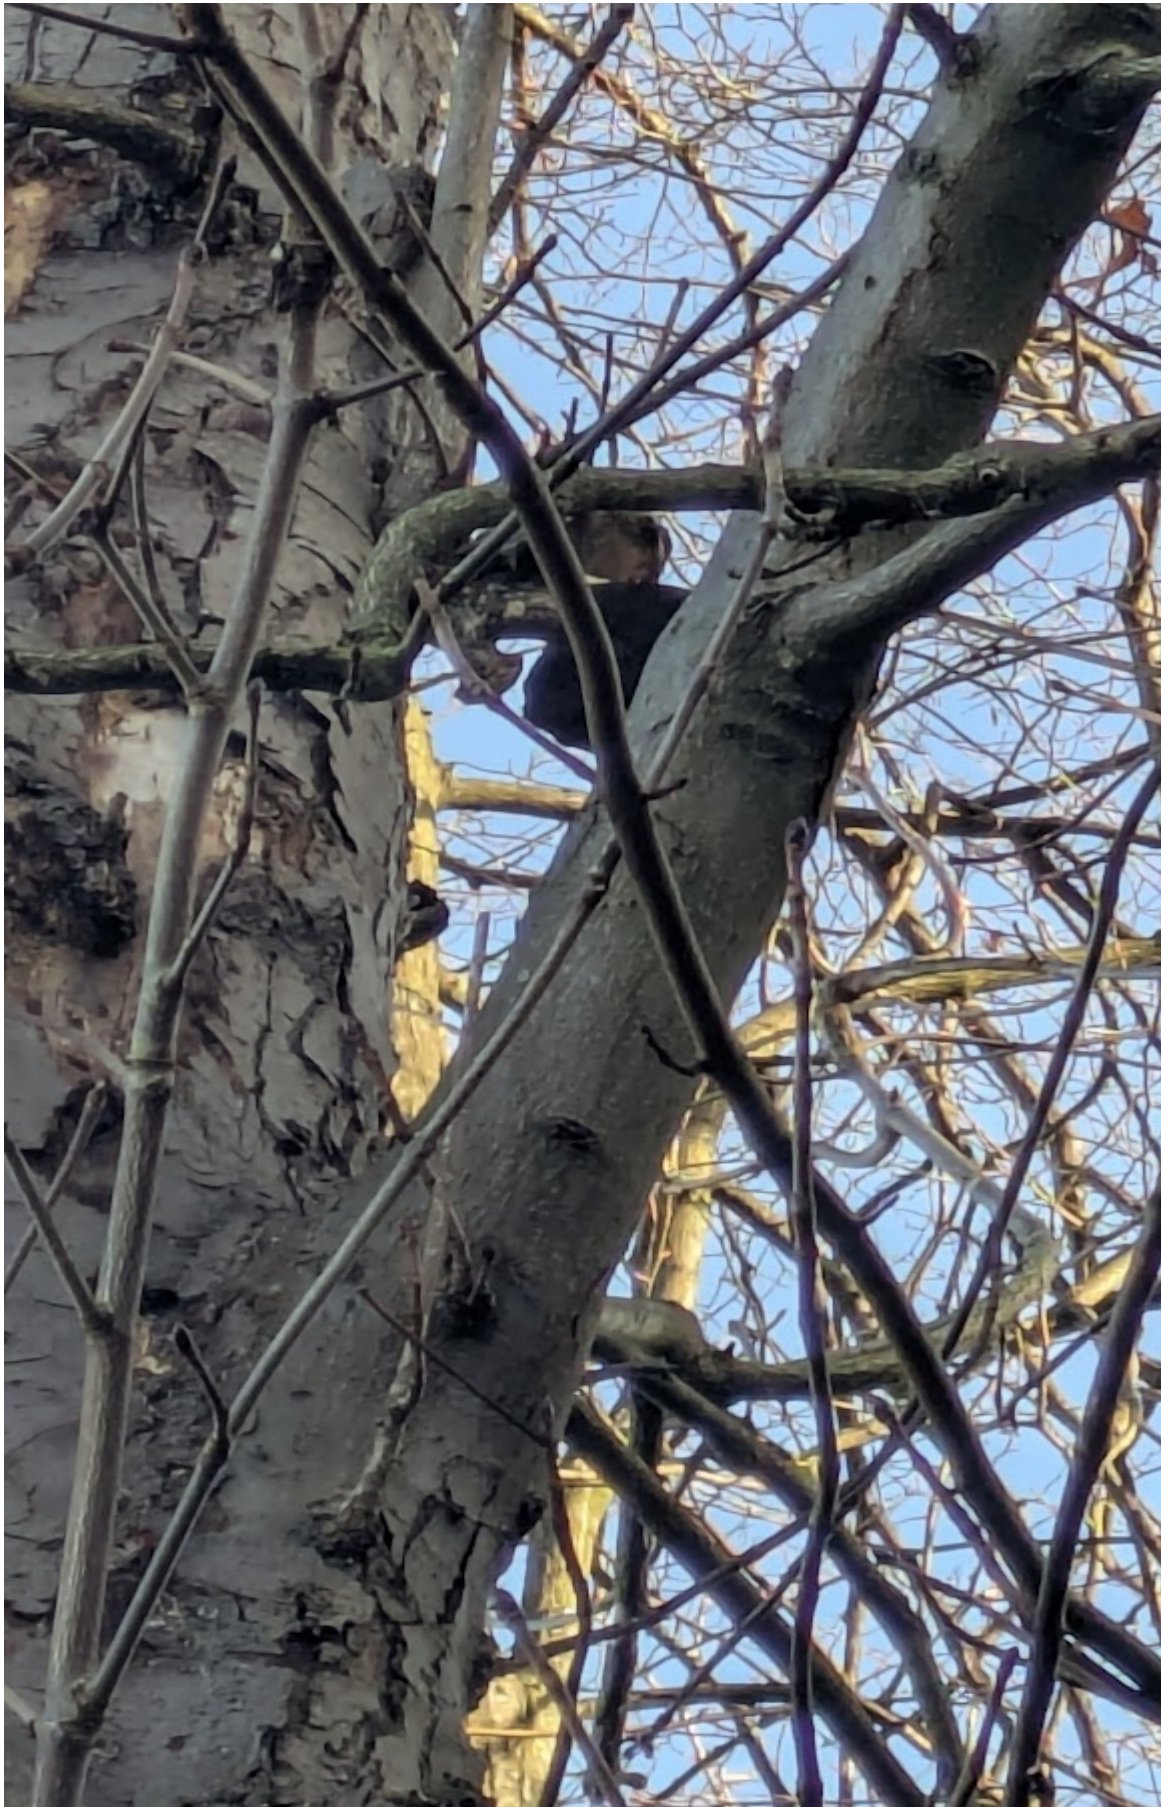
Chestnut in A1, cambial necrosis and more dryads saddle.
