**Far Westhorpe Farm**  
Heritage Statement  
Cottage - internal wall and  
first floor chimney  
**24-001-301**

Revision B – Issued for approval 18-02-26

**Far Westhopre Farm**  
**Penistone**  
**S10 2FX**

**Structural inspection**  
**9 September 2025**

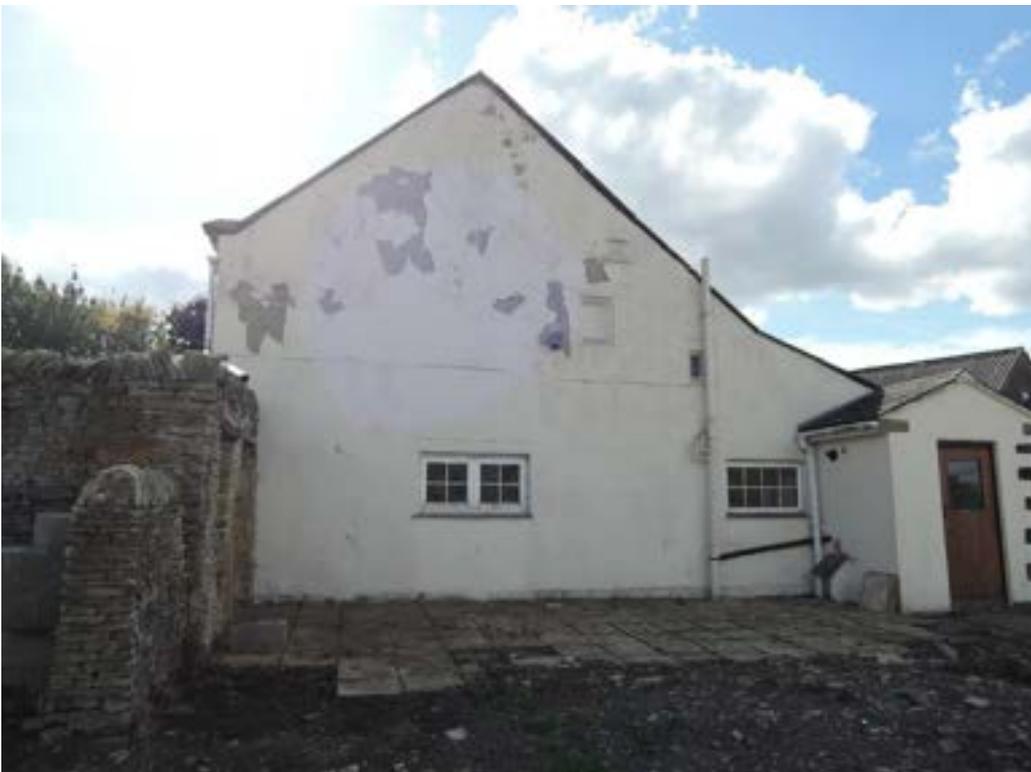
Northeast gable. Tired and peeling paint/render but no major cracks or bulging apparent.

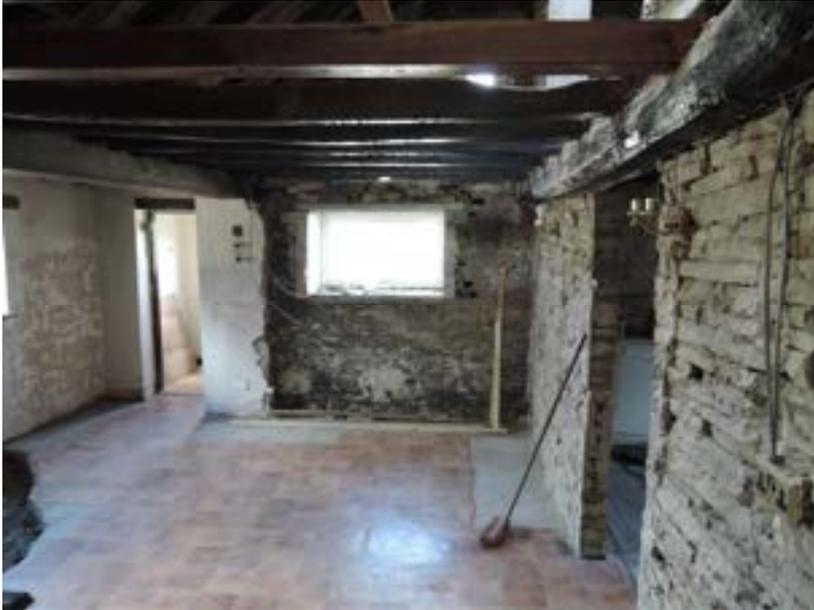
Kitchen. Non load bearing walls unstable under beam on right a touch unstable as they are loosely constructed and have informal head restraint. Take down and rebuild in blockwork as required.

The non loadbearing wall between kitchen and dining room (top photo page 9) is in fragile and fairly unstable condition. It is built hard up to a large timber floor beam and is taking a little head restraint from it. It is our recommendation that it be taken down and rebuilt in blockwork with better masonry ties at the wall abutments and underside of beam.

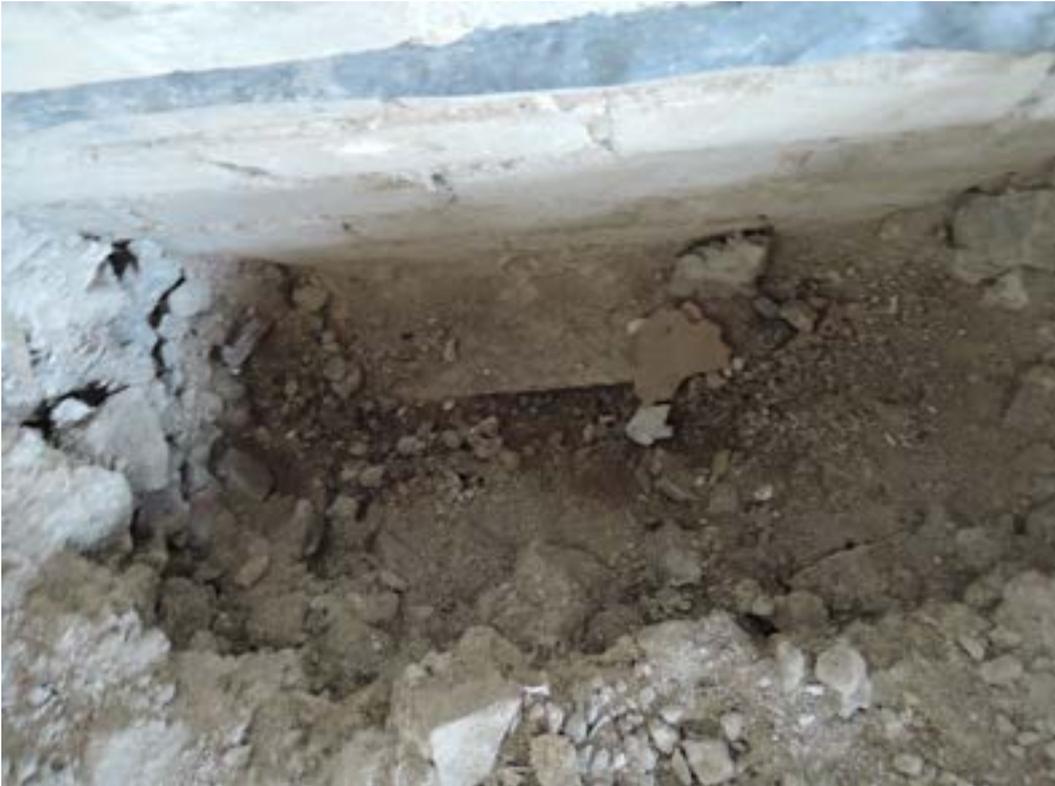
Trial pit showing foundation as concrete with 150mm projection at 300mm below slab. Foundation approx. 500mm – 600mm wide overall and therefore has capacity to support another proposed storey.

One trial pit was dug in the single storey extension to reveal the foundations (photos on pages 9 and 10) confirming the foundation as concrete with 150mm projection at 300mm below slab level. Foundation is therefore approx. 500mm – 600mm wide overall and so has capacity to support another proposed storey.

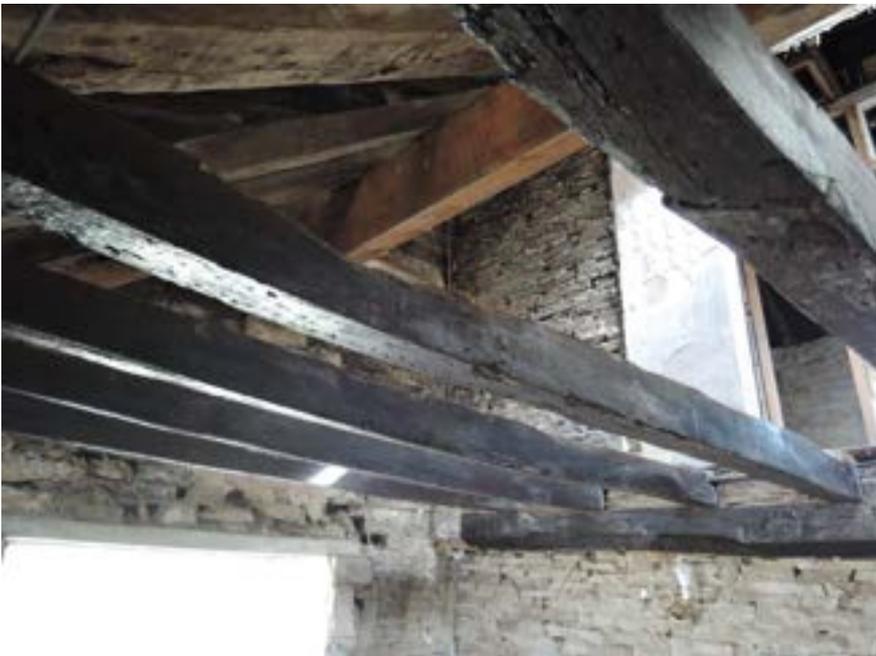
First floor (bathroom) joists over kitchen require replacement

The bathroom floor over the single storey extension has extensive woodworm (photos on pages 10 -12 inc) and so all beams and joists in that bay should be replaced with new floor joists as part of the first-floor extension works.

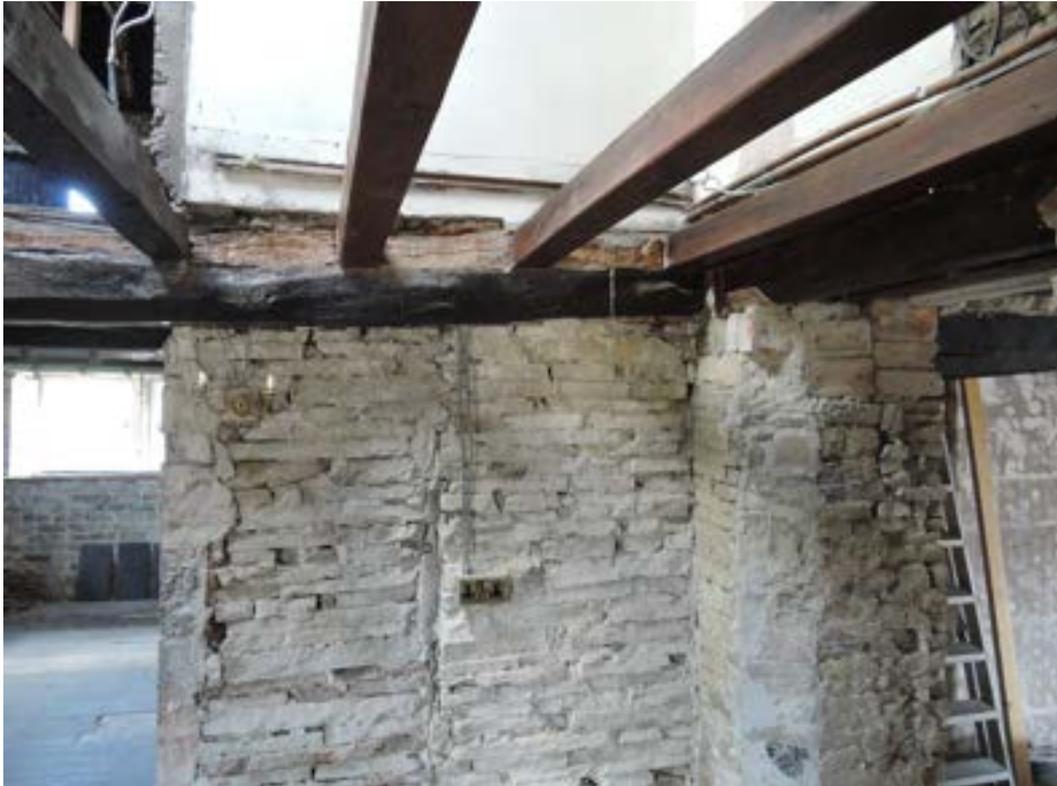
Beam with woodworm on kitchen/dining wall line. Unstable non load bearing wall (see comments under top photo page 9)

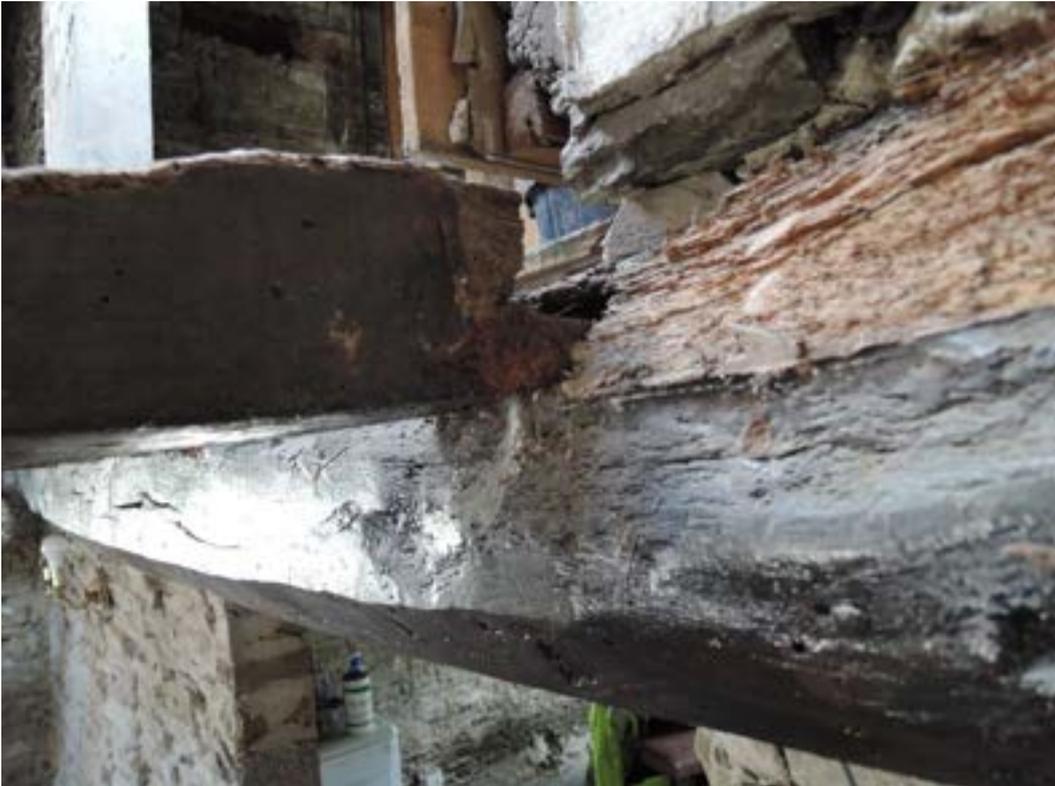
Joist end about to fail (several joists in this state)

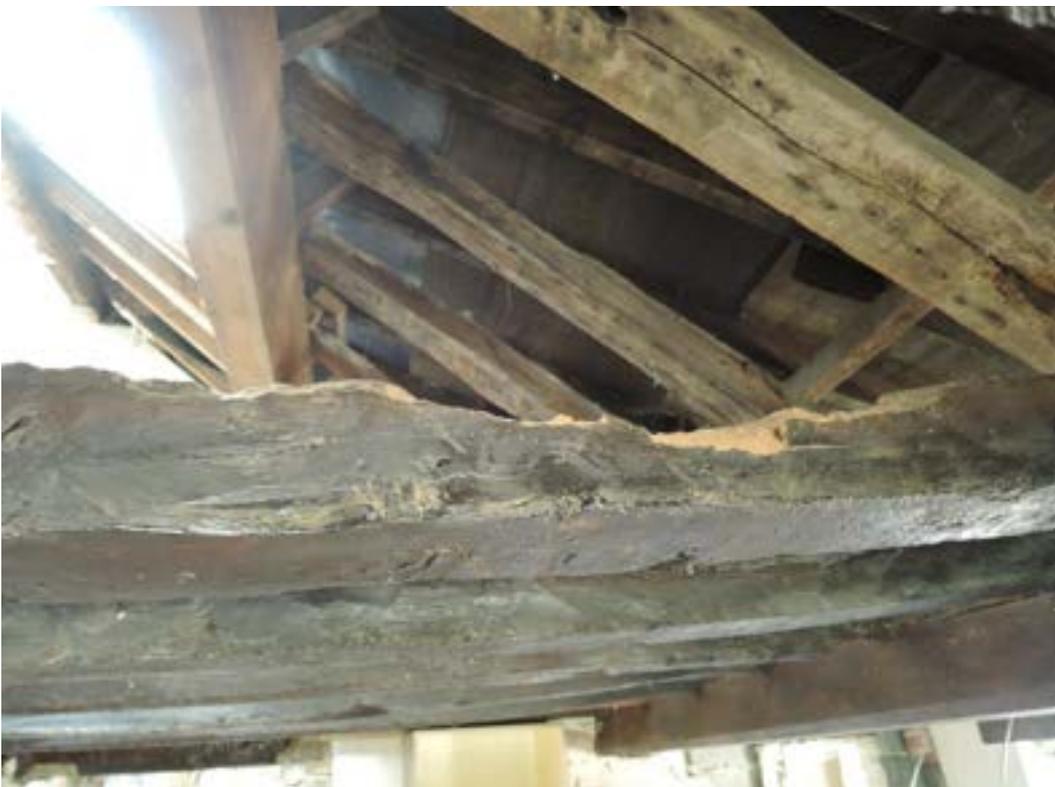
Timber mass losses due to insect attack.

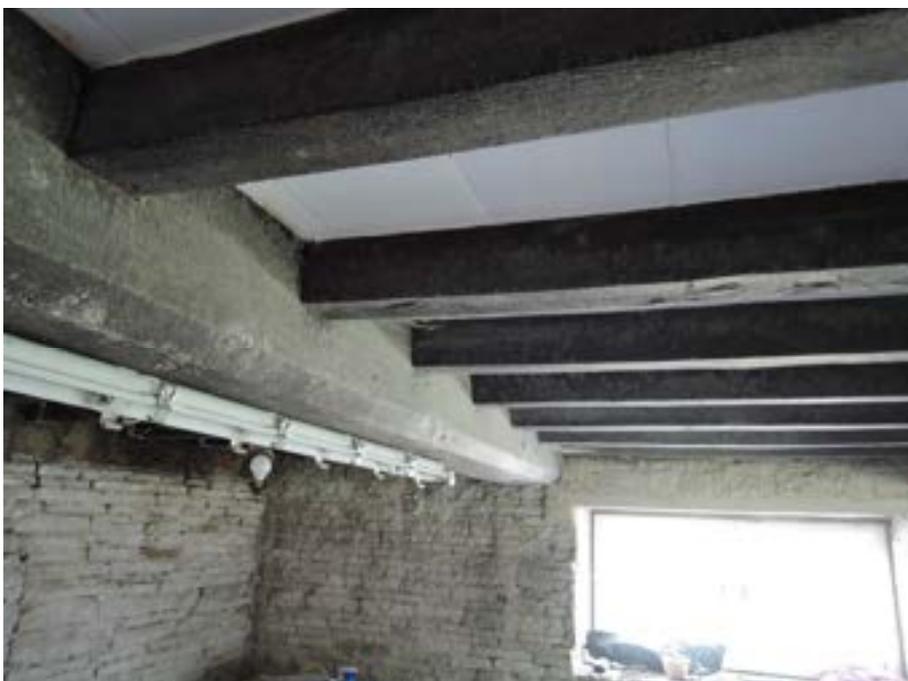
Dining room ceiling. First floor joists and beams in good order (subject to specialist inspection for rot/insect attack). Acceptable bounce under drop heel test.

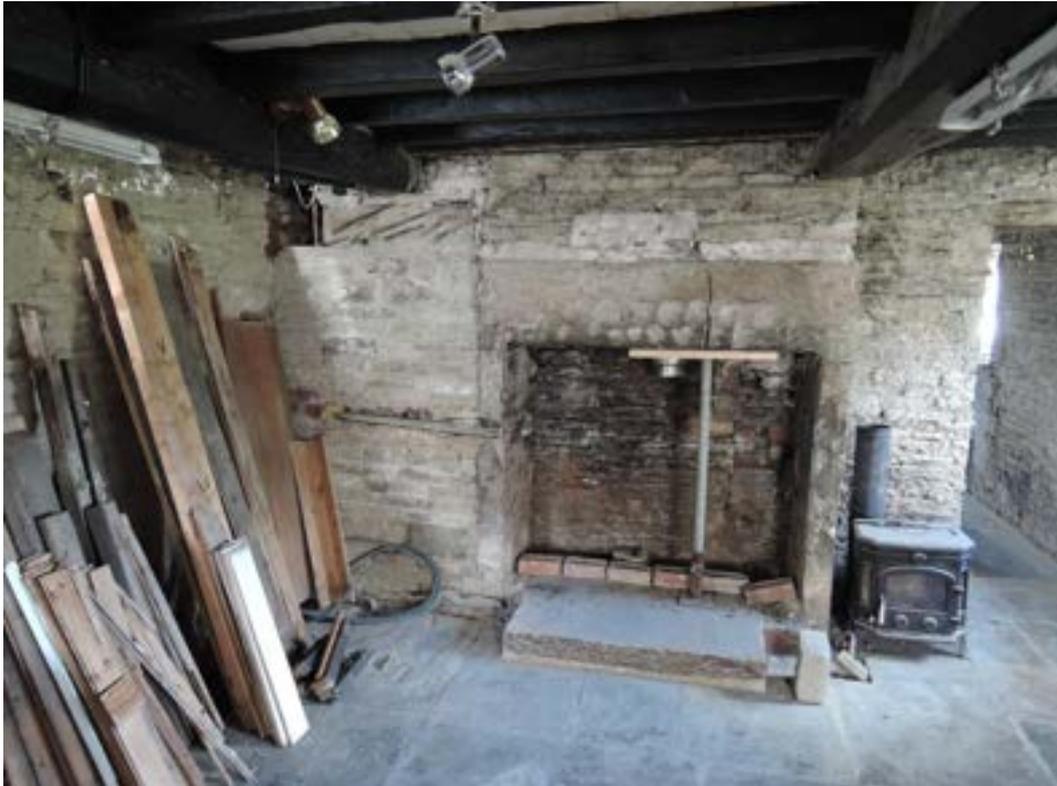
Living room fireplace. Cracked mantel stone with acrow prop. Right cheek wall has yielded out to the right following bending failure of mantel.

Repairs required to ground floor fireplace with cracked mantle stone and out of plumb right hand fireplace cheek (photo top of page 15)

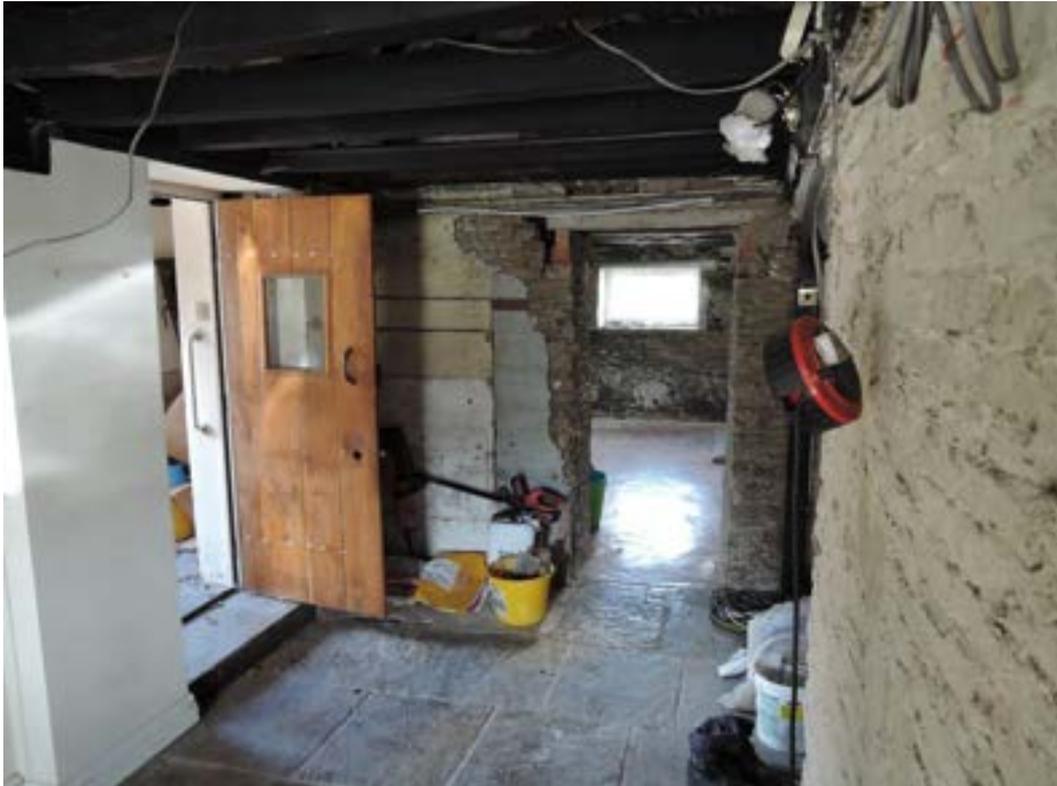
Hallway. Joists over to be replaced in new first floor works

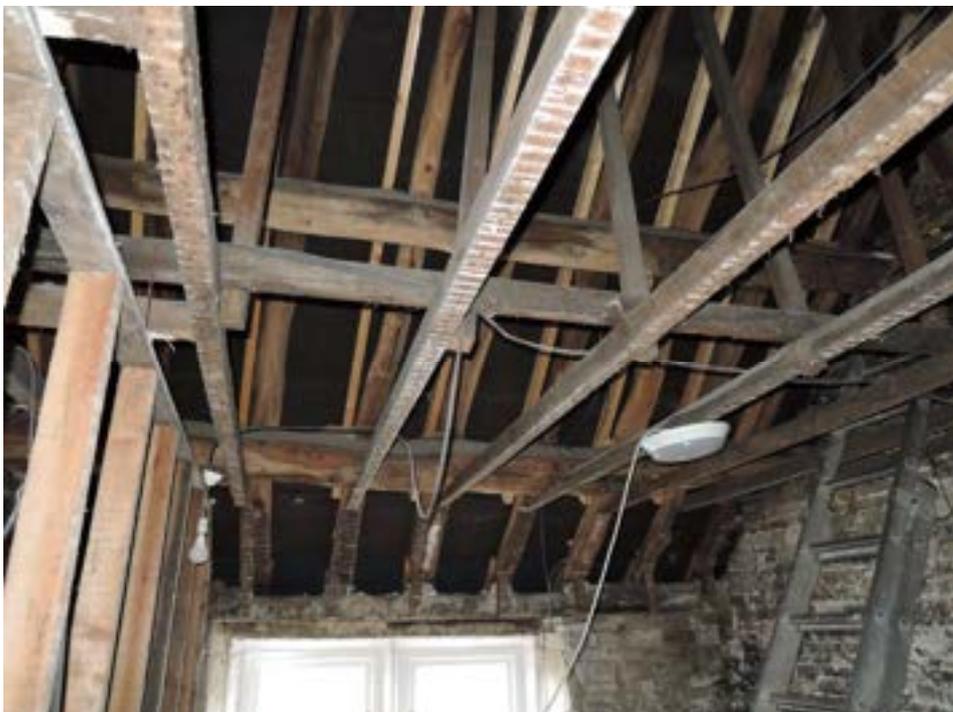
Roof over existing first floor bedrooms. Dry and weathertight. Specialist inspection recommended to check for fungal and insect attack.

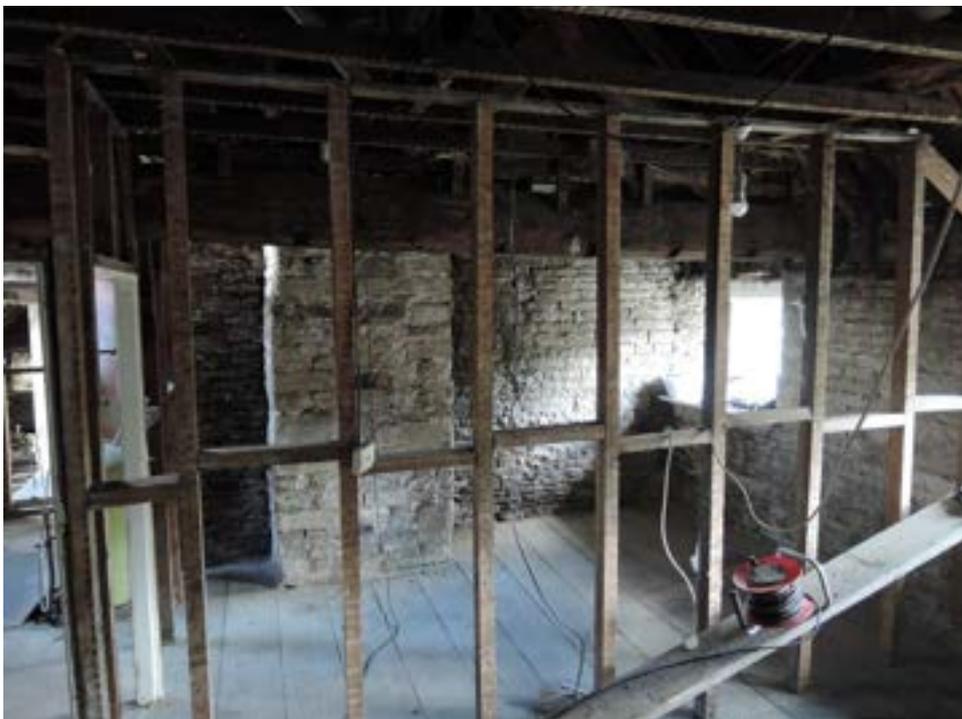
Stone flue from living room below (with cracked mantle). Terminates at ceiling and goes sideways into original chimney

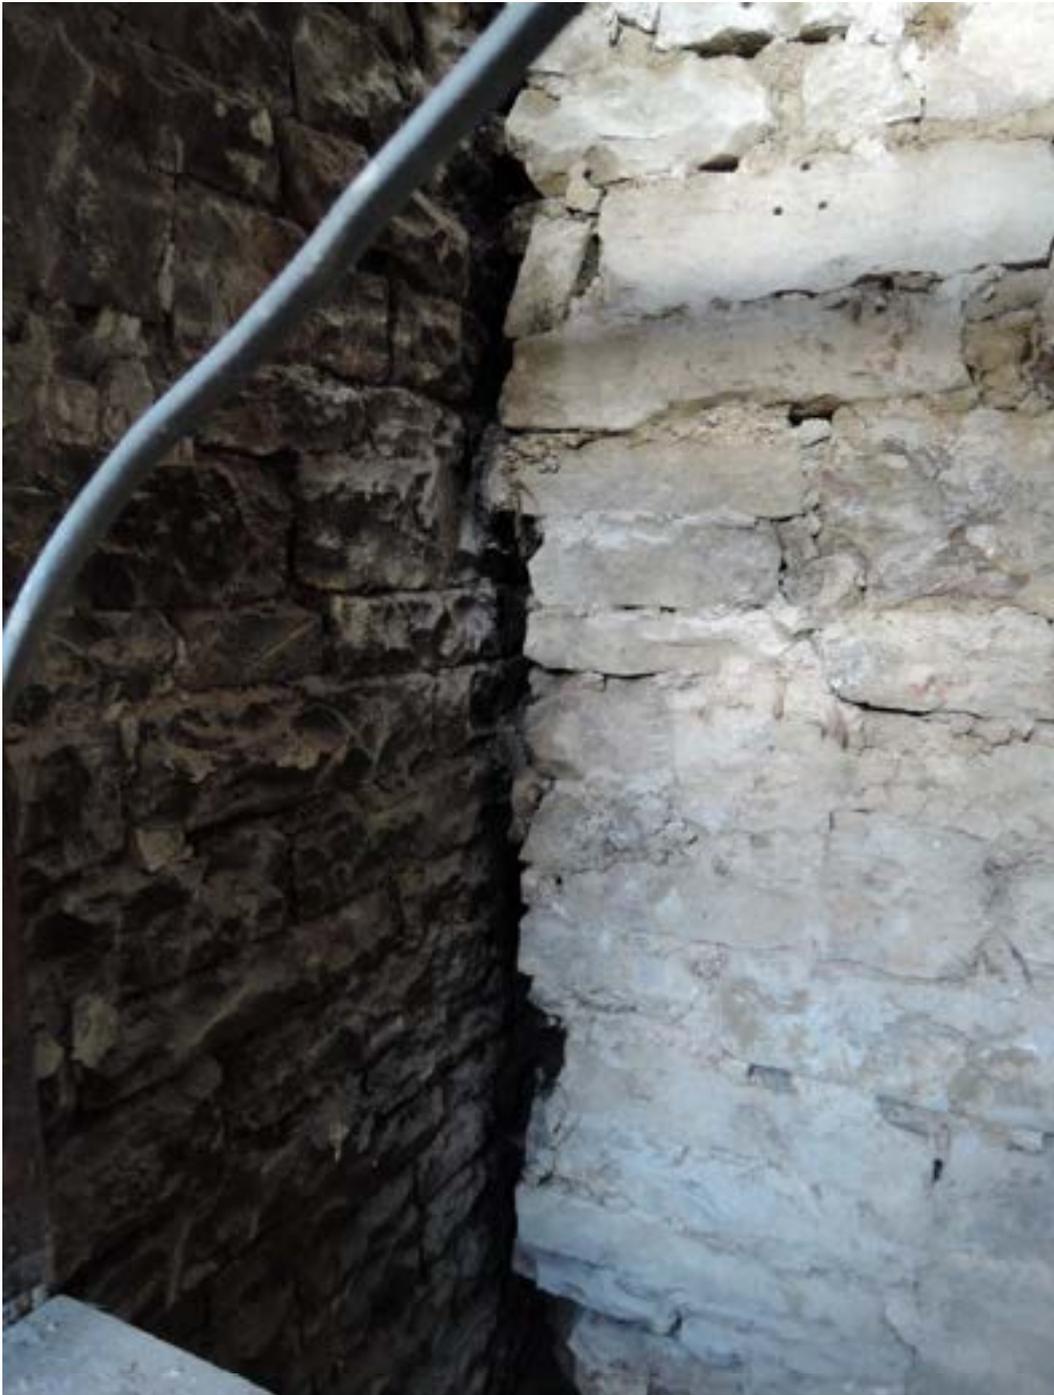
Stone flue left side not bonded into wall

The flue in the bedroom on the back of the original fireplace is not bonded into the bedroom party wall (photos on p17 – 19inc) and as it is redundant and reduces the bedroom floor footprint, we would recommend that it be removed to take out future repair liability.

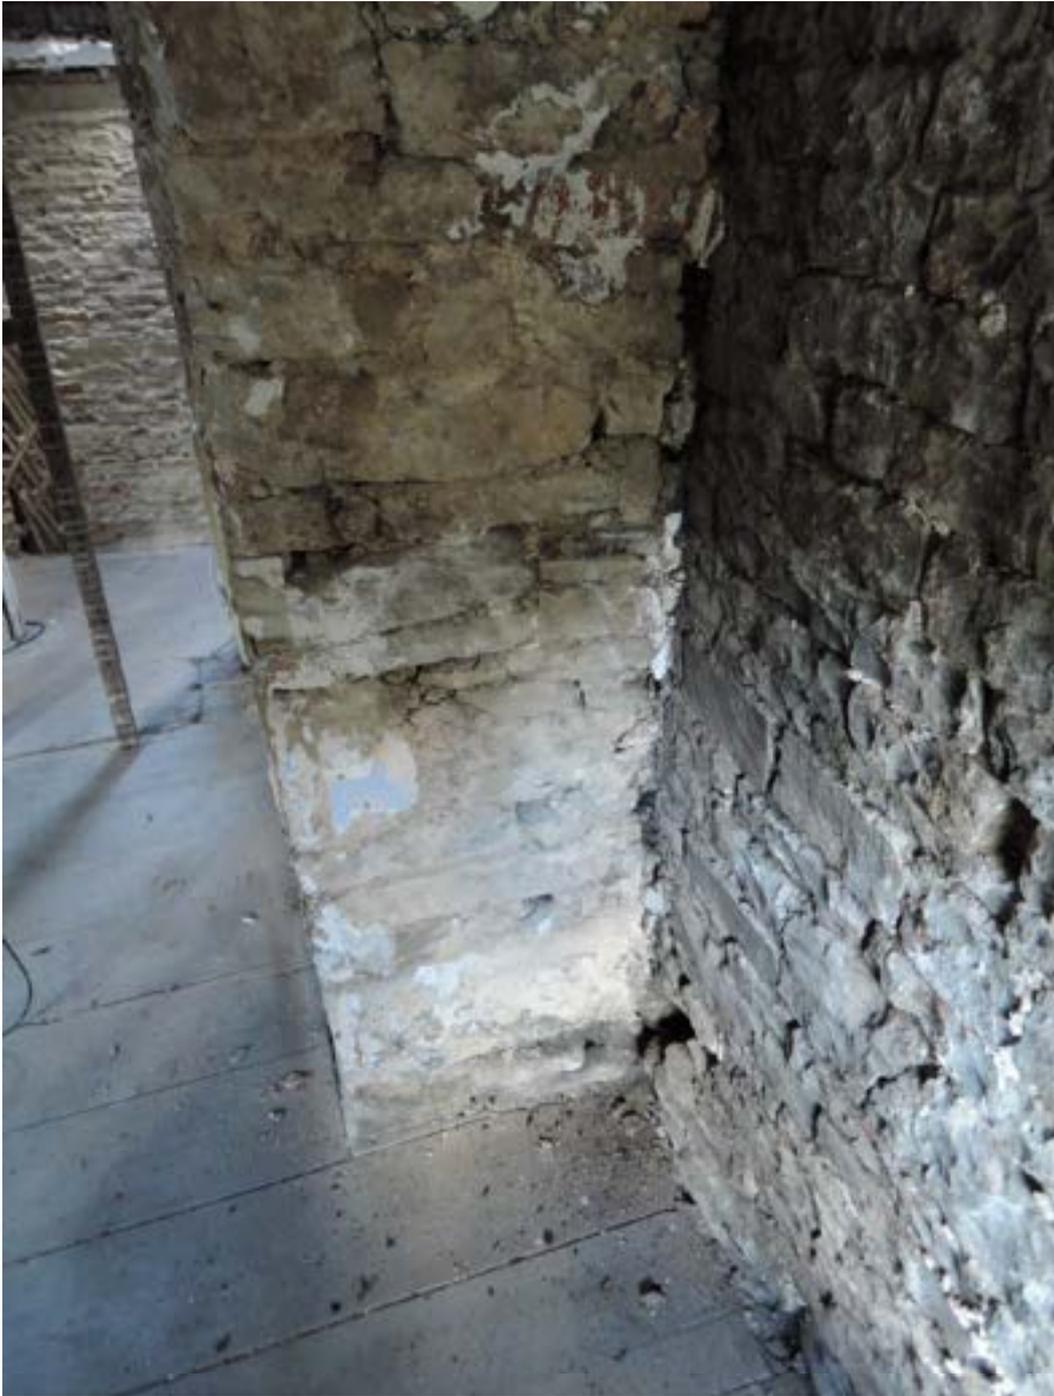
Stone flue right hand side. No bonding into wall

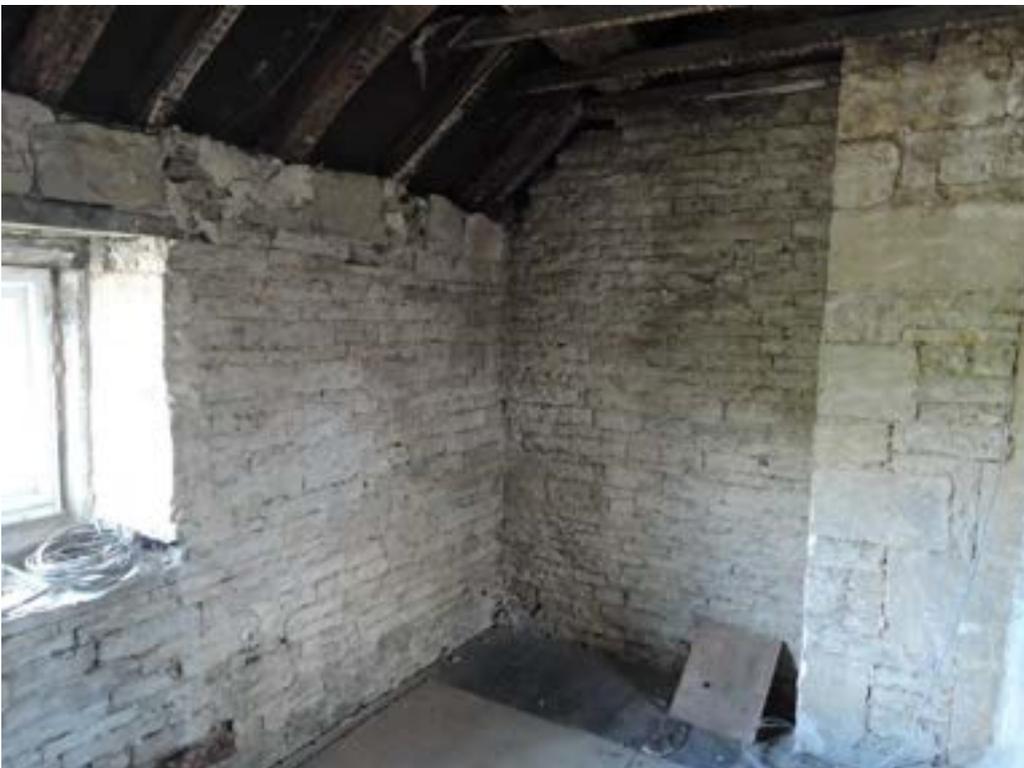
Garden side bedroom wall. Loose stones at head need looking at. Replace timber lintel.

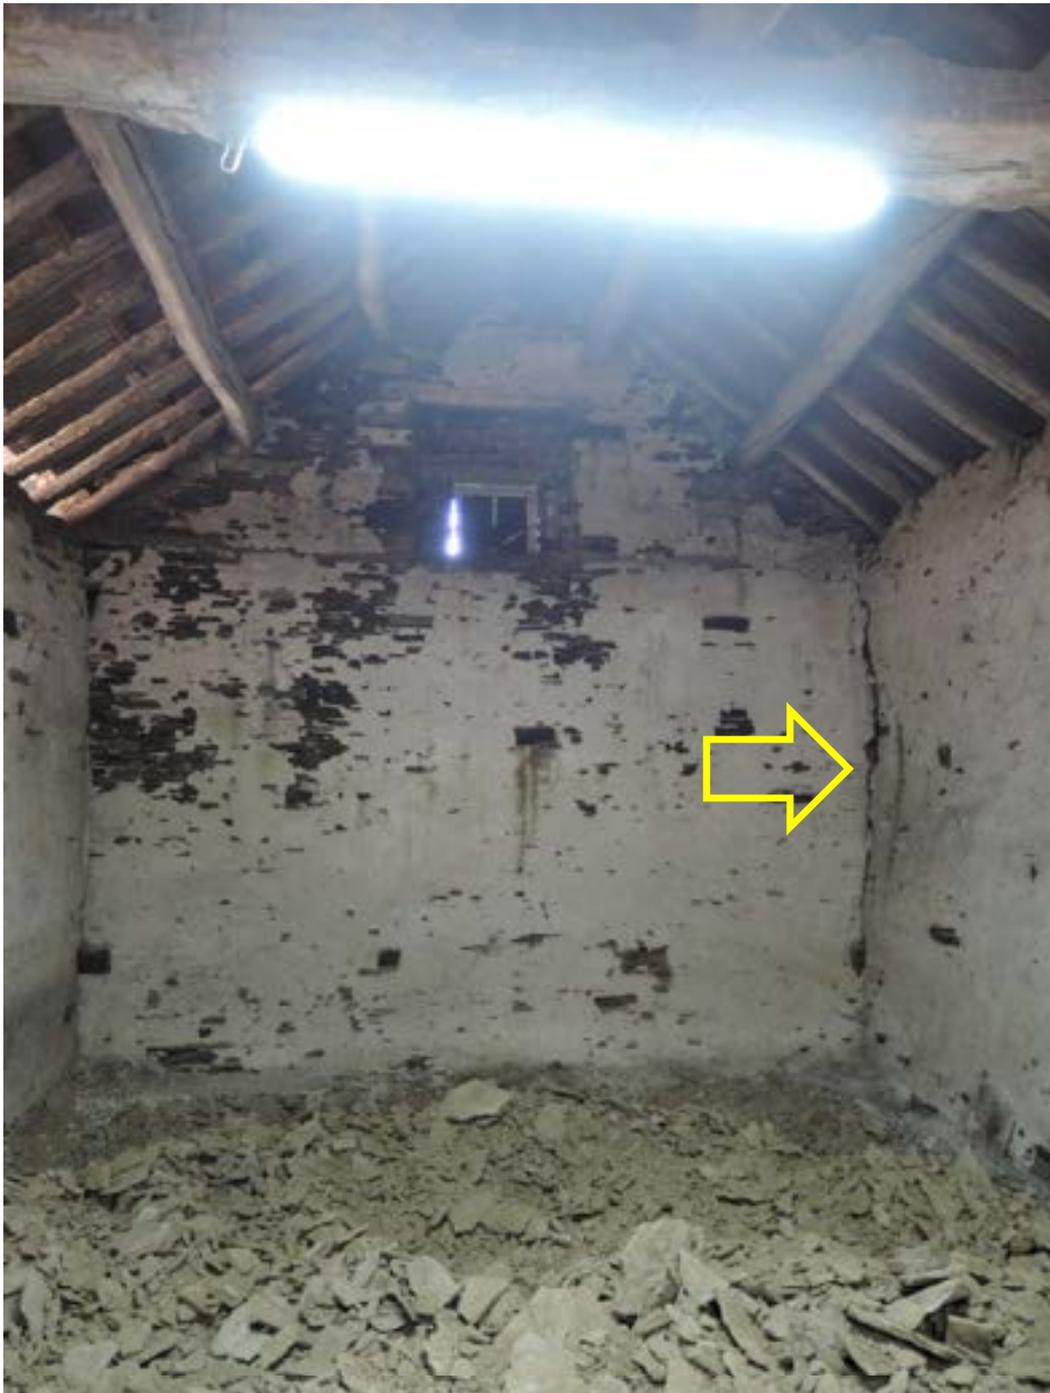
Large barn south gable. Bulge and crack arrowed where flank wall has released. Local dismantling and rebuilding recommended. Add this to the 'take down and rebuild' recommendation of the outward bulging gable (page 22). This picture is the inside face of the south gable

There is an outward bulge and serious crack mid height in the south gable wall (arrowed in photo on page 30) where the flank wall has released the gable. A small amount of dismantling and rebuilding will be required. The bulge is too large to lock in place by masonry stitching (Helifix or the like).

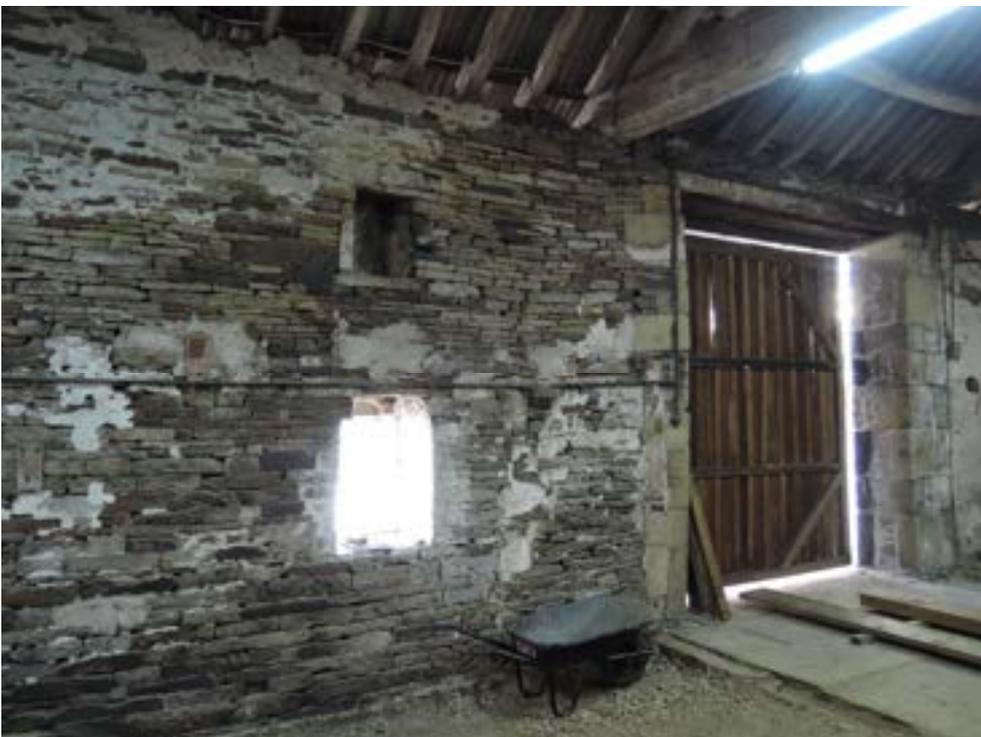
Courtyard wall and main door. Local settlement under truss left of large door. Foundation may need strengthening with local underpinning

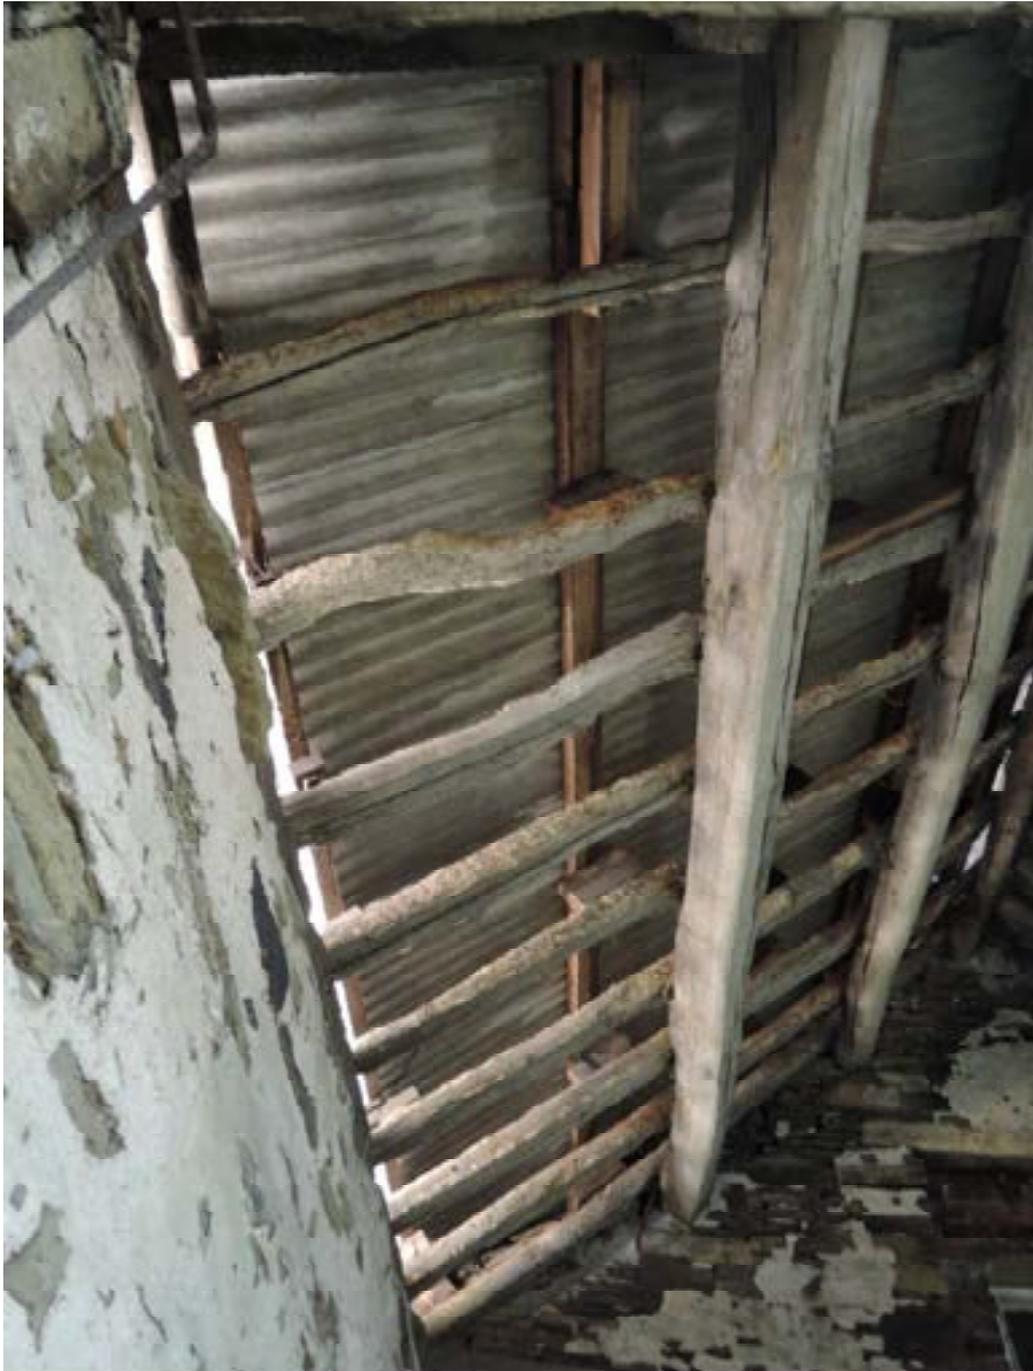
Roof southeast corner, rotting rafters: fairly typical of entire roof. New roof recommended for conversion into habitable building. Purlins and trusses may be suitable for strengthening and refurbishment, but rafters should be considered as end of service life.

Rafters are in generally poor condition and eaten away by wood worm. Purlins have most likely suffered from worm but as they are thicker larger timbers, they may be retained if treated by a specialist. The same goes for the timber king post trusses.

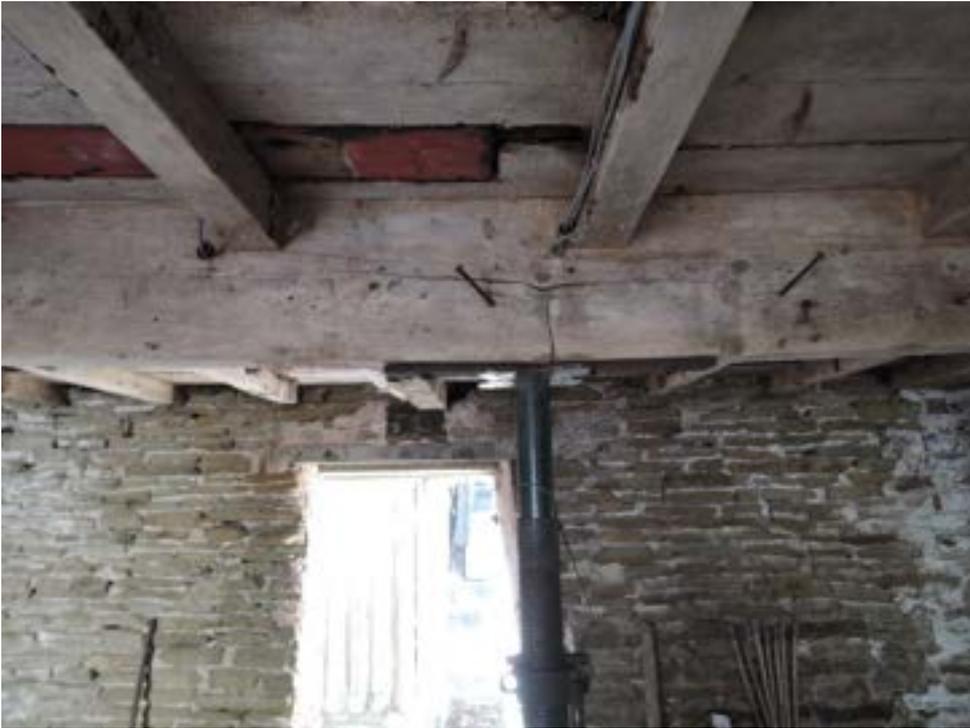
Small barn. Acrow prop to failed 1<sup>st</sup> floor timber beam

The first/mezzanine floor is worn out, has woodworm and a main beam is broken and currently supported on an acrow prop (photo page 37). Leaning walls have removed end bearings which are now on temporary timber propping. Considering its poor condition and support plus the very low headroom provided at ground floor, we recommend the floor be replaced in the refurbishment/remodelling.

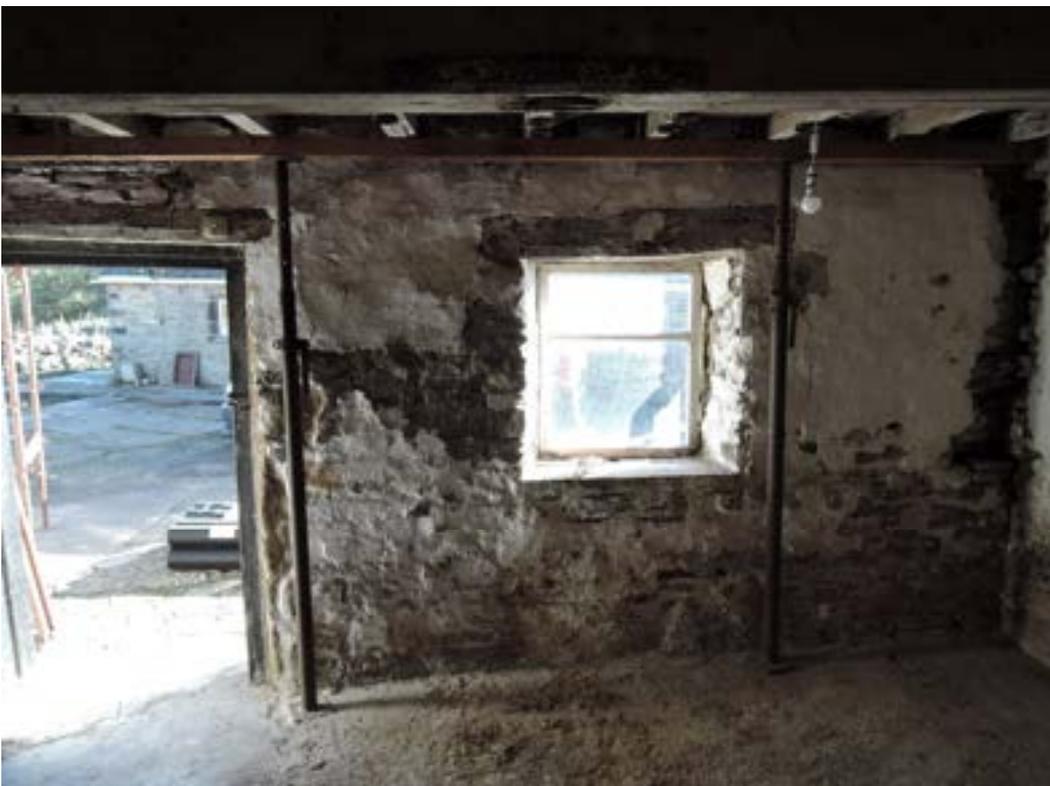
Outward leaning wall has released 1<sup>st</sup> floor joist ends which are now only supported on a makeshift timber bearer and acrows. Failed/absent wall internal wall buttress bonding full height (far right side of picture)

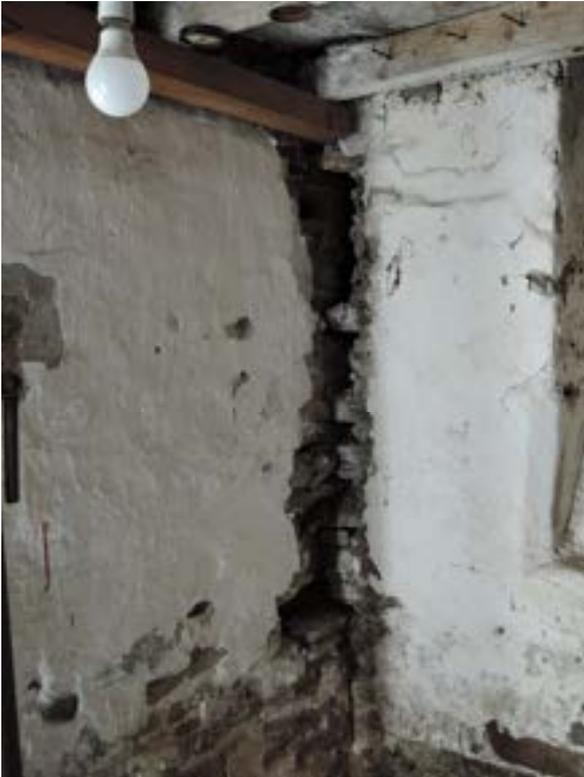
Large gap where courtyard wall is leaning away from internal buttress wall. Failed bonding/tying

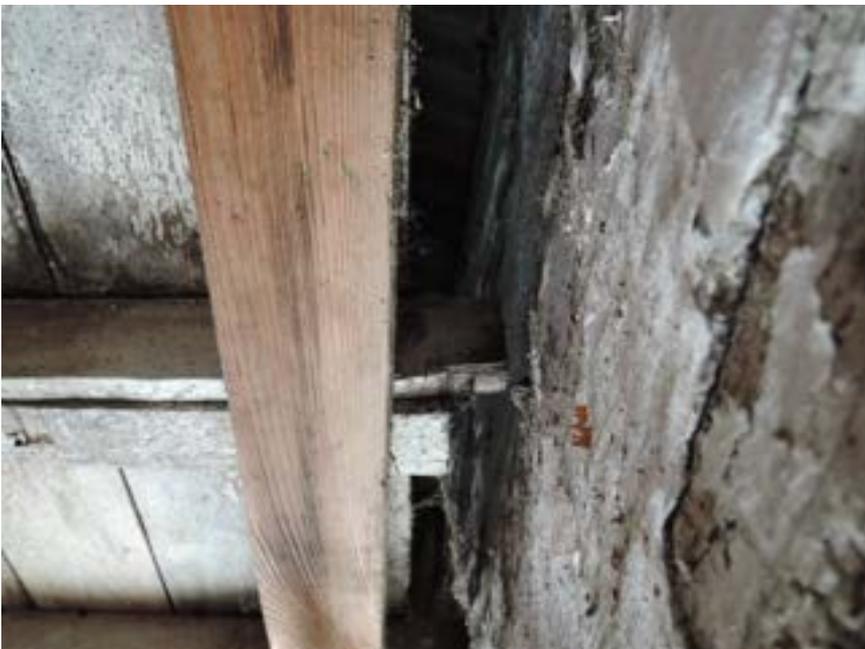
Wall has drifted out circa 75-100 mm completely releasing and abandoning first floor joist ends.

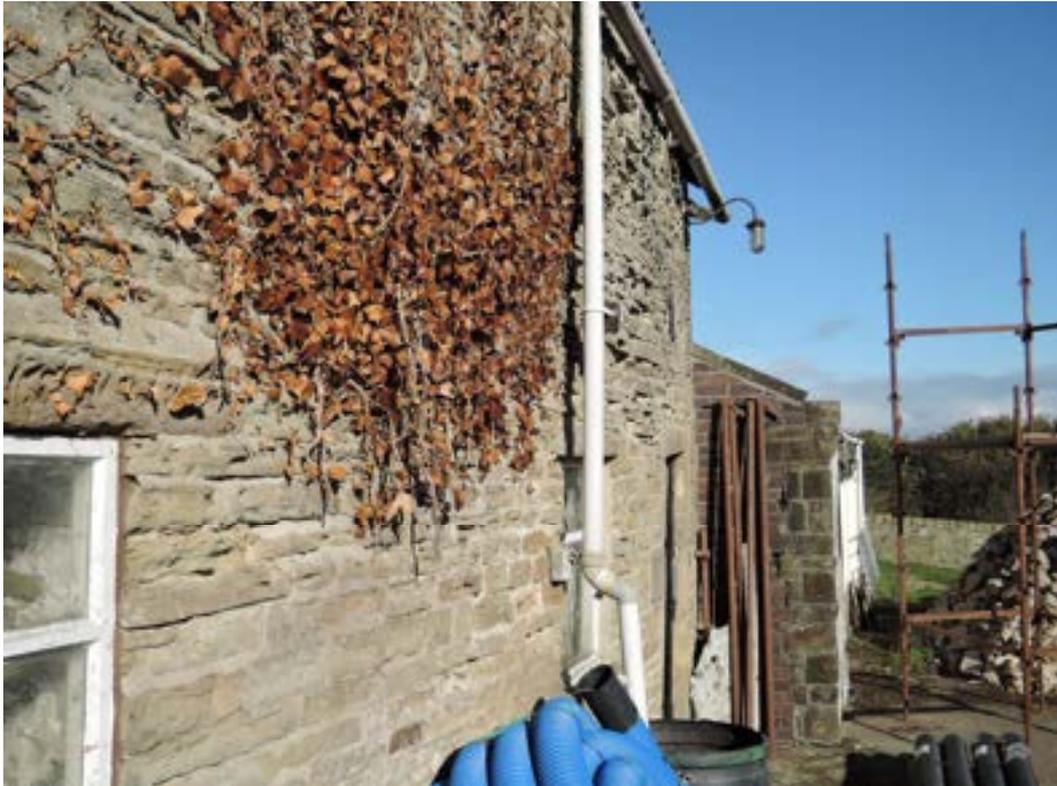
Small barn courtyard (east) wall leaning into yard abandoned first floor joist bearings (previous page)

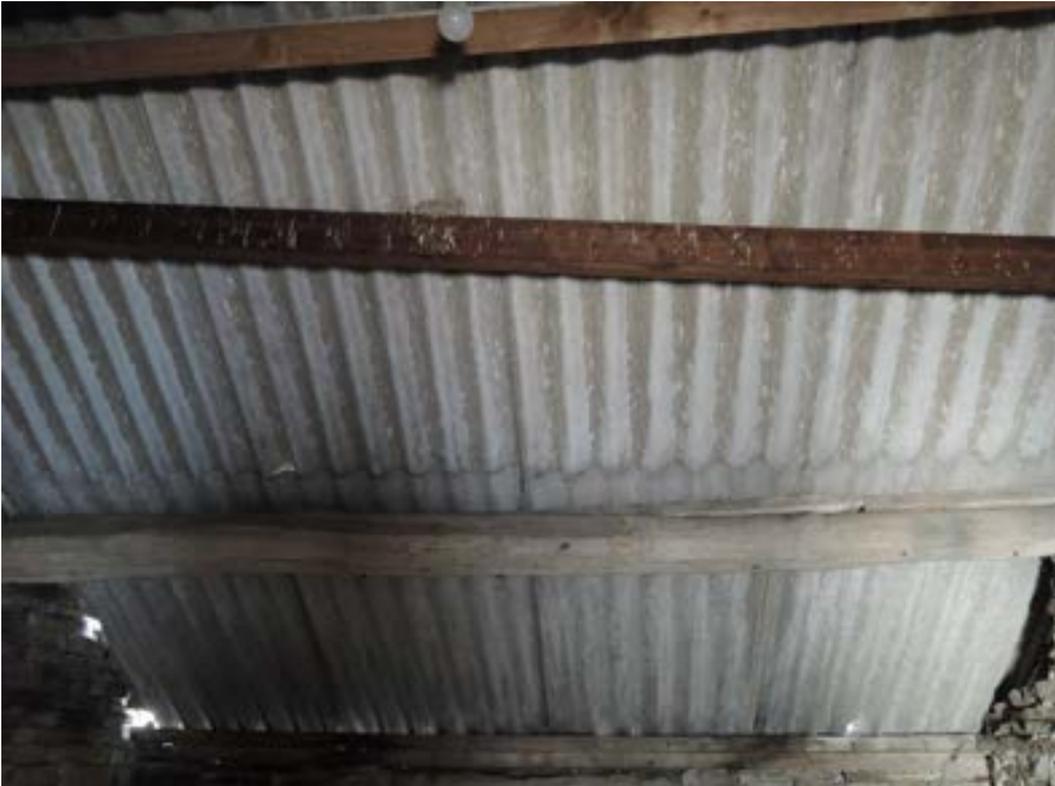
Roof. New rafters, purlins and covering required if being converted for habitation

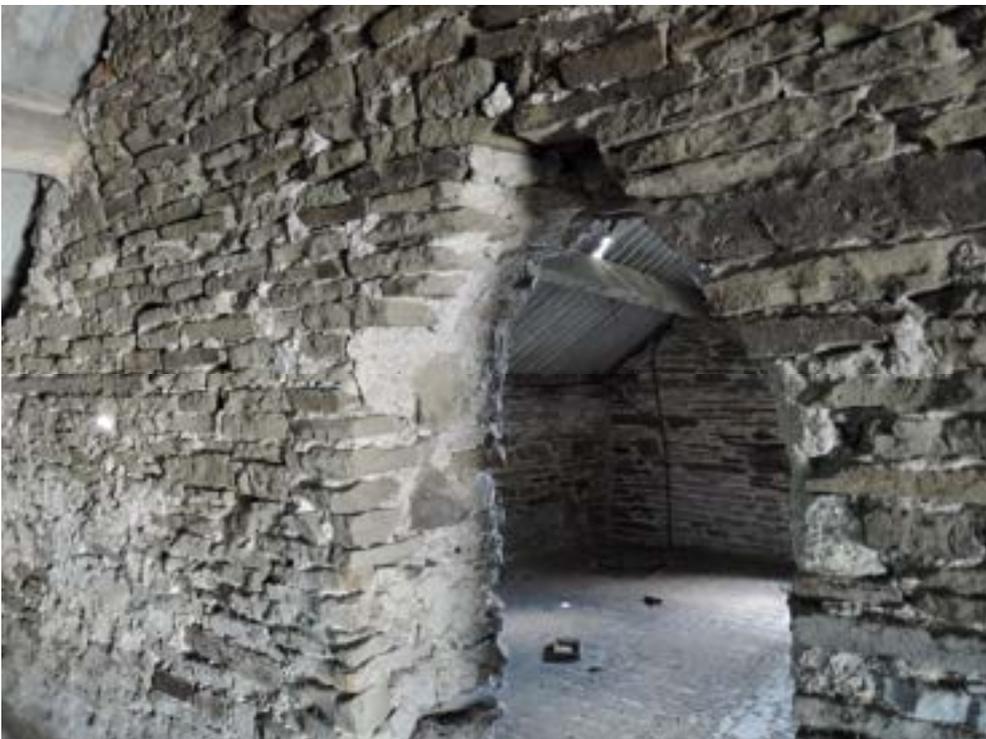
Inner wall first floor. Light repair required at head of arch

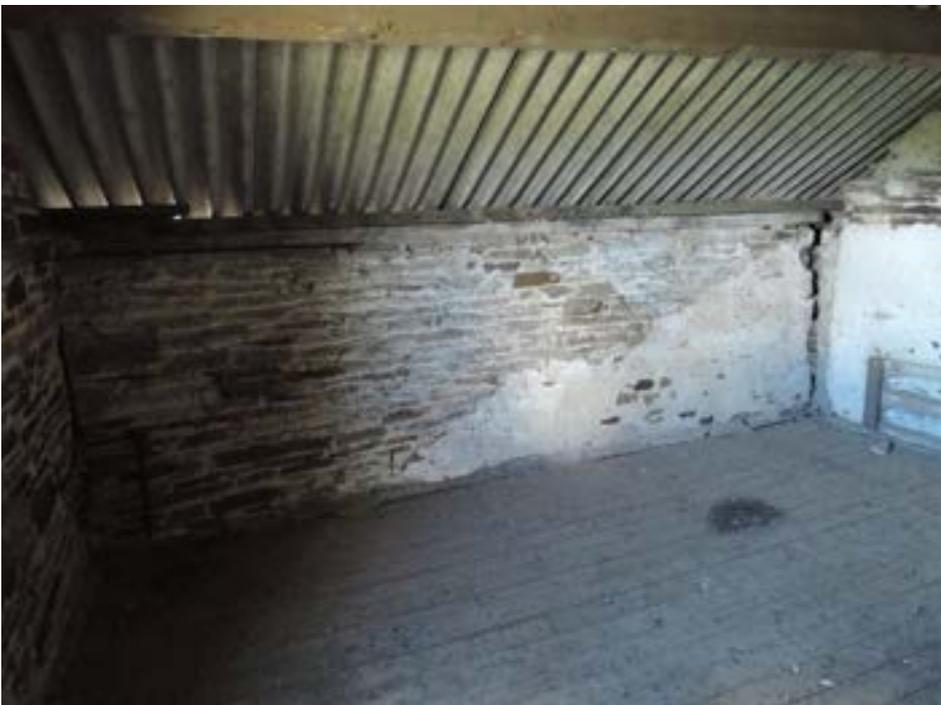
Corner cracking in wall junction indicating outward wall lean and lack of tying in
