**Far Westhorpe Farm**  
Heritage Statement  
Cottage - internal wall and  
first floor chimney  
**24-001-301**

Revision B – Issued for approval 18-02-26

**Far Westhopre Farm**  
**Penistone**  
**S10 2FX**

**Structural inspection**  
**9 September 2025**

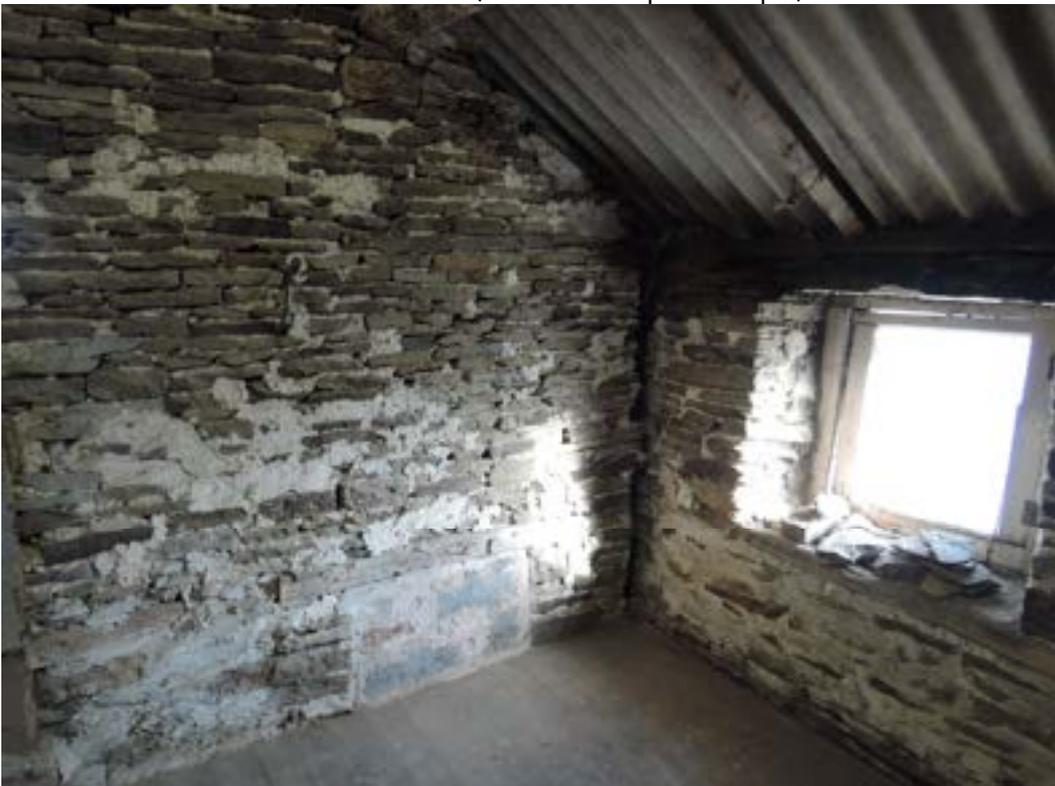
Small barn 1st floor west wall leaning out no bonding/tying to cross wall (large gap)
