# Wentworth Castle

## Plaster Ceiling Survey

02/08/2024

| <b>Nature of project:</b> | Plaster ceiling survey for multiple rooms |

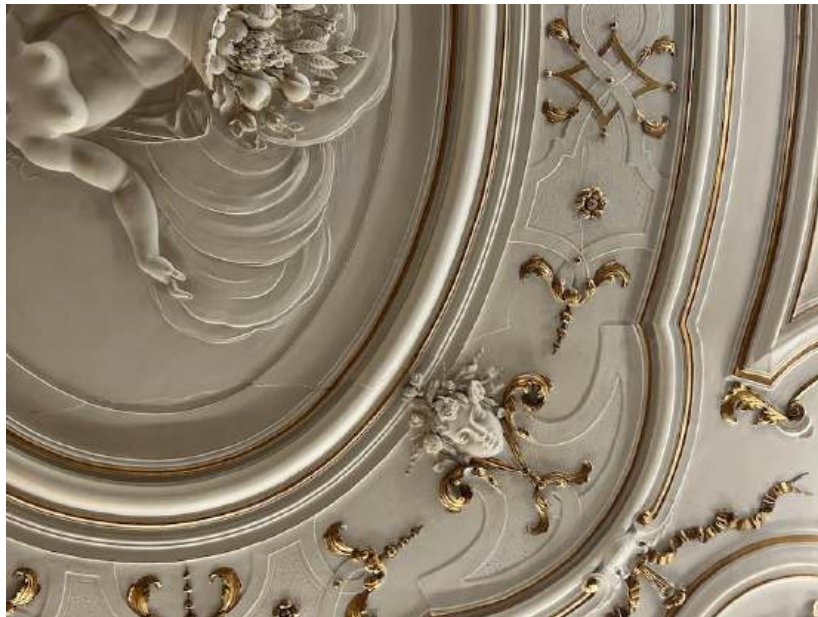
- The Blue Room, North End Room was found to be in good and stable condition.
- Multiple hairline fractures were noted throughout the ceiling and through the decorative details and cornice (Figure 3).
- There were multiple fractures noted at the junction between the ceiling and mouldings.
- The ceiling was found to be solid and stable from push testing.

*Figure 3. Image of hairline fracture running through the decorative plaster ceiling.*

- The ceiling expanse was found to be in stable condition from observation and tactile testing of the underside.
- If possible, observation of the upper side of the ceiling is recommended to ensure stability of the ceiling and its composing elements.

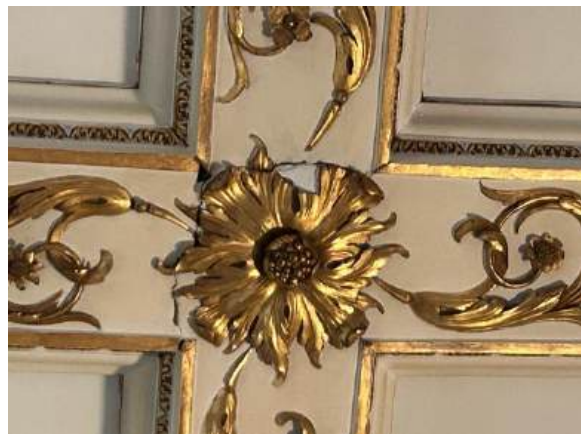
- Multiple hairline fractures were noted throughout the plaster, decorative elements, and cornice (Figure 8).
- Hairline fractures were noted on multiple enrichments; however, these may have been deliberate cuts created for the historic stabilization work on the upper ceiling (Figure 9).

*Figure 9. Fracture which could be a deliberate cut noted on multiple enrichments.*

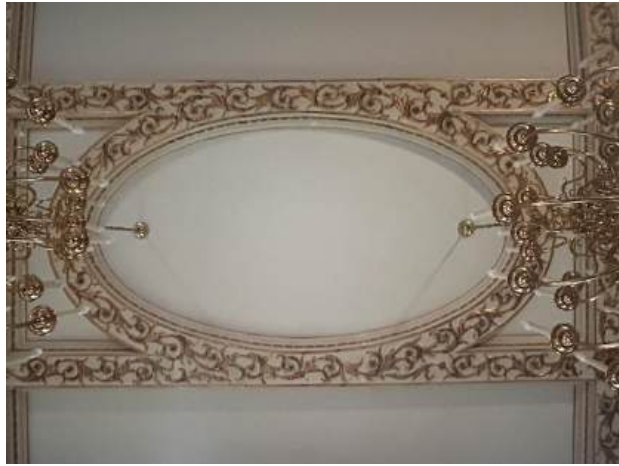
*Figure 12. Equally spaced fractured mirrored on East and West sides of the central decorative oval.*

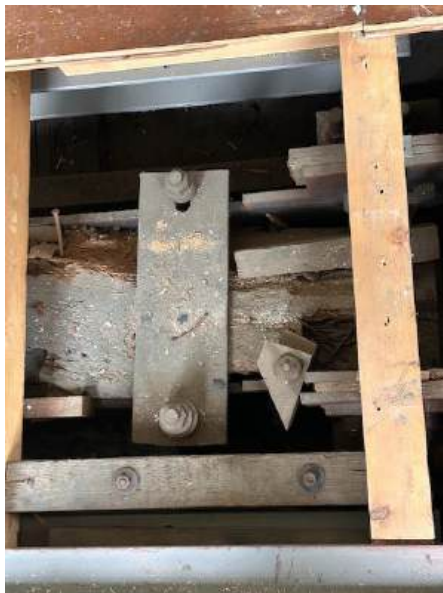
- Multiple hairline fractures were noted along the enriched decorative beams in equally spaced sequences. These also appeared to be deliberate cuts which could have been from the previous stabilization work to the upper side of the ceiling. Evidence supporting the insertion of deliberate cuts is aided by the visible presence of multiple bolts found between each fractured section. (Figure 11). These were found mirrored on both the East and West ends of the central decorative oval (Figure 12). These bolts match to the stabilization bolts viewed from the upper ceiling (Figure 13).

*Figure 13. Bolts visible from the upper side of the ceiling matching the location of the bolts visible on the underside of the ceiling.*

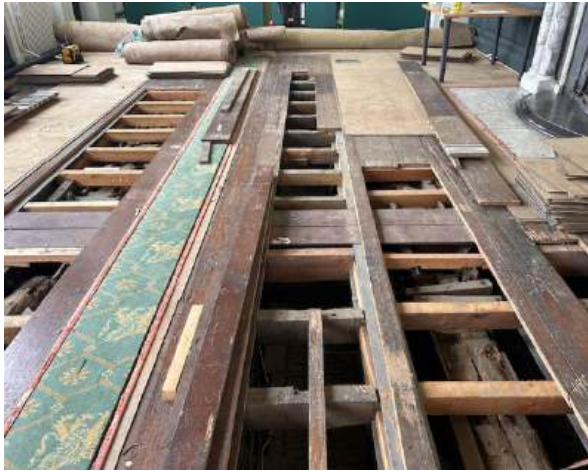
*Figure 15. Access to upper side of the ceiling was provided by expanses of the floorboards being lifted.*

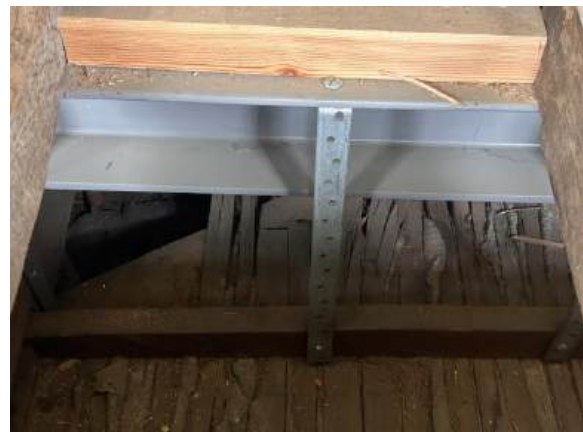
*Figure 18. Later steel beam gives evidence of a second phase of intervention and stabilization. Bat straps are attached, connecting the plaster ceiling to the structural repairs above.*

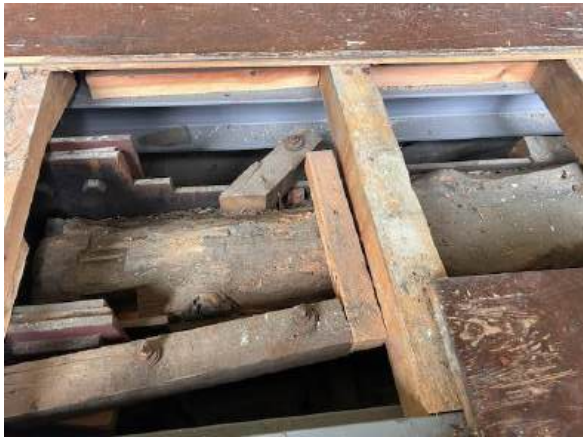
- Nibs and Laths were overall found to be in good condition (Figure 17).
- It appears that there were two major phases of renovation historically to the Blue Room ceiling. This is evidenced by red coloured inserted steel beams running East to West (Figure 17) and grey coated steel beams of a later manufacture found inserted running North to South (Figure 18). The later grey coated beams have bat straps attached which are fixed to the plaster ceiling below. Earlier steels were also found affixed in a support system for the remaining original timber beams (Figure 19).

*Figure 19. Earlier steels shown supporting timber beam with grey coated beams inserted parallel to the timber beams.*

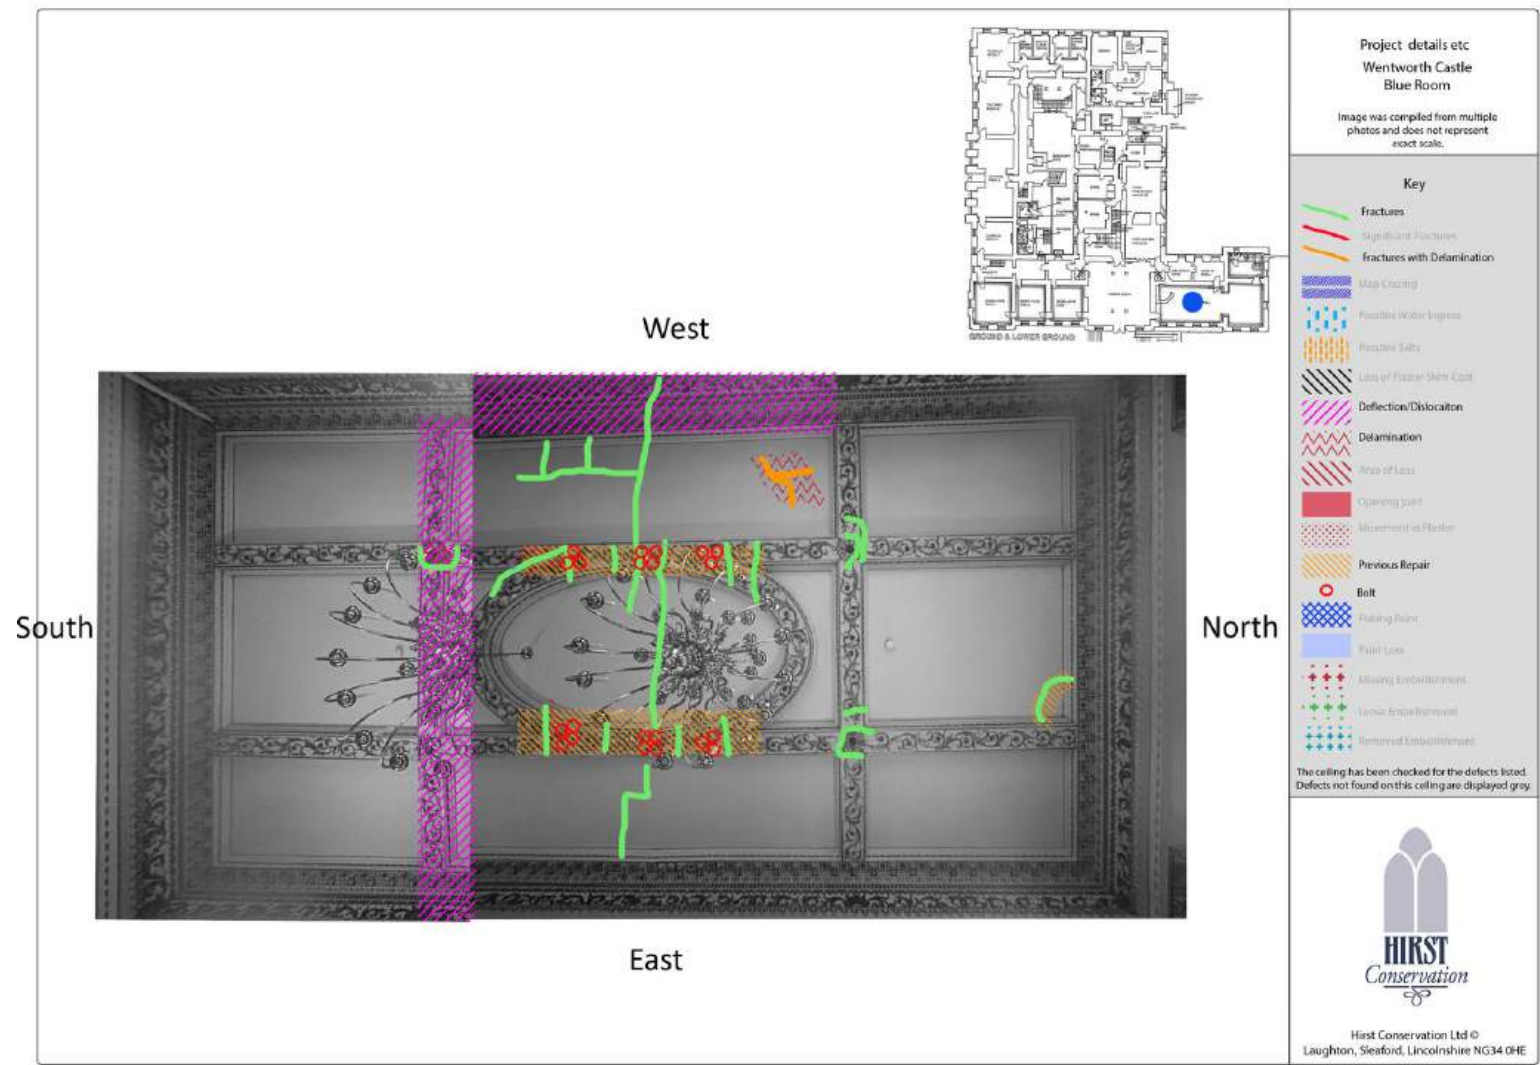
2.2.6. Blue Room Defect Diagram

- The full ceiling exhibited evidence of displacement, observed as bowing from East to West along the full expanse of the ceiling (Figure 6).
- Bowing and displacement were noted on the West facing wall's cornice from North to South (Figure 7).

- Multiple minor areas of loss and minor cracking and flaking were noted throughout the ceiling (Figure 14).

- The Blue Room plaster ceiling appears to be sound and stable due to the previous interventive stabilizing works which took place to the upper floor.
- From the information gathered to date, no areas observed were found to be of immediate concern regarding stability. However, please note that not all areas of the ceiling could be assessed as only a limited number of floorboards had been lifted.

- Extra support to the two timber joists which were found to be loose during the survey was recommended on site and a plan was devised with the architect for design and placement of the added support (Figure 24).

- It is recommended that the close consultation with the structural engineer is conducted to inform the best course of action for any additional stabilization requirements or plans.

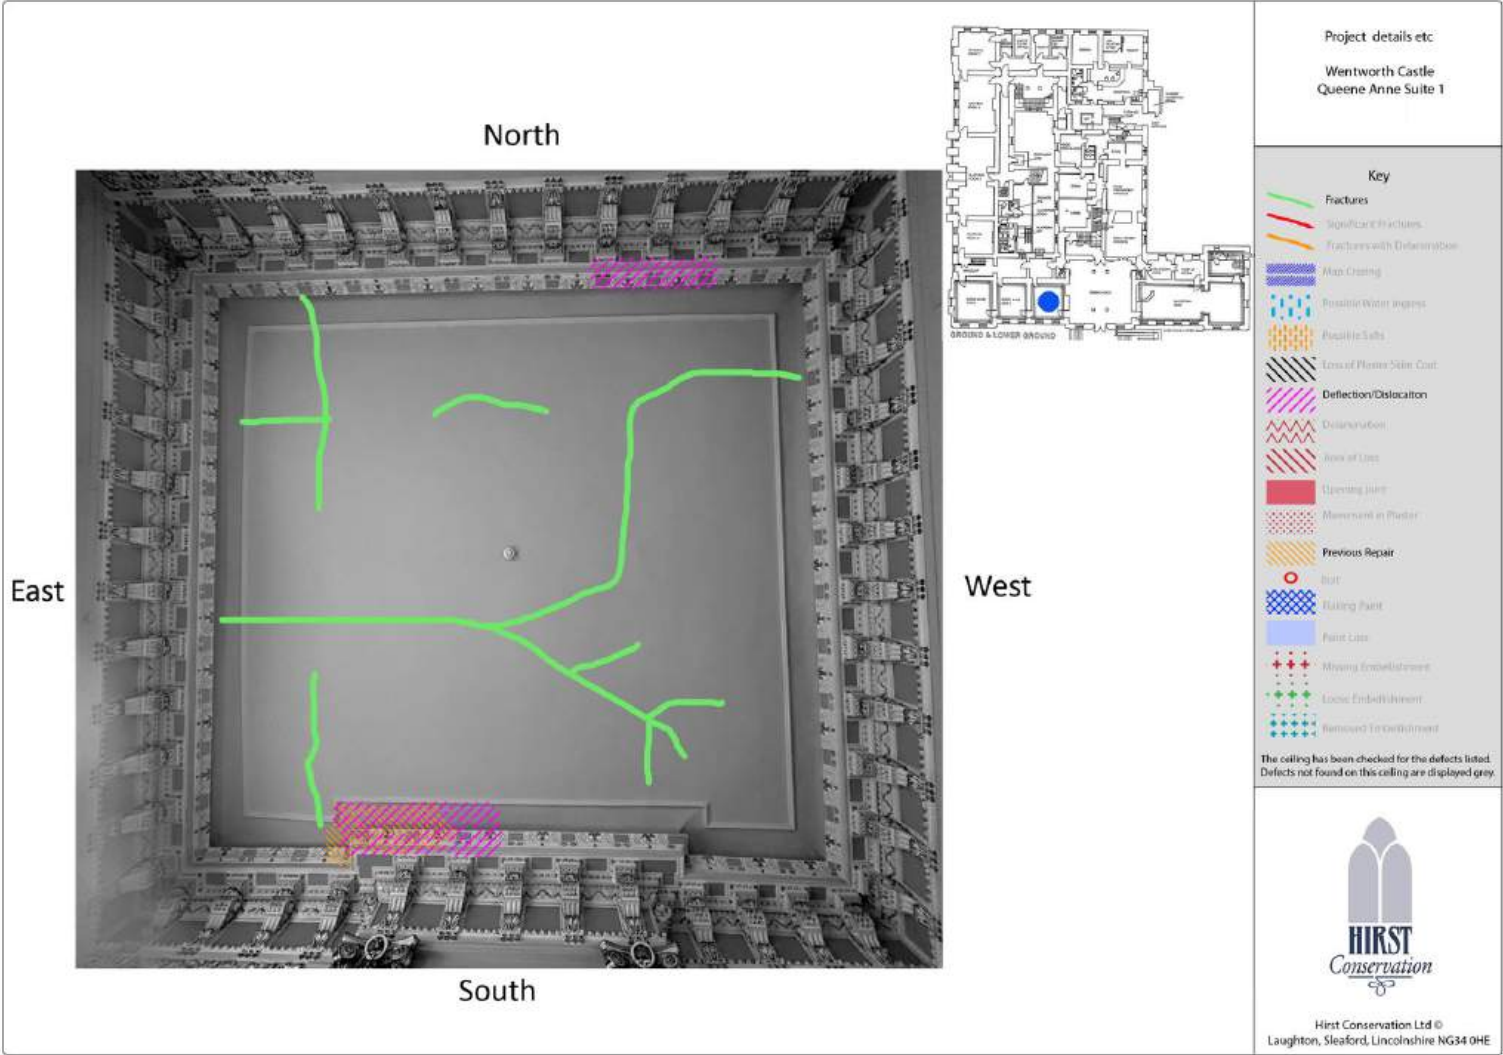
2.3.3. Queen Anne Suite 1 Defect Diagram

- Multiple very fine hairline fractures were visible throughout the expanse of the ceiling.
- Several fractures continued into the cornice. Fractures were visible on the cornice (Figure 28).
- Minor deflection was visible above the South wall cornice (Figure 29).
- Minor deflection was visible over the North wall corbels.
- Evidence of a previous patch repair was visible on the South wall cornice (Figure 30).
- Tactile push test revealed the ceiling to be sound and stable (Figure 31).

- It is recommended that the upper side of the ceiling is inspected to fully understand the stability of the ceiling and its composing elements.

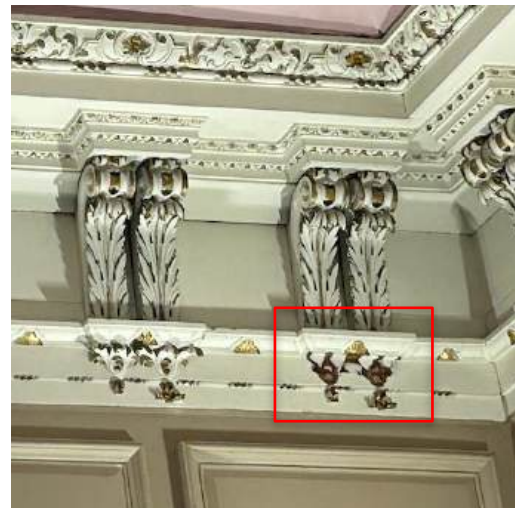
*Figure 42. Multiple embellishments missing throughout the cornice.*

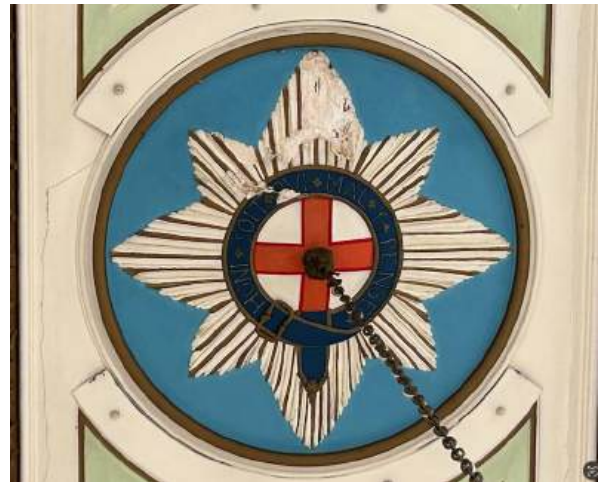
- The ceiling has multiple hairline cracks present throughout (Figure 47)
- There are some areas of loss present throughout the ceiling. An area of loss can be seen on the central rose, where there is a loss of paint and possible loss of plasterwork (Figure 48). Additionally on the central border (Figure 49). Closer inspection is needed to fully understand the type and level of damage.
- Five support straps attached with bolts were visible on the ceiling. (Figure 50).

*Figure 48. Area of loss in central rose.*

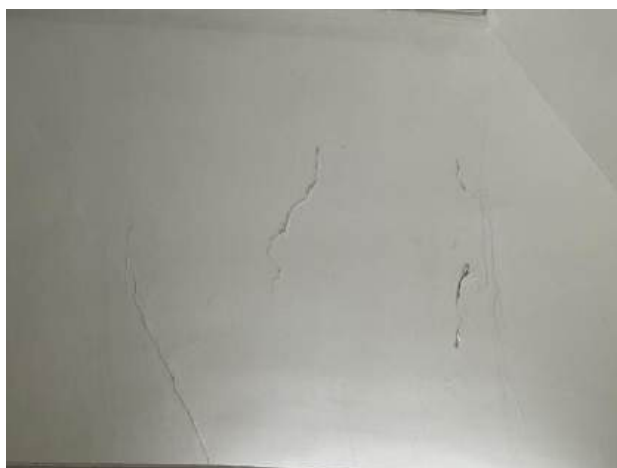
*Figure 55. Fractures with delamination and potential water ingress or salts visible.*

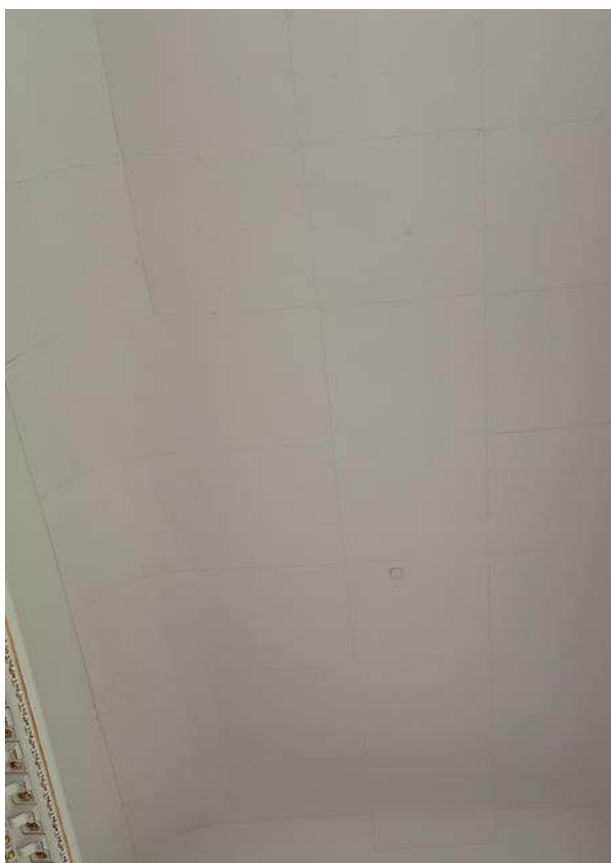
- A large expanse of the ceiling appears to be covered in boarding. The edges of the cove appear to be original with the majority of the expanse of the upper ceiling being covered in plywood, used as propping after historic failure of the ceiling in this area.
- There are multiple hairline fractures noted throughout. Fractures were noted on the mitred edges of the ceiling.
- Fractures were observed in multiple enrichments.
- Potential water ingress or marks of historic water ingress were visible in multiple areas of the ceiling. With damage to the dental blocks and enrichments.

*Figure 59. Plasterboard meeting seams visible on large expanse of the ceiling.*

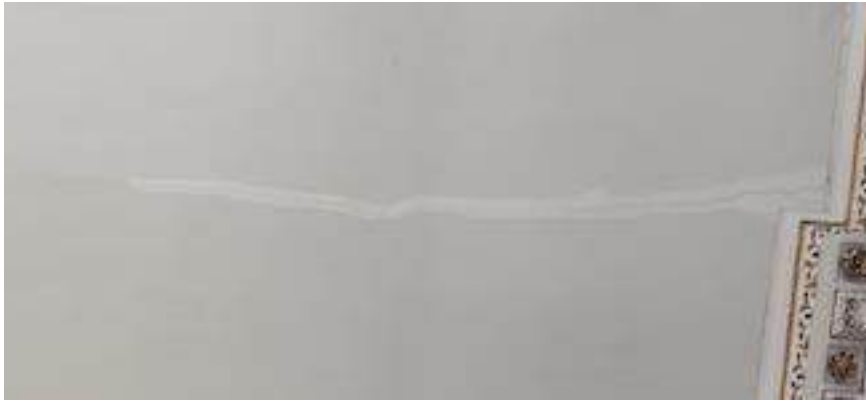
*Figure 62. Fracture visible on the ceiling.*

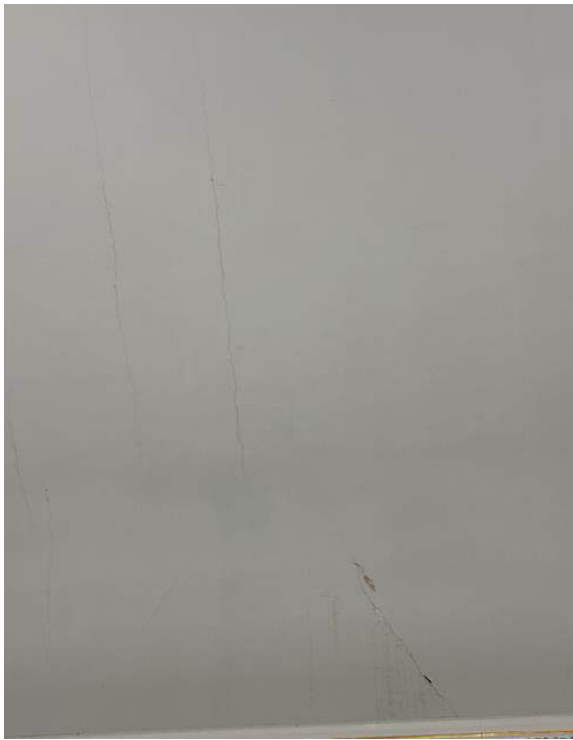
*Figure 65. Multiple fractures running through ceiling.*

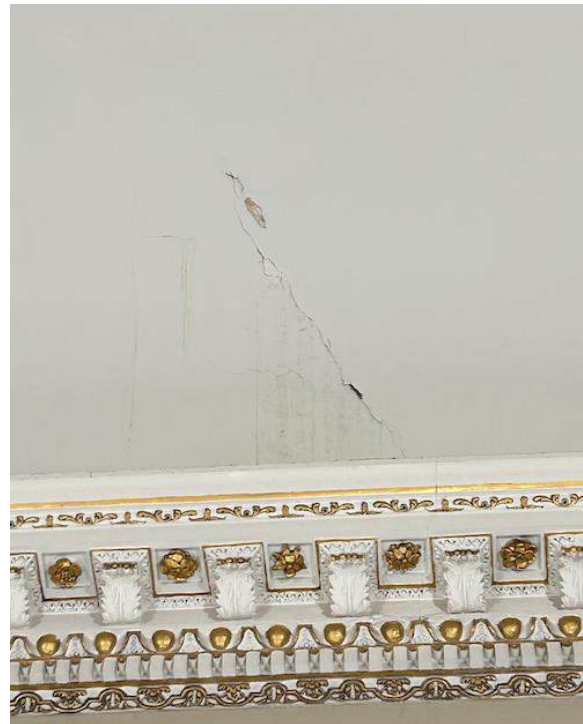
*Figure 66. Fracture resulting in loss and possible ingress.*

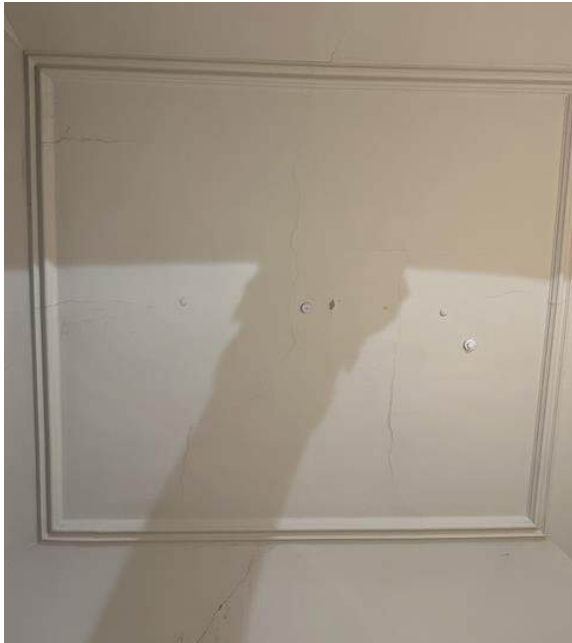
*Figure 69. Fractures seen throughout ceiling expanse.*

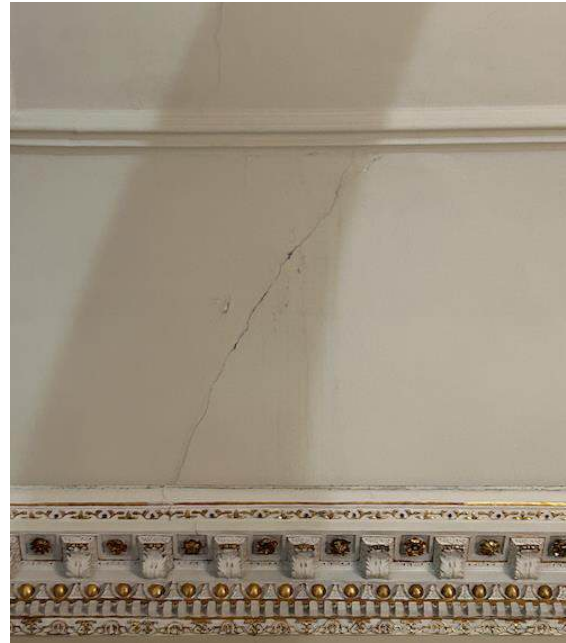
*Figure 70. Fracture with loss and delamination and possible water ingress.*

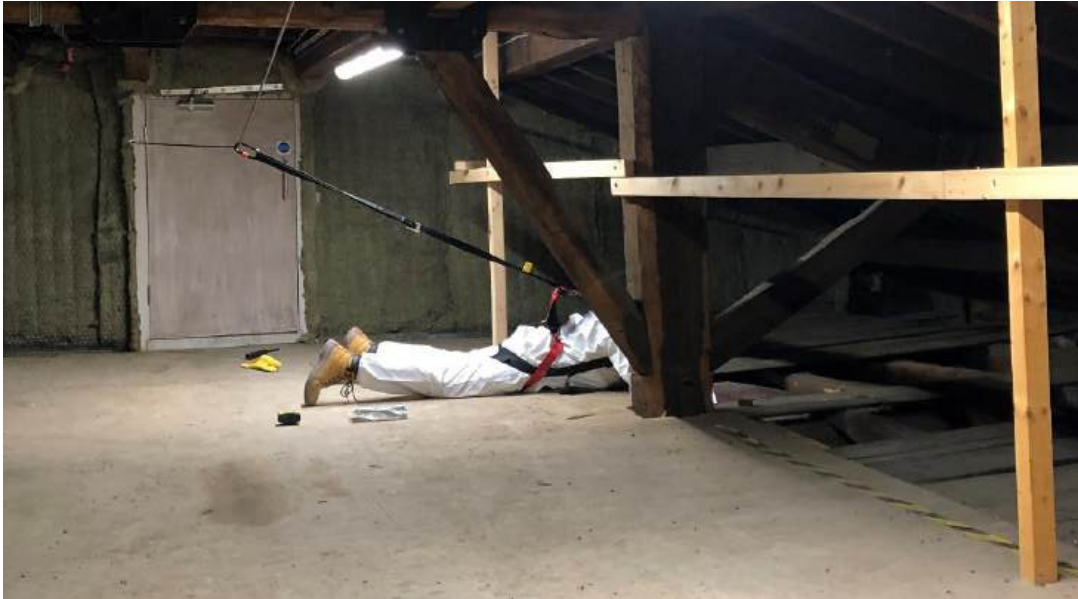
Figure 71. Keith Langton inspecting the topside of the ceiling, note location of hoist and boarded floor, limiting access for inspection. Shown at \*4 in the diagram below.

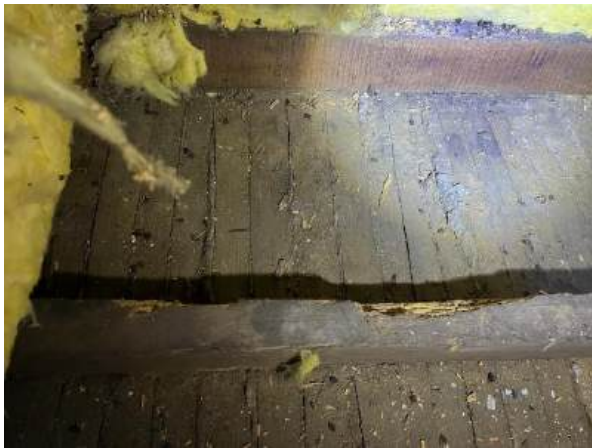
This has impacted the formation of the nibs which act as a supportive key to hold the plaster to the ceiling. The historic failure of the ceiling was likely caused by the water ingress, softening and adding weight to the plaster, and the lack of supportive nibs caused by incorrect spacing of the lath promoted the failure.

*Figure 73. Location \*1 lath to the North end of the Long Gallery, showing the spacing is too close together.*

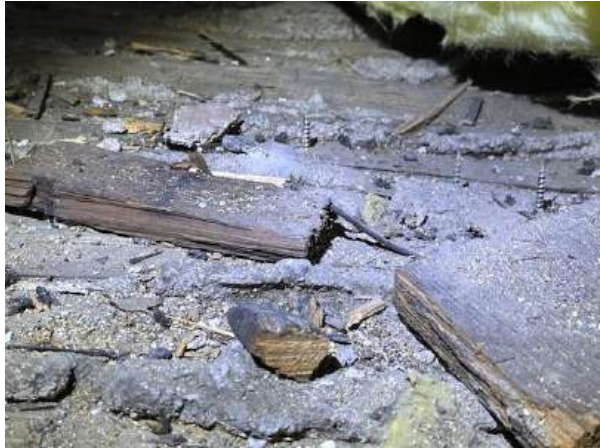
*Figure 74. Screws through the lime plaster where the boards have been fixed to the ceiling. Note the lime plaster is still present in this area. Note the debris on the topside of the ceiling, located at \*4 of the diagram.*

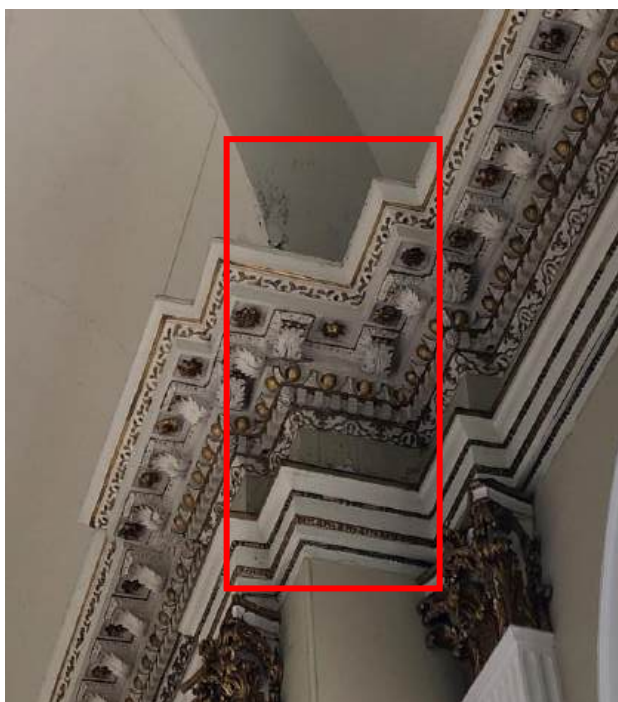
By looking at the approximate location of the ductwork on the floorplan, the ceiling directly below the North End rainwater trough, particularly the cornice to the East wall, has significant evidence of water ingress, it is not known if this is recent. However this evidence suggests that water may be leaking around the seal of the trough to the ceiling and wall below, causing the deterioration noted during inspection. However, the shape of the ceiling above this area may promote the flow of any water towards this area. Inspection of the roof and ductwork will inform further.

*Figure 75. Evidence of historic water ingress, the rain trough may be above this area to the North side of the Long Gallery.*

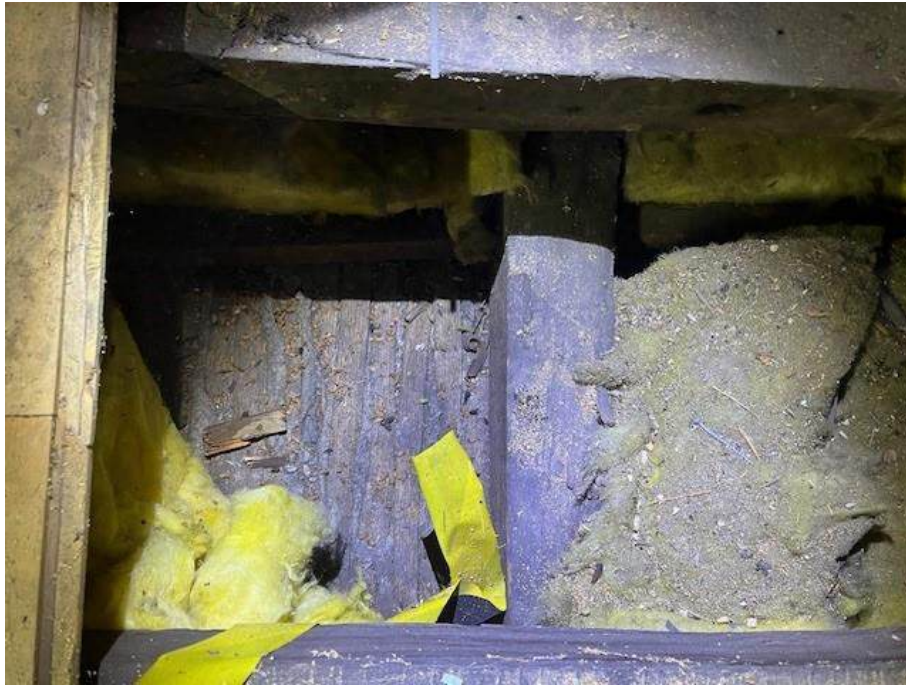
*Figure 77. Location \*5 showing the lath are spaced close together with minimal nibs present.*

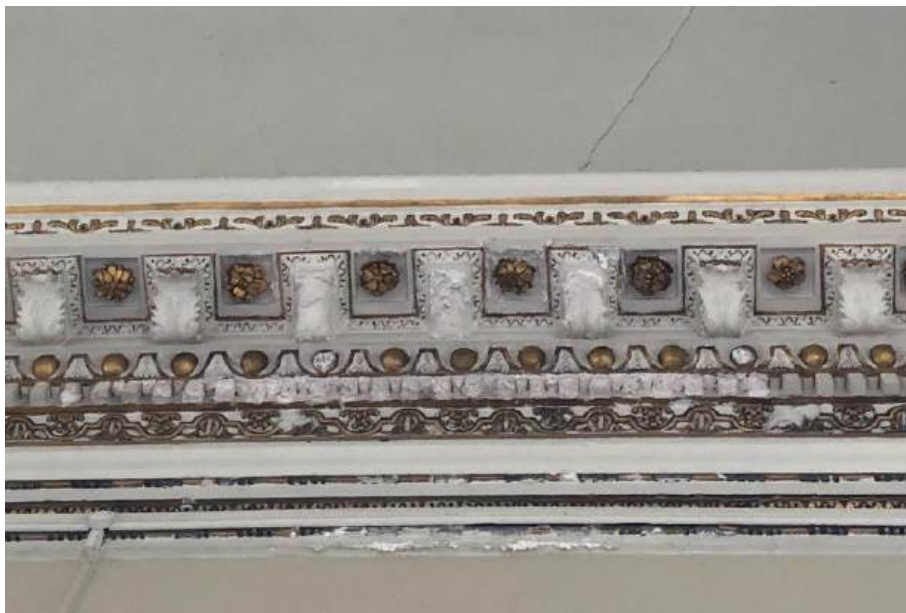
The area of cornice and plaster mouldings underneath on the East wall has suffered from significant deterioration from water ingress (See Fig. 78). Moisture readings may be effective in evaluating how much moisture is present in the wall/ ceiling to see if levels are high.

*Figure 78. Deterioration of the cornice, Egg and Dart and Dental Blocks.*

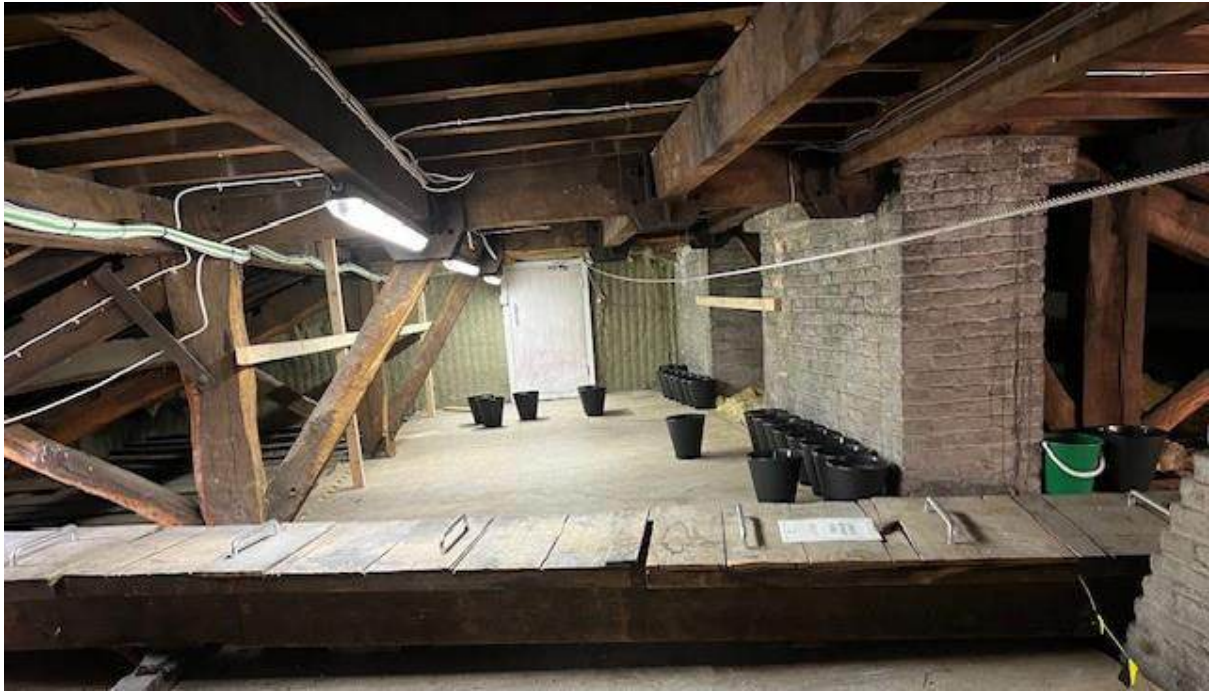
*Figure 80. Location of the South End rainwater trough. Note the buckets placed along the chimney suggesting lead flashing leak and strategically placed buckets in the walkway.*

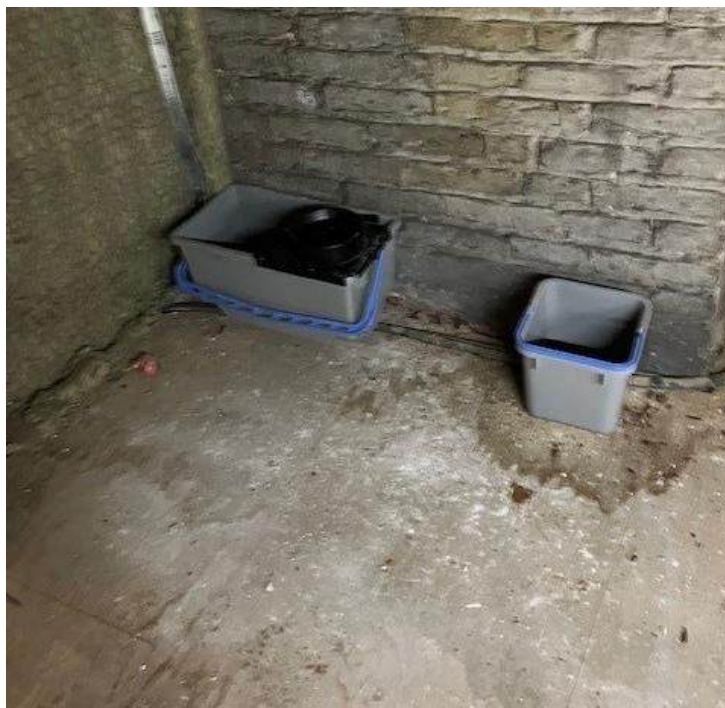
*Figure 79. Water staining of the plywood surrounding buckets suggesting leaks in the area of the bucket.*

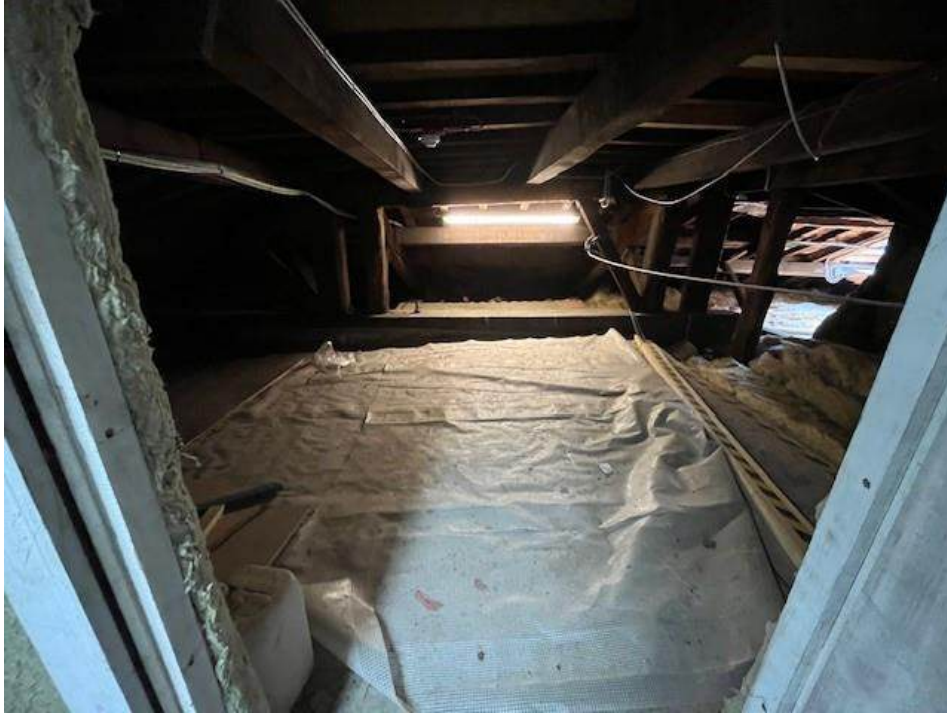
The single ceiling to the south end of the Long Gallery could not be inspected during the 06 August 2024 survey due to it being covered with sheeting and not known if the floor is stable.

*Figure 81. South End ceiling where plastic sheeting is present covering the walkway.*

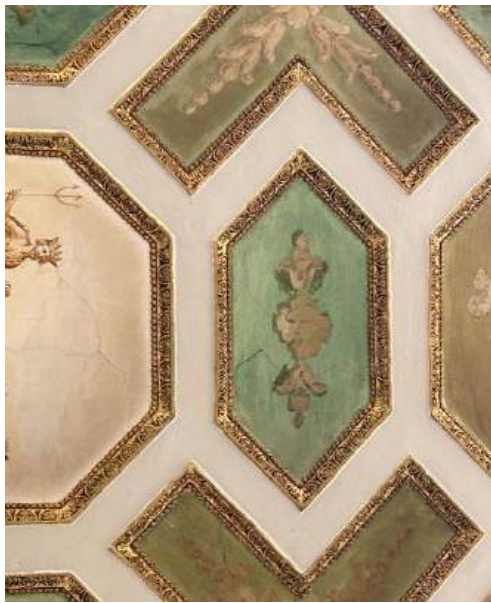
*Figure 88. Hairline fractures found throughout the ceiling.*

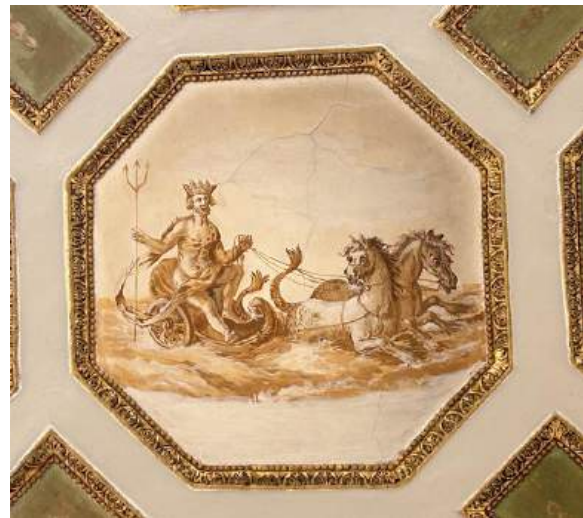
*Figure 89. Map crazing found on a painted panel.*

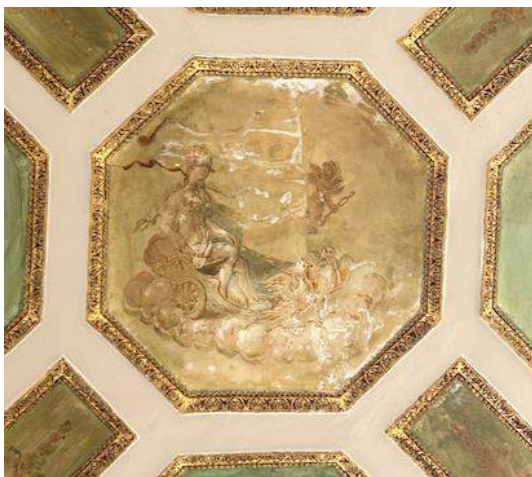
*Figure 90. Possible water ingress resulting in paint loss and discolouration.*

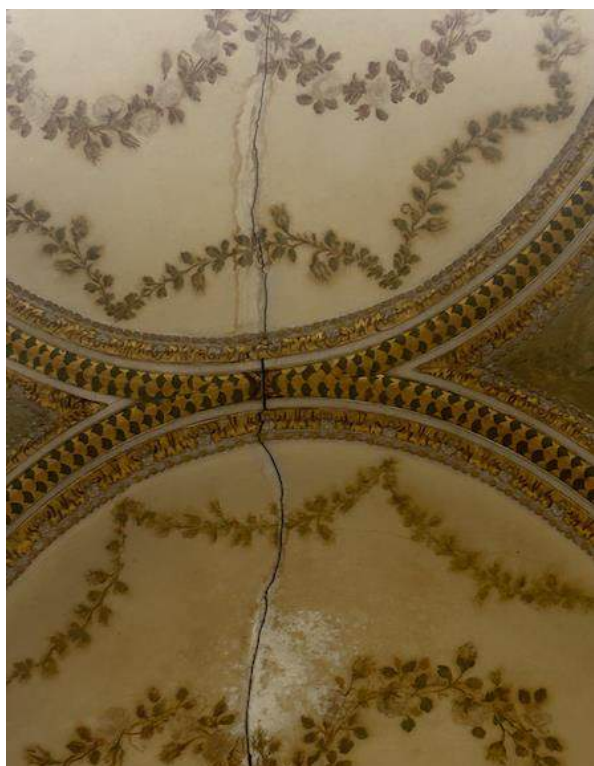
*Figure 95. Possible water ingress observed around fracture.*

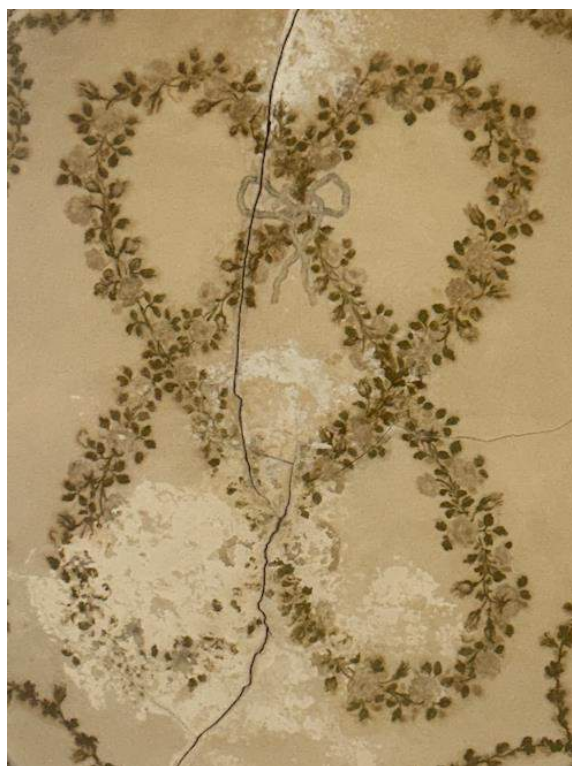
*Figure 96. Paint loss, flaking, and fading seen throughout the painted ceiling expanse.*

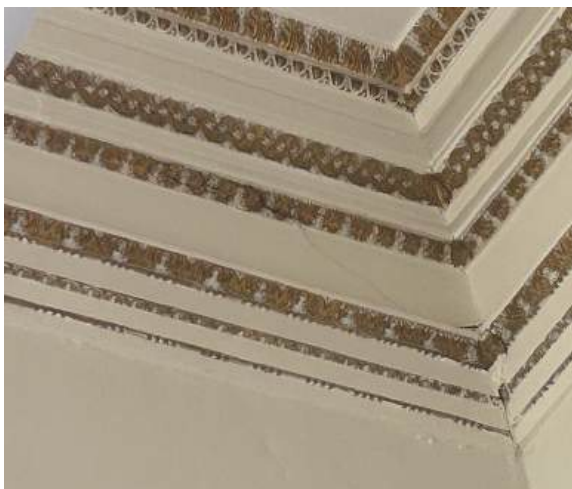
*Figure 101. Fracture running along cornice.*

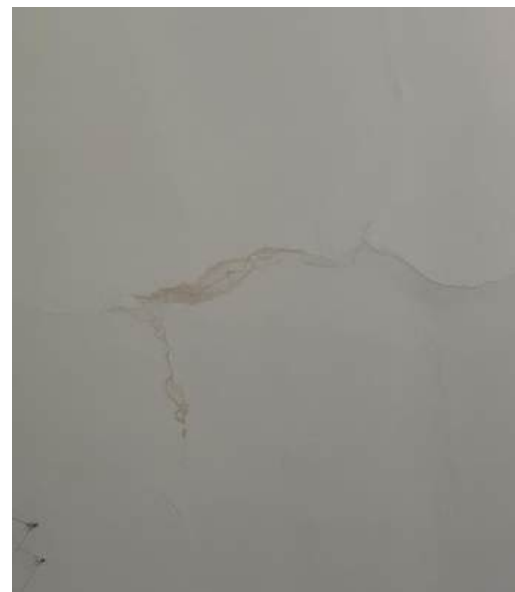
*Figure 102. Possible water ingress visible surrounding fractures.*

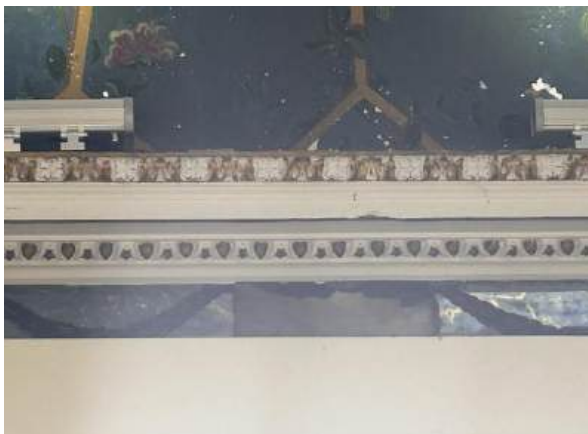
*Figure 107. Loss of mirrored frieze panel.*

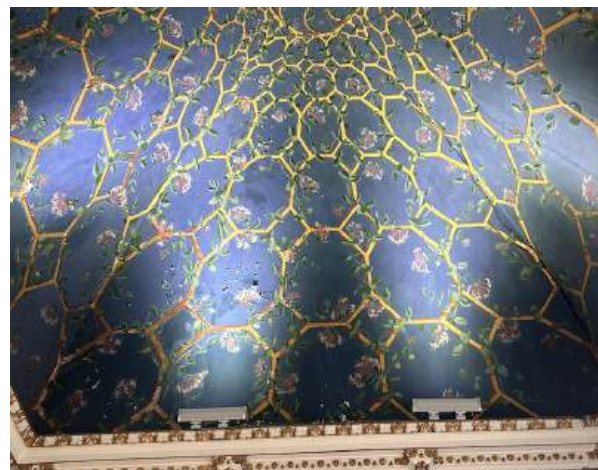
*Figure 110. Loss, flaking, and discolouration visible.*

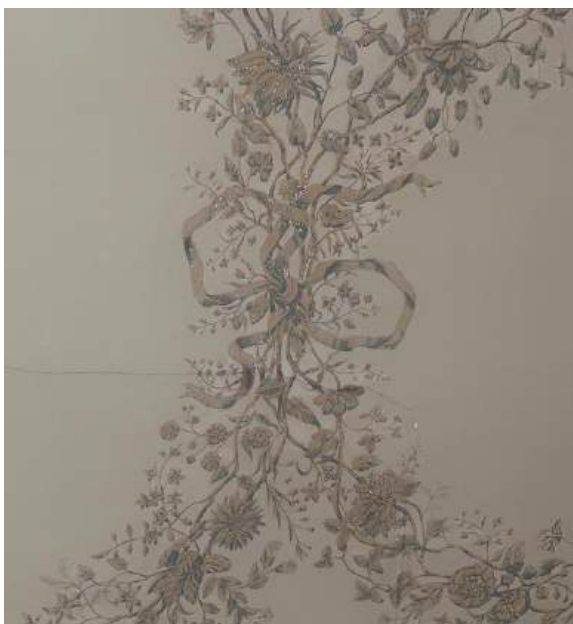
*Figure 117. Paint loss and flaking visible.*

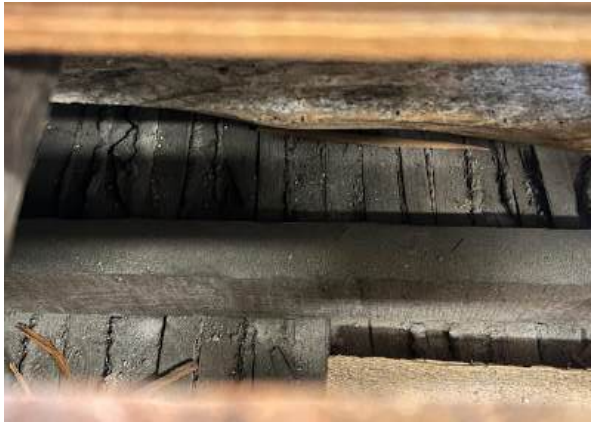
*Figure 119. View of laths and nibs, many nibs are missing.*

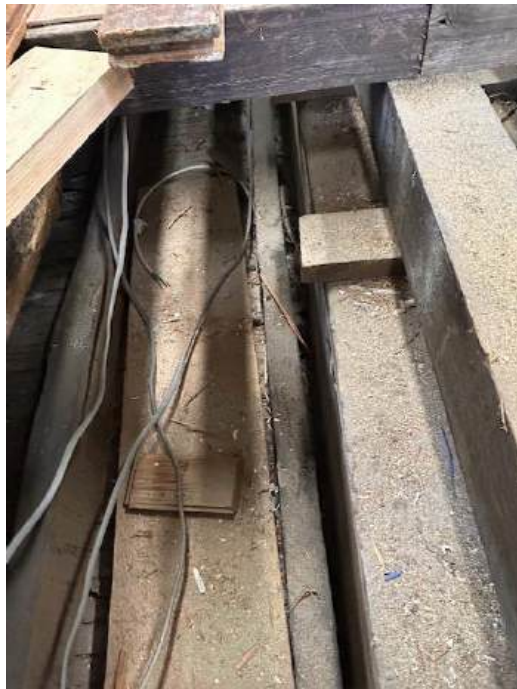
*Figure 121. Timber board seen resting on plaster laths and nibs.*
