27 January 2025

Ref: FC:2025/09

Re: Re: Purchase of property 1 Tivy Dale Drive, Cawthorne, Barnsley

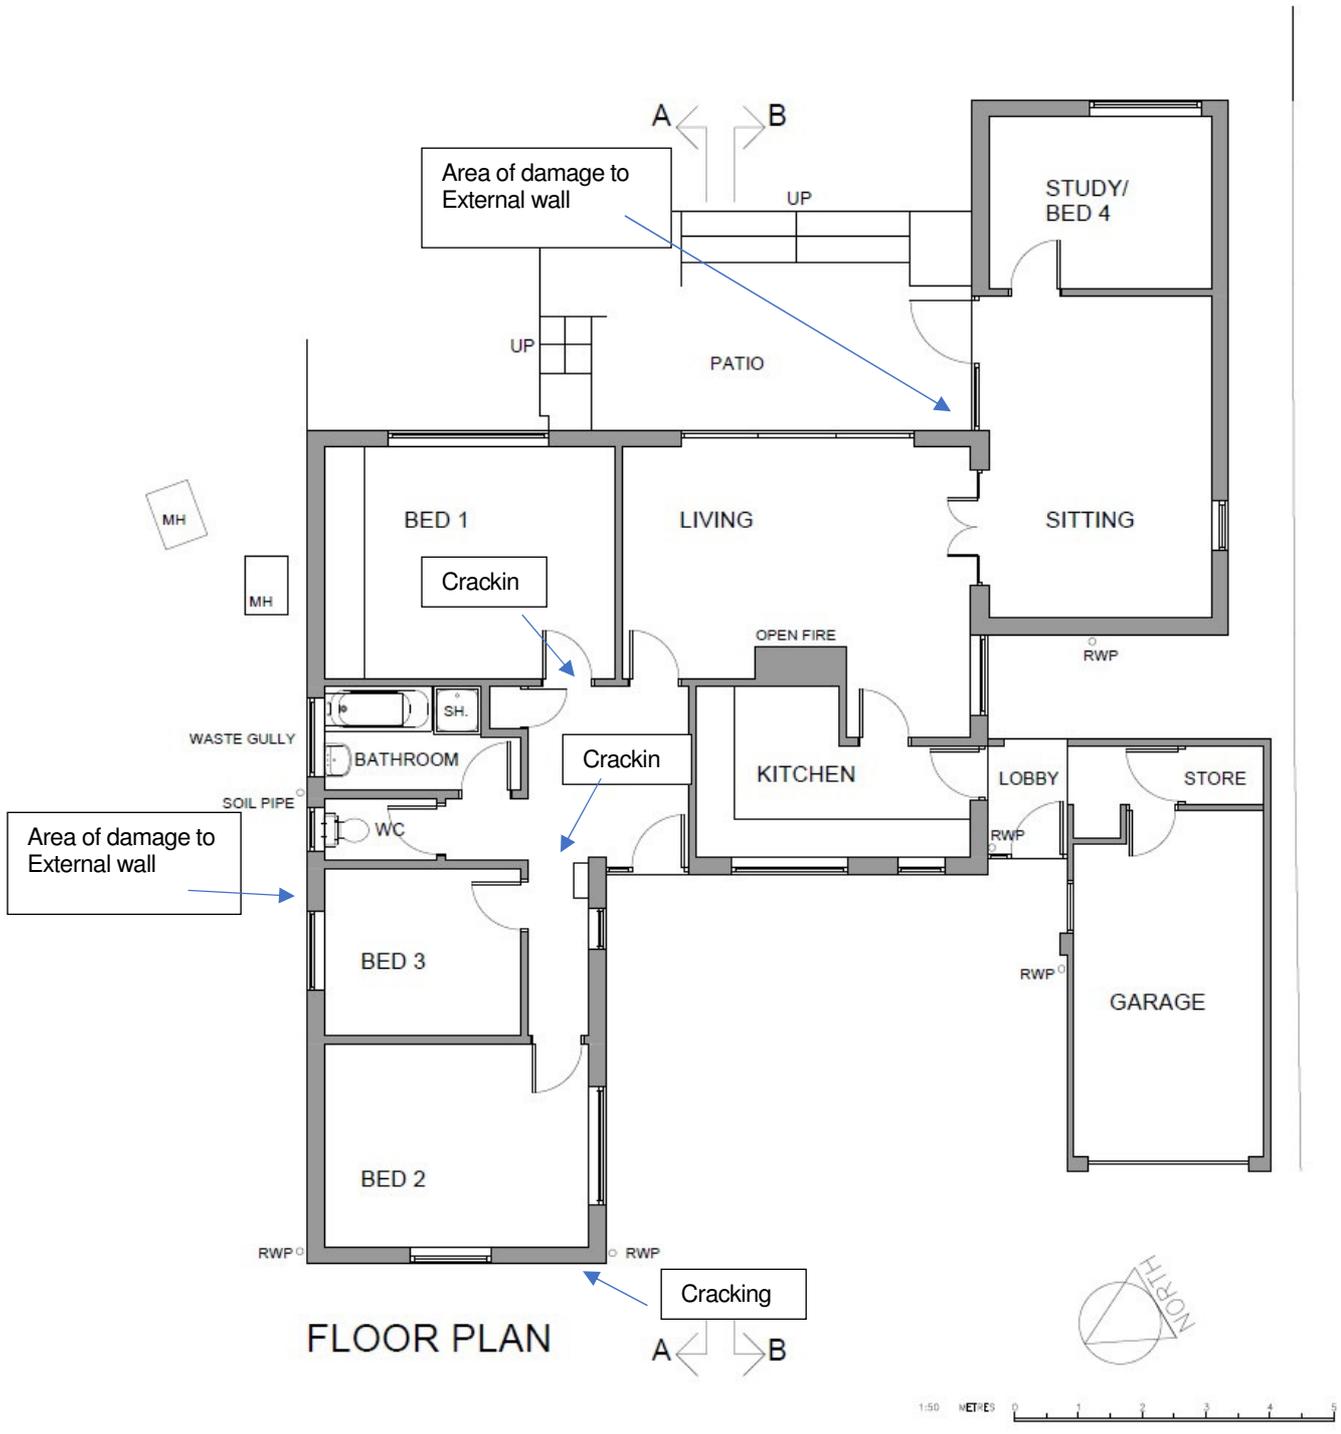
Fig. 2 Floor Plan

External examination reveals damage to external leaf brickwork, notably affecting the left flank wall against bedroom 3 and bathroom fig 2 together with slight damage to the rear elevation where the rear extension abuts the original. Maximum crack widths are in the region of 4mm.

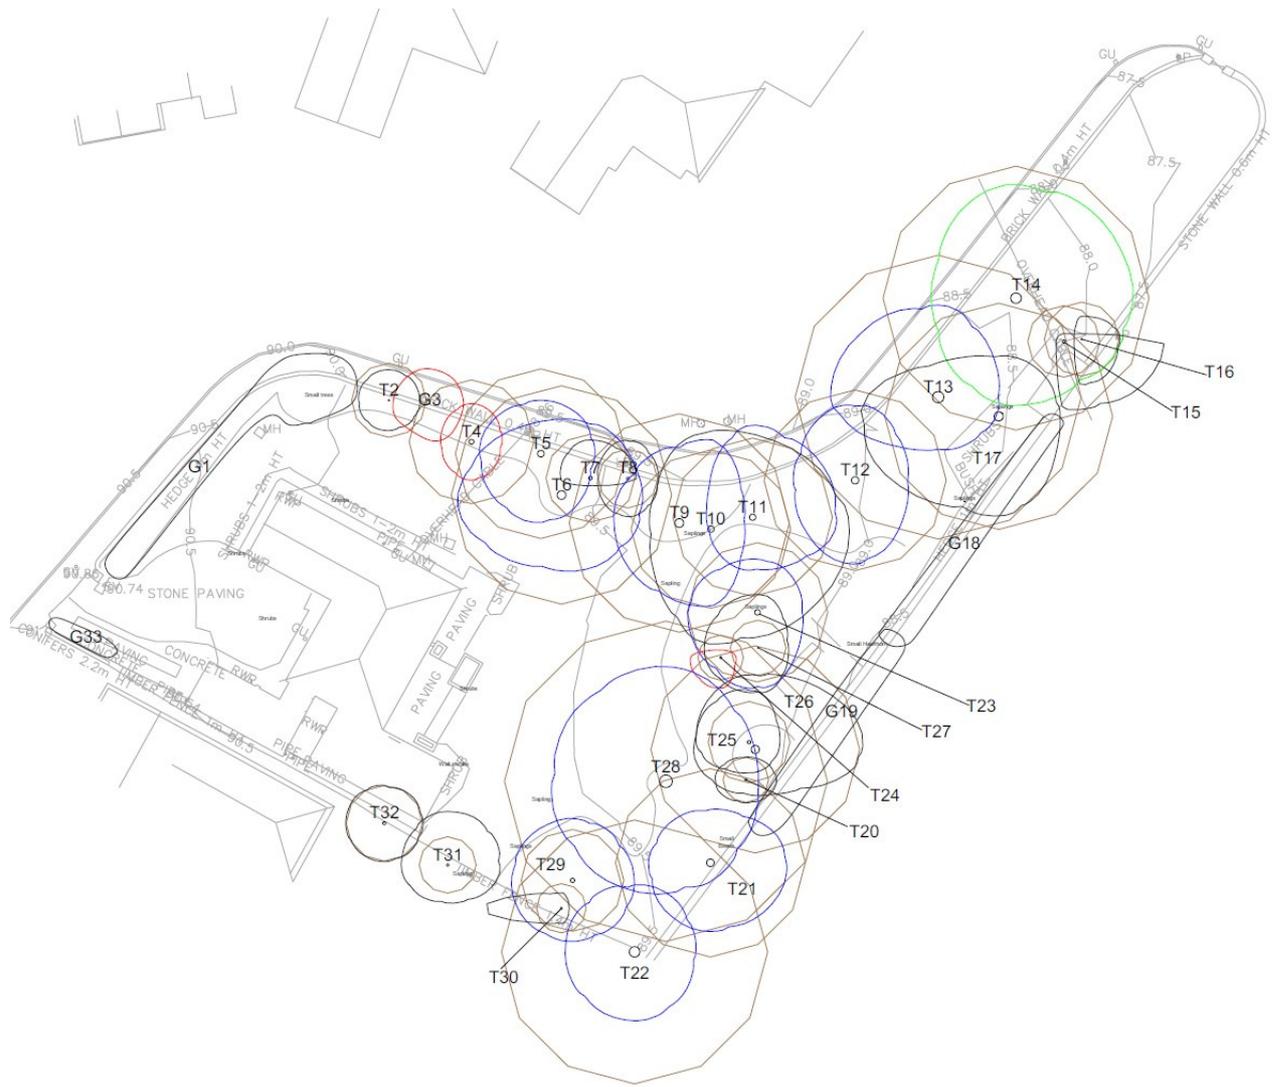
Fig. 3 Tree Plan

The close proximity of the mature trees growing against the north boundary in particular is likely to influence ground conditions and we suspect trees marked T5, T6 and T9, shown on fig.3 as being of most influence.

it would be beneficial to consider removal of trees T5, T6 and T9, which have been identified as of moderate amenity value, subject of course to planning consent being granted.

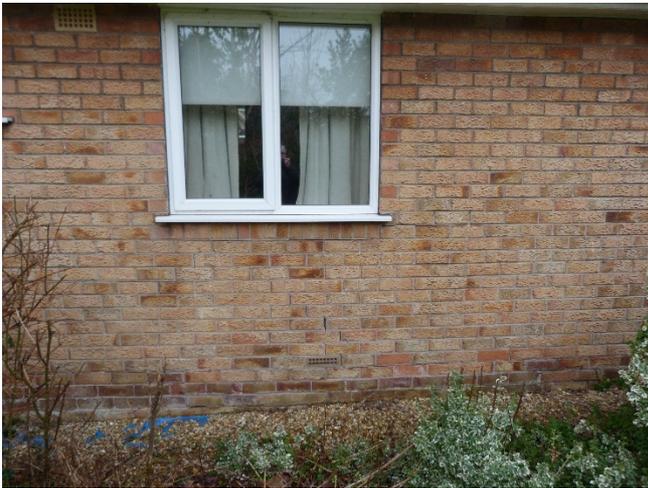
The side wall damage suggests slight rotation of the foundation below bedroom 3 window, as evident by slight lipping of the lower masonry below the fracture lines.

2. Damage under bed 3 window

A period of monitoring should then be undertaken followed by repairs which will include an element of masonry realignment and mechanical stitch bonding works.

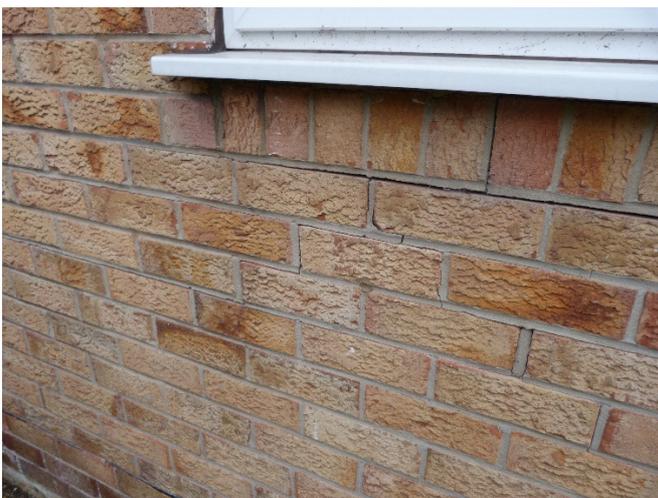
3. Slight lateral displacement

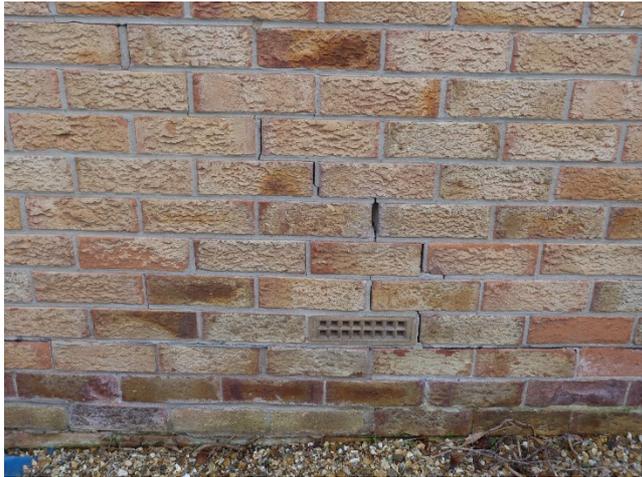
4. Step fractures

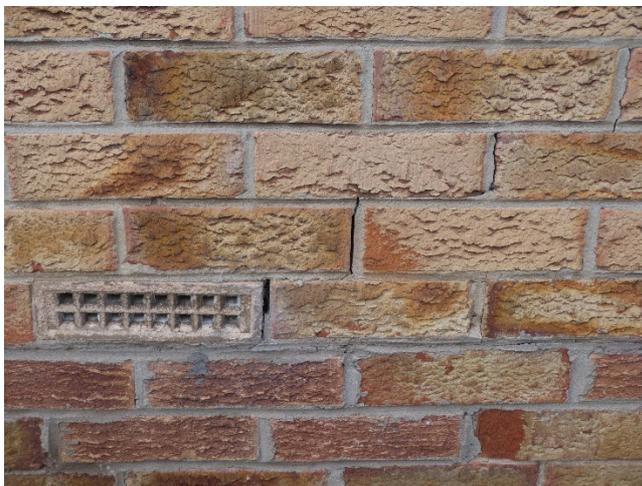
5. Slight step fracture

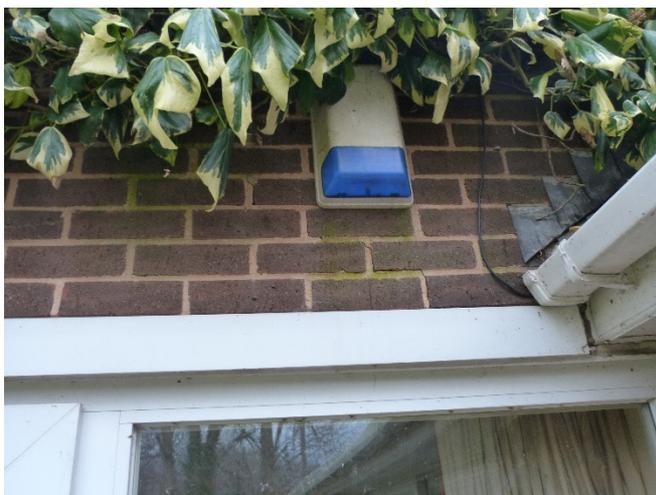
6. Slight differential movement of rear extension

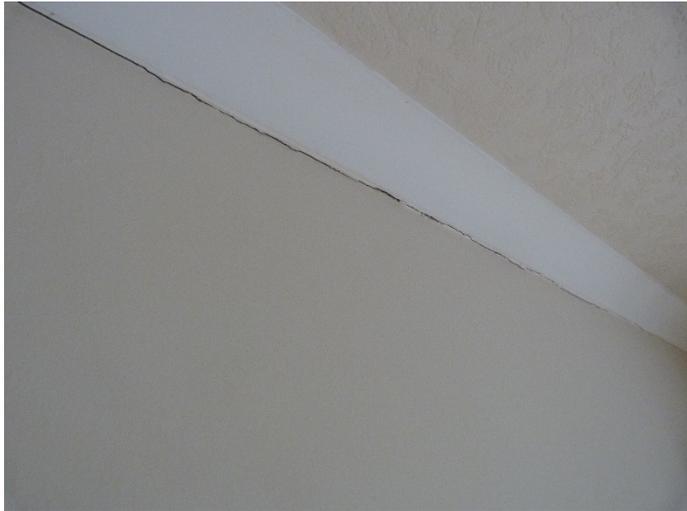
7. Parting to wall/ceiling angles

Internal fractures can be repaired via normal cosmetic procedures prior to redecoration.

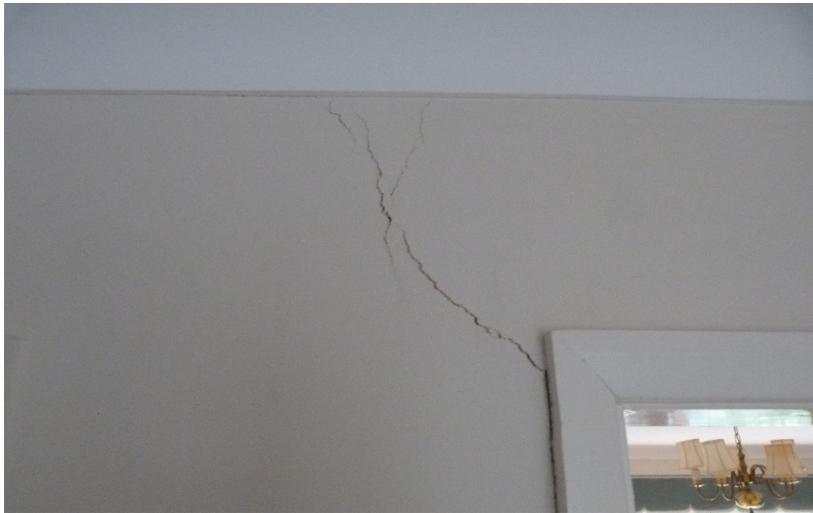
8. Diagonal cracking over internal doors

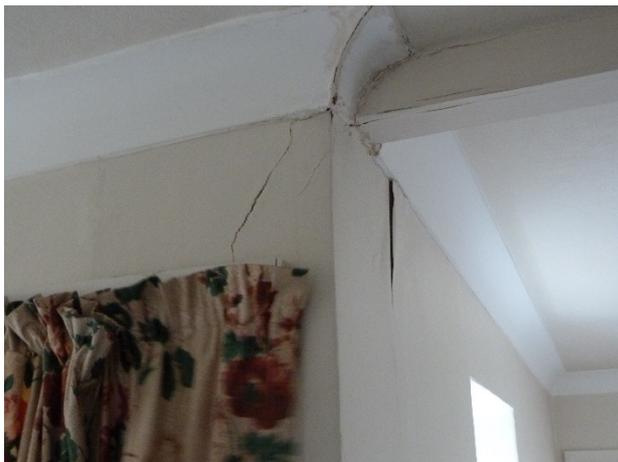
9. Minor cracking to wall angles

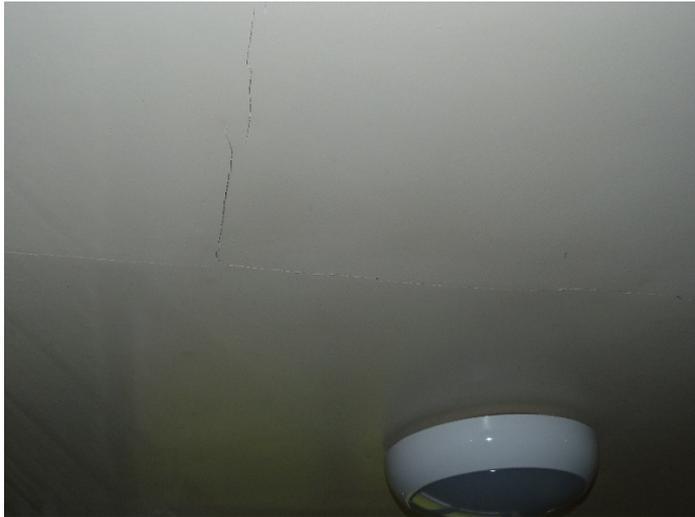
10. Cracking across ceiling

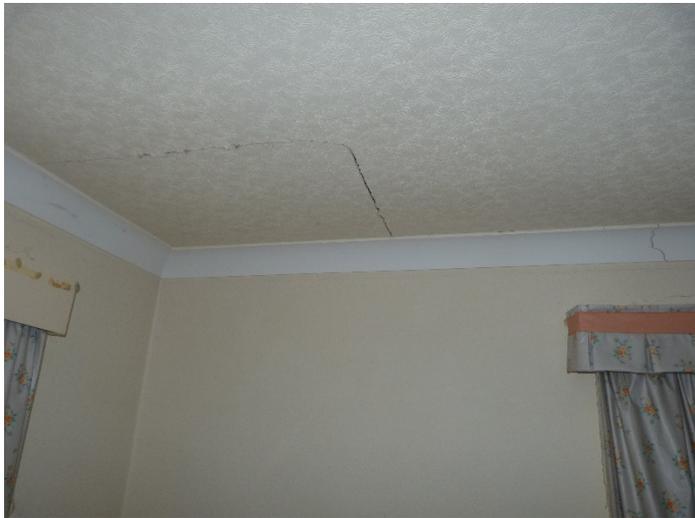
11. Cracking at ceiling board joints
