### Introduction:

This report has been prepared following a recent site visit to inspect an existing stone barn and to assess its structural condition and its suitability for redevelopment by conversion into a dwelling without the need for extensive demolition or reconstruction for the purposes of a planning application.

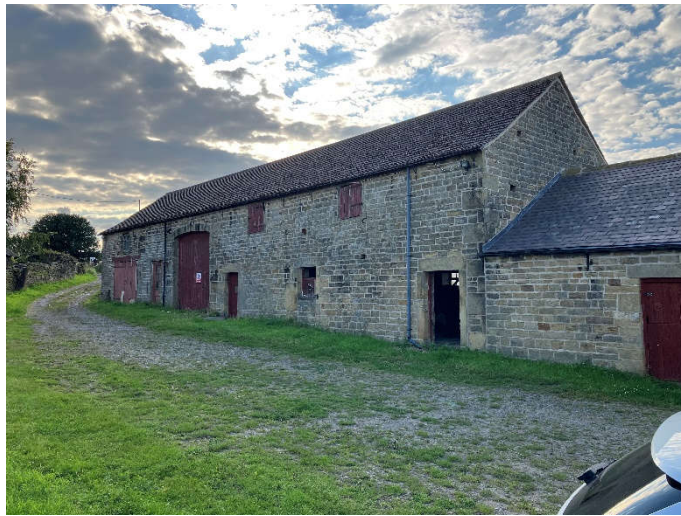
Fig 01. Barn South Elevation.

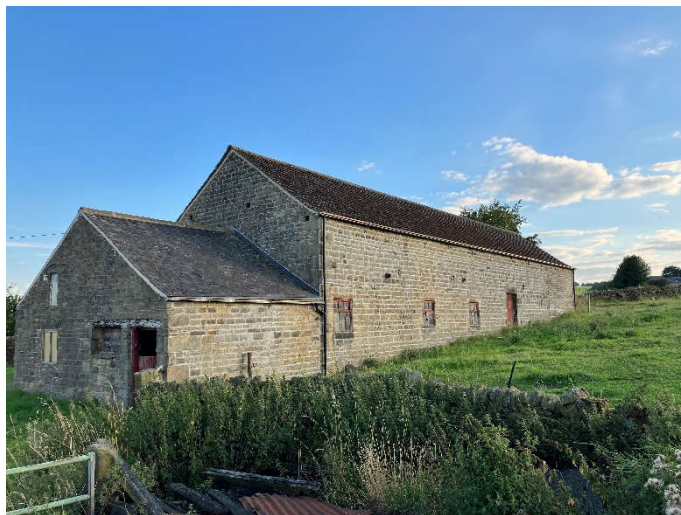
Fig 02. Barn North Elevation

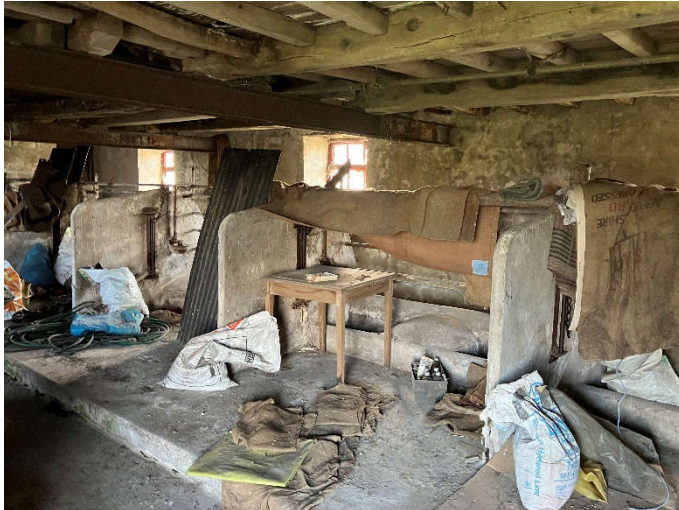
Two thirds of the central two storey stone barn include a milking parlour with a concrete floor and a hay loft above constructed originally of timber beams supporting stone flags at first floor level. The timber beams have deteriorated over time and steel beams have been added to help support the weight of the stone flags at first floor level. The remaining third of the main barn as no first floor and is open from ground floor level to the roof trusses.

Fig 03. Milking parlour and first floor steel and timber beams supporting stone flags.

The first floors are in need of replacement due to deterioration of timber beams supporting heavy stone flags.

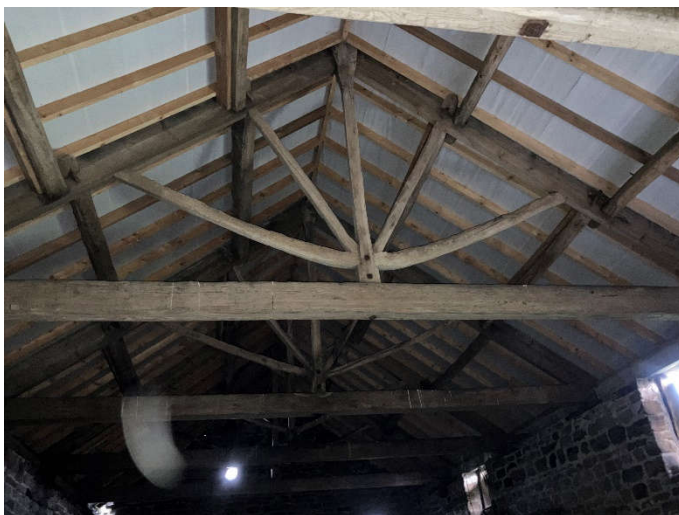
Fig 04. Trusses over main barn.

The original roof covering has previously been replaced with concrete tiles, breather felt and modern timber rafters over the original timber purlins and roof trusses. Some of the original timber purlins have been strengthened by adding now timber purlins along-side (as can be seen in Fig 04.) but generally the original roof timbers appear to be in good condition.

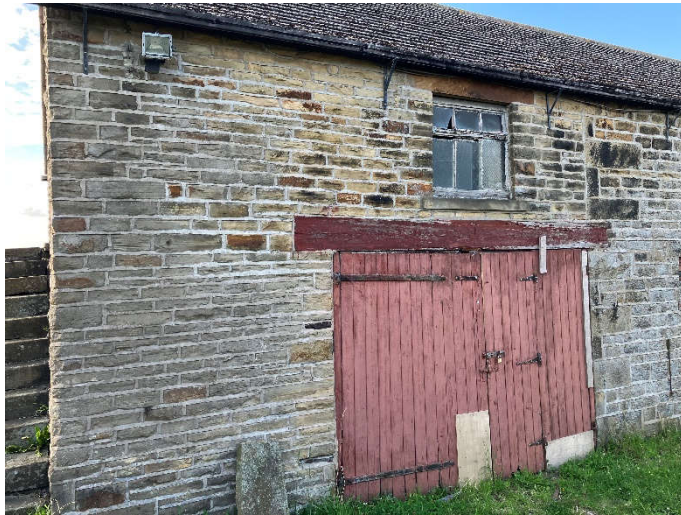
Fig 05. Small addition to west of main barn; note straight joint to reveal of door opening. Construction techniques suggest it was erected soon after completion of the main barn.

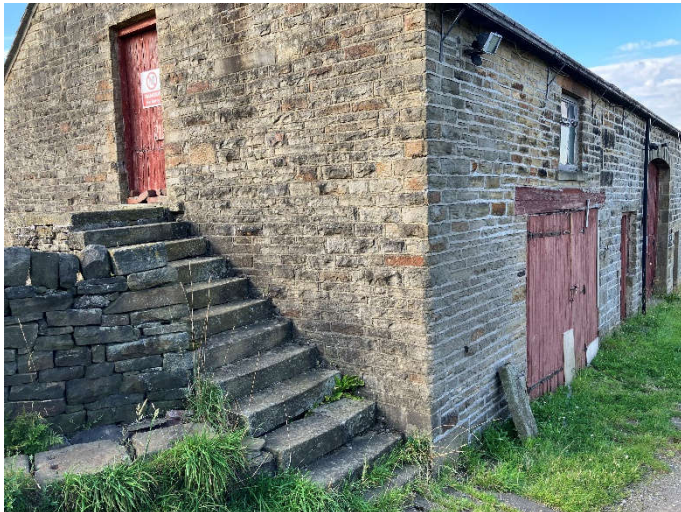
Fig 06. Stone steps and access to first floor hay loft in west gable.

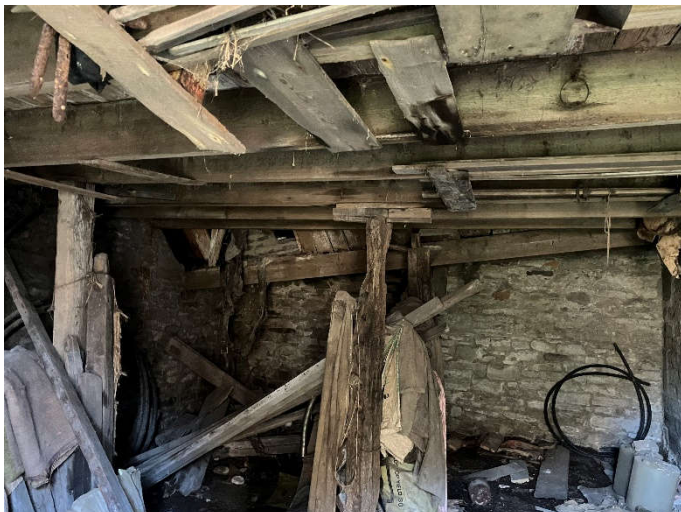
The two-storey addition to the west of the main barn is a single bay with a timber first floor which has partially collapsed and timber purlins spanning between the principal walls supporting the roof. There is no internal stair to the first floor however there is an external stone stair to the west gable with a door giving access to a small hay loft.

Fig 07. Partial collapse of timber first floor and temporary support posts.

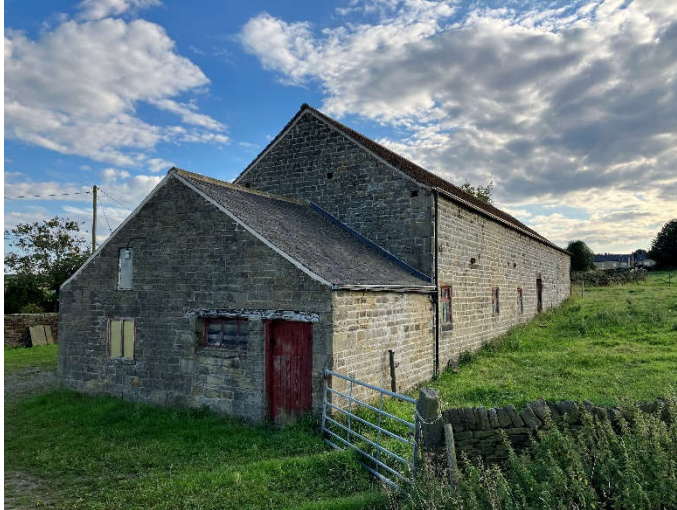
To the east of the central barn is a single storey dual pitch addition of similar age to the original barn. The plans show a number of adaptations since its construction including the installation of an internal wall and some timber stalls. There is a large opening in the east elevation with a timber lintel that has deteriorated and created some instability in the east gable requiring partial re-build of the gable wall above the opening.

Fig 08. Single storey addition to main central barn.

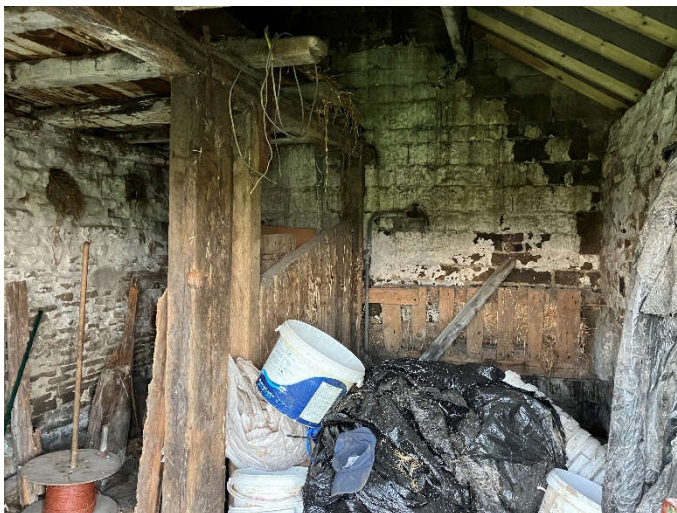
Fig 09. Internal view of single storey addition to main barn.
