# **STRUCTURAL APPRAISAL REPORT**

**Ivy House Farm  
Chapel Road  
Pilley  
Barnsley**

**REPORT NUMBER:** FC 2023.121

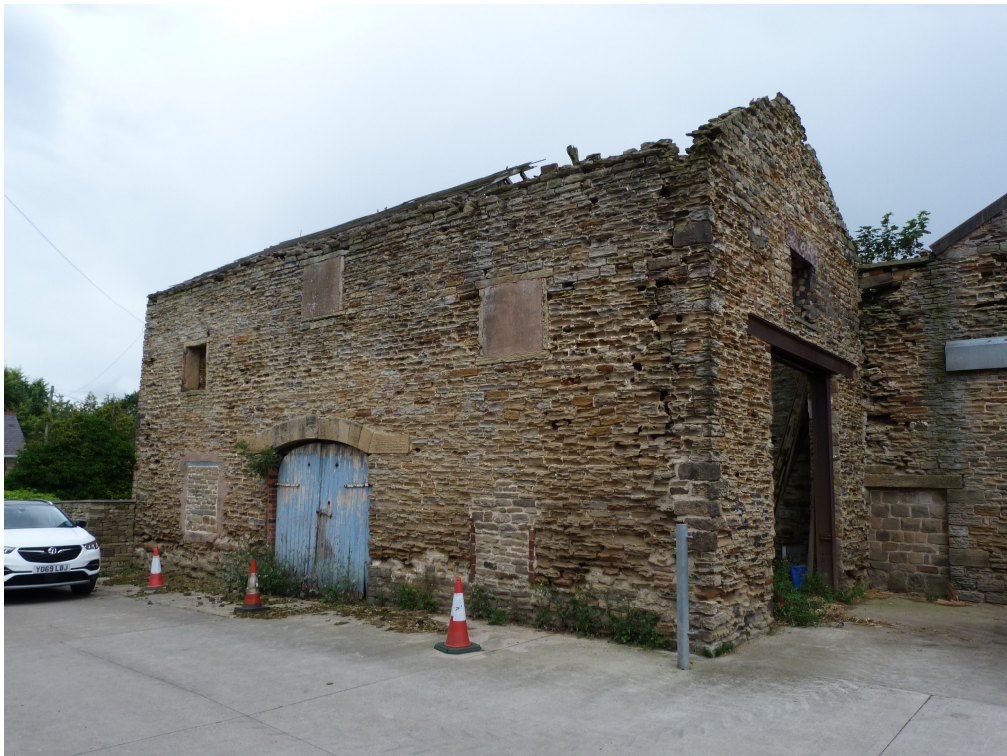
Five mullion windows (4No infilled) remain to the west elevation with ventilation slots to its east elevation. Photos 1 and 4.

1. North west elevation

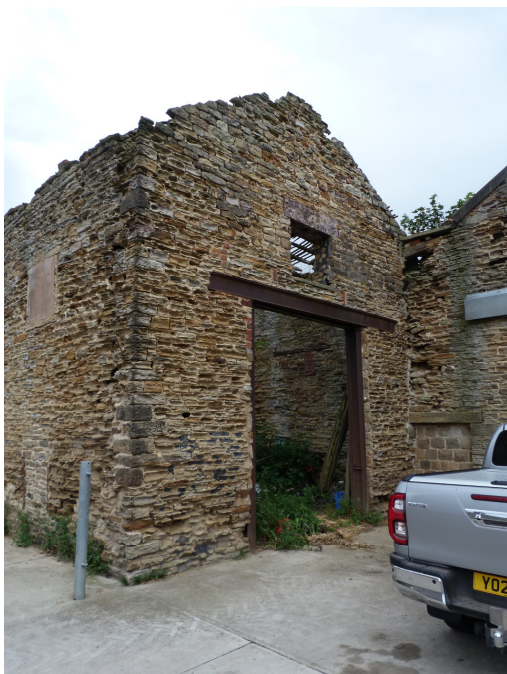
A tall opening has been created within the south gable, this framed by steel I sections and having a small lintelled window above. Photo 2.

2. South west gable

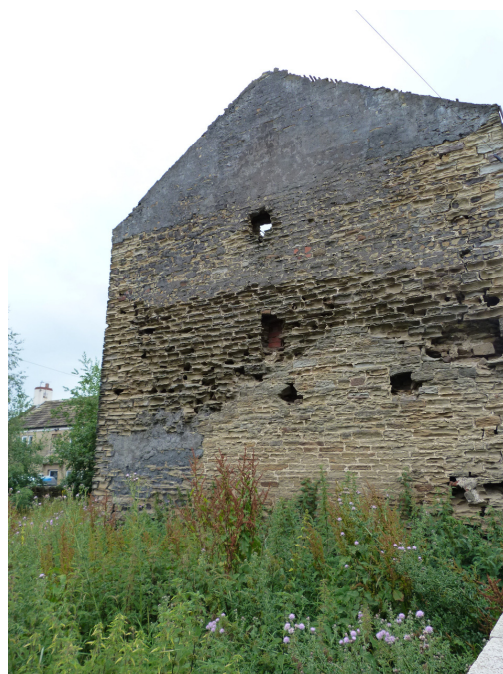
The north facing gable is rendered above eaves level and shows the outline of a former single story structure abutting. Photo 3.

3. North east gable

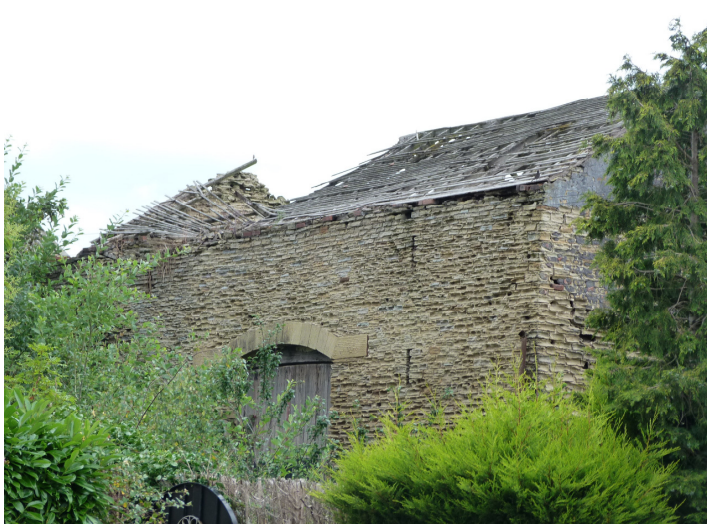
It's east facing elevation could not be fully examined but show signs of stone decay and partial collapse along eaves level towards the south facing gable. Photos 4 and 11.

4. South east elevation

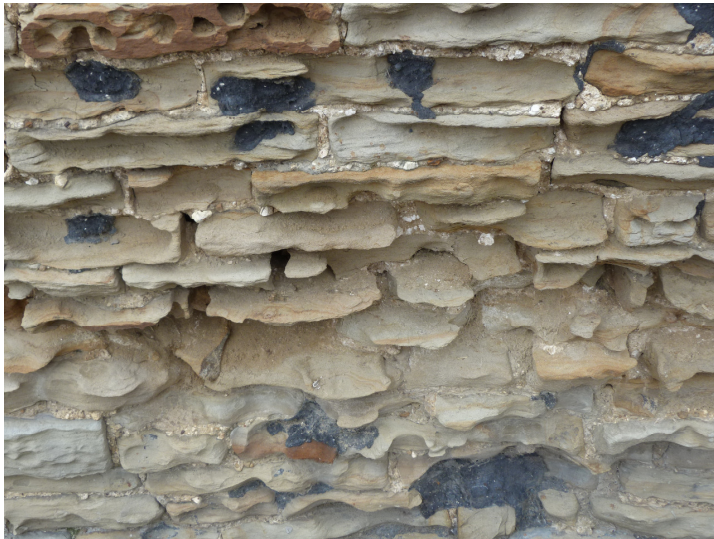
The soft locally quarried sandstone walling has weathered significantly on all elevations and internally to such an extent that this cannot be practically repaired by simple repointing and localised stone replacement methods. We estimate that at least 50% of the external leaf stone work is beyond salvage and repair. Photo 5.

5. Typical stone erosion

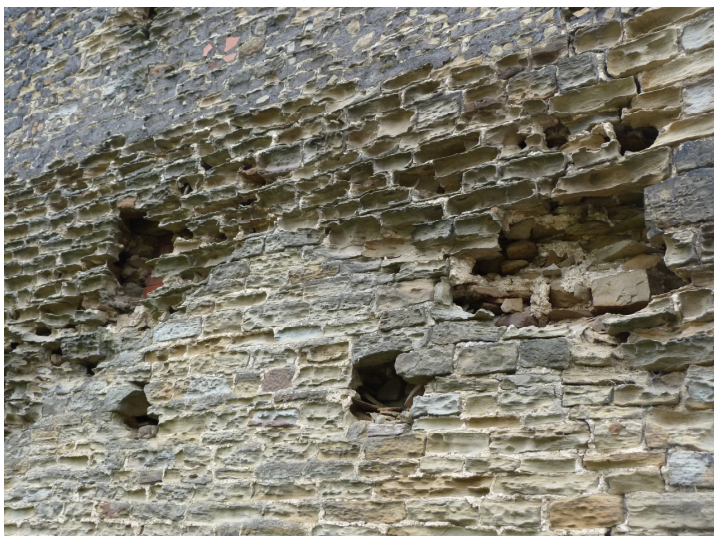
The north gable has six large holes as a result of weather erosion and 75% of its outer leaf suffers excessive stone decay. Photo 6.

6. Significant erosion of north east gable

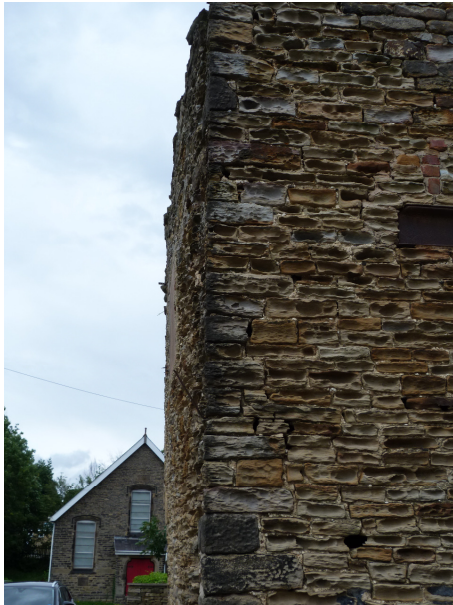
The west elevation is laterally distorted to an extent where this has become displaced upwards of 150mm within its height. Similar distortion is apparent to the other elevations. Photo 7.

There is evidence of lateral instability, undoubtedly exacerbated by the deterioration of the roof and loss of lateral support from the first floor, together with weakening as a result of the south gable opening.

7. Lateral distortion of west elevation

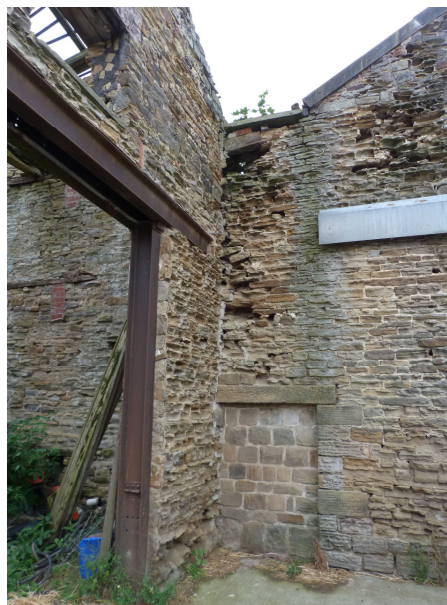
The south gable is in poor condition and has been weakened by the creation of the large opening.

8. Large opening to south gable

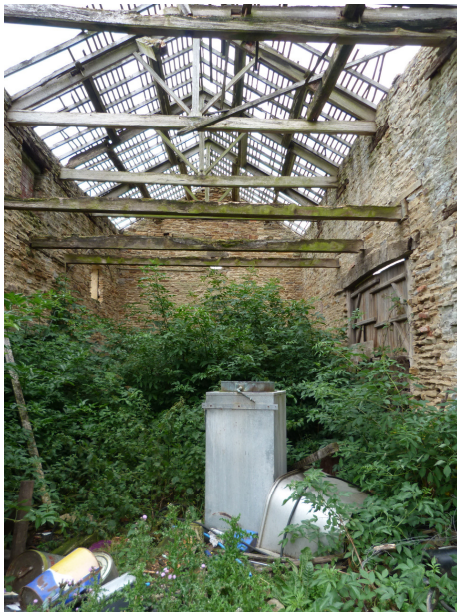
remain but the roof covering in its entirety has been lost. All floor joists and decking components have collapsed. Photo 9.

9. Interior

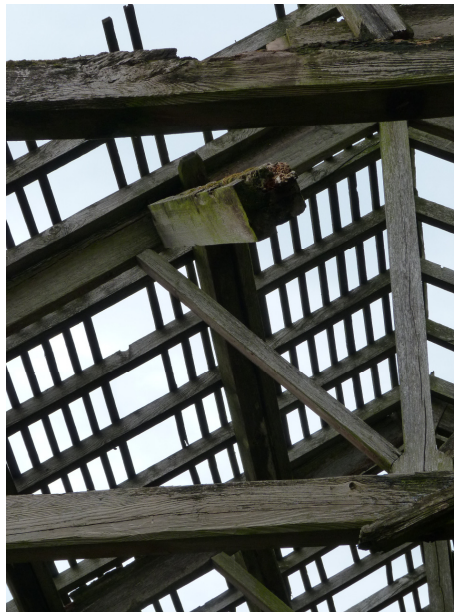
The roof is in a state of collapse and many timbers suffer excessive structural decay. Photo 10.

10. Collapse of decayed purlins

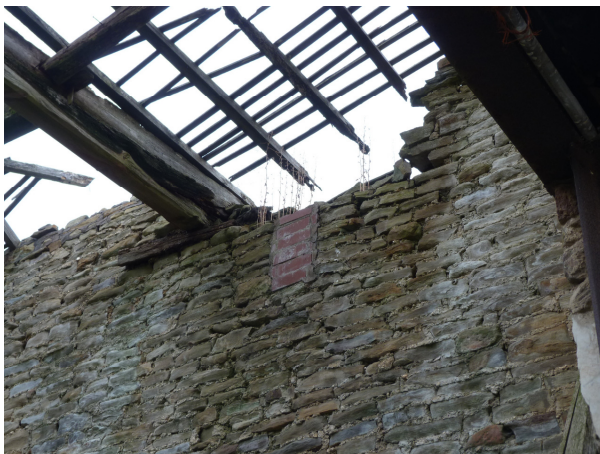
11. Collapse of south east elevation below eaves level
