CANNON HALL PARK

DEER SHELTER SURVEY

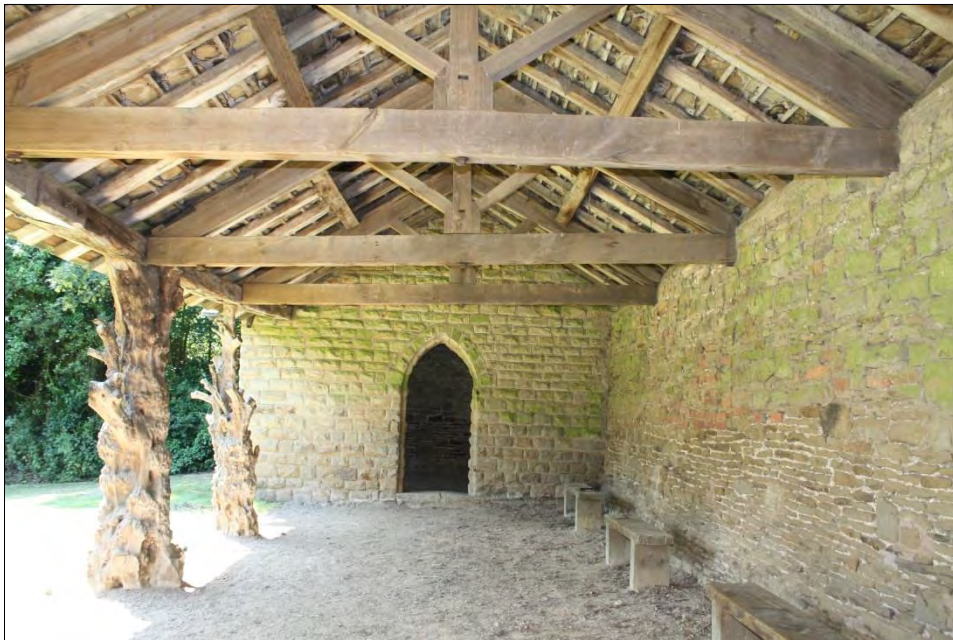
INTERNAL TIMBER STRUCTURE

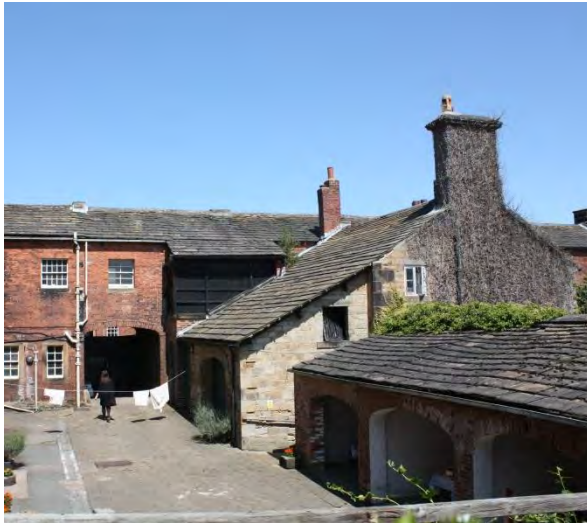
The following pages detail the retained features, and required repairs.

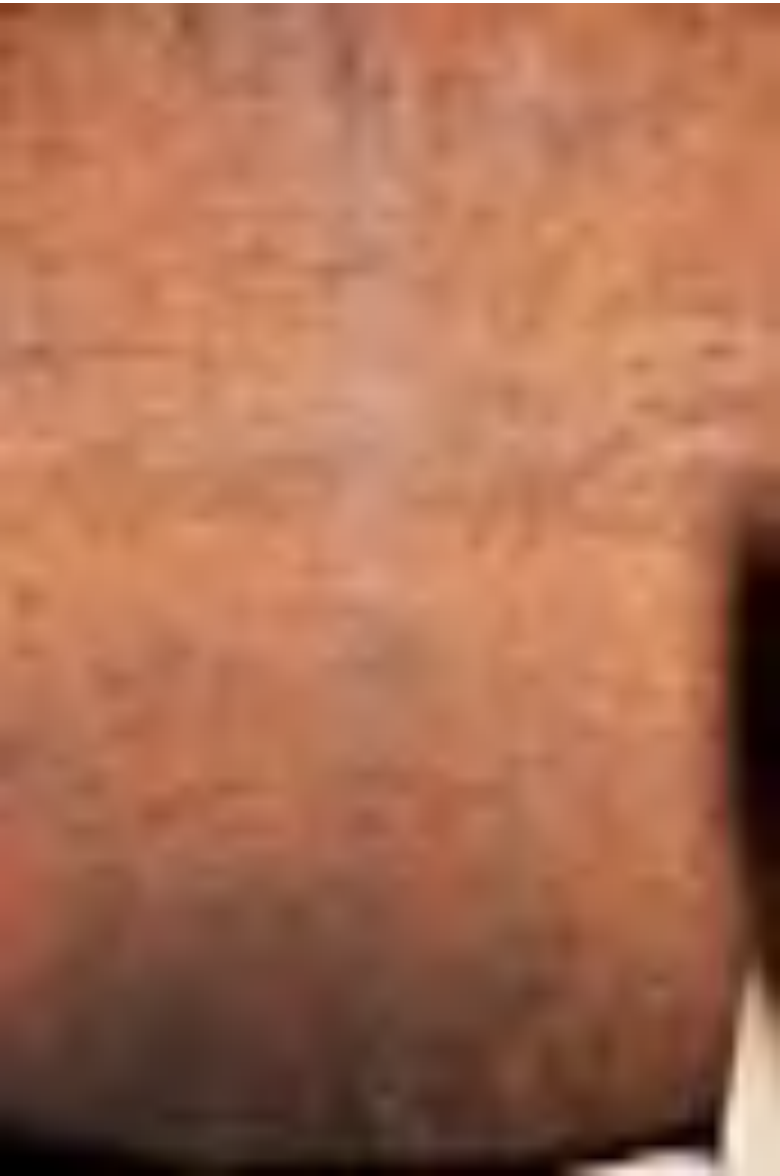
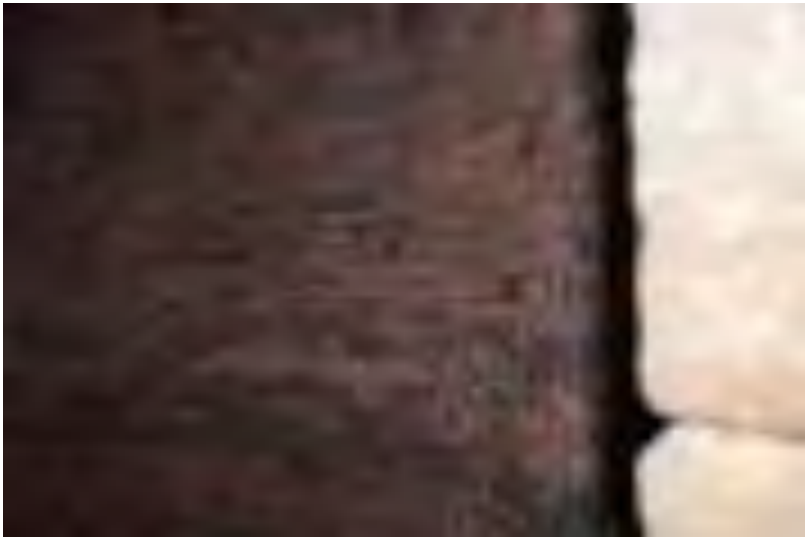
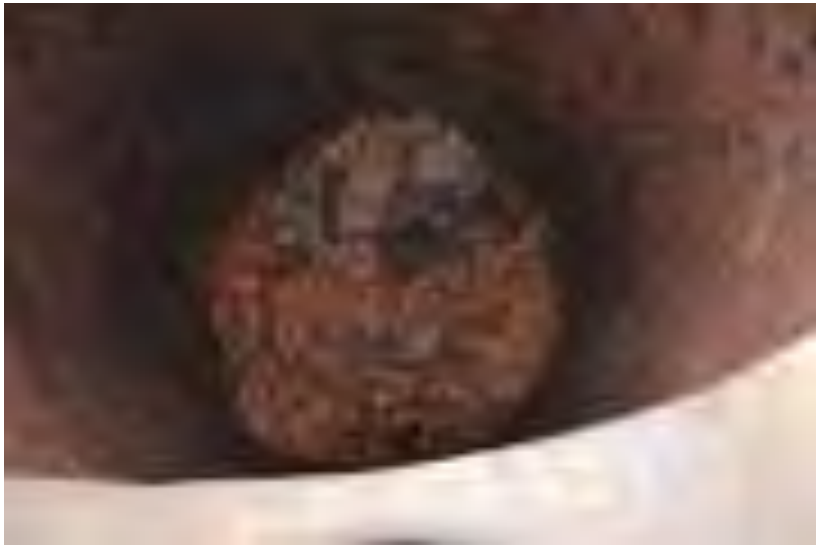
Internal brickwork was found to be in good condition, though there was a slight bulging of the domed roof in an area where a large tree has grown up to the side of the roof dome. This may be due to the tree roots, but does not give cause for immediate concern.

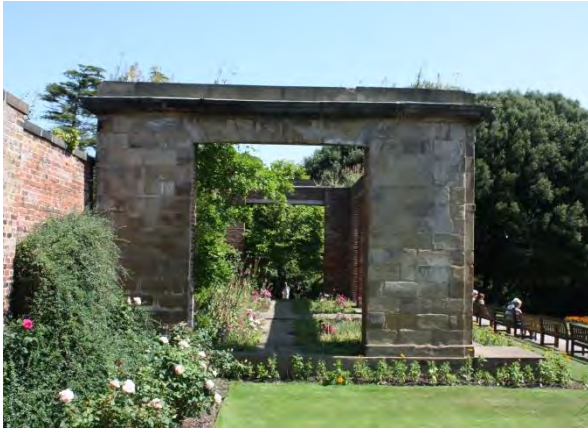
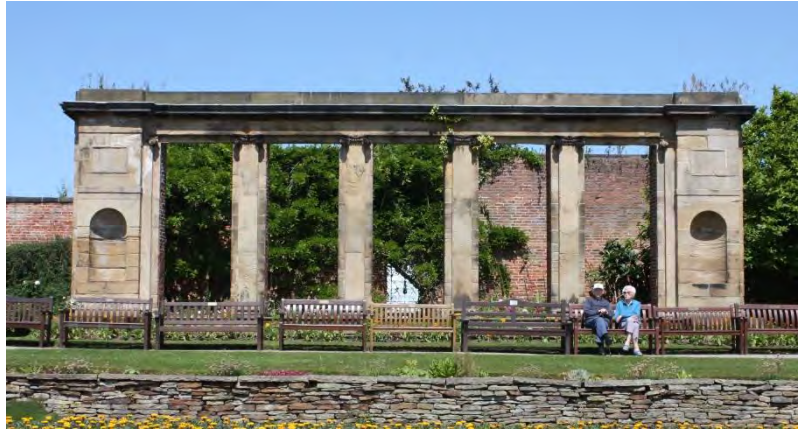
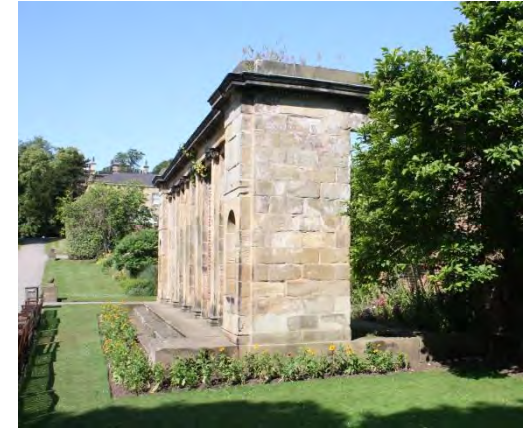
Scaffolding should be in the form of light-weight aluminium towers, set out carefully to avoid damage to the trees, and with stabilising props to the pathways. It will not be practicable to tie the scaffolding into the wall. Boards should be used to avoid over-compaction of the soil in planting beds.

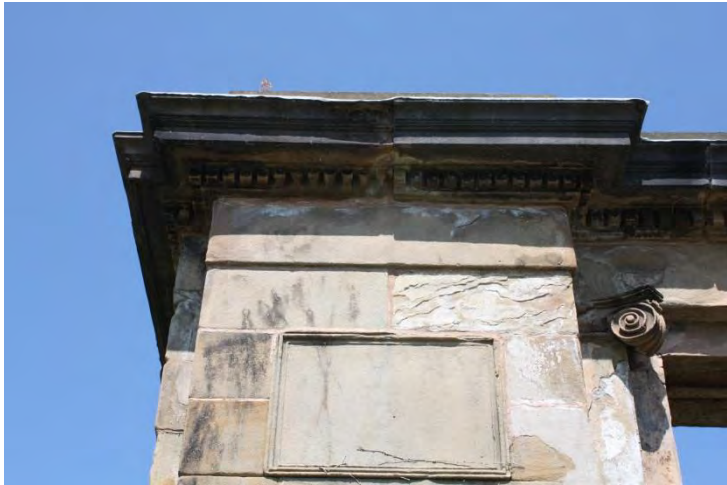
DISPLACE CORNICE TO WEST CORNER PIER

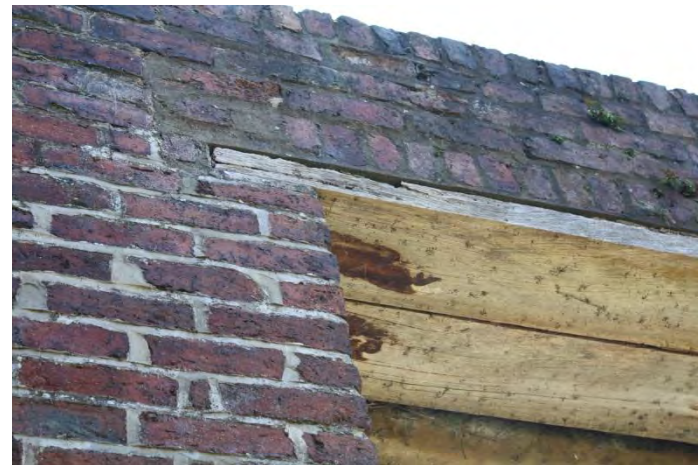
DECAY IN END BEARING OF INNER LINTOLS

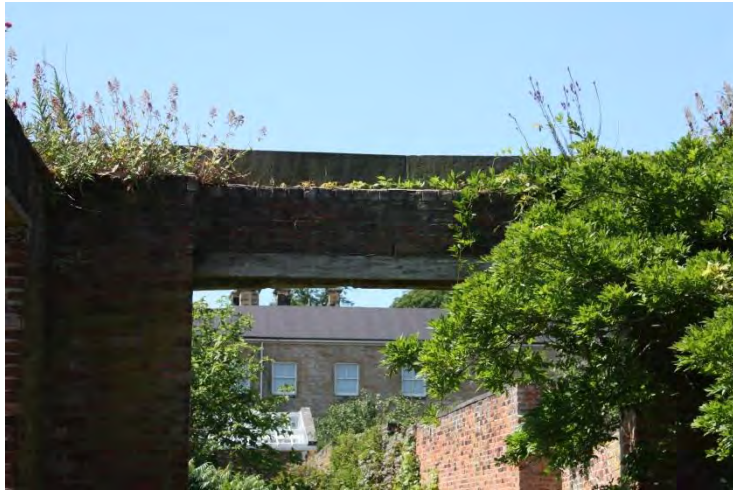
CRACKING TO BRICKWORK OVER WEST DOORWAY
BUDDLEIA GROWING IN WALL HEAD

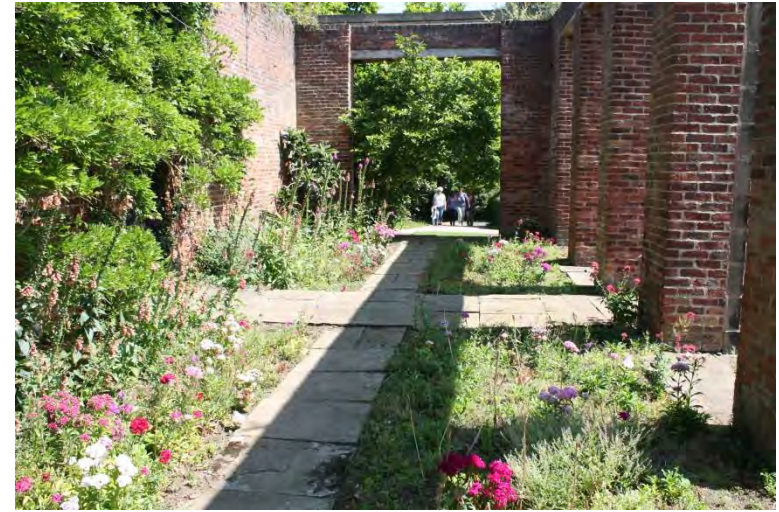
INTERNAL PAVED GARDEN IN POOR REPAIR

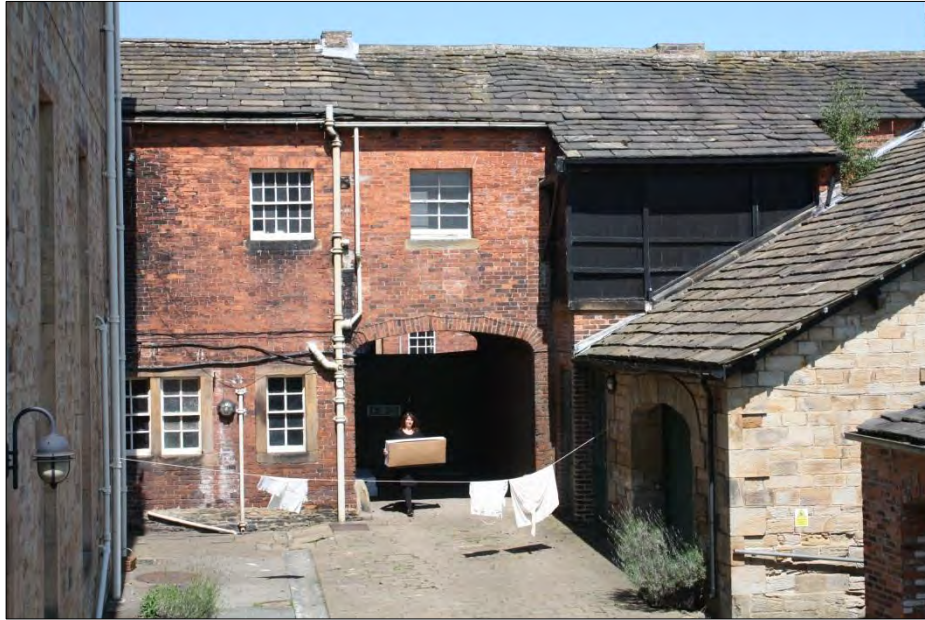
COTTAGE NO 1 – REAR ELEVATION FACING SOUTH

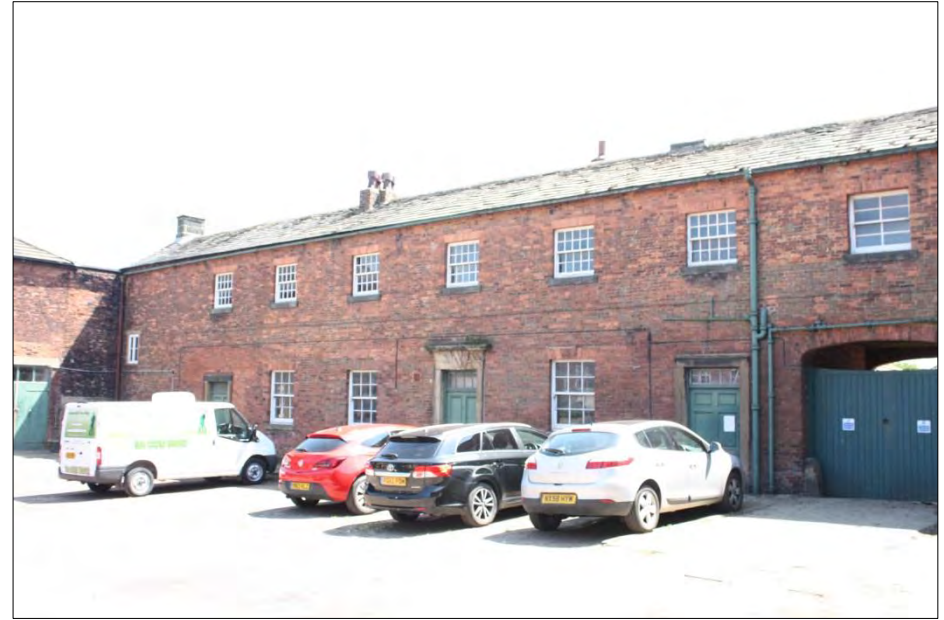
COTTAGE NO 1 – FRONT ELEVATION TO STABLE YARD

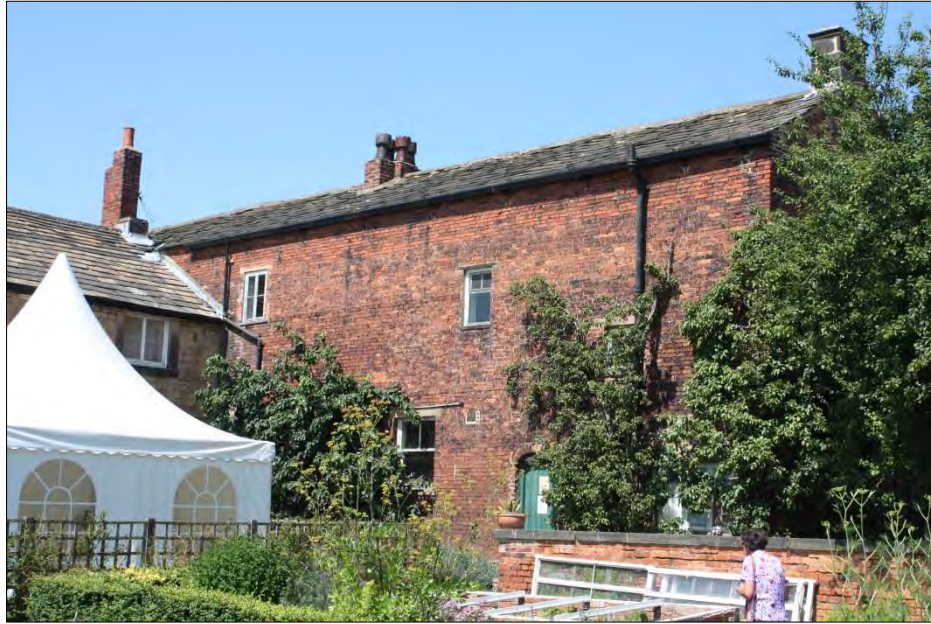
COTTAGE NO 2 – REAR ELEVATION FACING SOUTH

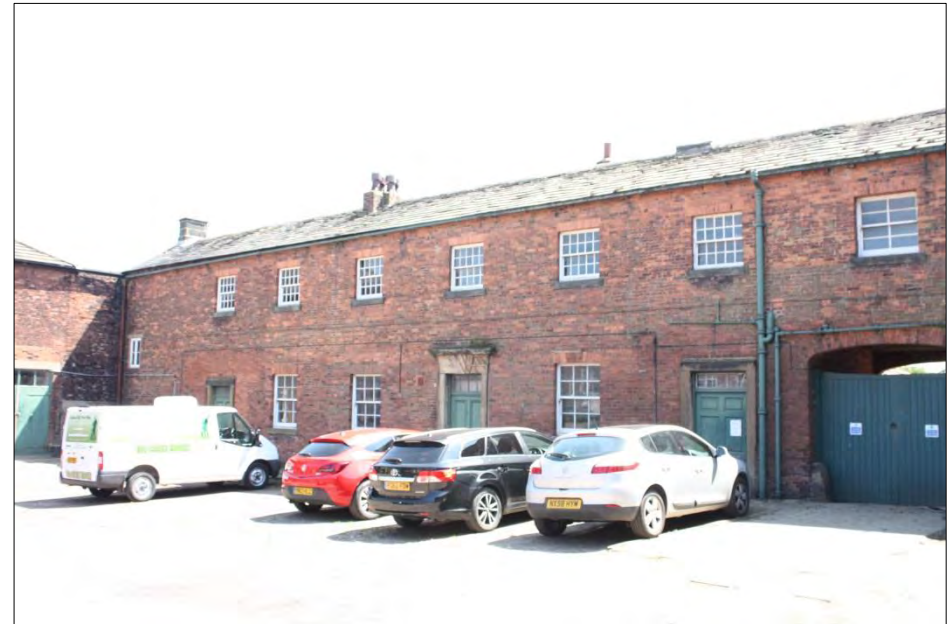
COTTAGE NO 2 – FRONT ELEVATION TO STABLE YARD

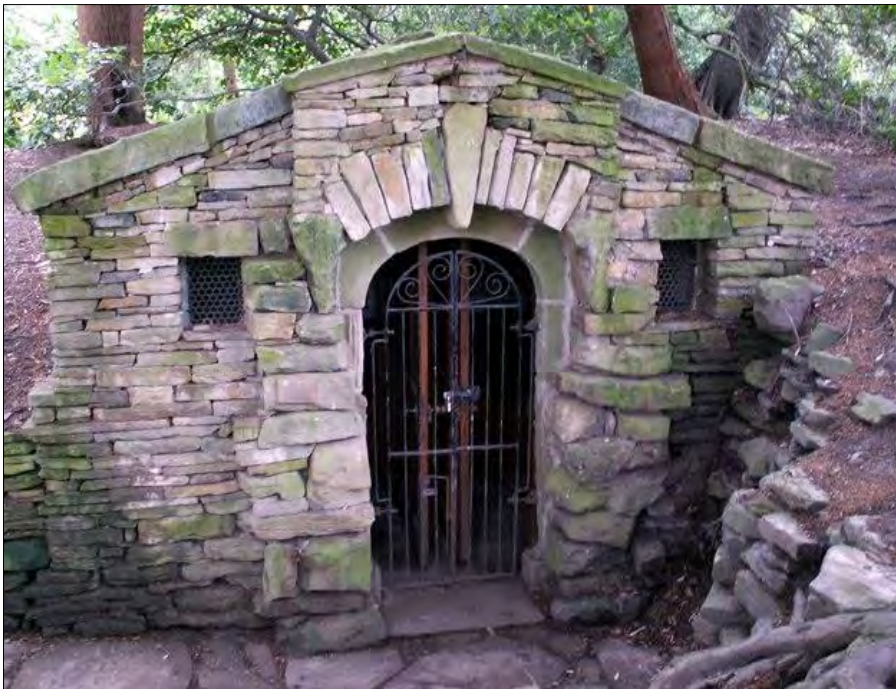
THE MIDDEN – FRONT ENTRANCE

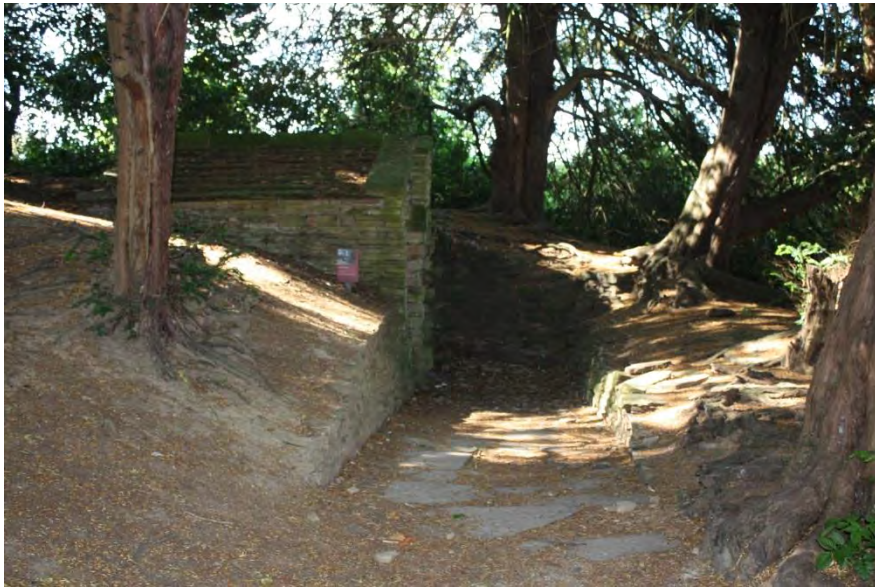
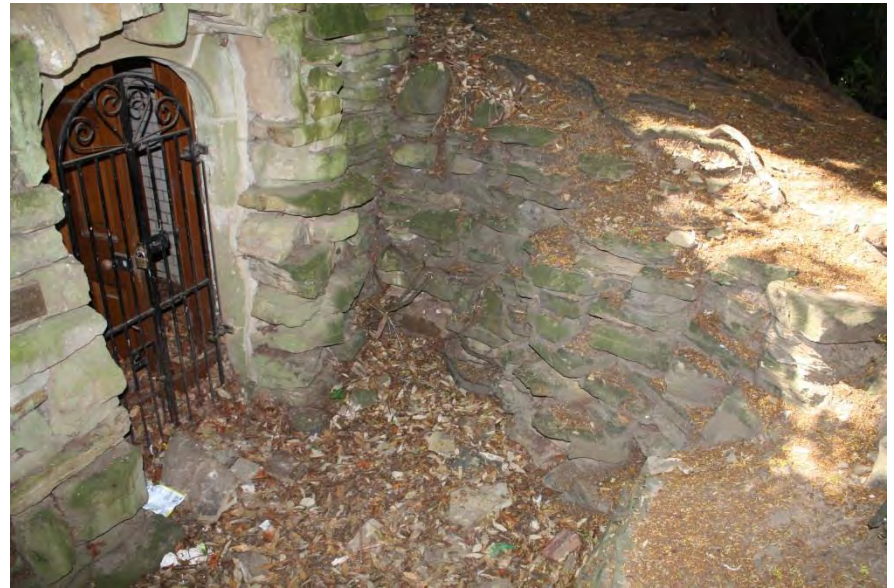
THE MIDDEN – BROKEN MASONRY TO ENTRANCE RAMP WALLS

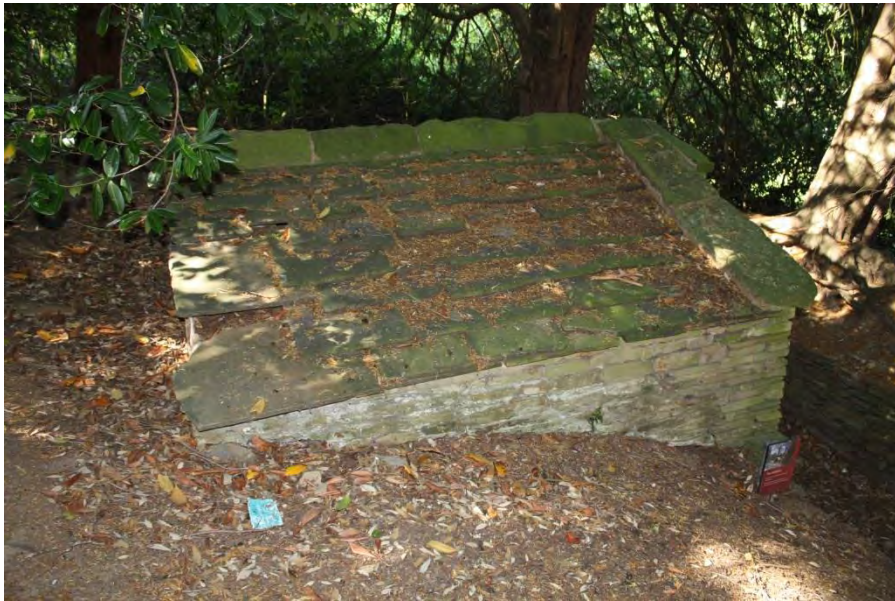
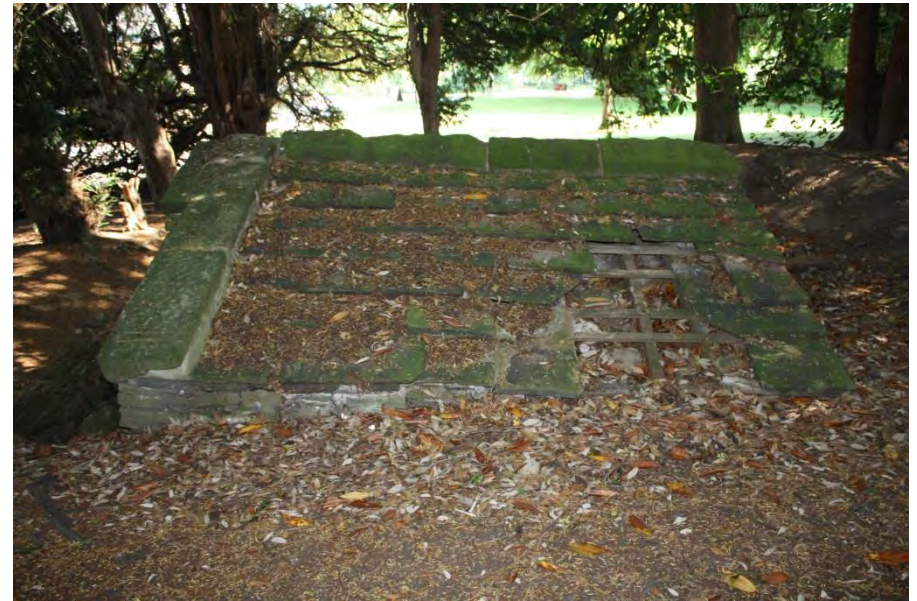
THE MIDDEN – STONE SLATES BROKEN BY CHILDREN CLIMBING ON THE ROOF.
