# Visit Report

| <b>Our Reference</b> | <b>IFS-DLG-SUB-11-0031530</b> |
| <b>Claim Reference</b> | <b>20610816/12</b> |

| <b>Claim address</b> | <b>The Gables<br/>Carlton Road<br/>Carlton, Barnsley<br/>S71 3JD</b> |

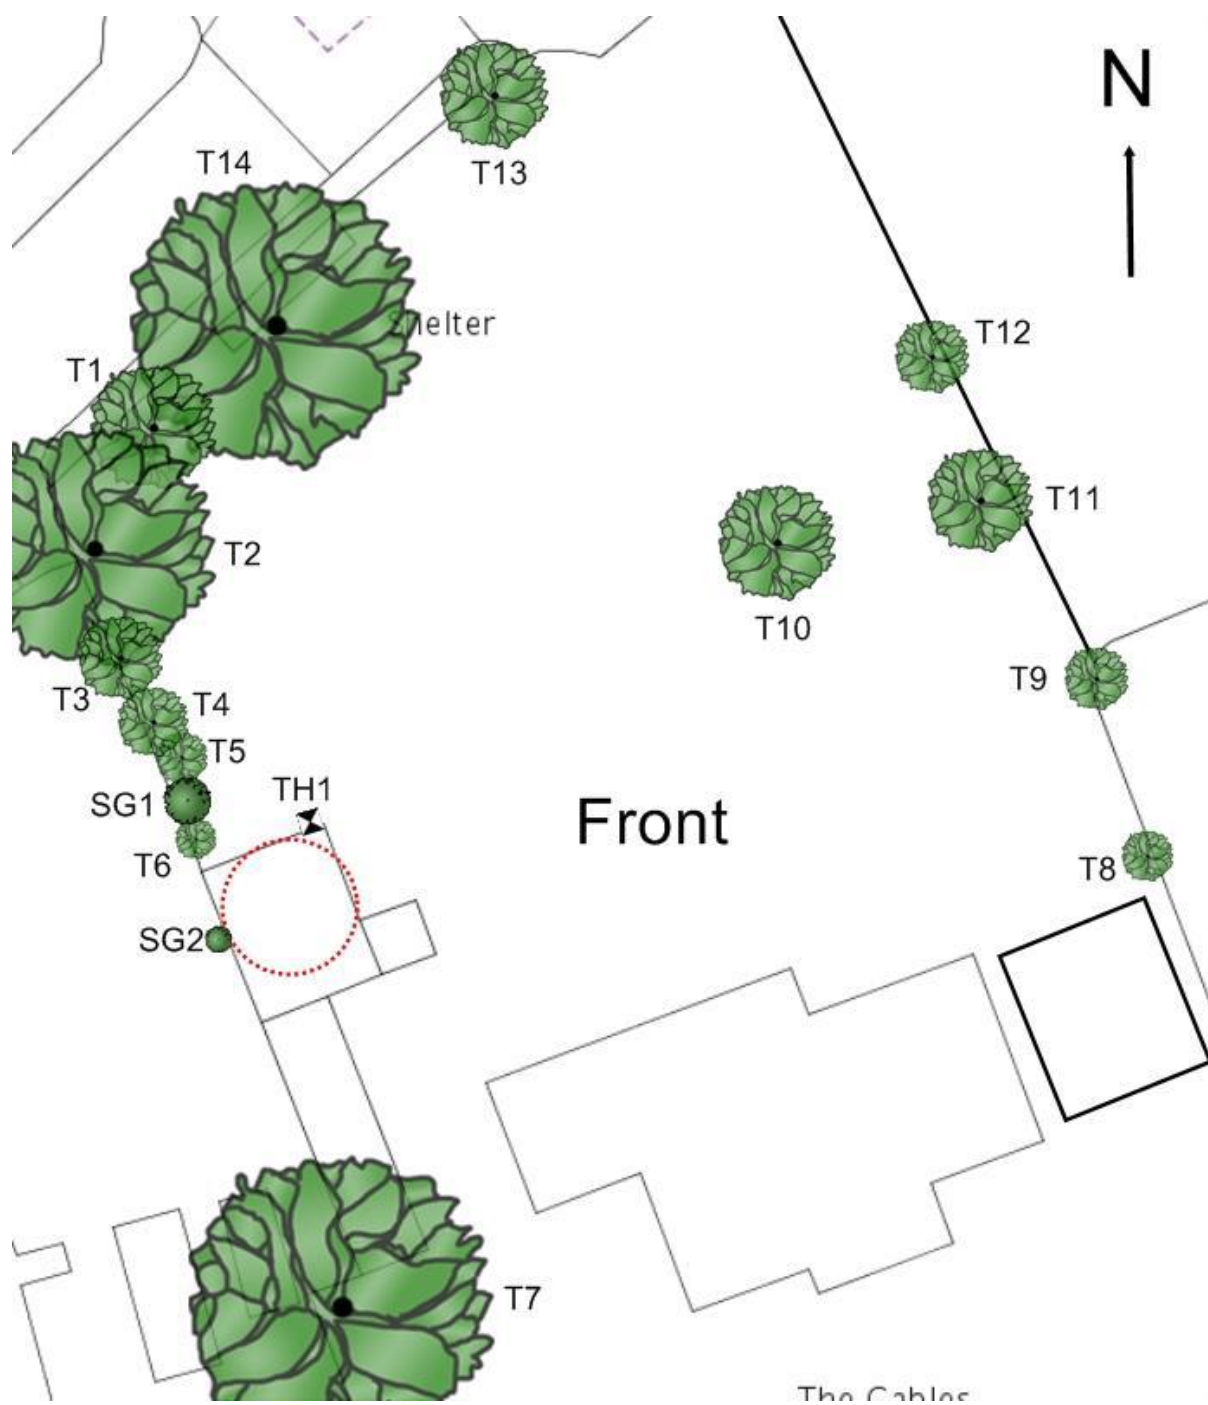
Fig 1: Site Plan

In regard to the vegetation adjacent to the right hand side of the building, the two dominant features, both of which are earmarked for removal in Marishal Thompson's latest report, are T14 (Ash) and T2 (Sycamore) located at 19 m and 14.4 m respectively from the building. Roots from both these species of tree were retrieved from beneath the foundation at the front right hand corner of the building.

I also noted however, that there is a further group of smaller trees and shrubs located much closer to the right hand side of the building, and this group also contains Ash and several Sycamore specimens. Marishal Thompson have discounted these smaller trees as not being implicated, due to their relatively small size and the depth of the roots encountered, but in my opinion the presence of the smaller trees at the very least throws doubt on the origin of the roots found in the site investigation, and may lead the local authority to request DNA testing of root specimens to confirm their exact origin.

Also of concern is the fact that there is a further mature Ash tree (T7) adjacent to the left hand kitchen annex (within 2 m of the building) but the vertical movement at the nearest monitoring station is within the range of approximately plus 5 mm and minus 2 mm, which is notably less than at the right hand side of the coach house where the dominant trees are much further away from the building.

- 1) Seek confirmation from Marishal Thompson that the following vegetation can be removed:-

T3 – Ash (5.2 m tall at 12.5 m distance)

T4 – Sycamore (6.6 m tall at 7.8 m distance)

T5 – Sycamore (4.4 m tall at 6.1 m distance)

T6 – Sycamore (4.4 m tall at 1.6 m distance)

SG1 – Privet (4.3 m tall at 2.5 m distance)

- 2) Arrange for the trees and shrubs listed above to be removed and their roots treated to prevent re-growth.
- 3) Implement revisions to the Schedule of Repairs to incorporate stitching bars to the external cracking on the rear elevation, and other minor amendments discussed on site (i.e. Repairs to damaged tarmac hardstanding at the front right hand corner of the building)
- 4) Appoint an approved contractor to carry out the repairs to the building
