# ARBORICULTURAL REPORT & Impact Assessment to BS 5837:2012 at:

***Woodlands Lodge,  
106 Hawshaw Lane,  
Hoyland,  
Barnsley,  
S74 0HH***

Report Date: *February 2026*

Reference: *AWA7313*

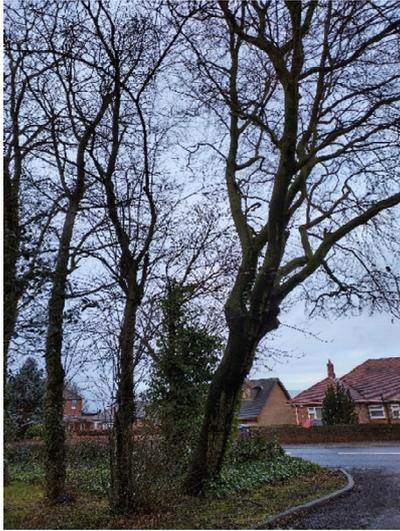
- 3.2.7 The highest value trees on site are the 4 retention category 'B' trees. These include: Beech T1, Sycamore T4, Norway Maple T6 and Lime T23. These trees are all in good condition with good long-term prospects. These trees also provide moderate amenity value within the site and have the potential to develop into higher value trees in time.

Photo 1: T1 and T2 from southeast.

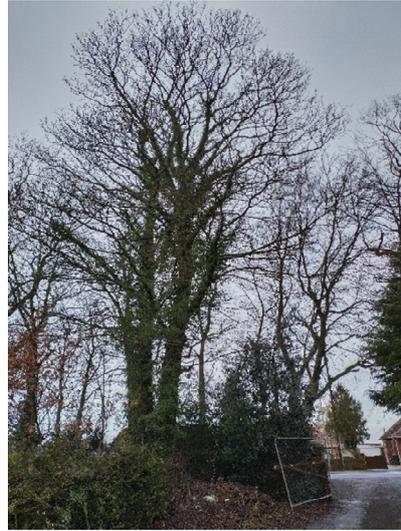
Photo 2: T3 and T4 from southeast.

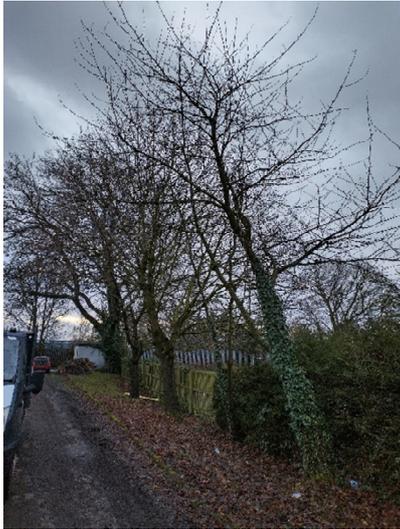
Photo 3: T5 – T8 from northeast.

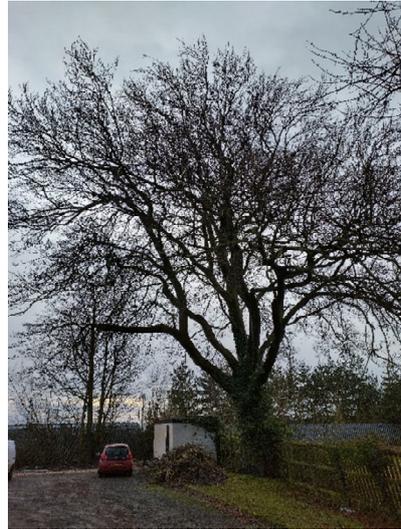
- 3.2.8 Mature Beech T8 has high visual amenity, however it has been classified as Category C due to the presence of decay fungus *Meripilus giganteus*, and evidence of declining physiological condition, which together reduce the tree's long-term retention value and life expectancy. Given the presence of a significant decay fungus, a separate detailed tree risk assessment, undertaken in accordance with recognised tree risk assessment methodologies, is recommended to inform any future management decisions. This would allow the tree's structural condition and risk profile to be considered independently of its BS 5837 retention categorisation. The remaining trees within the site are of particularly low value and should not pose any significant constraint on the development potential of the site.

Photo 4: T8 from northeast.

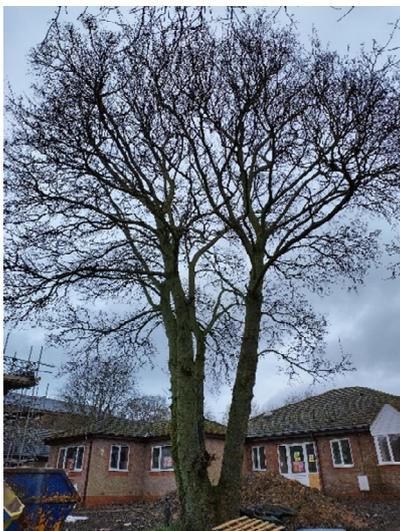
Photo 5: T12 from south.

4.2.2 The tree that requires removal to facilitate the development is T12. T12 requires removal due to the proposed play area and associated equipment proposed within T12's RPA.

4.2.3 T12 is an early-mature Sycamore with moderate amenity that has been classed as a retention category 'C' tree. At the time of survey we also noted that a significant proportion of the southern root area had already been excavated and exposed, with additional storage and ground disturbance within the Root Protection Area. These factors are likely to have adversely affected the tree's rooting environment and long-term stability.

4.2.4 Due to the low value of the tree to be removed the removal will have only a low negative arboricultural impact.

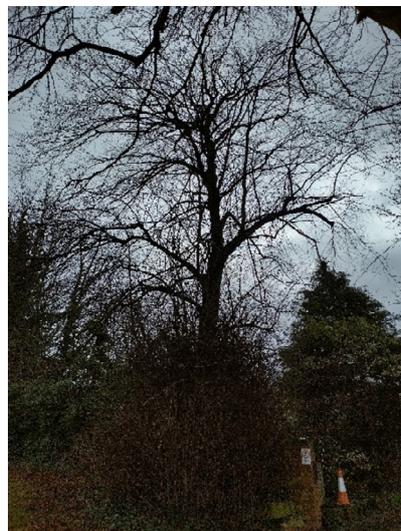
Photo 6: T23 from north.

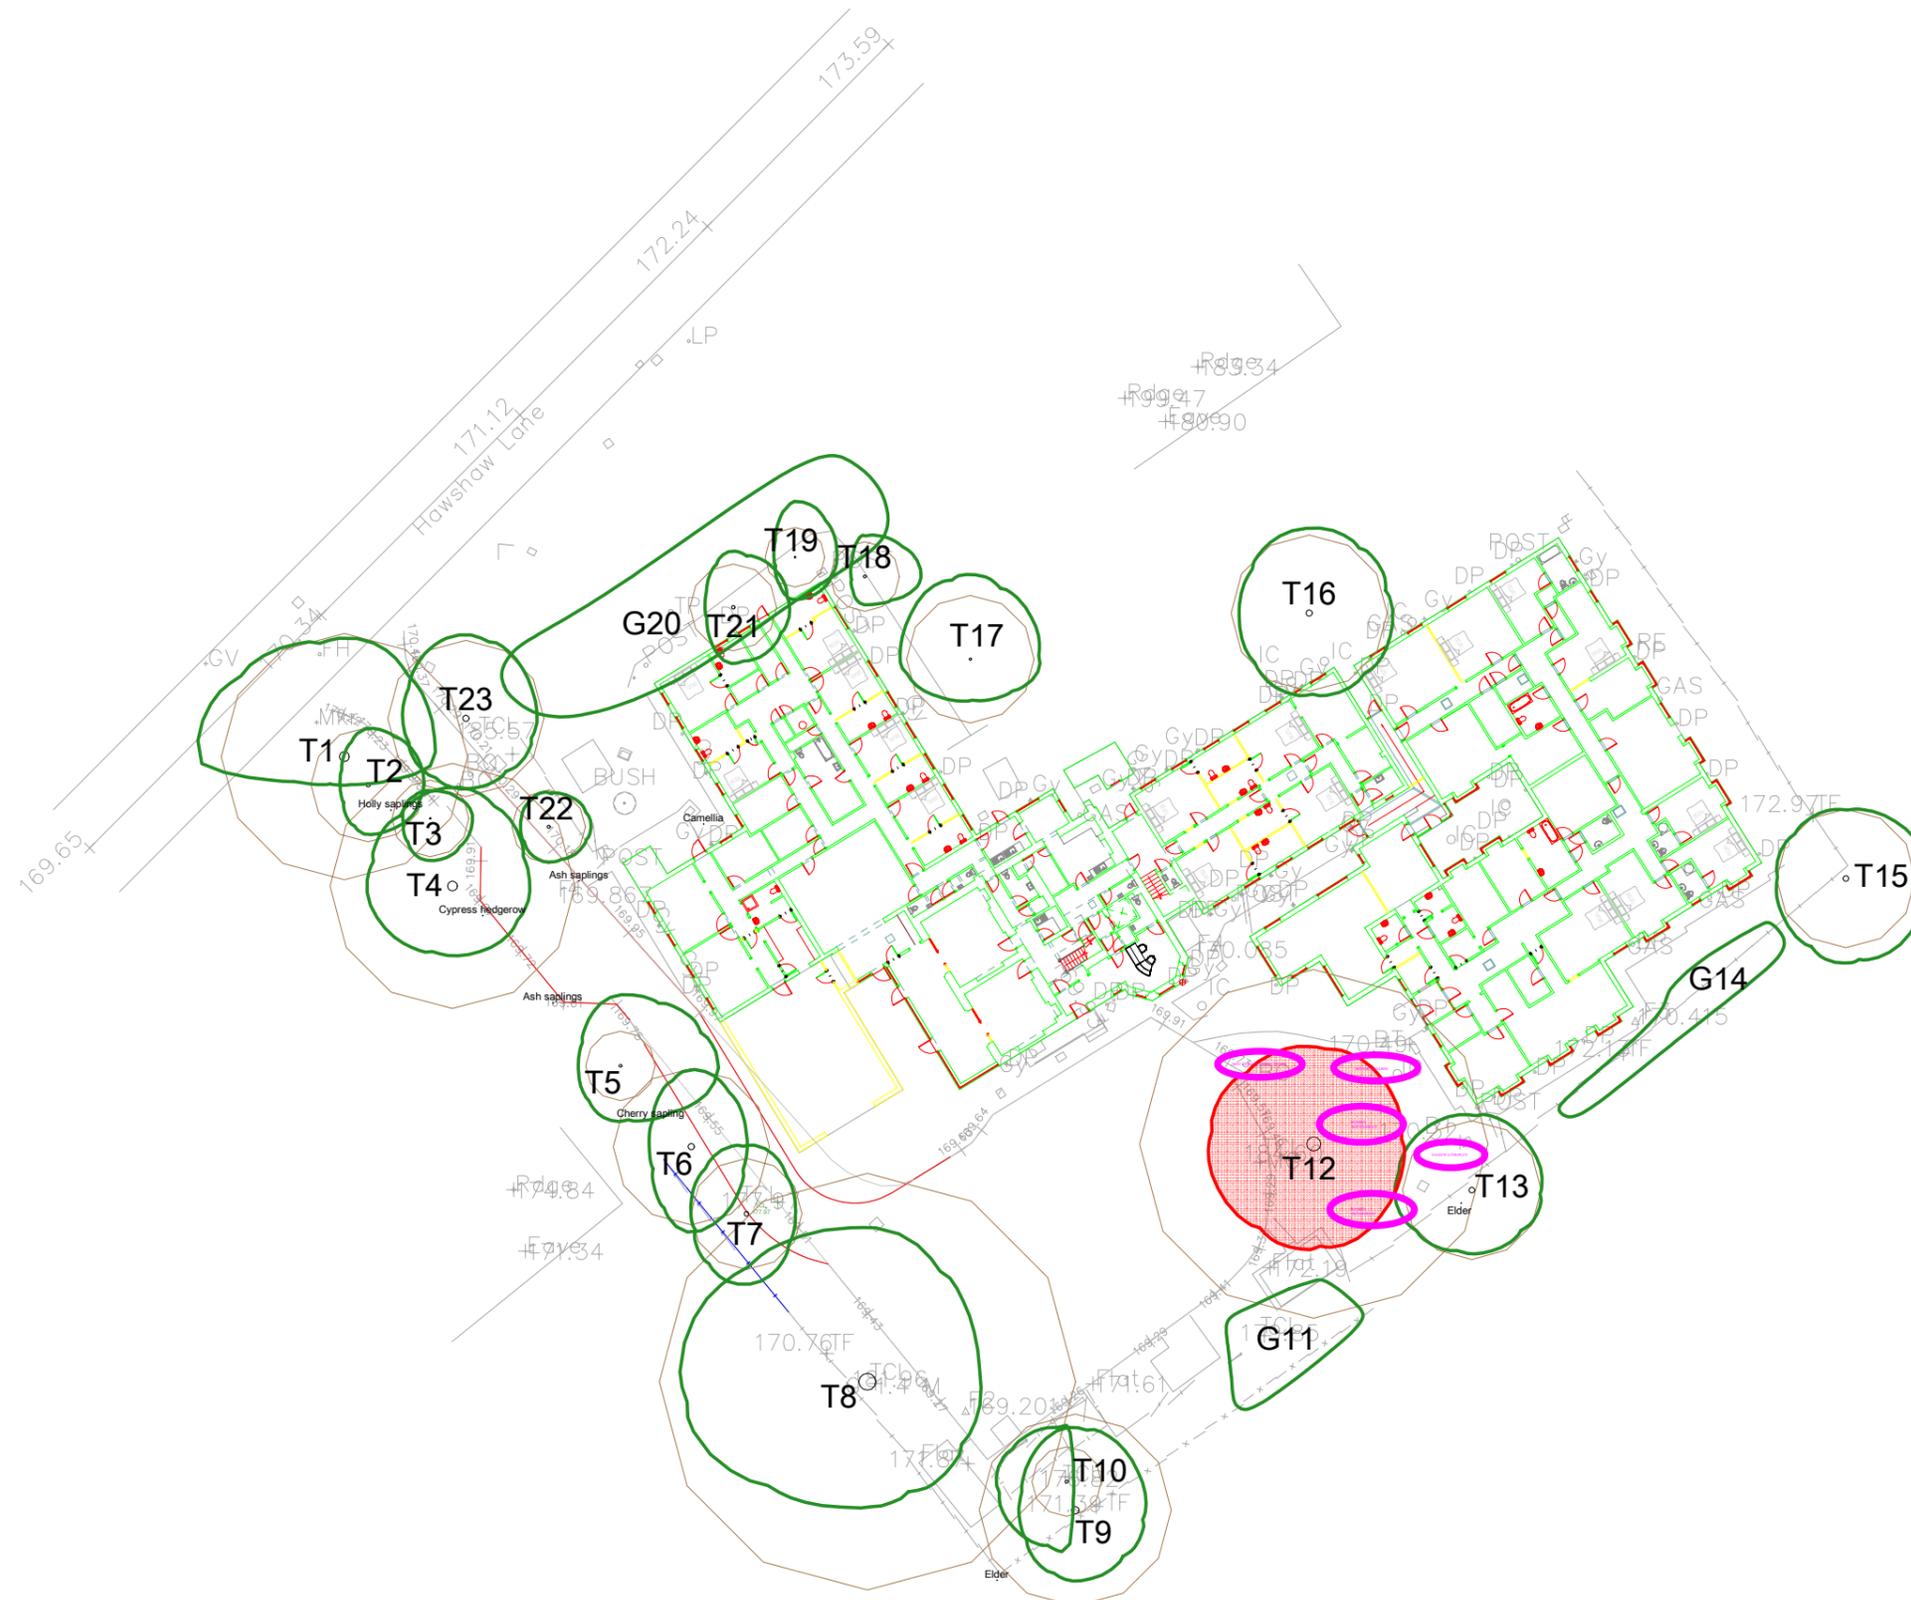
**Appendix 6:  
Tree Impacts Plan**

4.2.1 From assessing the new development proposals, 1 low value tree will require removal to facilitate the development as it is situated in the footprint of the development. No trees will require pruning works.

4.3.2 Potentially damaging activities are proposed in the vicinity of retained trees. The new development encroaches close to and into the edge of the RPA of T16 and T21. Construction within the RPA, can have negative impacts on tree roots. However, the encroachment is minor, and the development is generally limited to the footprint of the existing hardstanding and the existing care home. As such, it is unlikely that significant roots will be within these areas and the retained tree should remain largely unaffected by the works, provided care is taken during construction.
