# CRACK MONITORING

## for Subsidence Management Services

**Stonehurst, Green Road, Barnsley, Dodworth, South Yorkshire, S75 3RP**

Client:	Subsidence Management Services
Client Contact:	Mauro Loscalzo
Claim Number:	12517951H
Client Reference:	IFS-AXA-SUB-22-0104873
Policy Holder:	████████████████████
Report Date:	21 December 2023
Our Ref:	M20296

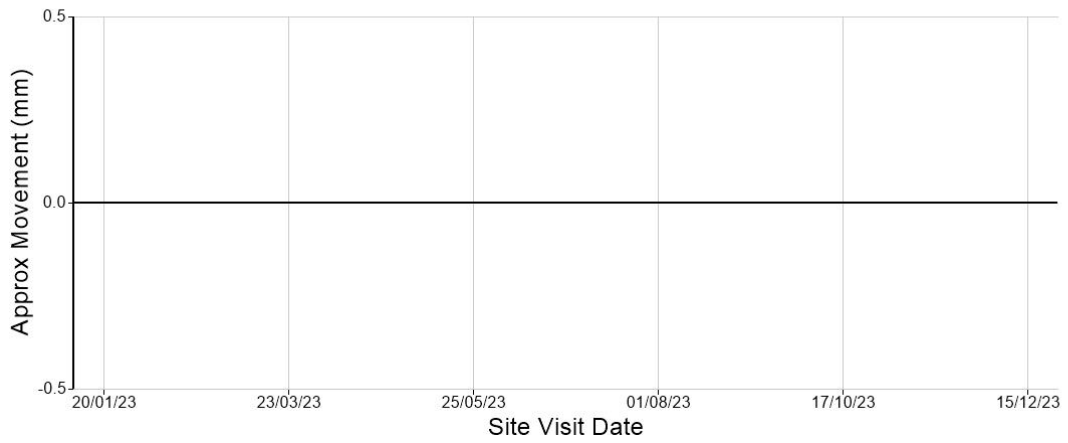
### C3

Unable to fix crack stations on location 3 as wall plaster was crumbling away.
