## Gate Piers and Posts

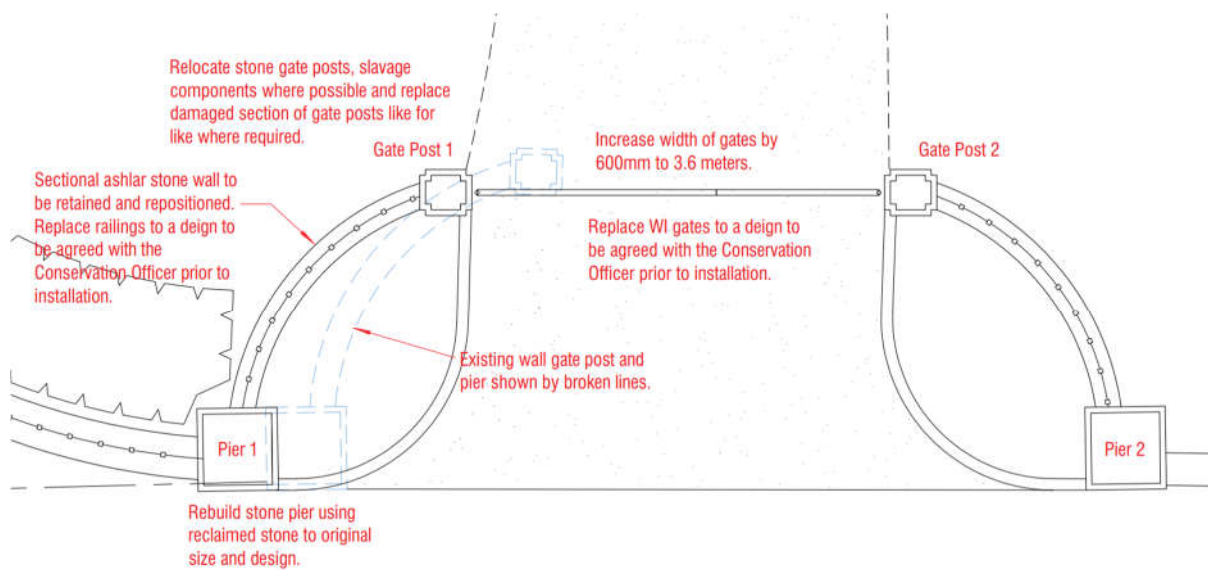
Fig 01. Plan of Access showing showing existing pier and gate post to left of access repositioned to increase width of access to 3.6 meters.

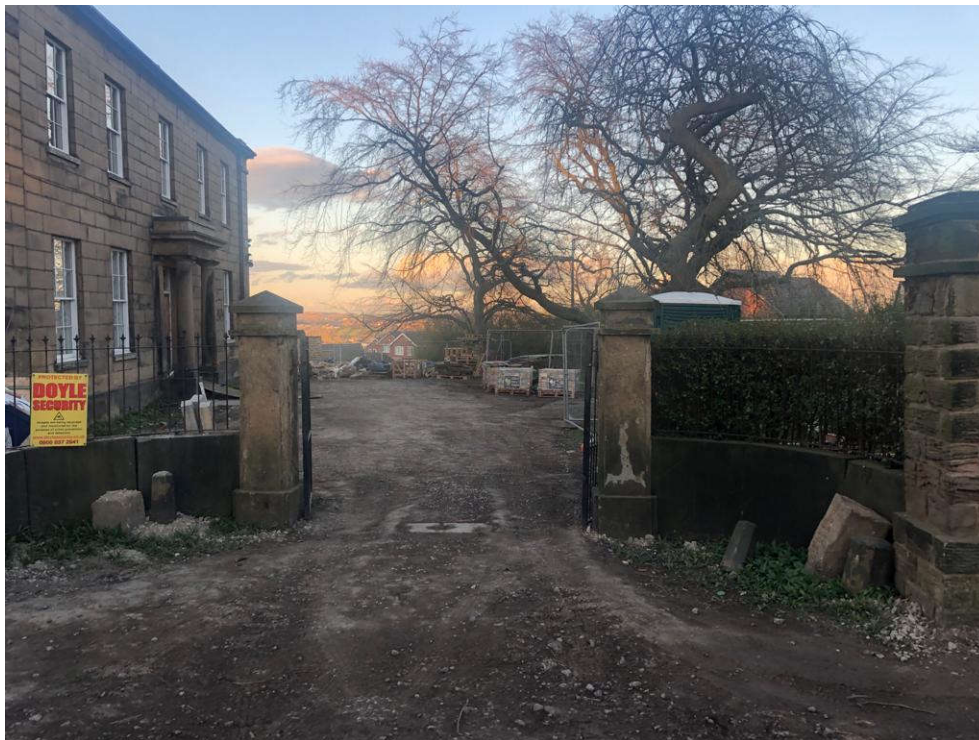
Fig 02. View of existing entrance with stone gate posts set within semi-circular ashlar low wall to entrance area and stone piers to outer corners.

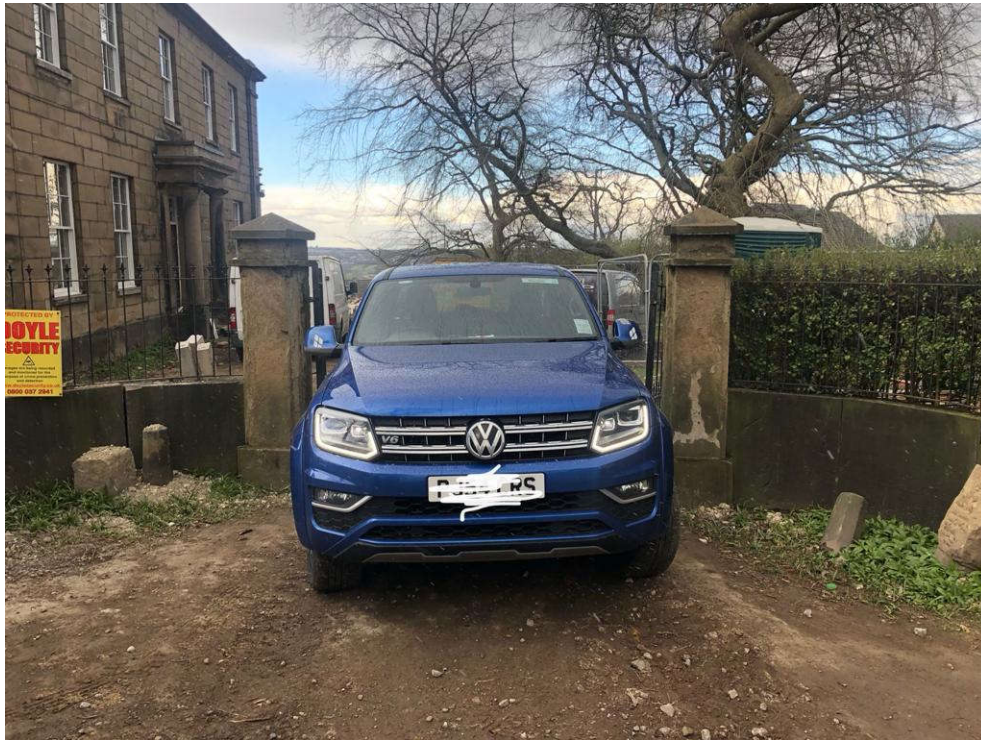
Fig 03. (Above) shows the existing entrance at less than 3.2m wide which is restrictive. Figs 04. and 05. Below show the condition of the existing stone gate posts which are badly weathered and fractured and require replacement to several components. These will be replaced using natural sandstone to match existing sections. Any components that can be salvaged, such as the cappings which appear to be in reasonable condition will be retained.

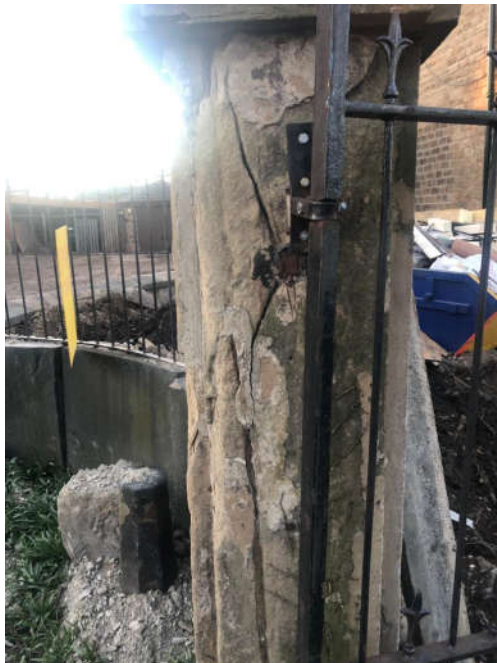
Fig 04. Left hand gate posts weathered and fractured from original iron hinge.

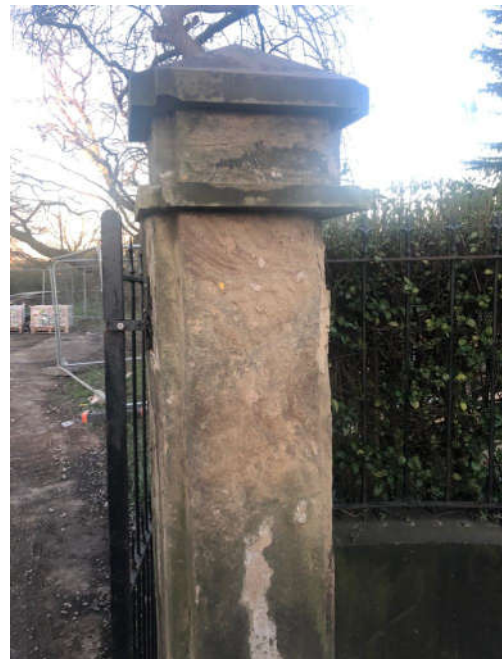
Fig 05. Right hand gate posts badly weathered and previously repaired.

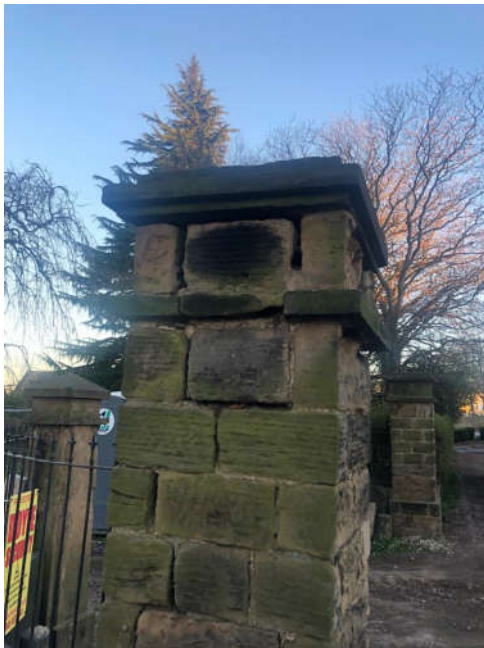
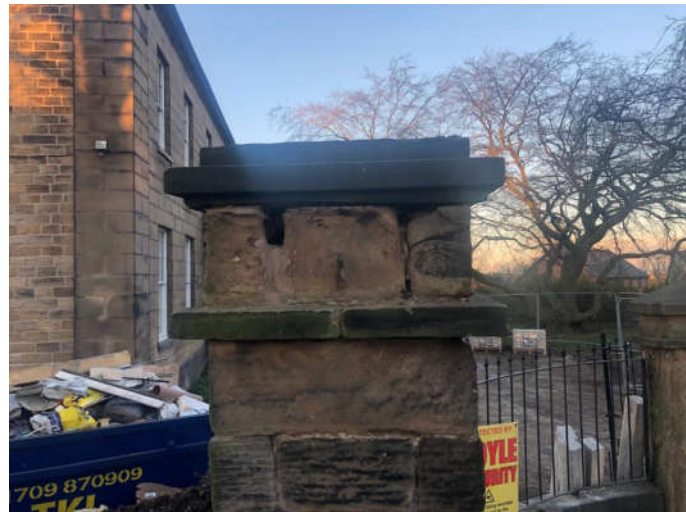
Fig 07. Left Hand stone pier

Fig 06. Left hand stone pier in images 06 and 07 badly weathered, to be taken down and rebuilt in new location using reclaimed materials and lime mortar mix as previously agreed.

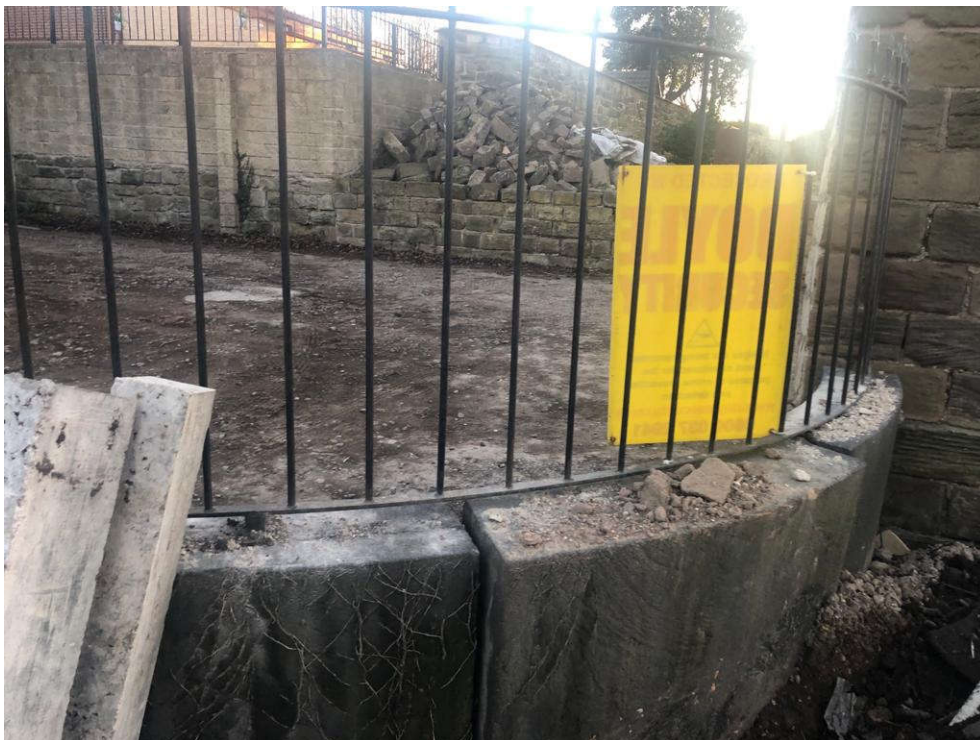
Fig 08. Low level semi-circular ashlar stone wall between stone piers and gate posts to be removed and reset ready to receive replacement iron railings. Design of iron railings and gates to be agreed with the Conservation Officer prior to installation.
