# CERTIFICATE OF REOCCUPATION

| Project Details | Certificate Ref: | AX01-COR | Project Ref: | J026712 |
| | Area to be Assessed: | Former dairy room | Scope of Works, including Dates: | Stage 4 Clearance - Unscrew AIB sheets to timber ceiling in former dairy room under fully controlled conditions. |
| | Client Address: | Healey Lane Business Centre - Unit 4, Healey Lane, Batley, West Yorkshire, WF17 8EZ | Site Address: | Cockle Edge Farm, Huddersfield Road, Ingbrichworth, Penistone, Sheffield, South Yorkshire, S36 7GF |

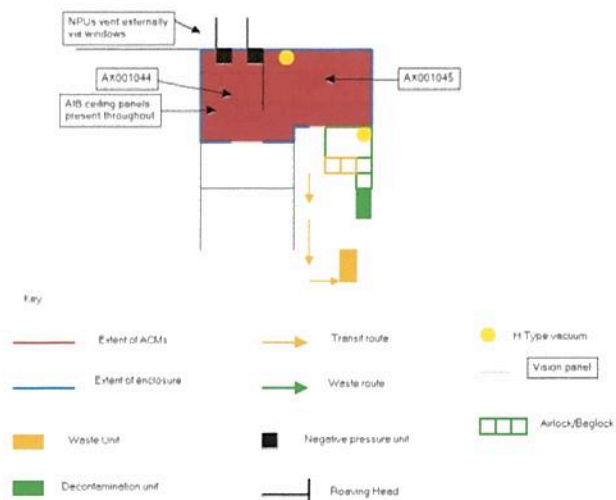
#### Drawing of Enclosure

Width: 3.5 m

Length: 9 m

Height: 3.5 m
