**BARNSELY CIVIC HALL ,ELDON STREET , BARNSELY  
FAÇADE, ROOF , DRAINAGE AND TILED FLOORING CONDITION  
SURVEY**

**Date: 1st FEBRUARY 2022 rev 1**

**BARNSELY CIVIC HALL FAÇADE, ROOF, SURFACE DRAINAGE SYSTEM AND TILED FLOOR  
CONDITION SURVEY**

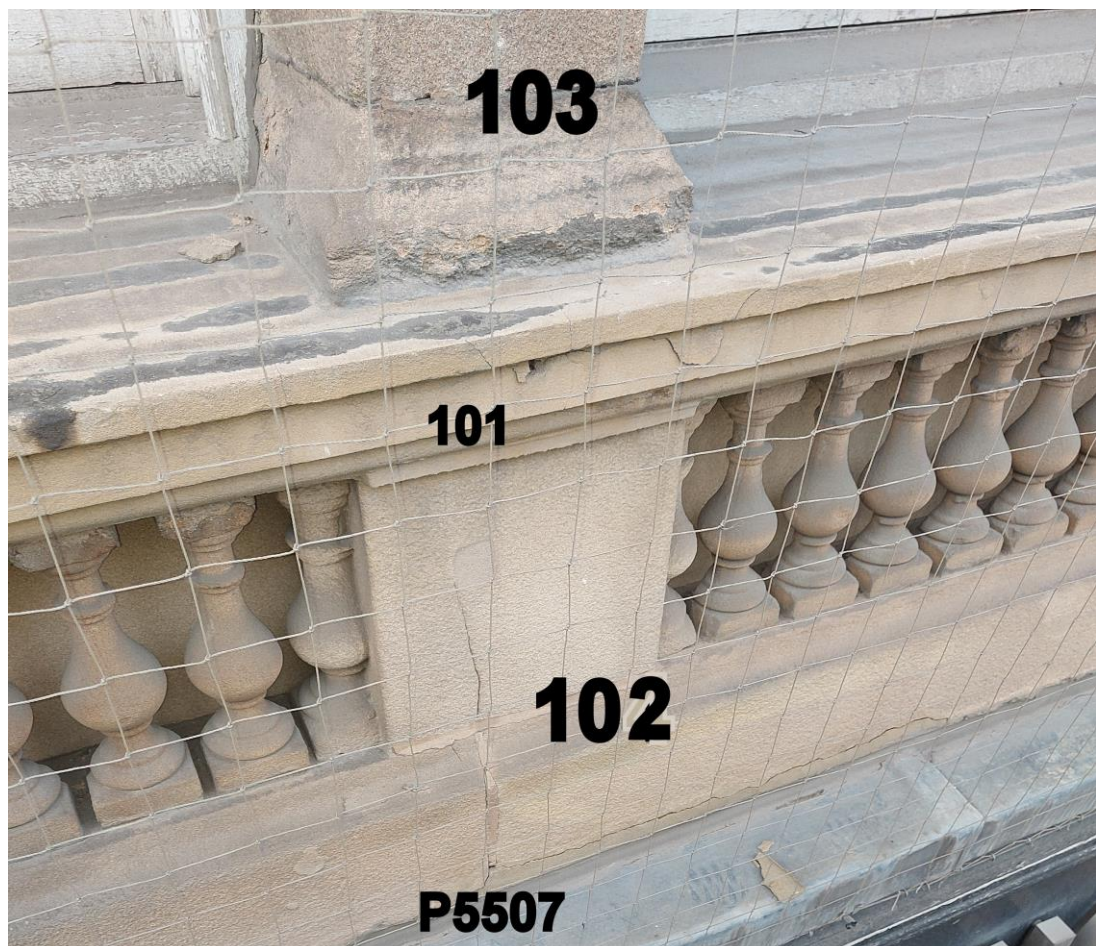
2.4.3

2.4.2 The façade has been extensively repaired with in situ mortar. Many of these repairs are still sound to a hammer test. Some show signs of crazing (fine cracking) but are still soundly bonded to the host stone. Where this is the case, the repairs have not been considered for any further intervention. See Photo 5507

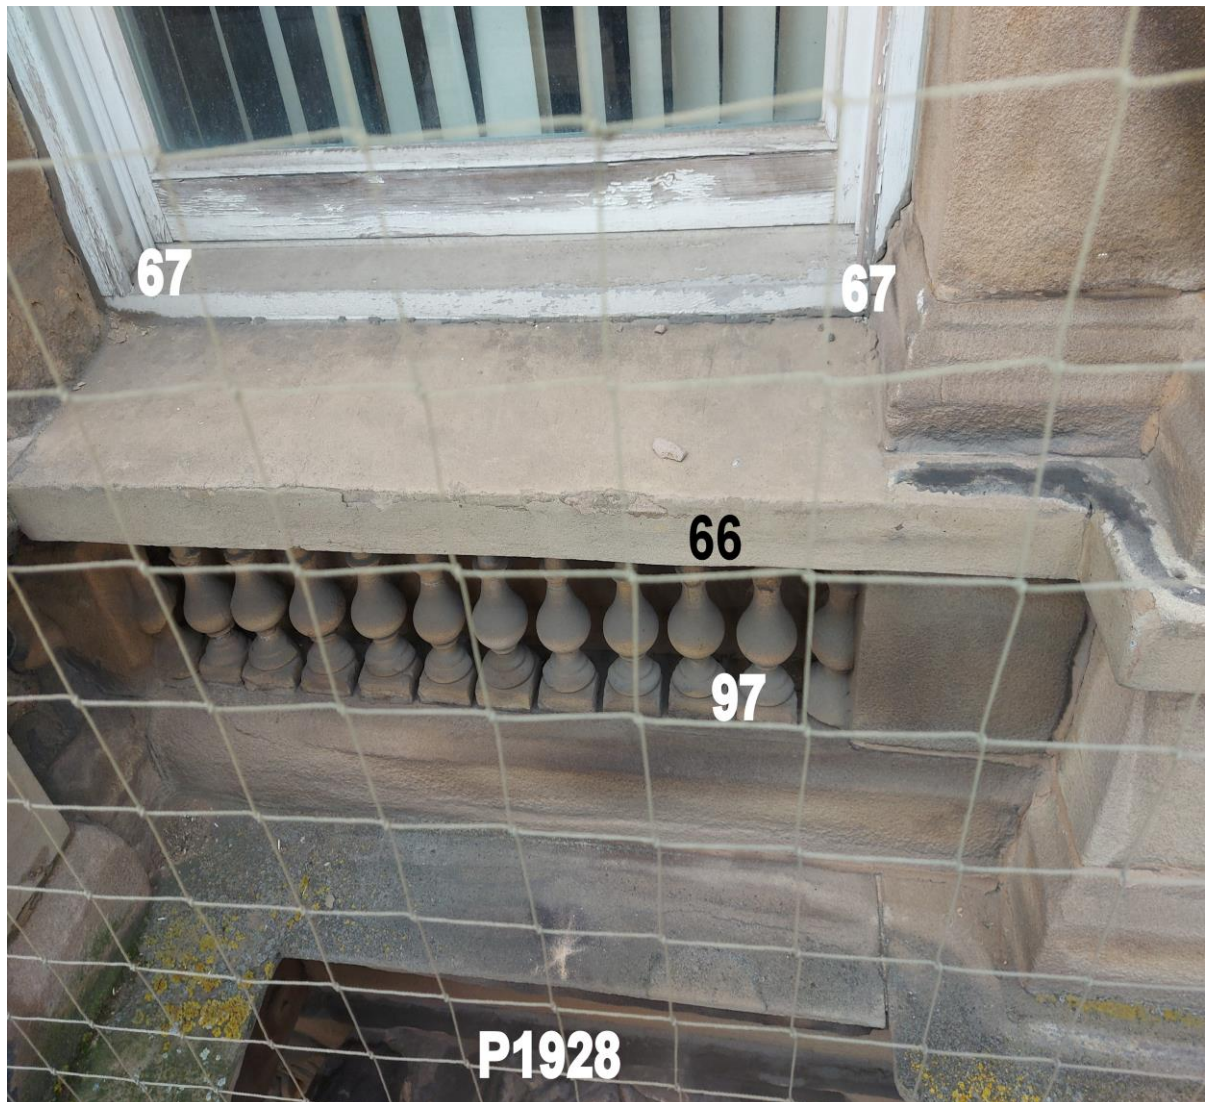
2.4.5

- 2.4.4 Some repairs are noted as failing and coming loose. The Bird netting system has contained the larger sections that have become loose. The cause of failure is noted as a number of reasons. The repair being too shallow. In some cases, as thin as 2 or 3 mm, insufficient cutting out at the perimeter resulting in feather edges and insufficient keying (cutting into the surface to increase the bonding qualities). See Photo 1928.

- 2.4.6 Where repairs are noted as failed or failing the decision to re-restore needs to be considered. It was noted in some locations where no cutting into the stone for a key had been performed that the revealed face was sound and could be considered for redressing rather than re – restoring. The façade has been Abrasive cleaned likely in the 1980's. During this period course abrasive mediums and high air pressure were commonly used, resulting in surface erosion and loss of finer detail (i.e. edges to arris's). With this in mind reforming damaged details to a 'crisp' detail becomes less significant. Any insitu repair has a limited life expectancy dependant on number of issues such as exposure, the base stone, preparation and the quality of the mortar. Also to affect a 'good' repair it may be necessary to remove more of the original stone to enable a minimum depth of repair (around 10mm). Most conservationist believe in retaining as much of the original fabric as possible.

- 2.4.7 Given the above, consideration should be given to redressing areas of failed repair by hand rubbing loose and friable surfaces to a sound base suitable for water runoff. Where suitable water run off cannot be achieved or the extent of erosion or decay is a major visual disfigurement restoration could be considered. Where the depth is excessive indentation with new stone may be required.

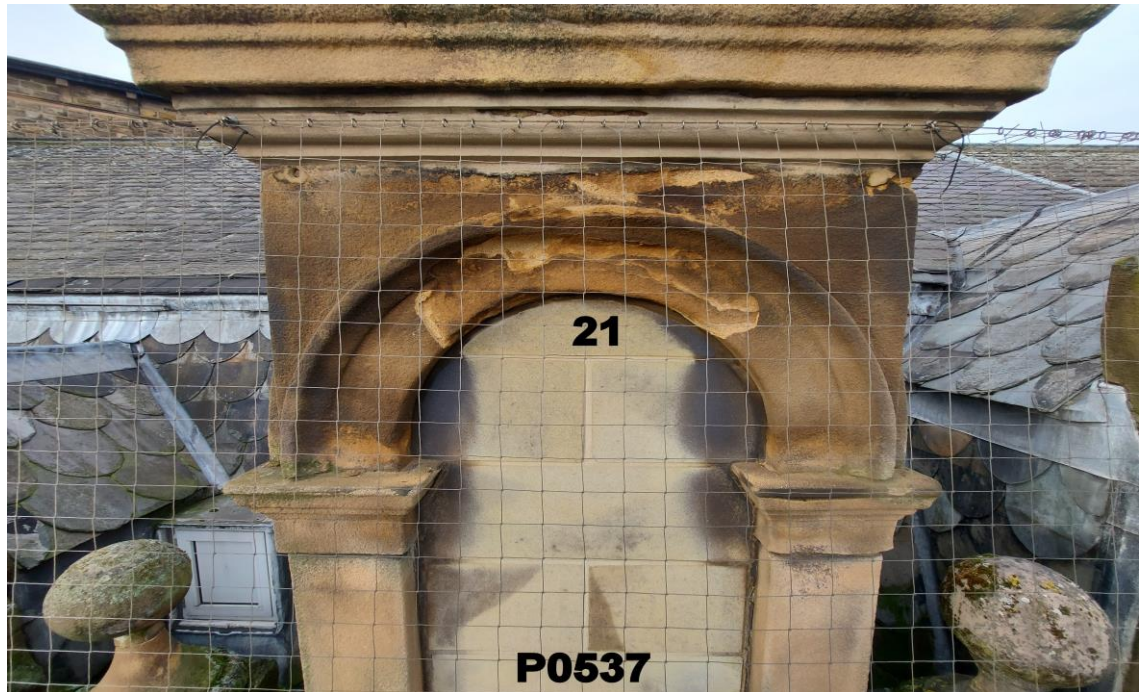
2.4.11

- 2.4.8 **Surface delamination or erosion**
- 2.4.9 Areas of the stone have become friable resulting in either crumbling or flaking of the surface. Generally, very shallow surface loss is noted (1 to 3 mm). See Photo P0537.

There is a large area of surface erosion to the lower 3-4 courses to the right-hand side of the main entrance. The extent and manner of any remedial works is a debatable and subjective issue. Differing opinions will be offered by many as to whether the decayed areas should be cut back, thus removing more of the original stone, with the aim of replacing it with new detailed stone sections. Alternatively, the area is prepared for restoration reforming the original design in an insitue mortar. This would preserve much of the original stone. The last option being to stabilise any loose areas by re dressing and repoint any defective joints. This preserves the original stone, and it is accepted in its weathered state as being part of the history of the building. This discussion needs to be held with the local Conservation authorities and funding parties. For the purpose of budgeting a provisional cost is offered for stone replacement. An agreement as to which individual units are to be made good (if any) needs to be agreed prior to determining this cost accurately.

- 2.4.10 In most instances removal of the loose surface by combined use of a bronze bristle brush and handheld masons drags will reform a hard weathering surface (redressing).

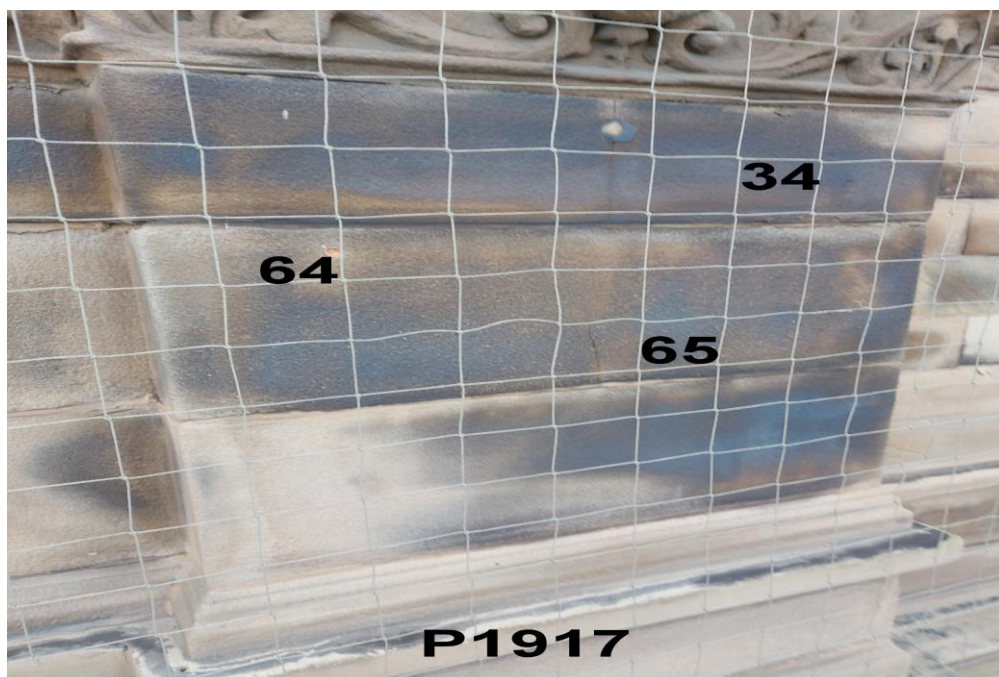
2.4.31

2.4.30 There are a number of areas particularly at high level with heavy black staining. It is difficult to offer a view as to the cause. These stains are typical of carbon staining, common on such buildings of its age due to industrial smogs of the early 20<sup>th</sup> century. Indeed, it is likely that the building was almost black, and this is the reason abrasive cleaning was considered at some point as the cleaning medium. See photo P 1917

2.4.32 However, images taken in 2004 show the building in a 'clean state. Thus, these markings have appeared over the last 17 years. Similar staining could be identified with damp penetration. However, as the roof area was totally refurbished during the early 2000's and there are no current signs of water damage this would appear not to be the case.

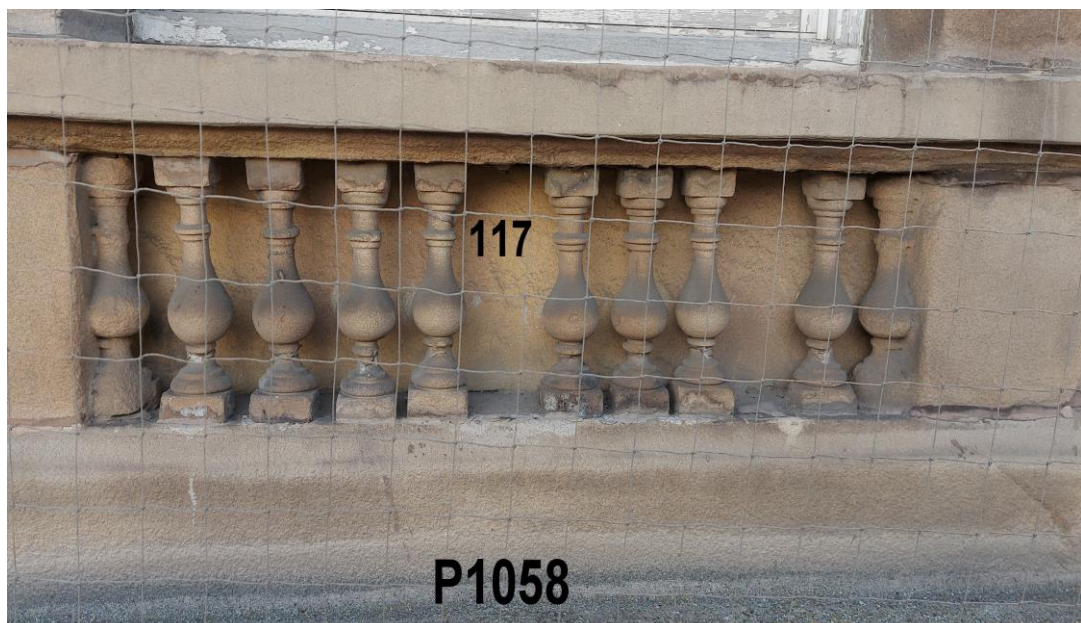
2.4.36

2.4.35 There are a few missing small baluster rails to the mock balcony areas at second floor level. These should be considered for replacement. See Photo P1058.

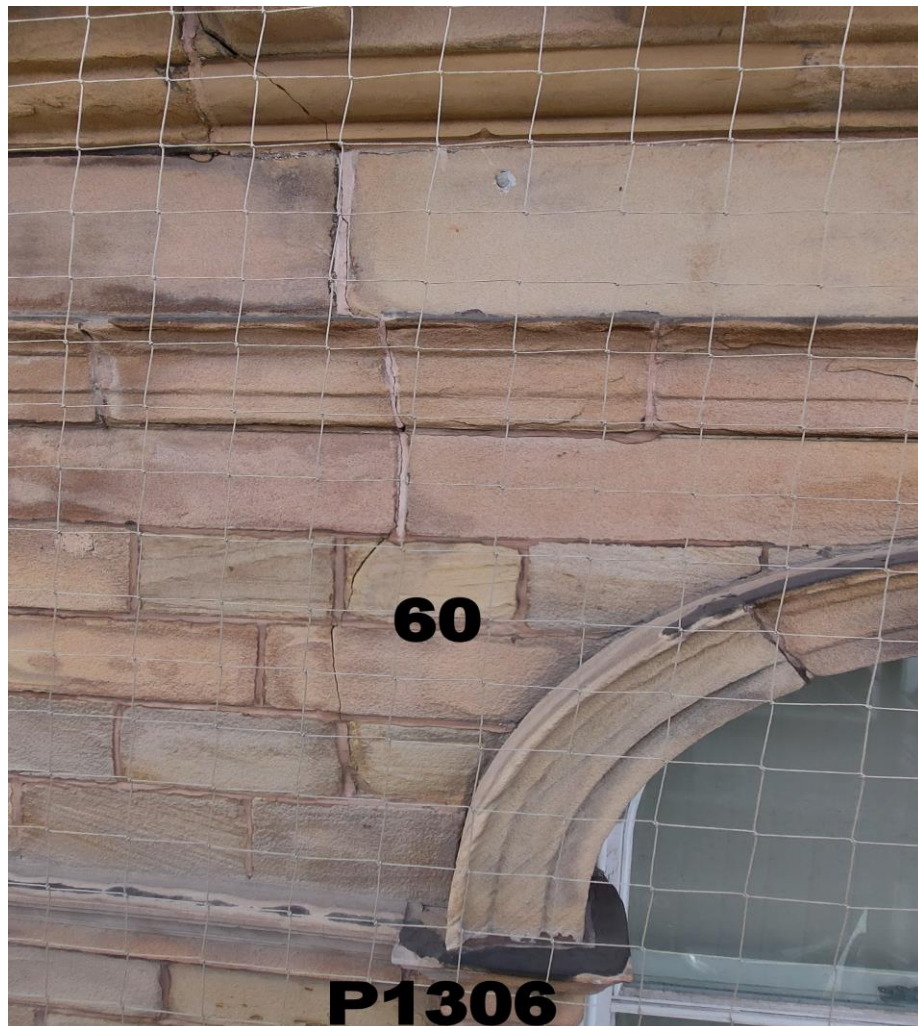
2.4.42

2.4.41 One area of cracking was noted (item 60) . Although not considered significant by the surveyor the projects structural engineer should review the item for comment. See photo P1306.

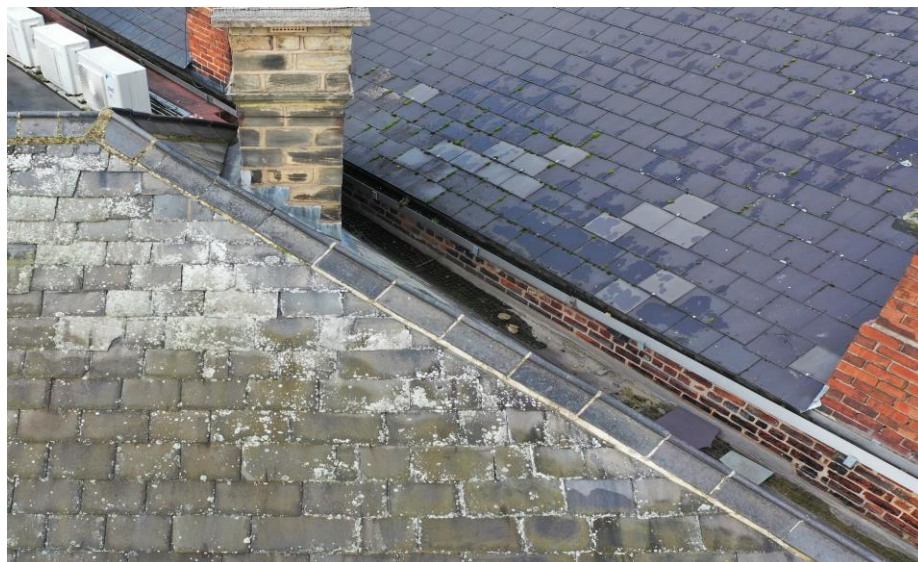
3.3.8

- 3.3.6 Outlets to box gutters appeared clear and unobstructed.
- 3.3.7 The gutter to the adjoining property on the North side appears to me out of alignment and slipped. This is resulting in excessive discharge on to the roof of the Civic Hall. This however does not appear to affect the integrity of the roof. The adjoining landlord should be notified, and access granted for them to remedy the defect.

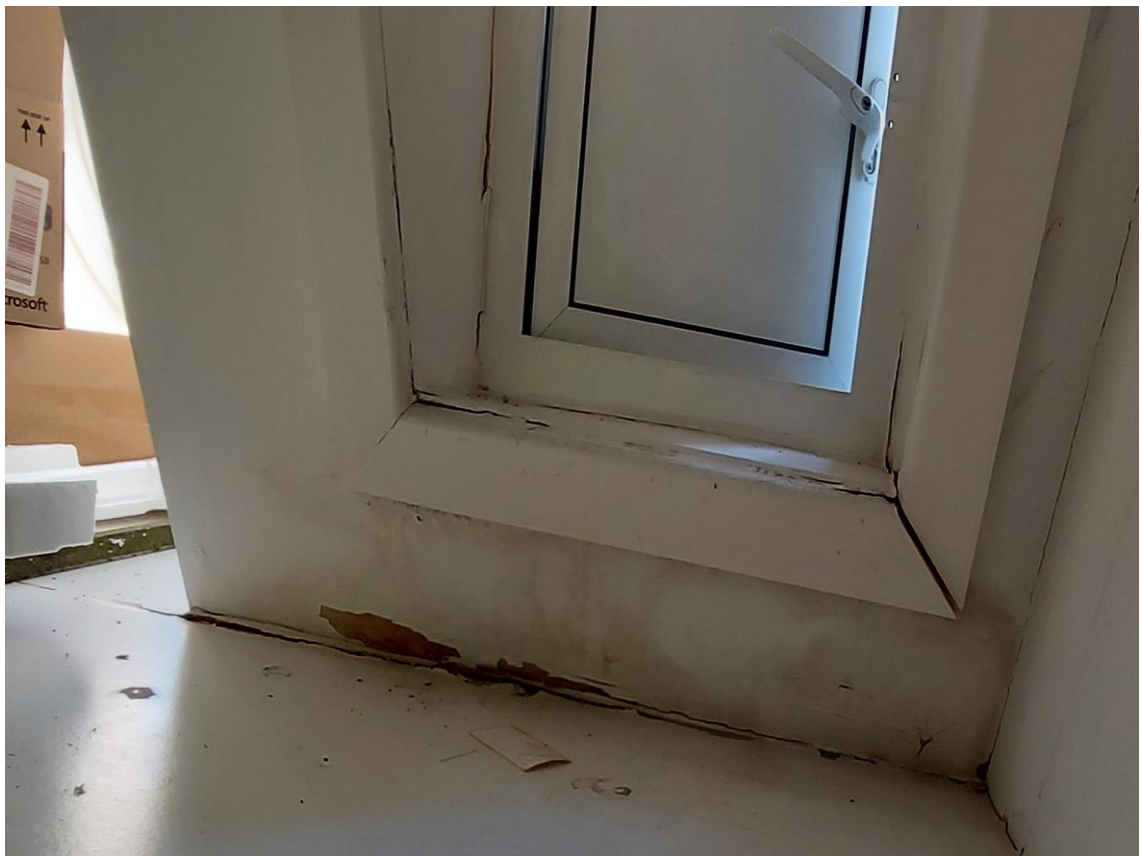
3.4.2

3.4.1 A walk around the upper floor revealed no water staining from potential leaks Except for 2 locations around the small access hatches between the dormer window sections. Staining suggested water ingress around the frames. Internal surfaces were dry. Externally it appears that additional mastic has been applied around the frames. Although untidy (due to the awkward access) these repairs appeared to be functional. The area would need to be inspected after a period of heavy rain to fully assess the watertightness of the repairs.

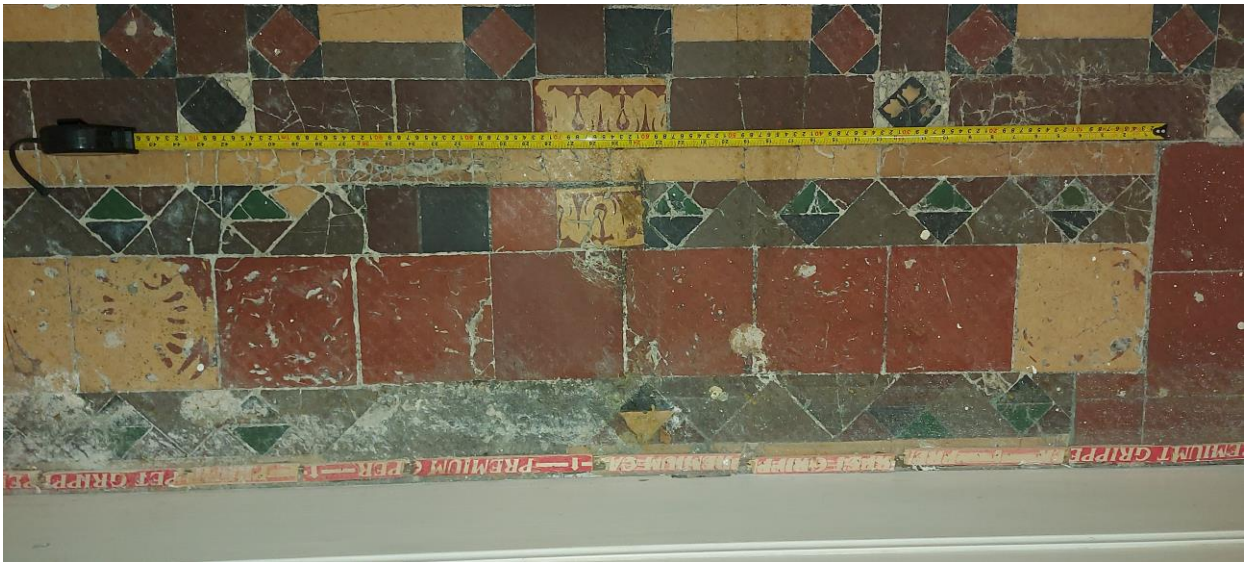
5.3.2 There are a large number of cracked or crazed tiles

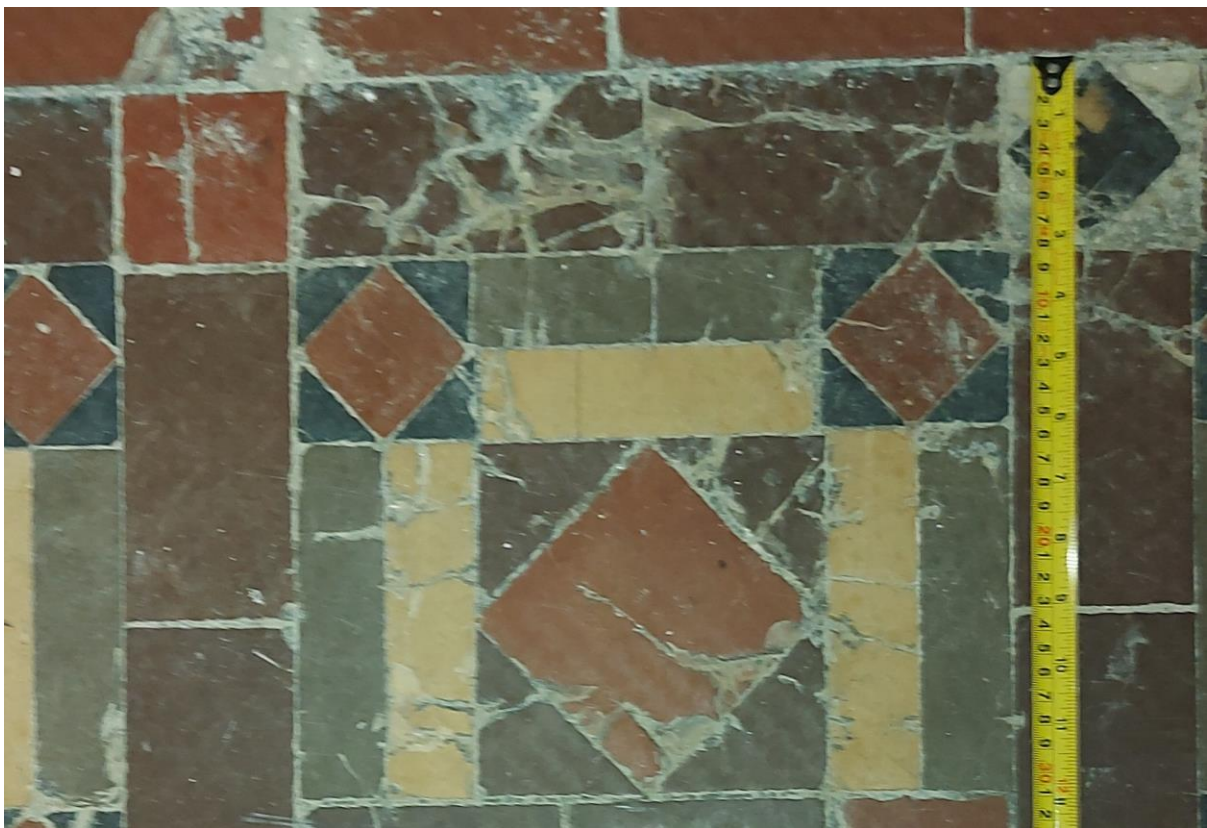
5.3.3 There are areas where cementitious and 'other' coatings have been roughly applied and areas infilled with screed / mortar.

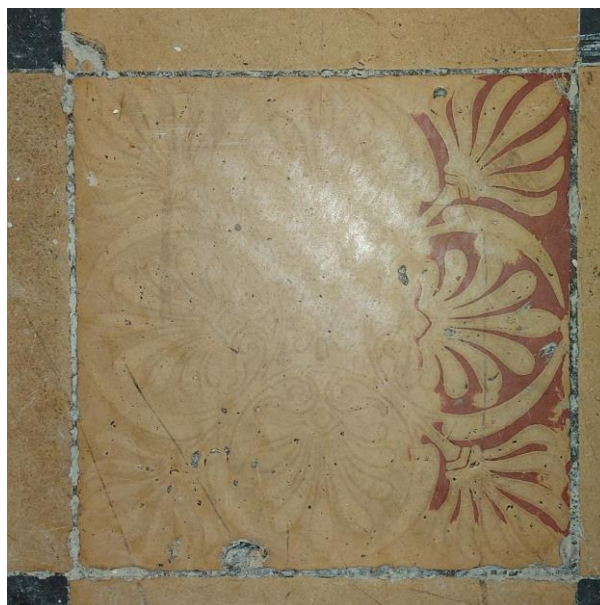
5.3.6

Within the pattern of through coloured tile there are printed tiles with ornate designs. In what were previously heavy trafficked areas these prints have worn, some to the extent of being 'very faint,' or now invisible.

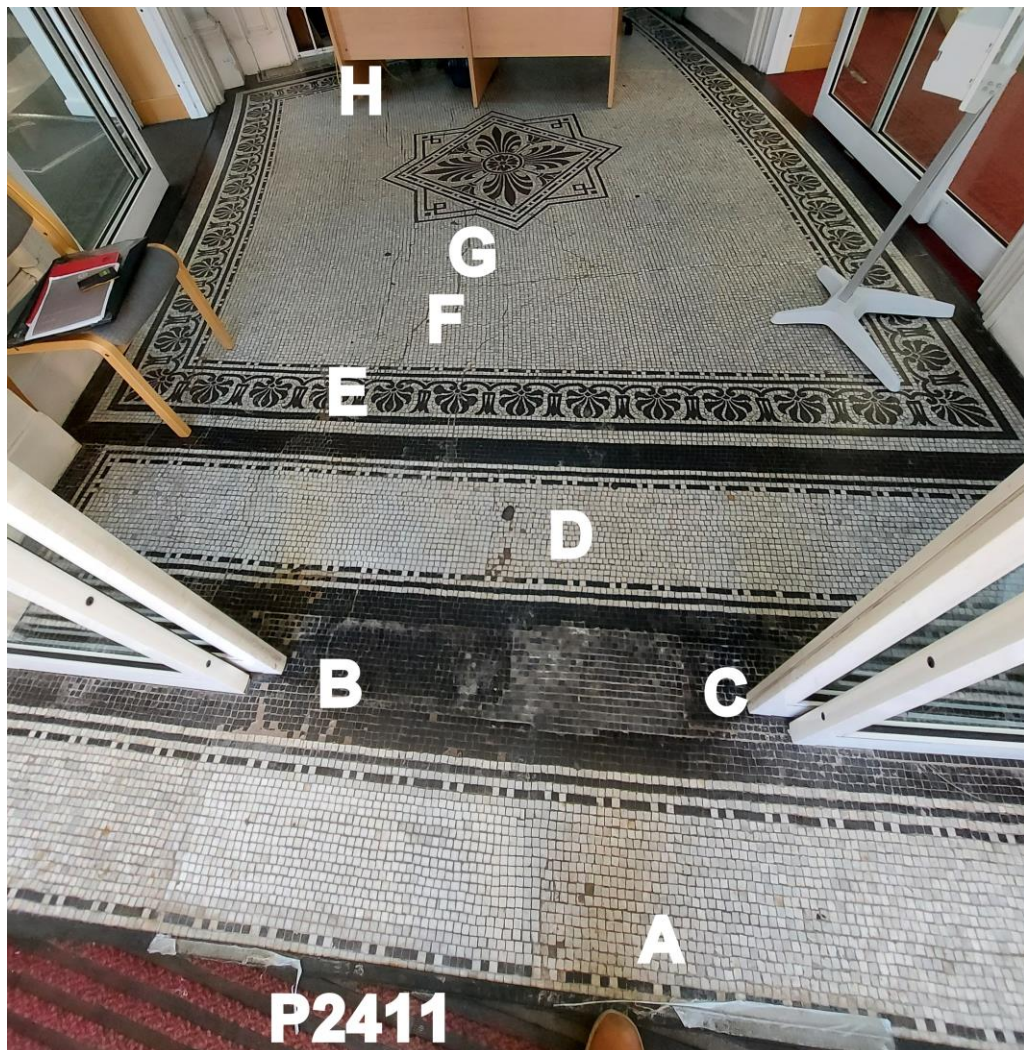
- 5.7.1.3
- 5.7.2 Photographs of each defect are located in Appendix 7 and are referenced with the letter assigned to that specific defect.
- 5.7.2.1 Item A.4 no white mosaic tiles missing. Image P2411 and P2850.

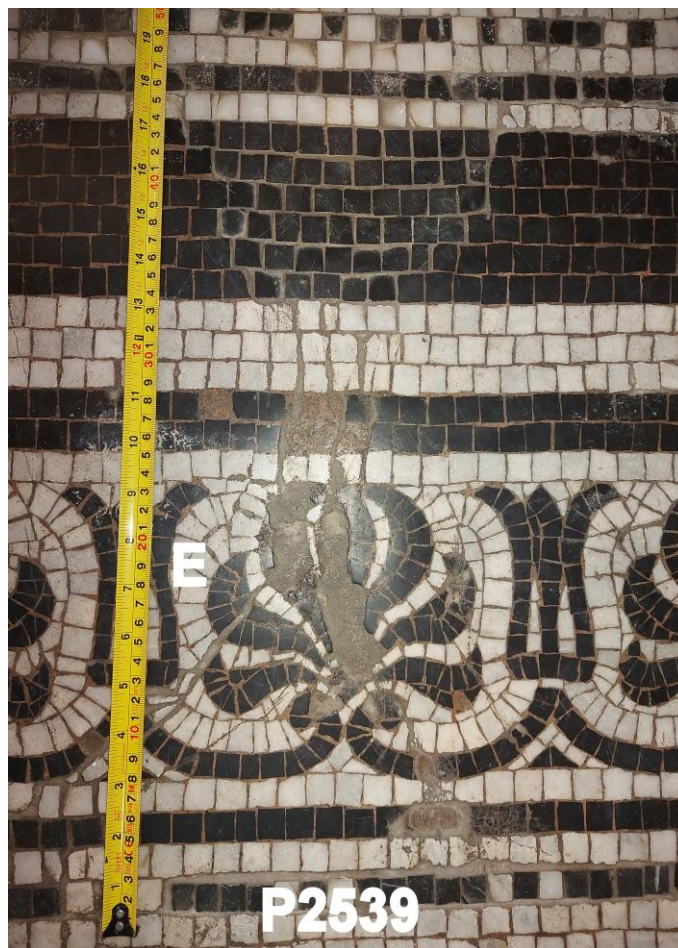
5.7.7

- 5.7.3 Item B. 30 no individual black tiles missing poorly repaired. Image P2411 and P3423.
- 5.7.4 Item C. large previous patch repair in lighter black (dark grey) tiles. Image P 2411 and P2859.
- 5.7.5 Item D. 6 white tiles missing / patched. Image P 2411.
- 5.7.6 Item E. Patch repair to pattern band. Image P2411 and P2539.
