**ARBORICULTURAL REPORT**  
**& Impact Assessment**  
**to BS5837:2012 at:**  
***347 Doncaster Road***  
***Barnsley***  
***South Yorkshire***  
***S70 3PH***

Prepared for:  
*AH Estates Ltd*  
*Church Lane,*  
*Worsbrough Village,*  
*Barnsley S70 5LQ*

Date: *May 2019*

Reference: *AWA2688*

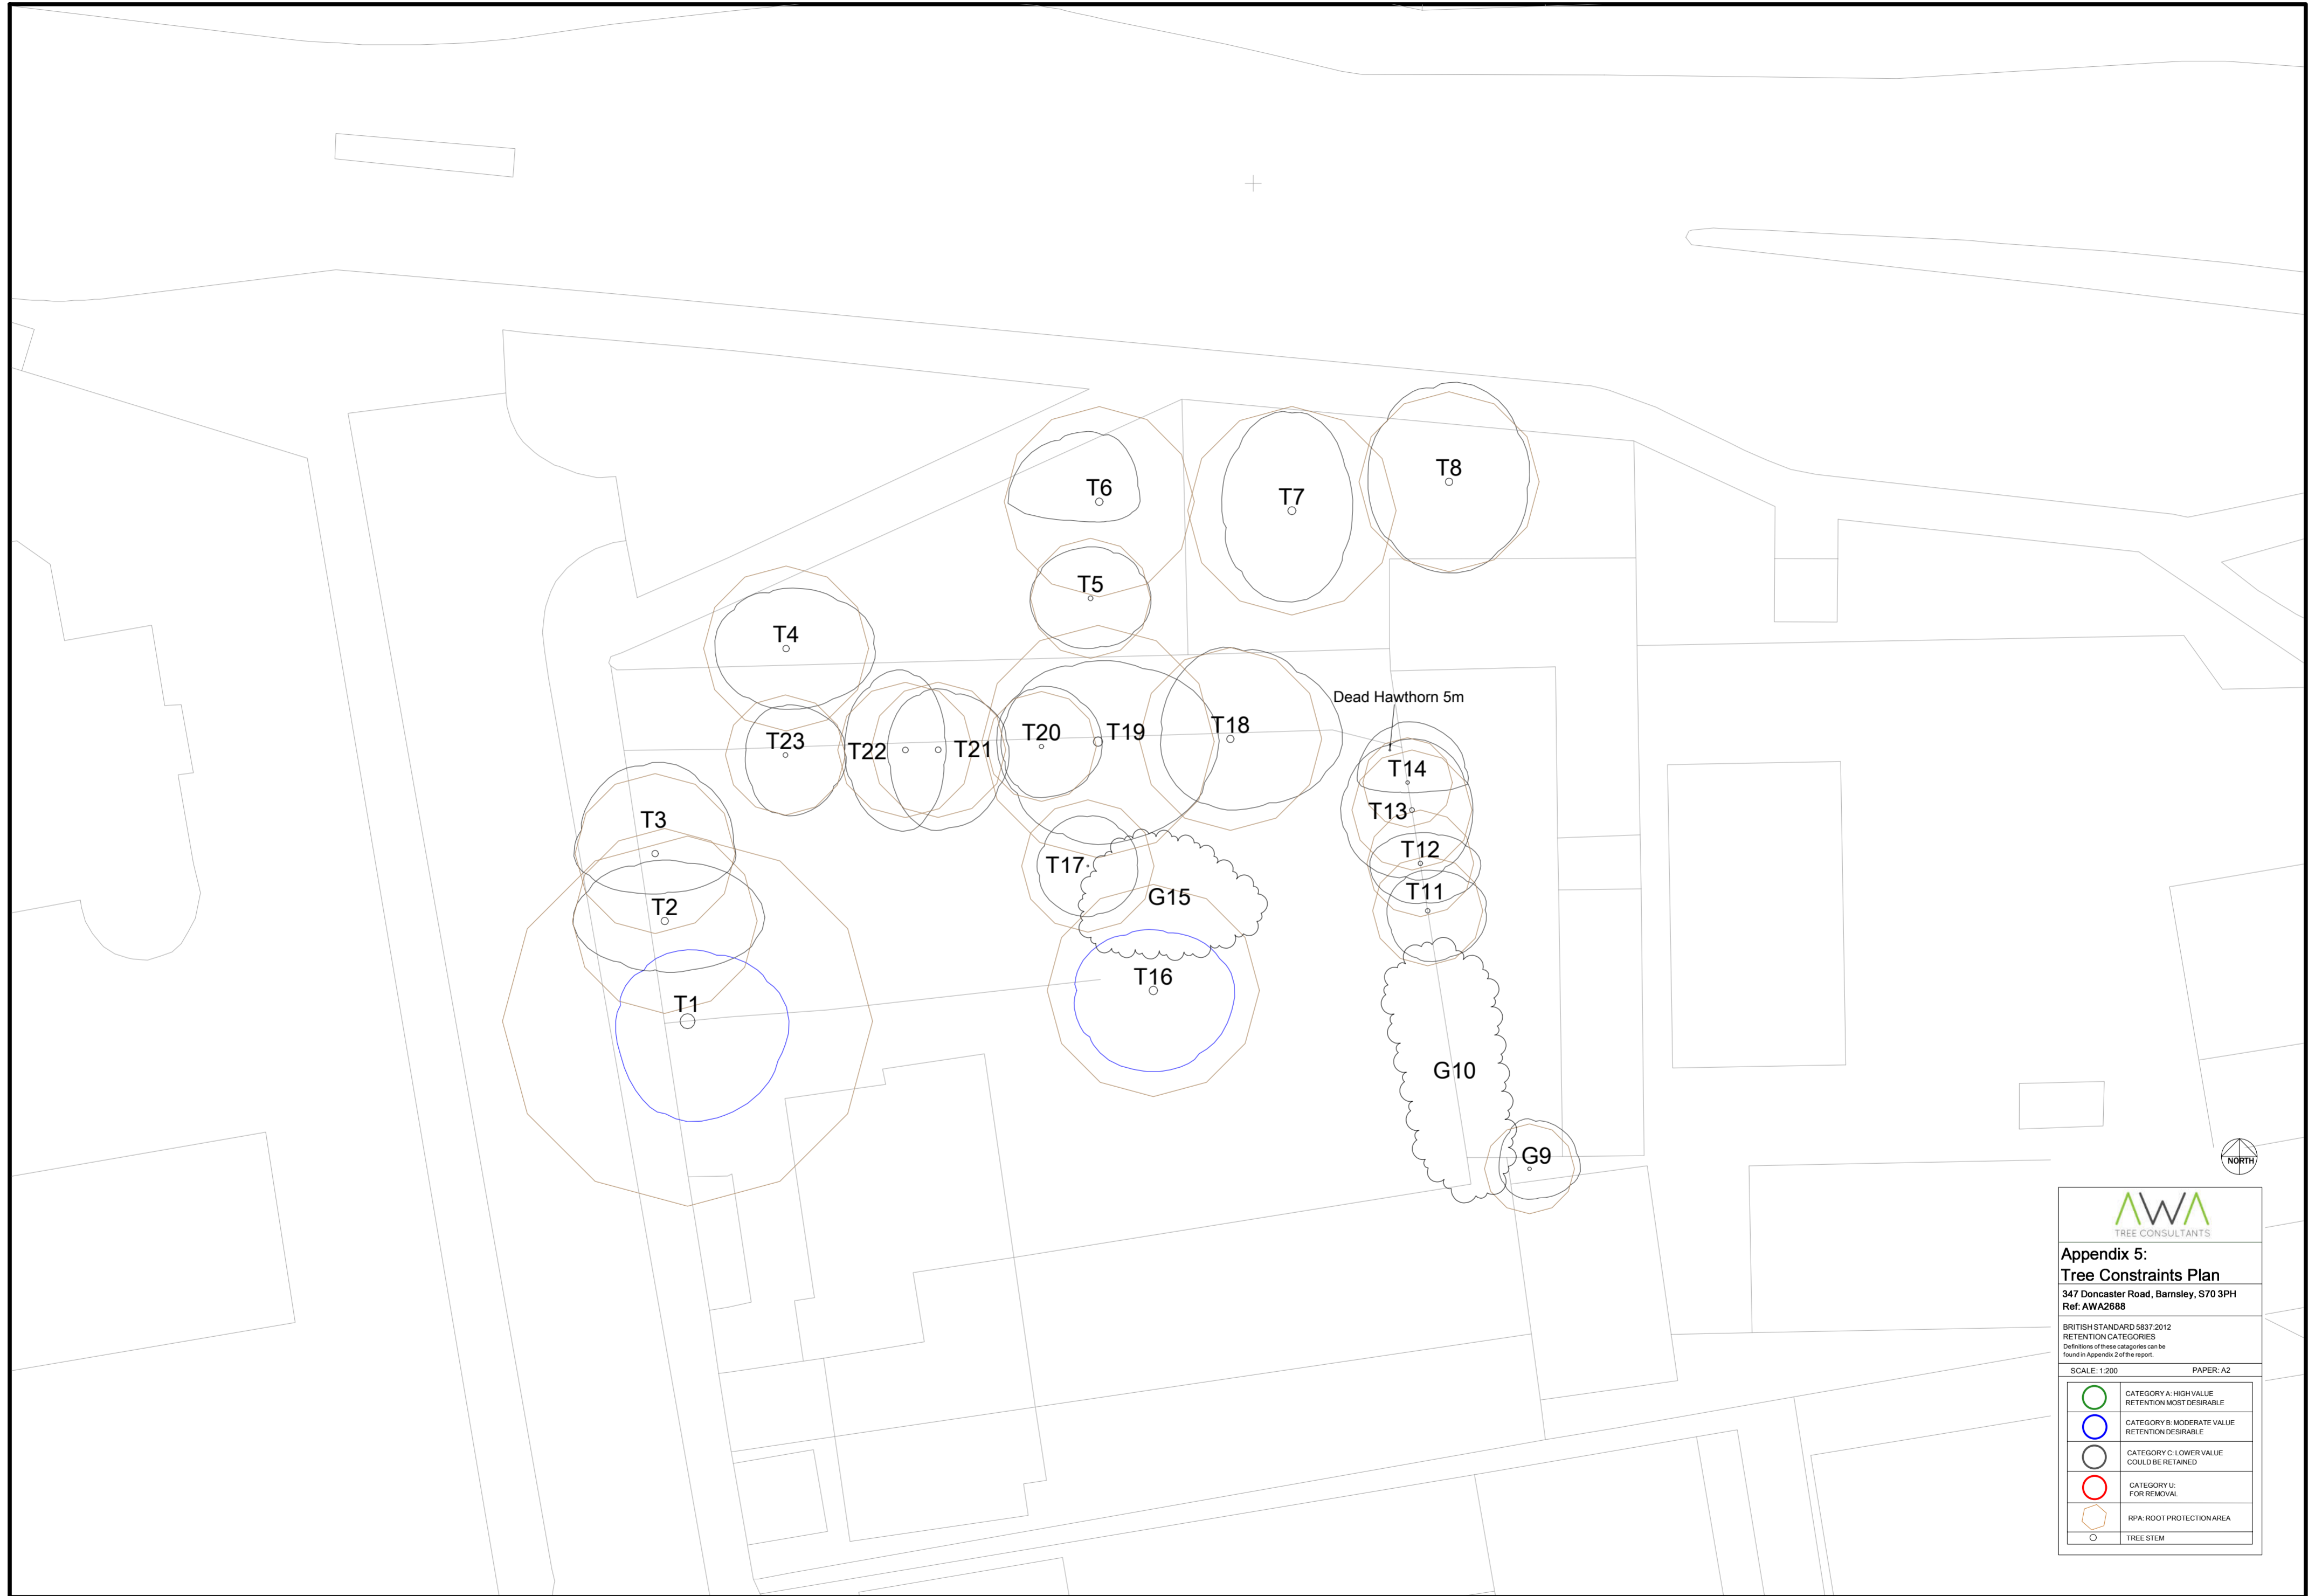
**Appendix 5:  
Tree Constraints Plan**  
347 Doncaster Road, Barnsley, S70 3PH  
Ref: AWA2688

- 3.2.11 The tree Root Protection Area (RPA) detailed on the Tree Constraints Plan at Appendix 5, has been used as a layout design tool, to inform on the area around a tree where the protection of the roots and soil structure is treated as a priority.

- 3.2.13 The RPA for each tree has been plotted as a polygon centred on the base of the stem. Due to the presence of roads, structures, topography (and past tree management) the RPA is likely to be a simplified representation of the tree roots actual morphology and disposition. However, detailed modifications to the shape of the RPA would largely be based on conjecture and so have been avoided.

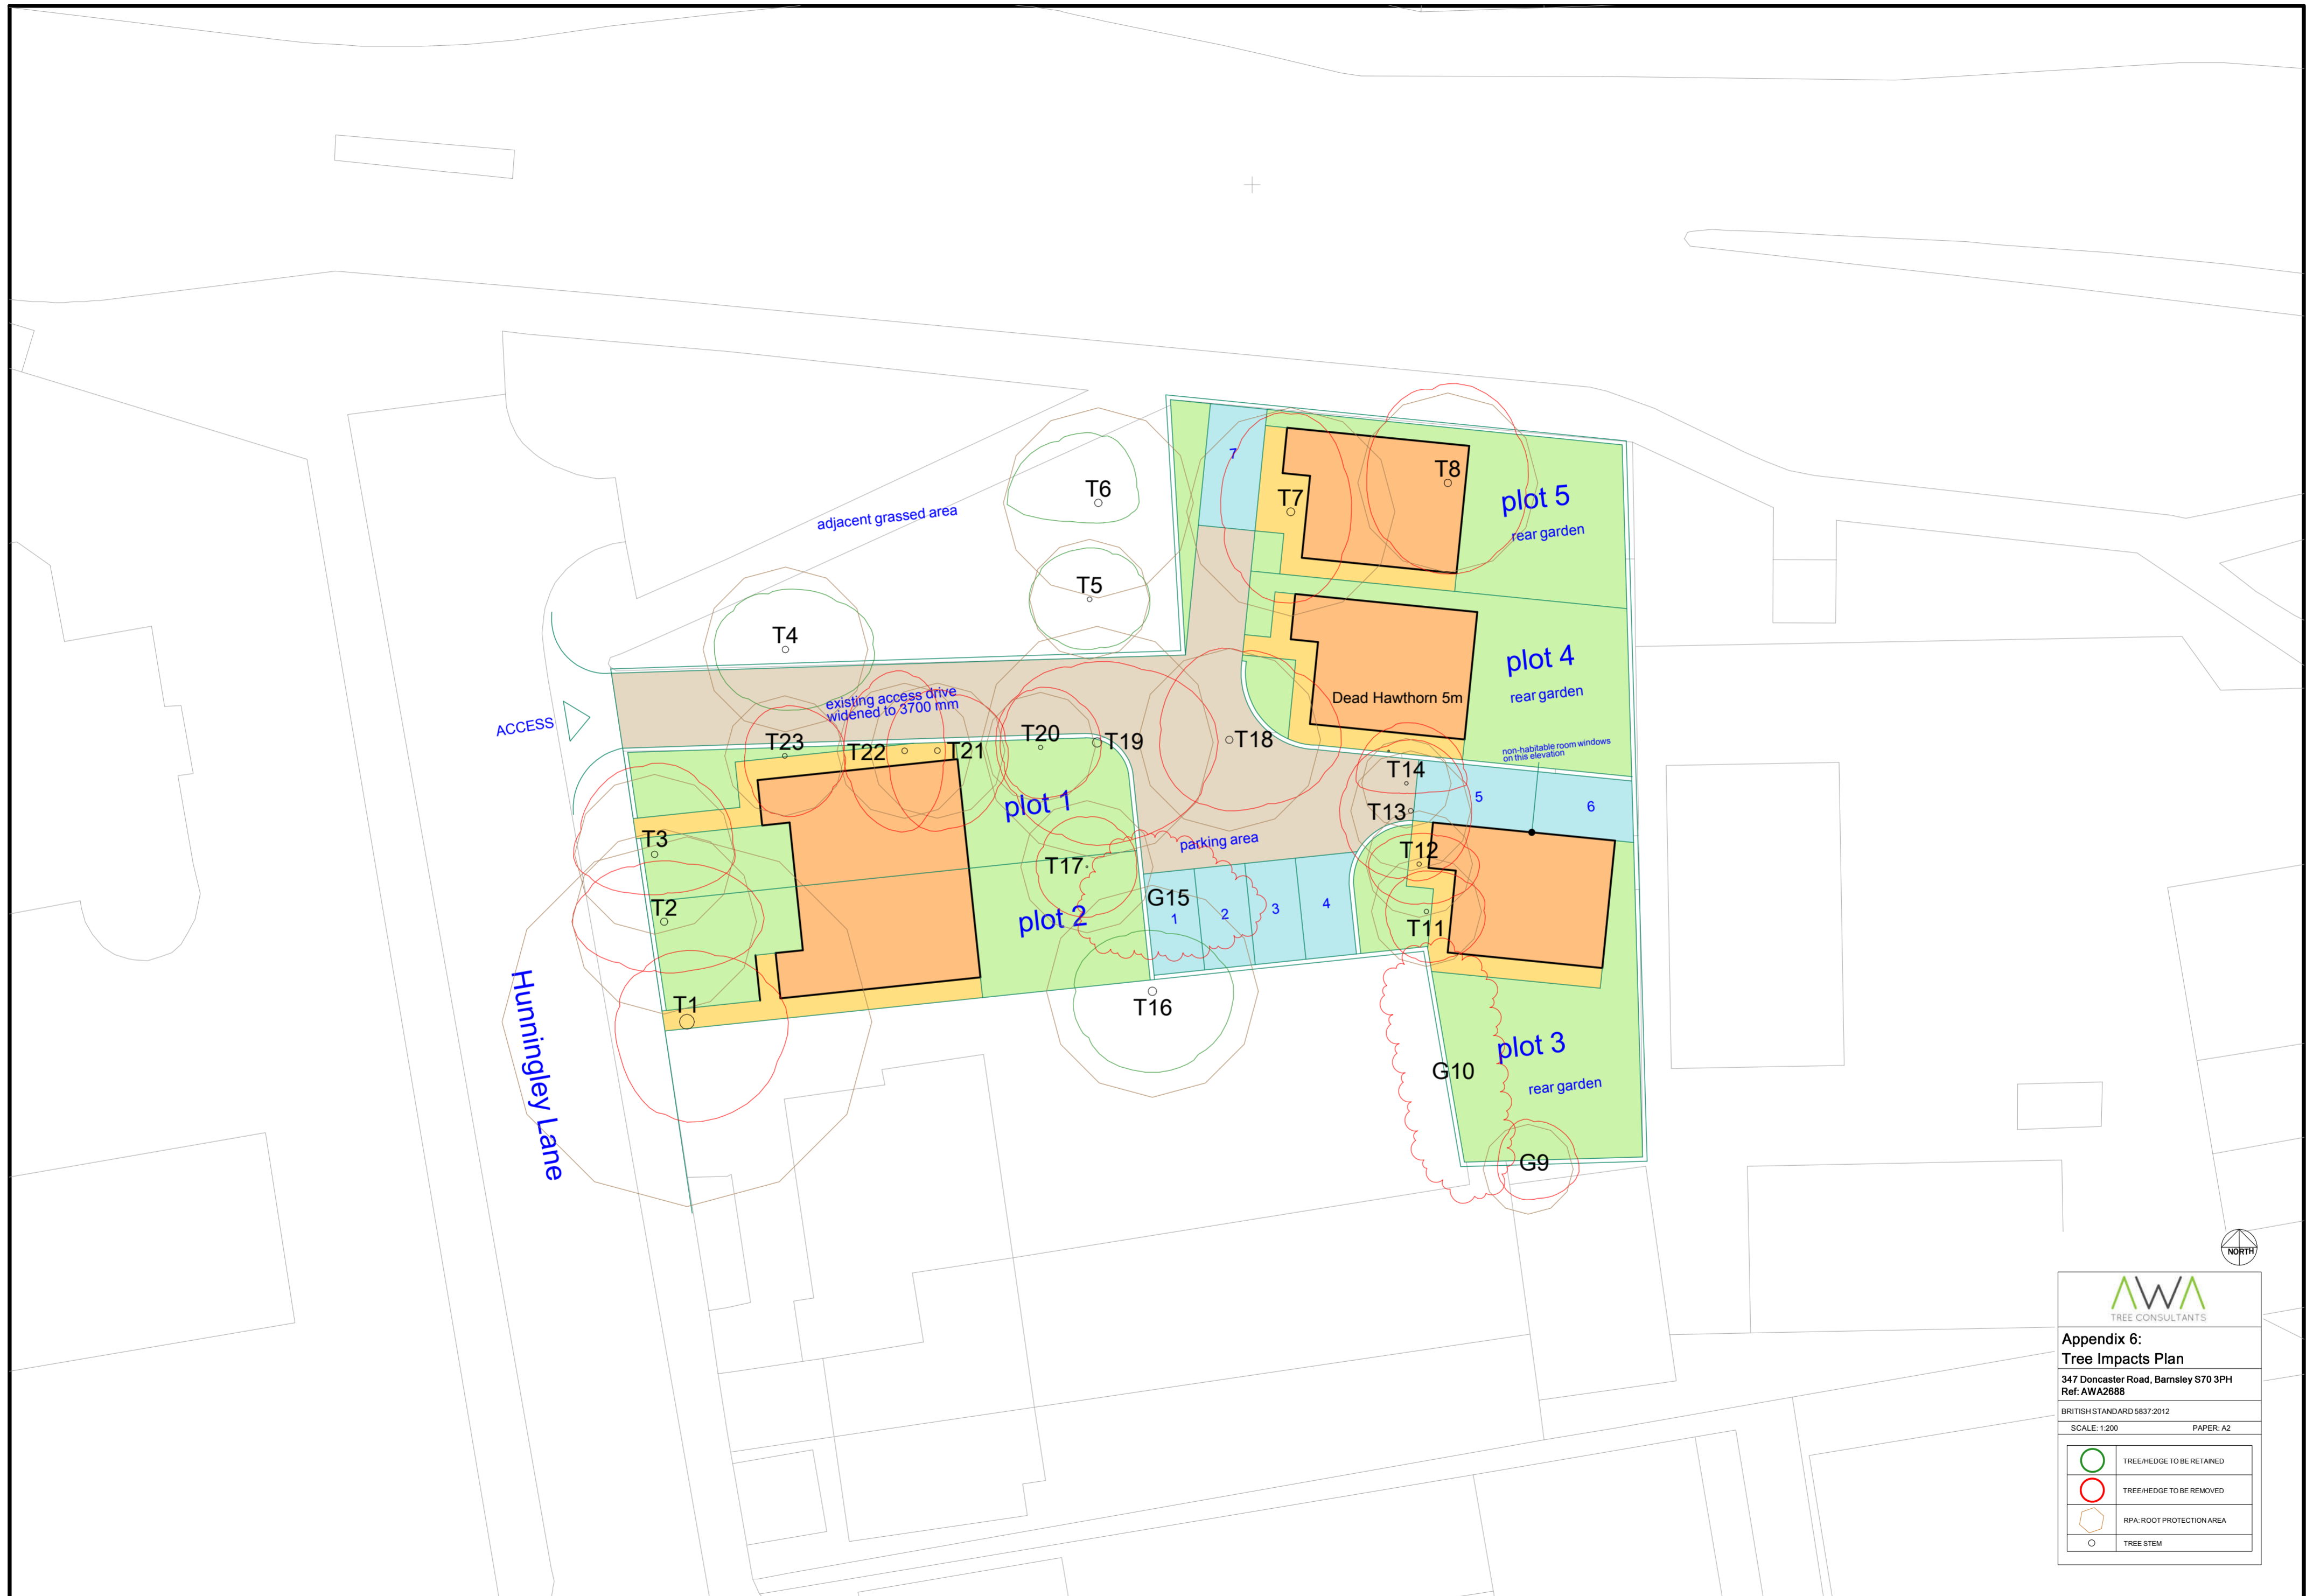
**Appendix 6:**  
**Tree Impacts Plan**  
 347 Doncaster Road, Barnsley S70 3PH  
 Ref: AWA2688  
 BRITISH STANDARD 5837:2012  
 SCALE: 1:200 PAPER: A2

4.2.1 From assessing the new development proposals, most trees and groups within the site will require removal as they are situated in the footprint of the structures or their retention and protection throughout the development is not suitable. The trees that require removal are T1, T2, T3, T7 to T15 and T17 to T23.

4.3.2 The RPA of the adjacent trees T4 and T5 encroaches close to into the site, however these trees should remain unaffected by the development provided that the current hard surface within the RPA is retained intact and care is taken throughout the demolition and construction works.

4.3.3 New car parking spaces are proposed that encroach into the RPA of T16. The construction of hard surfaces within the RPA can have negative impacts on tree roots. However, the potential negative impacts can often be overcome or minimised by employing a 'no-dig' type construction methods with a porous final surface.

- 4.5.1 The retained trees will require protection by fencing in accordance with BS 5837: 2012, during the development phase.
- 4.5.2 An associated Arboricultural Method Statement detailing protective fencing specifications and construction methods close to the retained trees can be provided.
