# **ARBORICULTURAL REPORT & Impact Assessment to BS 5837:2012 at:**

***9 Broom Close,  
Barnsley,  
S70 3EG***

Date: *October 2024*

Reference: *AWA6265*

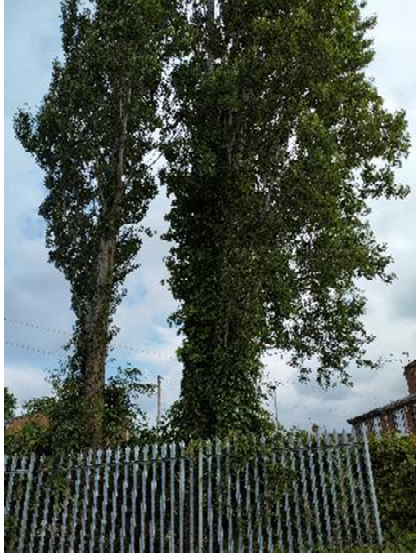
- 3.2.7 Large early-mature Poplars T1 – T3 are prominent and provide moderate amenity to the surrounding area. Despite their size and stature within the landscape, they have defects which limit their long-term prospects. T1 has some decayed stubs at the base and T3 has some exposed roots to the east where recent ground works have taken place. Within a more developed context, it is unlikely that these trees are suitable for retention, but within the current site context they can be retained. Due to these defects, these trees are only retention category 'C'.

Photo 1: T1 – T3 from south.

4.2.2 The trees that require removal to facilitate the development are T1, T2 and T3.

4.2.4 The trees to be removed are all lower value, retention category 'C'. T1, T2 and T3 are all early-mature self-set Poplar trees in fair condition, each with defects that limit their long-term prospects. T1 is multi-stemmed with some decayed stubs at the base, T2 is heavily ivy covered preventing detailed inspection of unions and T3 has some exposed roots at the base where electrical works have historically taken place. Although the three trees have moderate amenity value, all three trees are situated unsuitably close to existing properties and highways and due to their species' characteristics, are likely to pose a risk in future if left in place. Due to the low value of the trees to be removed the removals will have only a negligible negative arboricultural impact and mitigation planting will make up for the loss of amenity provided by these three trees.

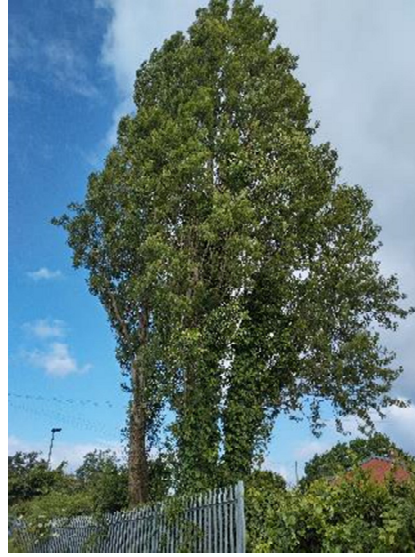
Photo 2: T1 – T3 from south east

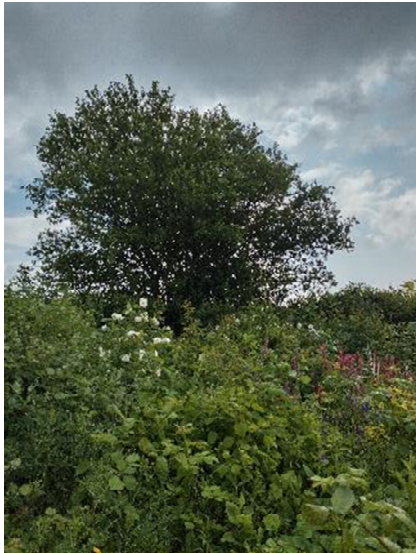
Photo 3: T4 from west.

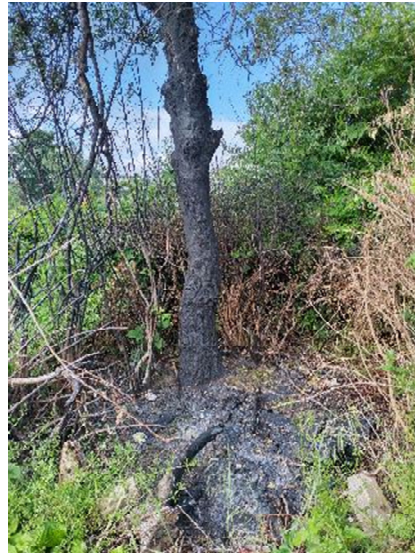
- 3.2.8 Silver Birch T6 and T7 both have fire damage at the base, which is causing cavities and decay. The fire damage on T6 is severe, and although T7's fire damage is less severe, there is moderate dieback in the crown of T7 and T7 is leaning. Both trees have limited long term prospects and are in poor condition. Both are retention category 'U' trees and are recommended for removal regardless of any development at the site.

Photo 4: Fire damage to base of T6.

4.2.7 2 trees require removal regardless of the development due to their poor condition and limited long-term prospects – these are T6 and T7.

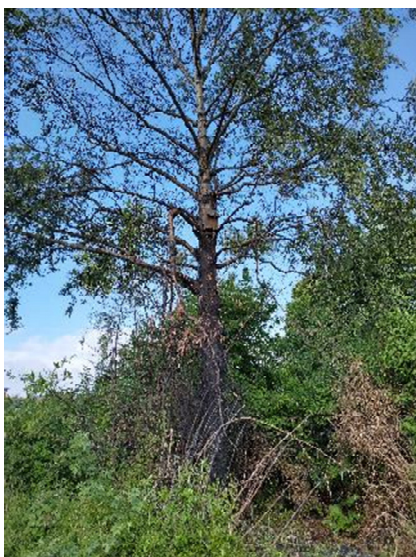
Photo 5: T6 from east.

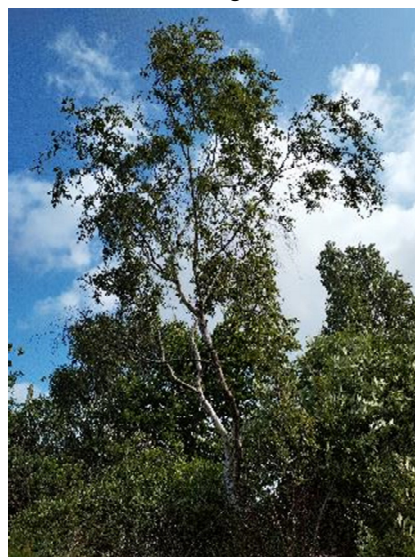
Photo 6: T7 from south west.

T7	Silver Birch	<i>Betula pendula</i>	Semi-mature	5	1	230	Yes	1.5	1.5	2.5	4	3	Limited access around base	Single stemmed. Slight lean. Old pruning wounds	Old pruning wounds. Moderate dieback. Minor deadwood	Moderate dieback in crown. Leaning south. Minor fire damage at base.	Poor	Fair	< 10 yrs	Low	U	Removal recommended regardless of any development on site.
T8	Beech	<i>Fagus sylvatica</i>	Semi-mature	6	2	100, 150	Yes	2.5	2	3	2	1.5	Limited access around base	Twin stemmed at 1m. Vertical	Normal		Good	Good	>40 yrs	Low	C	No works required.
T9	Silver Birch	<i>Betula pendula</i>	Early-mature	8	1	300	Yes	3	3.5	5	5	3.5	Limited access around base	Single stemmed. Vertical. Old pruning wounds. Epicormic growths	Old pruning wounds		Good	Good	>40 yrs	Moderate	C	No works required.
