# STRUCTURAL BUILDING SURVEY

## PROPOSED CLASS Q RESIDENTIAL CONVERSION

Bothy on land off Hartcliffe Lane, Hillside, Thurlstone, Sheffield, S36 9QJ

**Report Ref:** TH/Ridge/Bothy/Struct/01/July 2019/v01

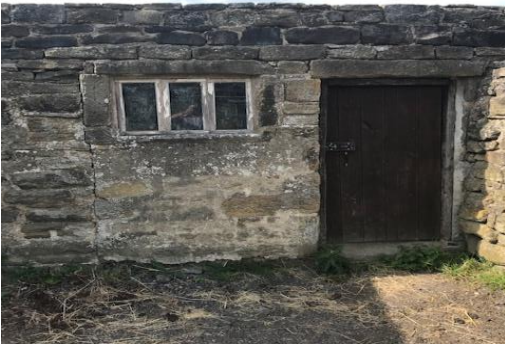
### *South East Elevation (Front)*

The south east elevation (front) facing Hartcliffe Lane is generally plumb and exhibits no signs of significant historical movement and no significant signs of extensive damage.

Remedial works are required to the stonework, pointing and heads & sills but the elevation is fully capable of retention with no visible or obvious areas of bulging. No immediate requirement to repair by extensive dismantling and/or rebuilding.

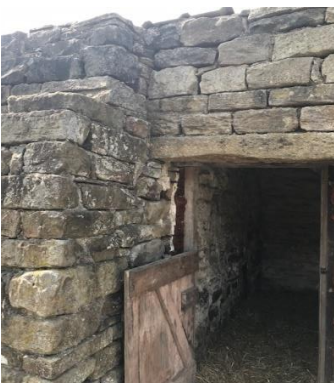
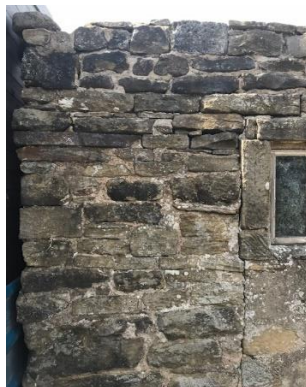
Some pointing defects and external cracking is evident on the outer leaf at the front - the crack convention is *Moderate* and the elevation is plumb and stable.

Should be fully capable of repair/retention with no areas of excessive bulging and no requirement to dismantle wholesale and/or rebuild except in isolated areas.

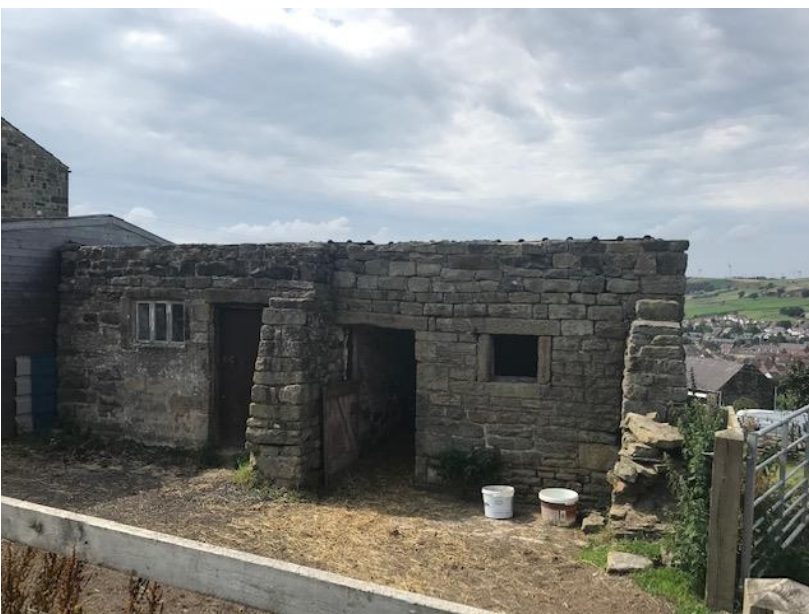
The south east elevation (front) facing Hartcliffe Lane is generally in good general order. Repair work is required, but much of this is cosmetic, relating to the external buttresses which offer substantial additional support to the elevation.

All the stonework is capable of full retention with no areas of bulging or structural failure observed.

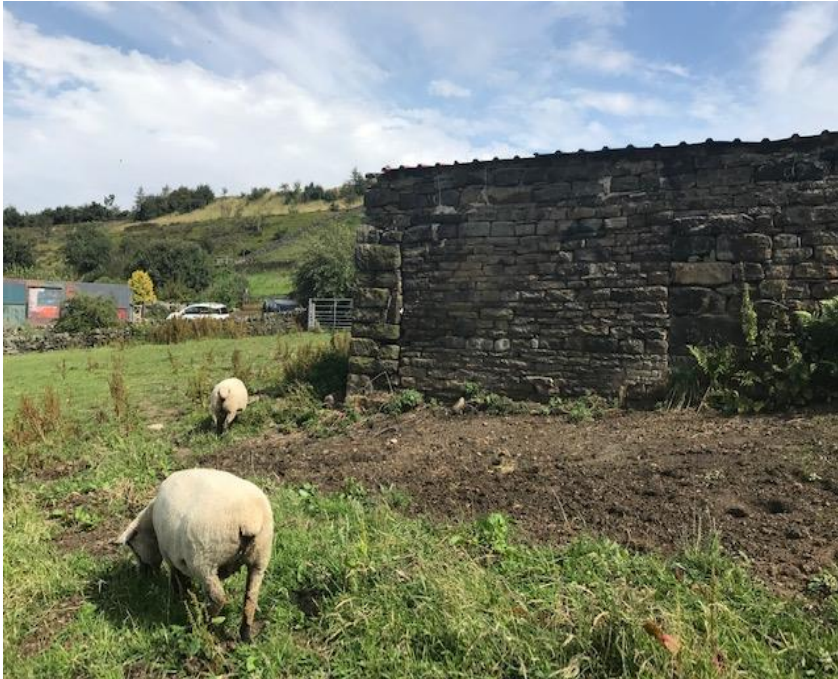
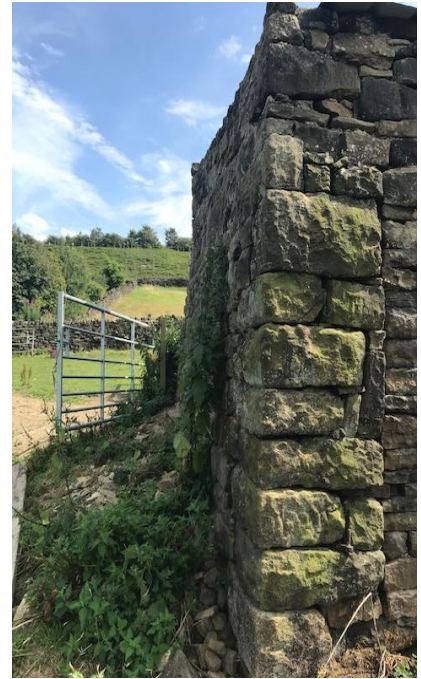
### North West Elevation (Rear)

The north west elevation (rear) facing Hill Side Lane is generally plumb, but it does exhibit some moderate signs of dilapidation and very slight structural movement - most likely due to reconfiguration of openings. There is some slight separation of the joint at the gable, but there are no signs of significant bulging or structural failure. Repairs will be required in isolation (only) and the overall elevation should be fully capable of retention.

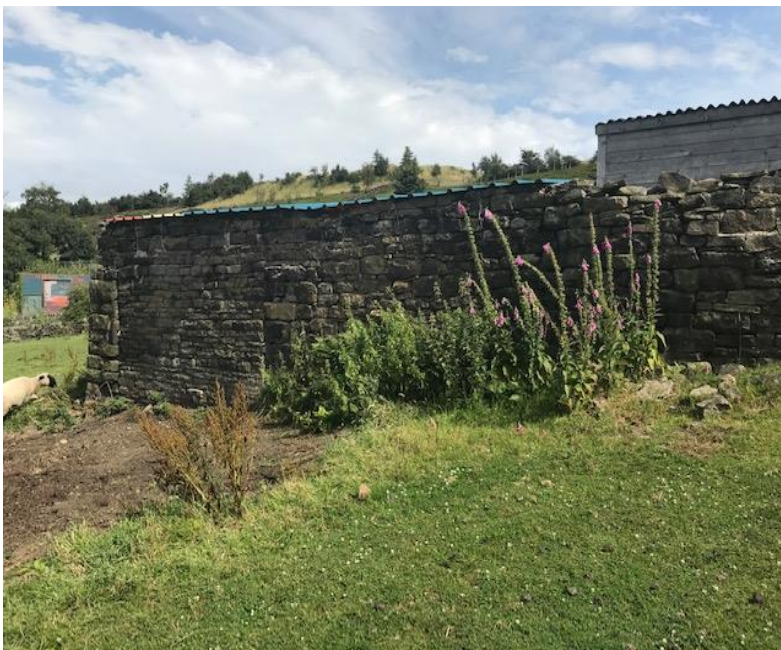
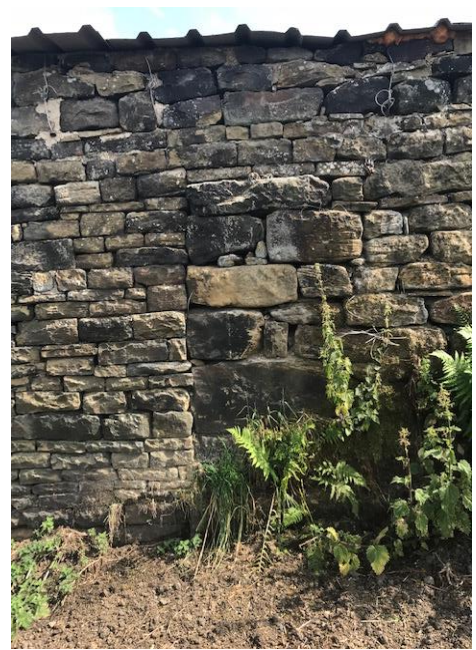
The north west elevation (rear) shows the original rear wall extending further than the front elevation, indicating that the front has been modified at some point in the buildings' past. There is also a rear opening (shown on the right) which has been blocked up in larger coursed stone. There are some defects; dilapidation and minor cracking across the rear (*Moderate*) but it is generally plumb and structurally sound. It should be capable of full retention, with no areas of bulging and no immediate requirement to dismantle and/or rebuild (except in isolated locations).

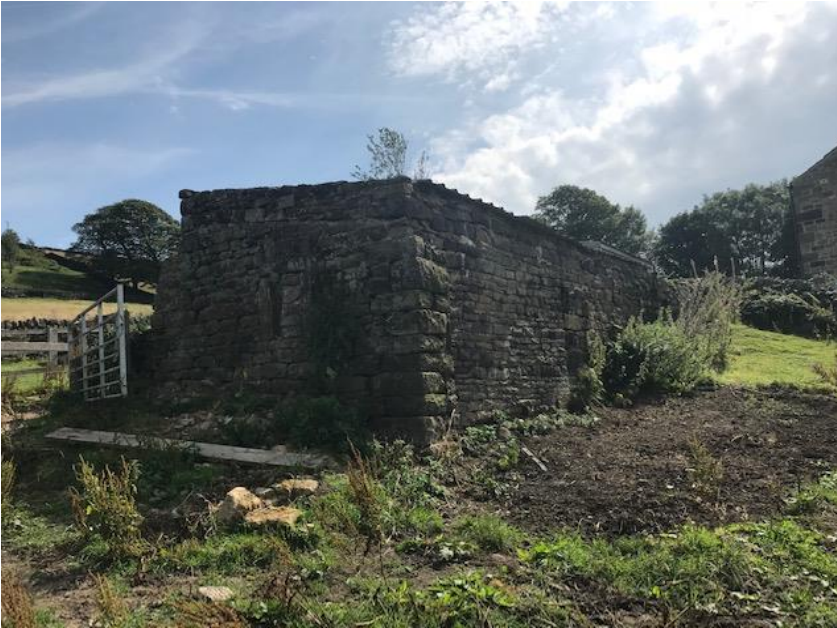
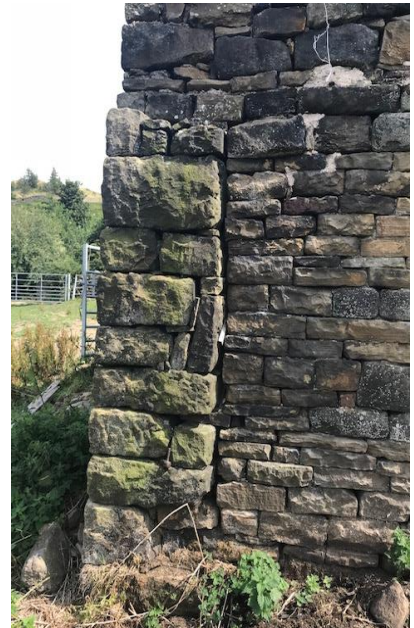
*North East Elevation (Side Gable)*

The north east elevation (gable) facing into the plot is robust and constructed of thick stones in the outer leaf. The extrados of the gable wall tapers outwards slightly, creating a strong buttress like effect, and whilst there are some general signs of dilapidation; mortar-less joints and pointing defects etc., this is most likely how the gable would have been constructed, and there is obvious no deviation from it is original profile. The gable is therefore fully capable of full retention, with no areas of bulging and no immediate requirement to dismantle and/or rebuild.

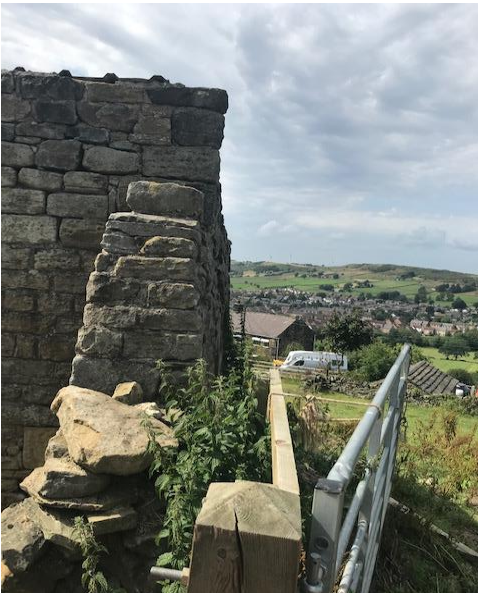
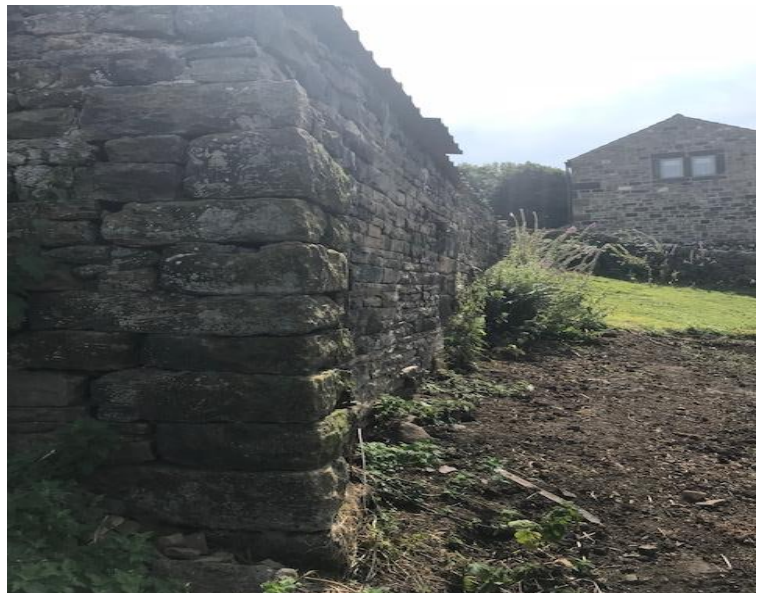
The north east elevation (gable) as viewed from the front shows some irregularities in the stonework of the outer leaf, and there is some separation between the larger quoin-like stones of the gable and the thinner coursed stone of the front elevation itself. It is unclear whether this relates to erosion; a lack of mortar and/or pointing defects.

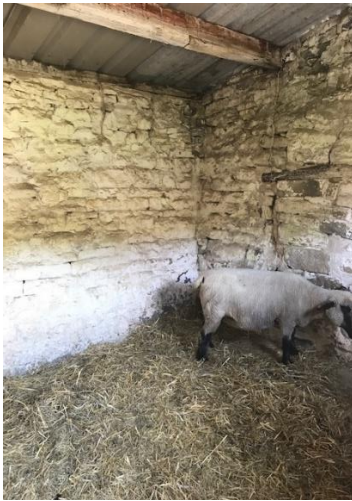
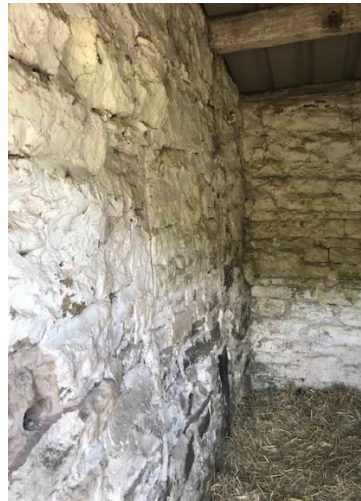
## Internal

The stonework inside the *bothy* is covered liberally with a limewash, and there were no signs of bulging of the inner leaf or any evidence of spreading of the wall core.

There were no signs of significant structural damage and whilst there was some nominal cracking observed inside (categorised as *Moderate*) the inner leaf structure is generally intact, plumb and is capable of retention.

The exposed purlins were dry, and the roof covering was completely intact with no evidence of excessive water ingress.
