**PROPOSED MANAGER'S HOUSE AT ANNAT ROYD FARM
SPICER HOUSE LANE, INGBIRCHWORTH S36 7GG**

I write following my inspection of a small outbuilding and the remains of a collapsed building that stand on the site of the proposed Manager's house at the above. It is intended to build the new house across the combined footprint of the present structures and incorporating the space between them.

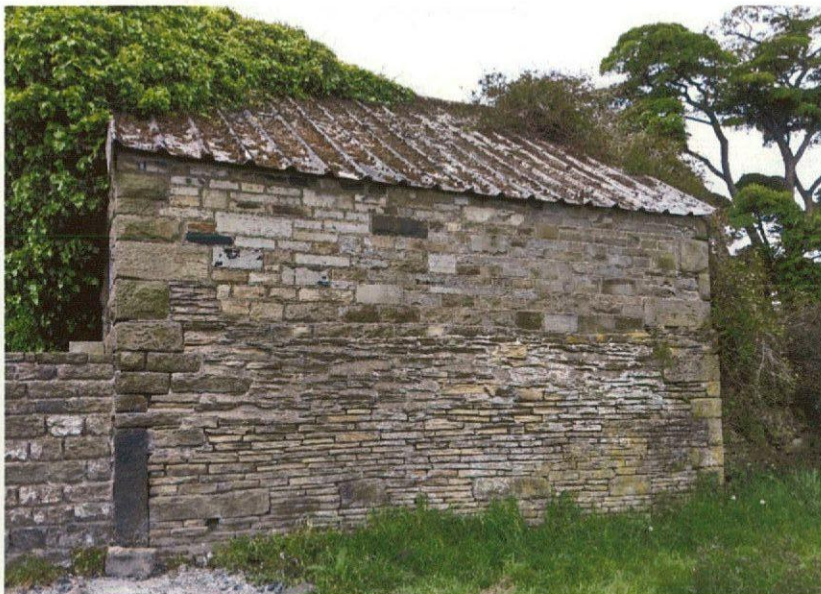
Photograph 1 – The Small Outbuilding

The walls of the existing building and what little remains of the collapsed building are of coursed sandstone. The original stone slates on the outbuilding roof have been replaced with asbestos cement sheeting.

Compared with the rest of the building, the stonework in the lower half of the back wall is softer and more weathered, the coursing is much shallower, and it appears to be considerably older. The weathered stonework has been filled with cement mortar.

The foundations of the outbuilding will be constructed at a shallow depth, as all farm buildings used to be, and the soil in the locality is known to be clay, generally of low to medium plasticity. It is most unlikely that the foundations will be deep enough to comply with the minimum foundation depths stipulated in the present Building Regulations.

The stonework that remains in the small building and in the ruins of the collapsed building is poorly constructed and unsuitable for retention as part of the proposed new dwelling.

The present foundations are expected to be too shallow to prevent subsidence due to drying-shrinkage of the clay soil and underpinning a relatively small quantity of such poor stonework is both impractical and uneconomical.

The walls should be taken down to facilitate the construction of new, deeper foundations, in compliance with the Building Regulations.

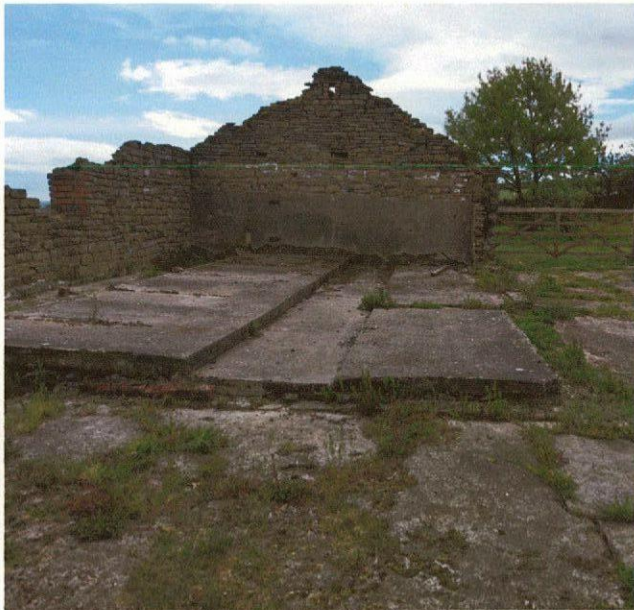
Photograph 2 – The Building Remains

Only the lower part of the back wall and a shared gable end remain of this collapsed building. The stonework is partly coursed and partly random, with little of the mortar remaining. The walls are poorly constructed and there are some inclusions of the softer, shallower sandstone.

The foundations of these remains will also be constructed at a shallow depth in clay soil and, as with the small outbuilding, the foundation depth is very unlikely to comply with the present Building Regulations.
