# **ARBORICULTURAL REPORT & Impact Assessment to BS 5837:2012 at:**

***Plumpton Lodge,  
Manchester Road,  
Thurlstone,  
Barnsley,  
S36 9QW***

Prepared for: *Coda Studios*

Reference: *AWA6846*

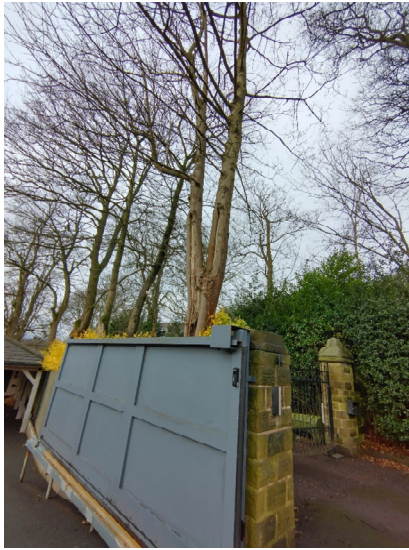
- 3.2.8 T1, G2, T3 and T4 are a row of adjacent Sycamores with moderate amenity to the north of the site boundary. All of these have suffered poor pruning practices in the past resulting in poorly healing pruning wounds with minor

cavities on the stems. T1 has a significant wound on the stem from the base to approximately 4.5m. This is occluding but there is decay within the cavity. It is likely that the long-term prospects of these trees are reduced as a result of these defects and they are retention category C.

Photo 1: T1 to T4 from east

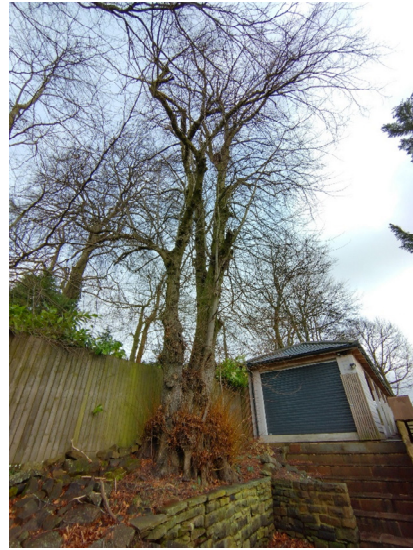
- 3.2.9 T5 is a mature Lime. It is situated on a 1m high retaining wall between the residential property and the car port. It has co-dominant stems at 1.4 m and multiple further tight unions within the crown, likely with included bark which is typical of this species. There is minor and moderate deadwood throughout the crown and on the ground around the base and it is in fair physiological and structural health. This species can grow to a very large size, and it is likely to outgrow its restricted location, limiting its long-term prospects. However, it is a prominent tree within the site, and with appropriate management will likely provide good amenity and arboricultural benefits in the medium term. It is retention category C.

Photo 2: T5 from west

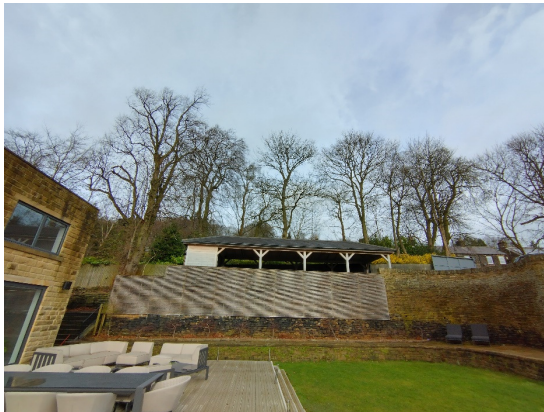
Photo 3: Northern boundary of site

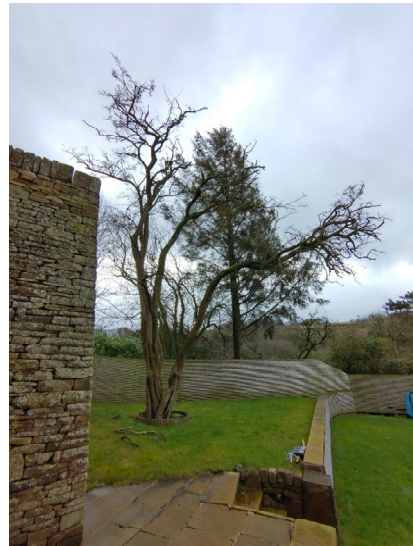
- 3.2.11 Hawthorn T11 is situated on a raised area of lawn to the east of the garden. This has co-dominant stems and the southwestern stem leans heavily over the lawn with some decayed cavities at the base. This is likely in decline, however it can be retained for wildlife habitat and arboricultural interest, but it is recommended that works be carried out regardless of the development in order to extend its safe life.

Photo 4: T11 from northwest

- 4.2.7 1 tree has works recommended regardless of the development. Hawthorn T11 has had pruning works recommended to reduce the weight and leverage on the stems in order to extend the tree's safe life expectancy.

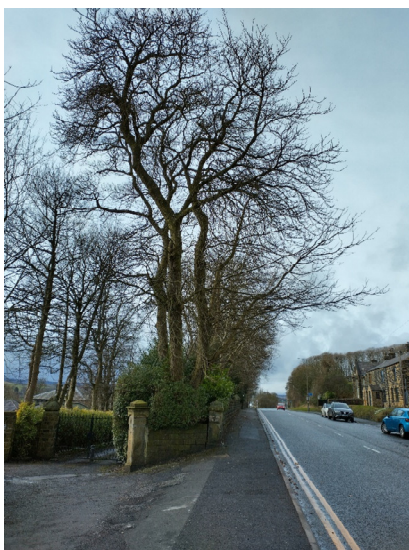
- 3.2.13 Horse Chestnut T22 is a very large adjacent tree overhanging the access drive to the site. This is in good physiological health with some minor structural defects. It is likely to be undermining the structure of the boundary wall. It has moderate amenity value with good long-term prospects and is retention category B.

Photo 5: T22 from east

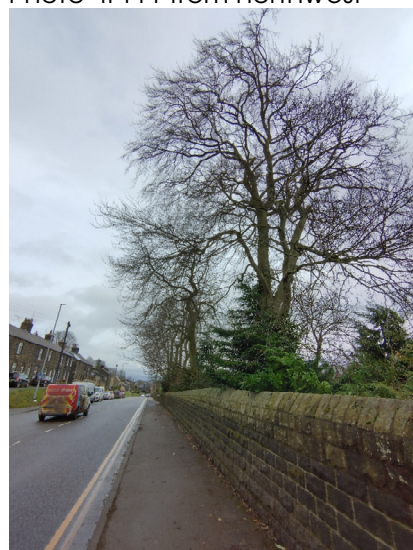
- 3.2.14 Beech T28 is also adjacent beyond the northern boundary of the site. This has high amenity value and is a prominent tree overhanging the road through the village. Access was limited so inspection was only cursory but it appears to be in good physiological and structural health and is retention

category A.

Photo 6: T28 from west
