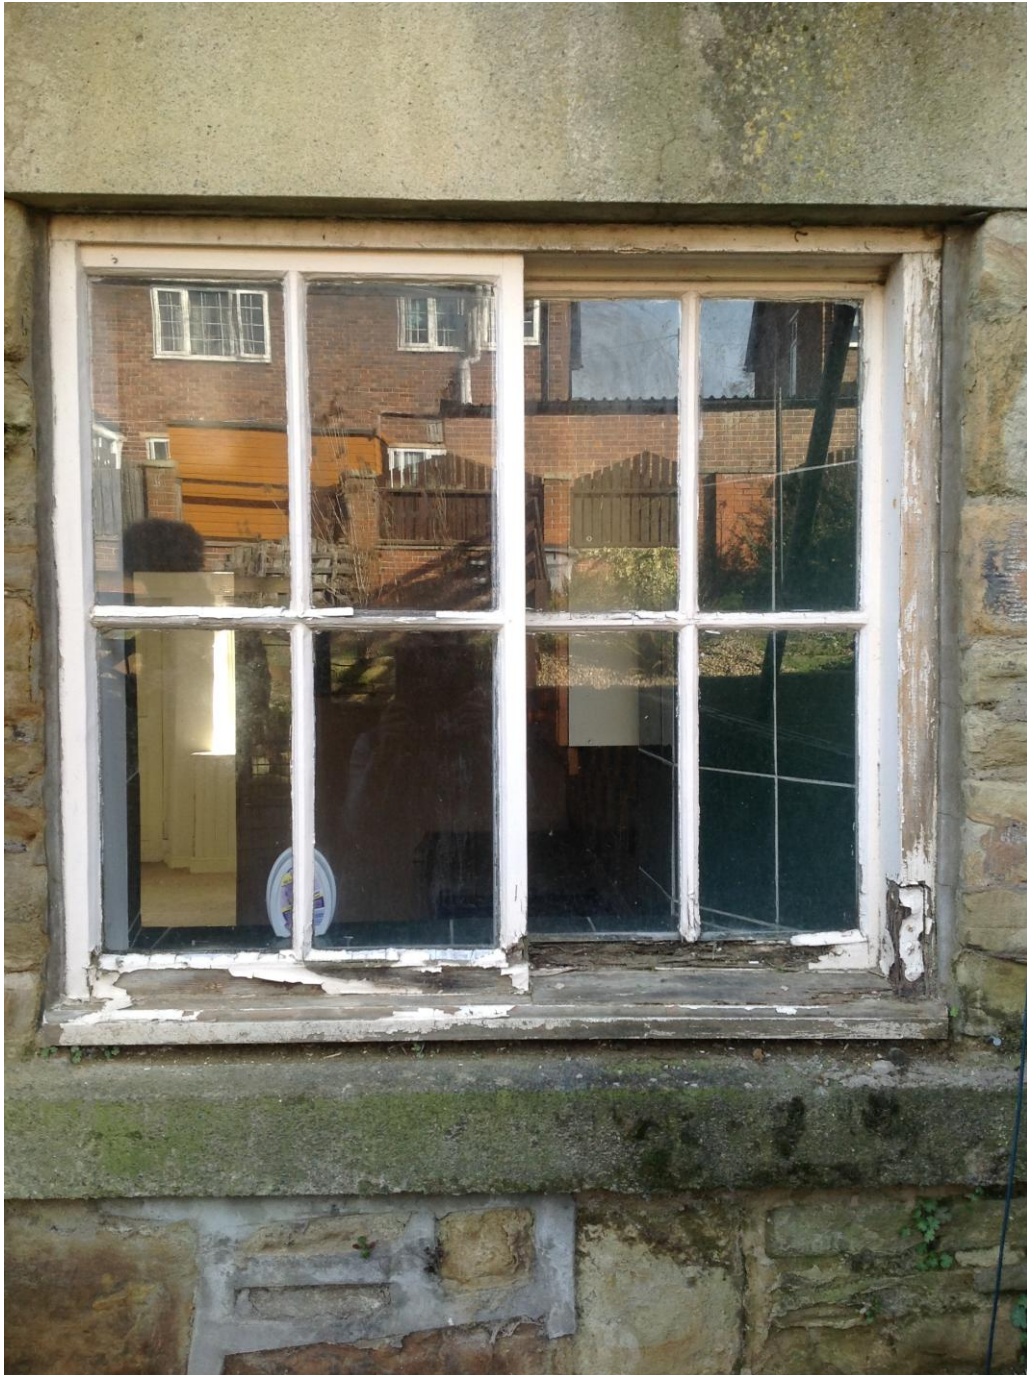
The traditional sliding single glazed Georgian timber windows are all rotten and require complete replacement. It is proposed that they are replaced with Side opening timber windows with one recessed panel to closely resemble the original windows.

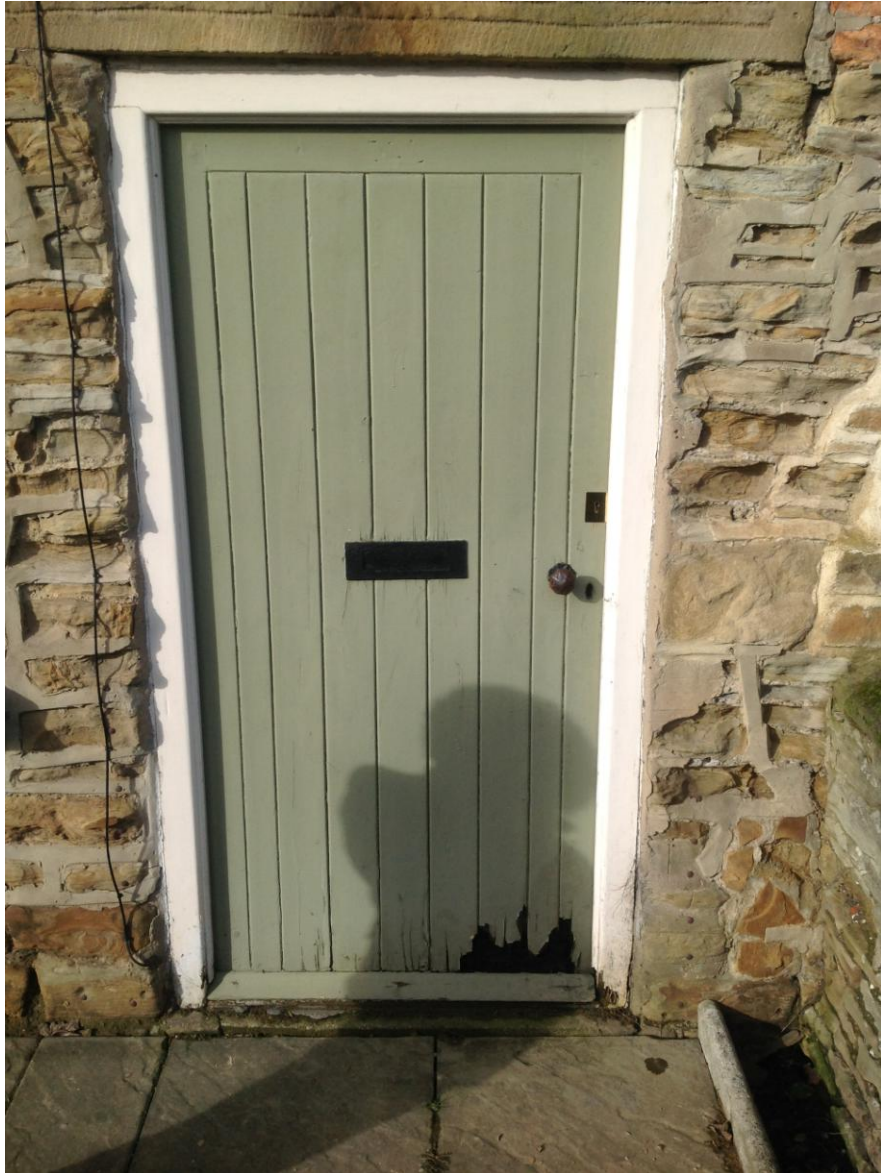
The front solid timber ledged and braced door is badly rotten and requires complete replacement. It is proposed that this is replaced with an exact like for like door.

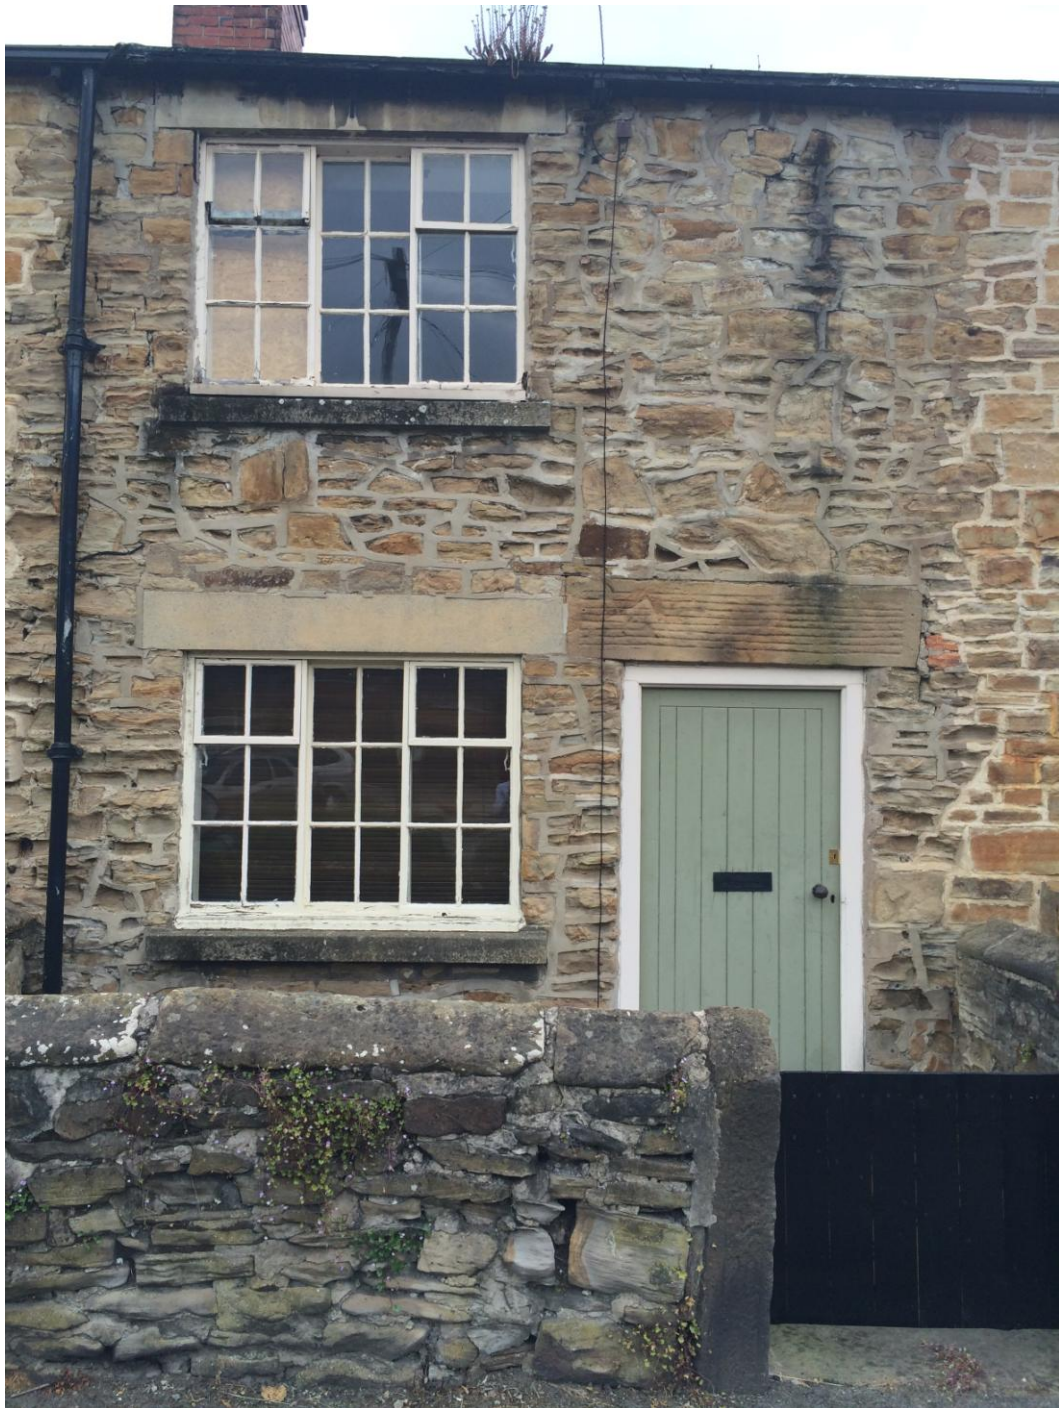
Some of the stone work is in need of replacement particularly around the rain water pipes. The pointing is also of cement mixture which does not compliment the softness of the stone and has contributed to the weather damage to the stone. It is intended that the existing pointing is removed and replaced with a NHL 3.5 Lime mortar mix.

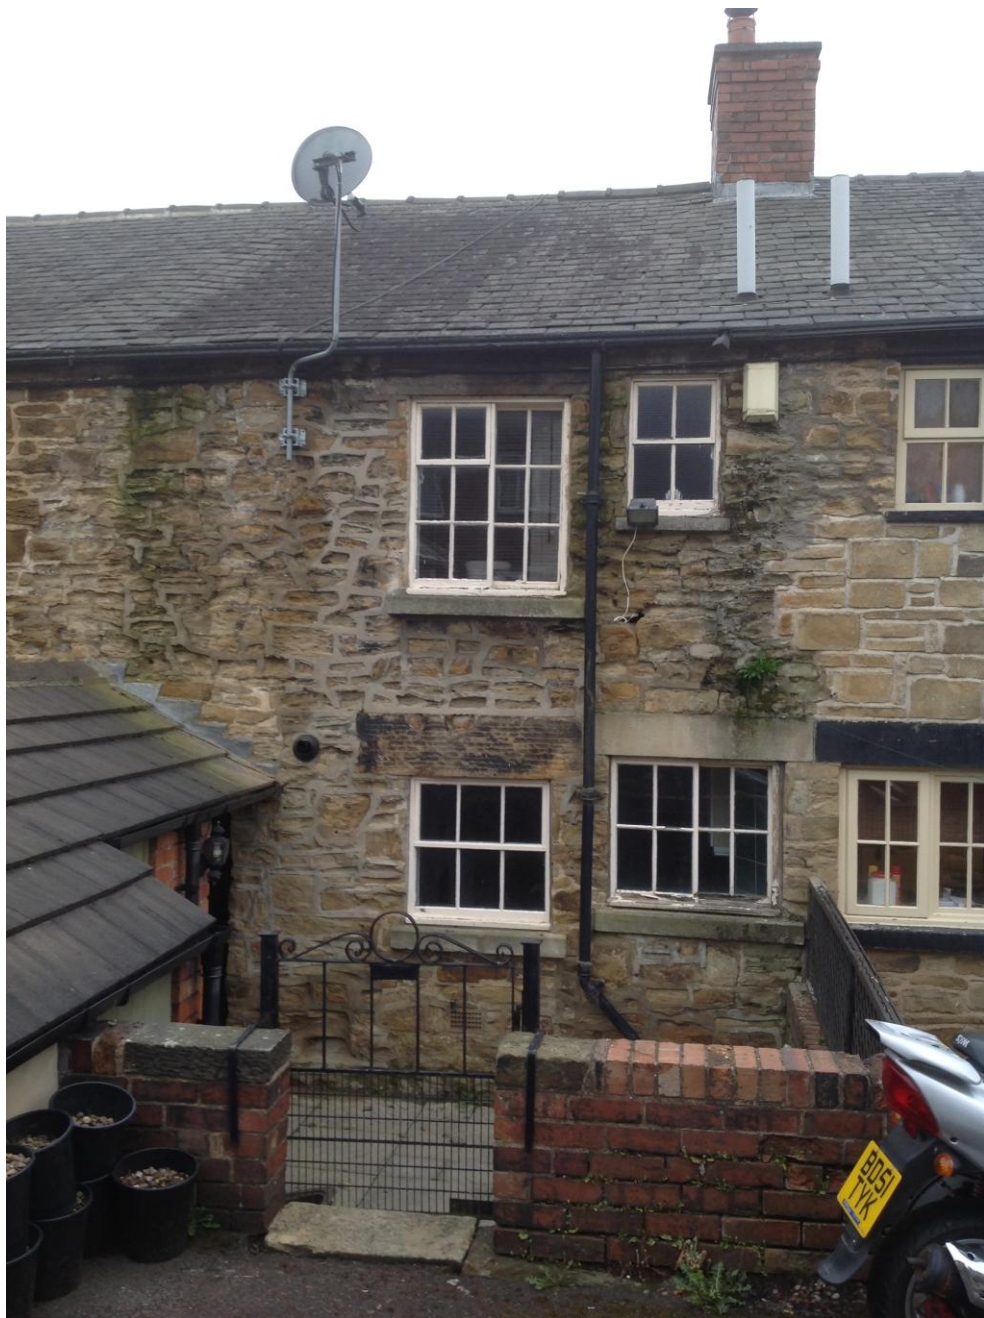
Some of the stone work is in need of replacement. The pointing is also of cement mixture which does not compliment the softness of the stone and has contributed to the weather damage to the stone. It is intended that the existing pointing is removed and replaced with a NHL 3.5 Lime mortar mix.

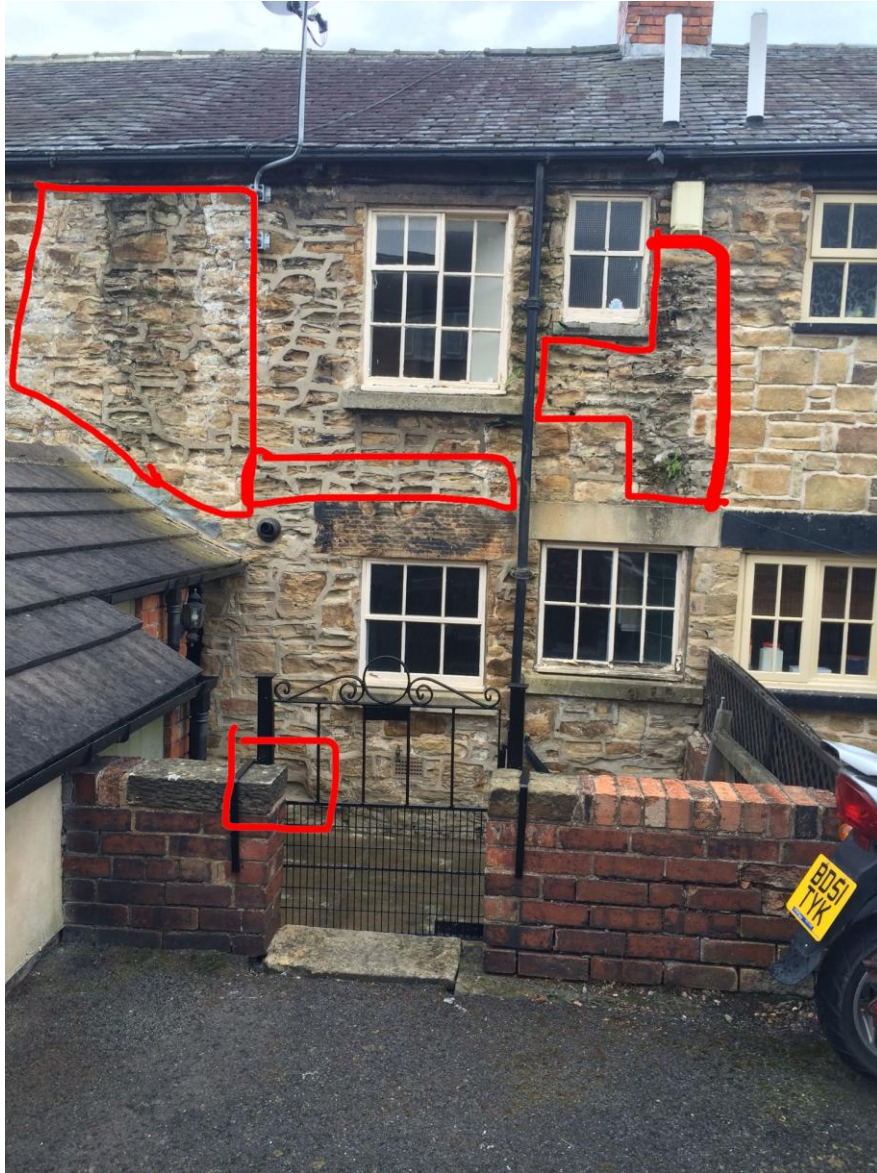
Areas of worst affected stone to the rear of property. The areas will be assessed once the original pointing has been removed and where necessary the stone will be replaced with local stone to match.

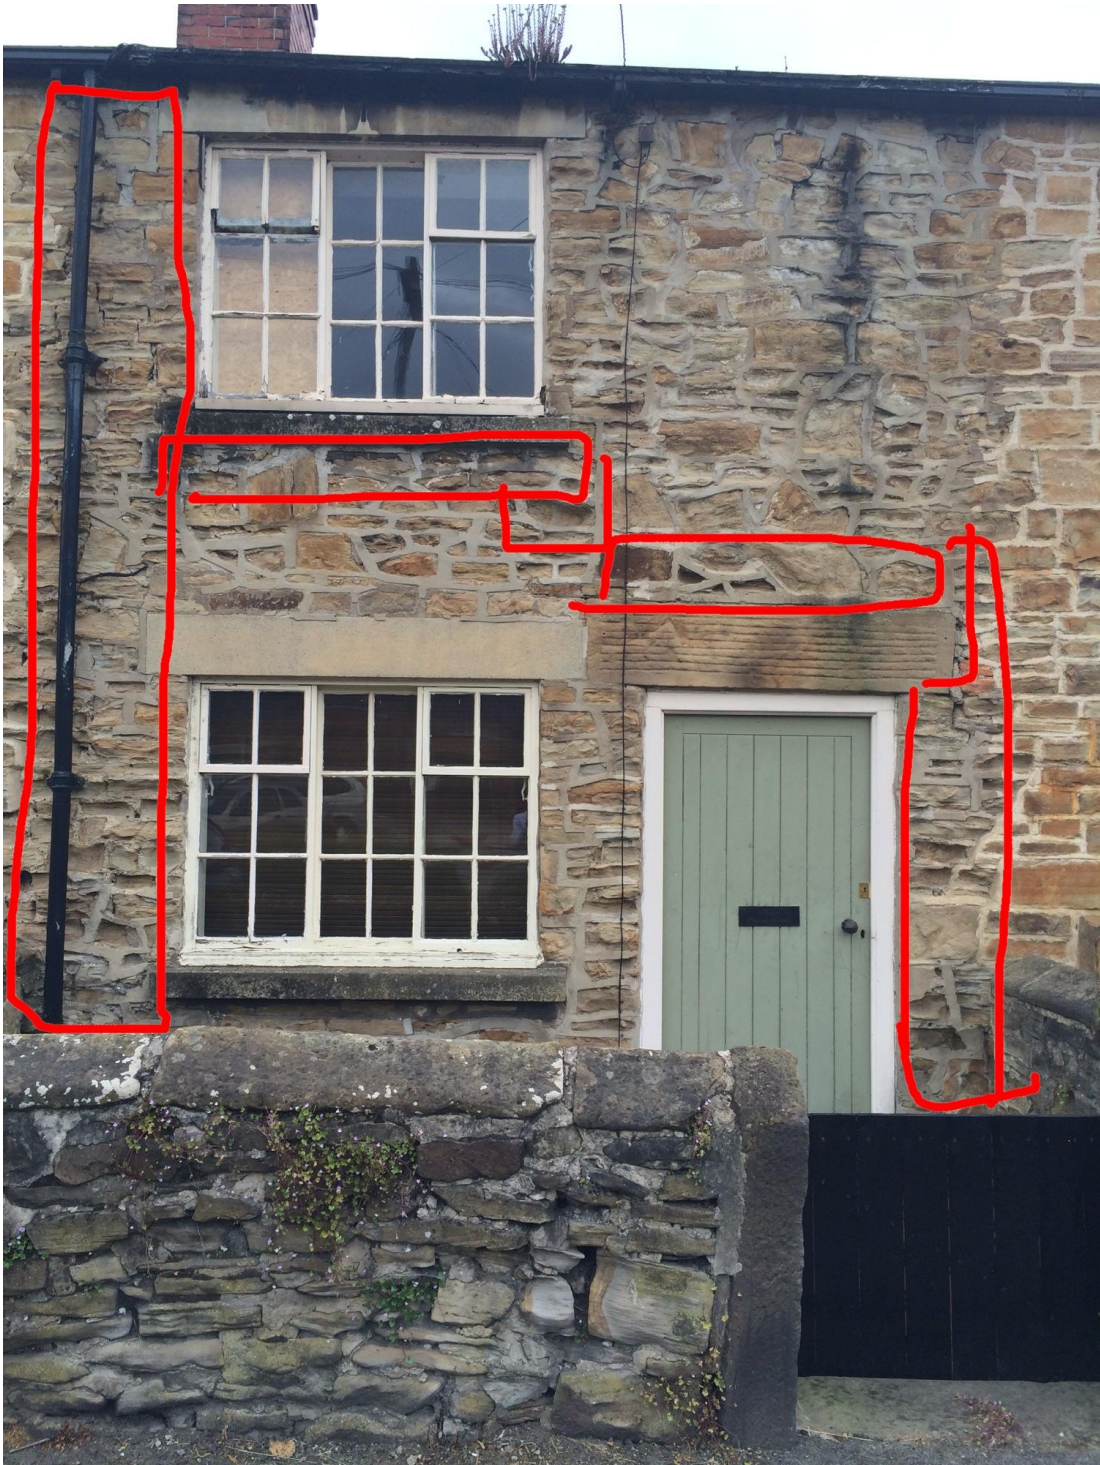
Areas of worst affected stone to the front of property. The areas will be assessed once the original pointing has been removed and where necessary the stone will be replaced with local stone to match.

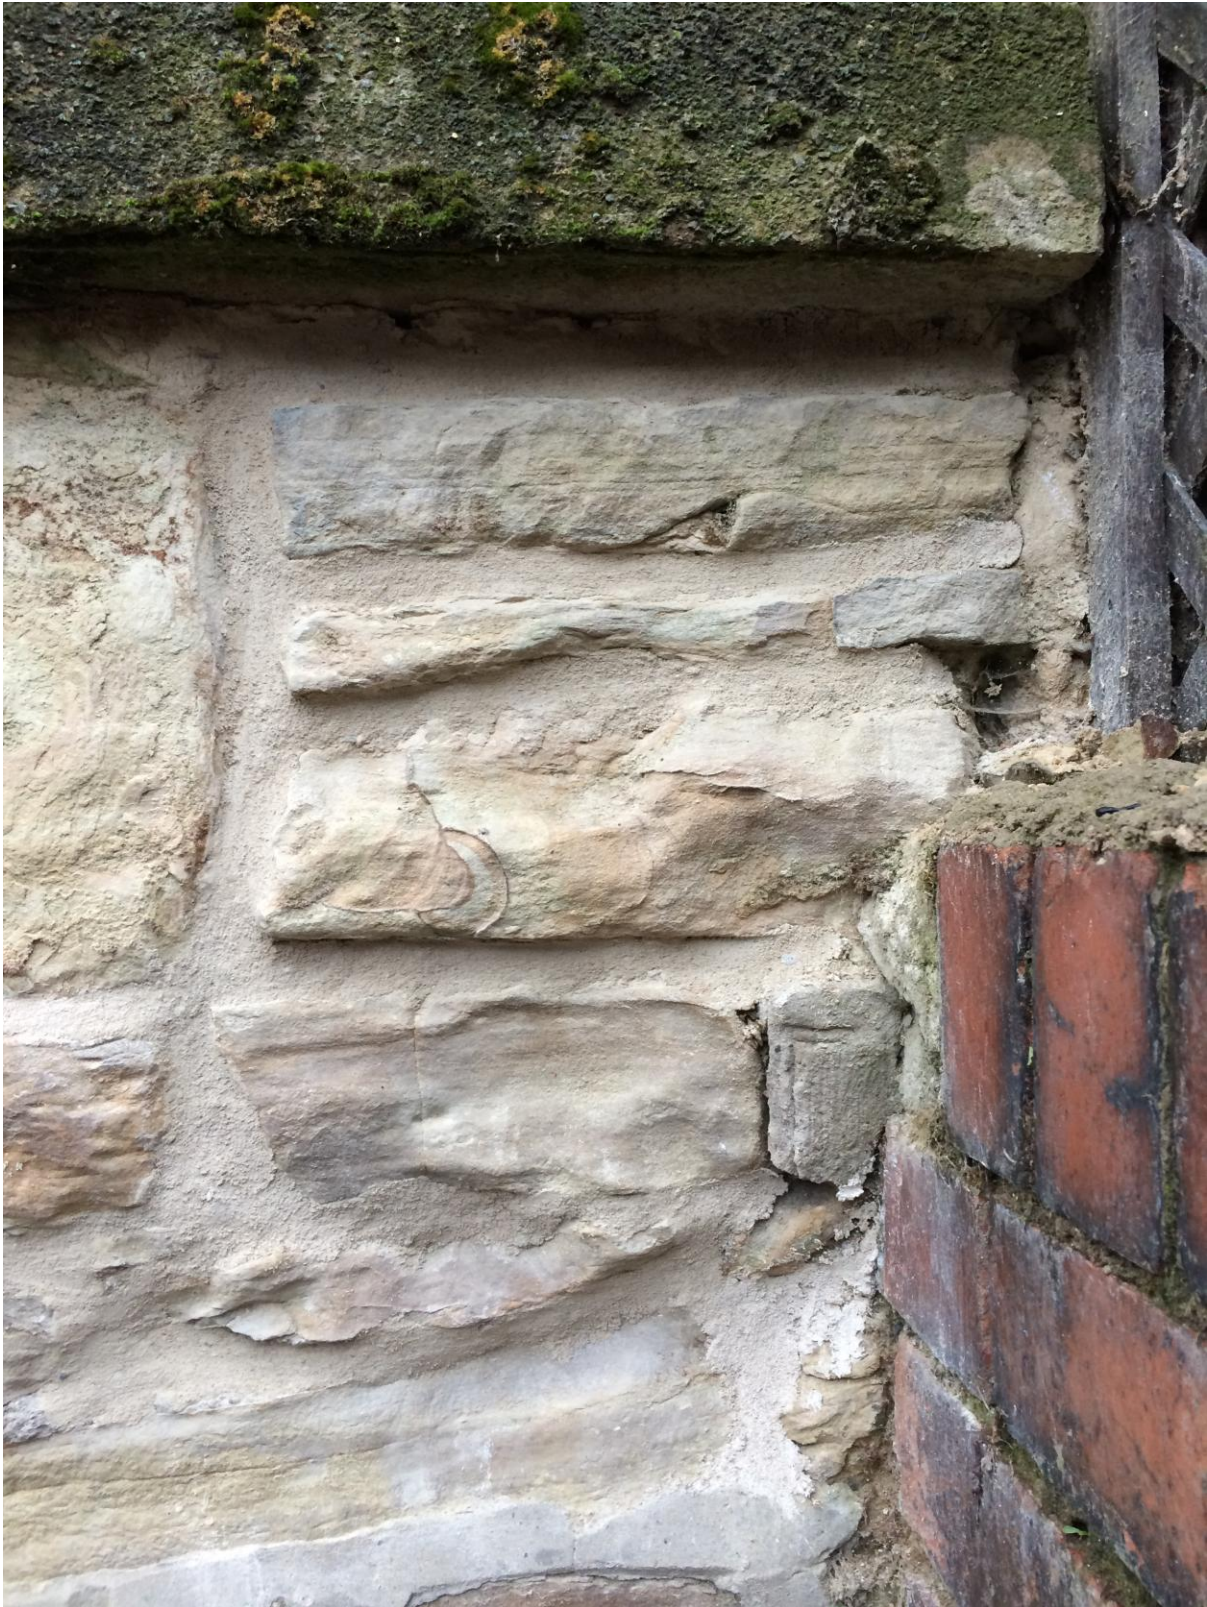
Sample area of proposed pointing using a mix of cement: lime (NHL 3.5): sand: mix of parts 1:2:9 with sand comprising 3 parts soft to 3 parts sharp grit sand.
