# Arboricultural Report

## Grenfell, Chapel Lane

| <b>Report Ref:</b> | GCL01-20 | <b>Report Date:</b> | 19th September 2020 |

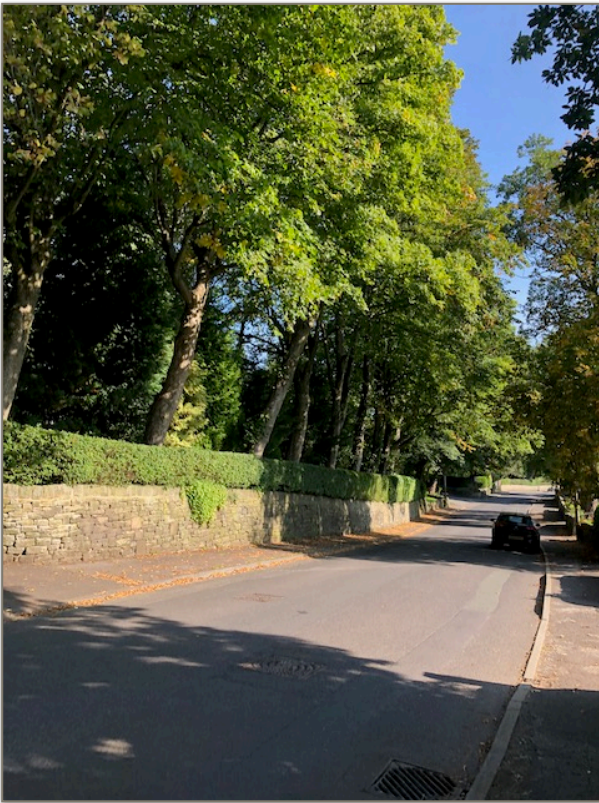
Figure 1.

Trees within the survey region are generally in good condition and play a considerable role in the local aesthetic (Figure 1). When combined with the trees on the opposing side of the road, they form part of a fragmented avenue.

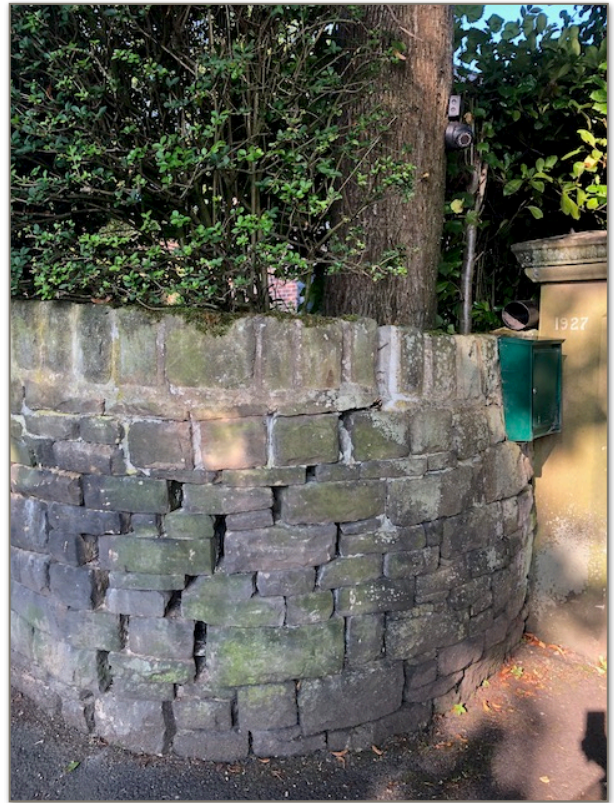
Figure 2.

These stems are located on top of a stone retaining wall behind a privet hedge. Due to their location, root expansion appears to be exerting pressure on the wall, which can be visually observed in regions where the mortar is missing or cracked (Figure 2).

Despite the lack of rooting volume towards the road, it is generally considered that roots will expand in other directions to make up for this lack of soil. In addition, roots are stronger in tension than compression and have likely fused or tangled together. With these factors in mind, the risk of root plate failure towards the road is considered negligible.

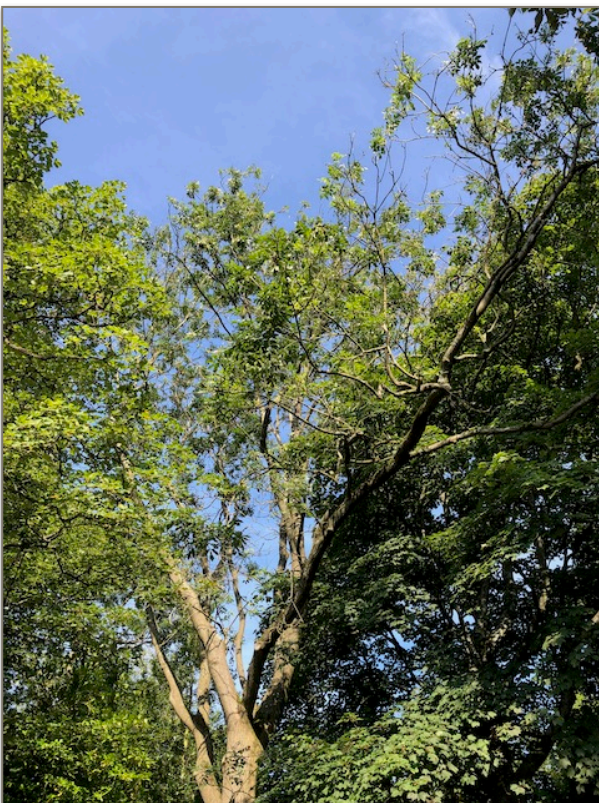
Figure 3.

The tree in the worst condition is the Ash (*Fraxinus*) tree (T11) which is suffering from Ash Dieback (*Hymenoscyphus fraxineus*). This infection has reduced leaf material by approximately 30% (Figure 3). Another effect of this fungus is that stems and branches become brittle and have an increased likelihood of failure or fracture.

| Tree ID | Age Class Species | Height (m)<br>Diameter (mm) | N<br>W<br>S | Observations and Comments | Recommendations | Work Priority |
|---|---|---|---|---|---|---|
| T11 | Mature Ash<br><i>Fraxinus excelsior</i> | 18<br>610 | 5<br>5<br>7 | Stem located on top of a retaining wall approximately 1.5m above road level with roots exerting pressure onto wall. Specimen not part of the original pollarding conducted on the aforementioned trees. Tree has good form but is suffering from Ash Dieback ( <i>Hymenoscyphus fraxineus</i> ) which has caused the loss of approximately 30% of the leaf matter. | Tree is likely to continue to decline and early removal should be undertaken. | Average |

Unfortunately, due to the poor condition and severity of Ash Dieback, as well as the threat of transmission to nearby specimens, it has been recommended that T11 should be removed and replaced with a different species.

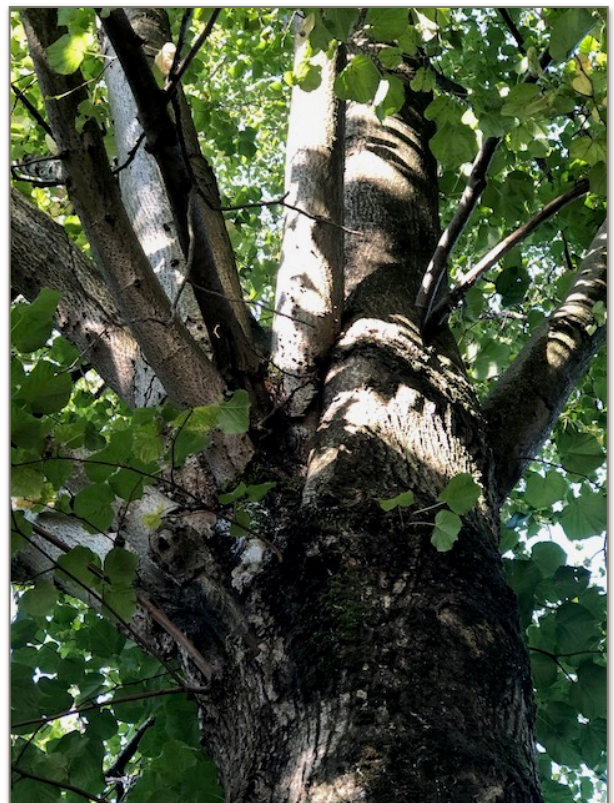
Figure 4.

| Tree ID | Age Class<br>Species | Height (m)<br>Diameter<br>(mm) | N<br>W<br>E<br>S | Observations and Comments | Recommendations | Work<br>Priority |
|---|---|---|---|---|---|---|
| T1 | Mature<br>Lime<br><i>Tilia x europaea</i> | 16<br>500 | 6<br>6<br>3<br>5 | Stem located on top of a retaining wall approximately 1.5m above road level. No direct access around the base of stem due to vegetation. Retaining wall has multiple cracks most likely caused by root pressure. Tree has been historically pollarded at approximately 4m. Some cambial damage and tight union development around pollard point. Cambial damage is assumed to be as a result of squirrels. Minor broken branch on west side. Canopy height 4.5m. | Where two stems have bark included union, remove one stem and inspect old pollard point for decay. | Low |

No significant works have been recommended for the Lime (*Tilia*) population, however minor improvements can be made with the removal of bark included unions on T1 (Figure 4) and maintaining the canopy height at 5m over the road in line with the Highways Act 1980.
