Asbestos Demolition Survey

Project No : AF-1206

Address: 6 Bourne Walk, Staincross, Barnsley

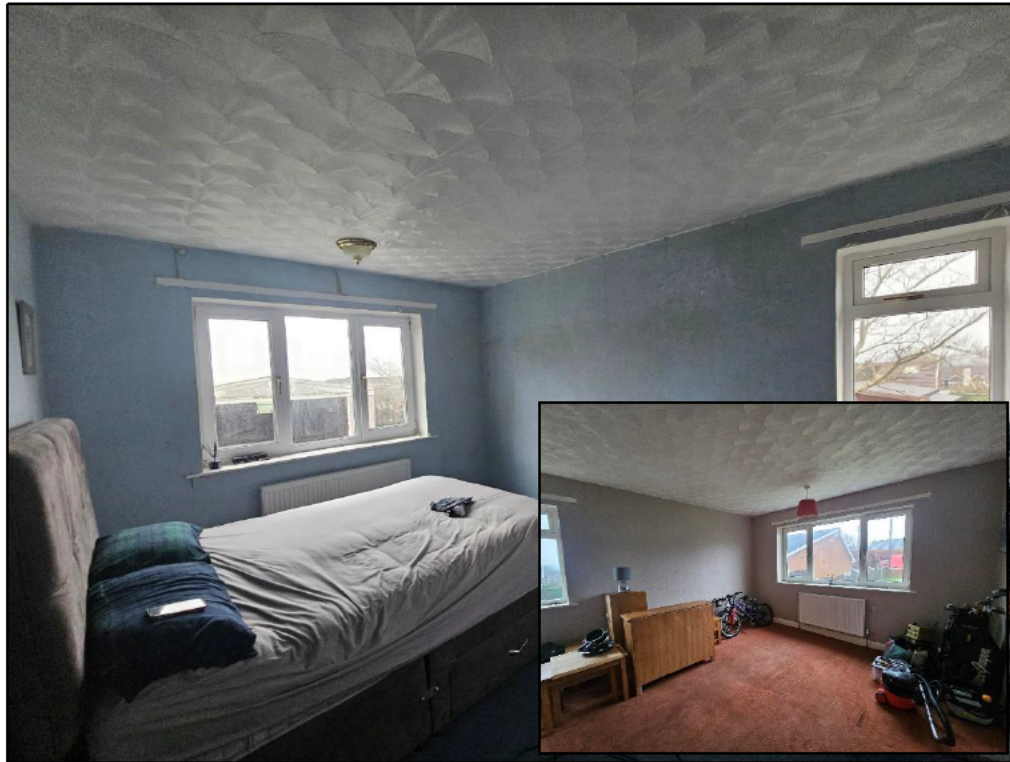
Date	Building	Floor Level	Area / Room
12 th Feb 2026	6 Bourne Walk	Ground Floor	Bedrooms
Feature/Item	Material Type	Sample No.	ID Type
Ceiling	Textured Coating	001	Sampled

Product Type	Damage	Surface Treatment	Asbestos Type
Textured Coatings (1)	Good Condition (0)	Composite Materials (0)	Chrysotile (1)

Extent	Unit	Material Risk Score	Exposure Potential
40	M ²	2	Very Low Risk

Recommendation
Remove prior to any disturbance or demolition work

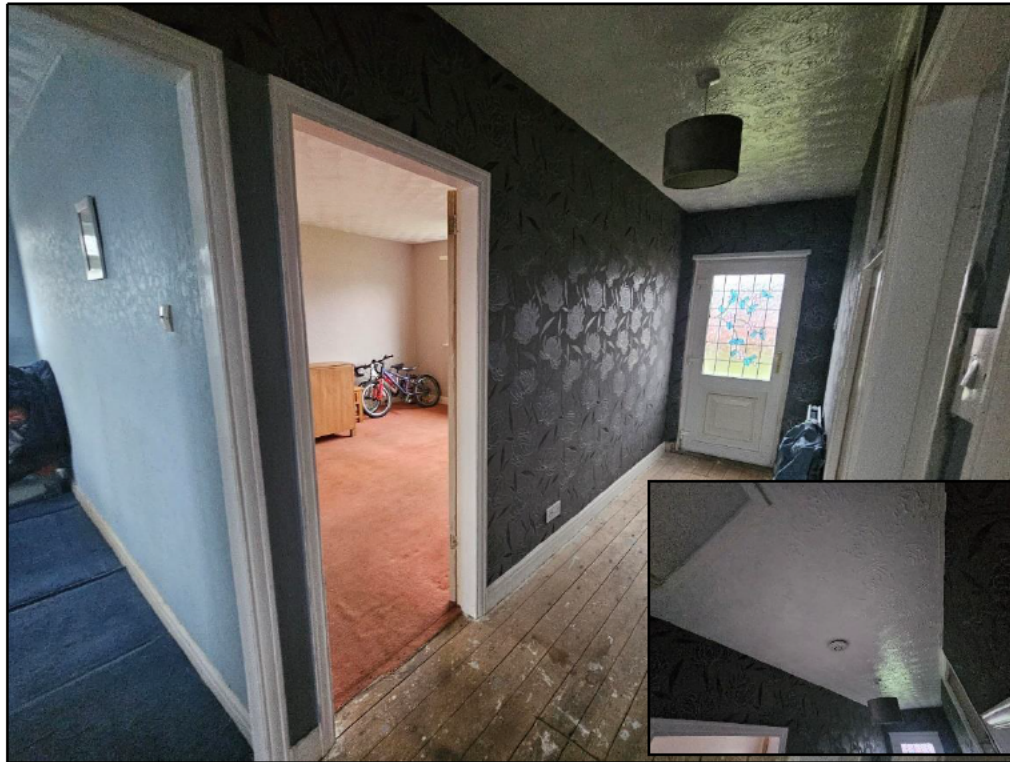
Date	Building	Floor Level	Area / Room
12 th Feb 2026	6 Bourne Walk	Ground Floor	Hallway
Feature/Item	Material Type	Sample No.	ID Type
Ceiling	Textured Coating	002	Sampled

Product Type	Damage	Surface Treatment	Asbestos Type
Textured Coatings (1)	Good Condition (0)	Composite Materials (0)	Chrysotile (1)

Extent	Unit	Material Risk Score	Exposure Potential
10	M ²	2	Very Low Risk

Recommendation
Remove prior to any disturbance or demolition work

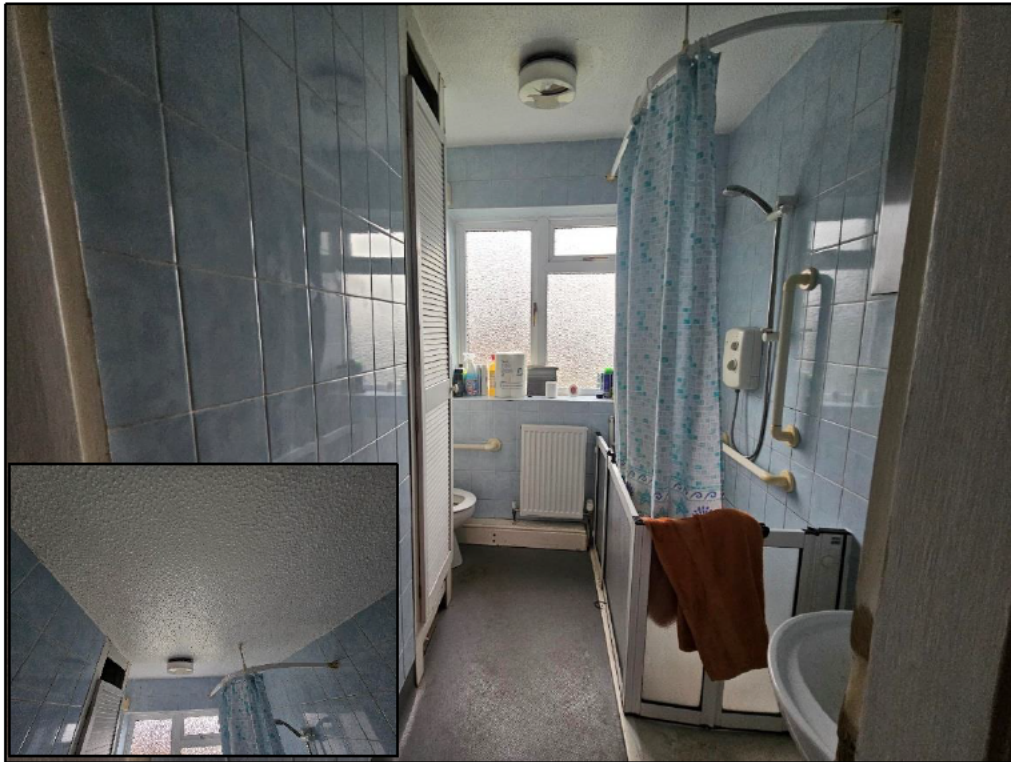
Date	Building	Floor Level	Area / Room
12 th Feb 2026	6 Bourne Walk	Ground Floor	Bathroom
Feature/Item	Material Type	Sample No.	ID Type
Ceiling	Textured Coating	003	Sampled

Product Type	Damage	Surface Treatment	Asbestos Type
Textured Coatings (1)	Good Condition (0)	Composite Materials (0)	Chrysotile (1)

Extent	Unit	Material Risk Score	Exposure Potential
5	M ²	2	Very Low Risk

Recommendation
Remove prior to any disturbance or demolition work

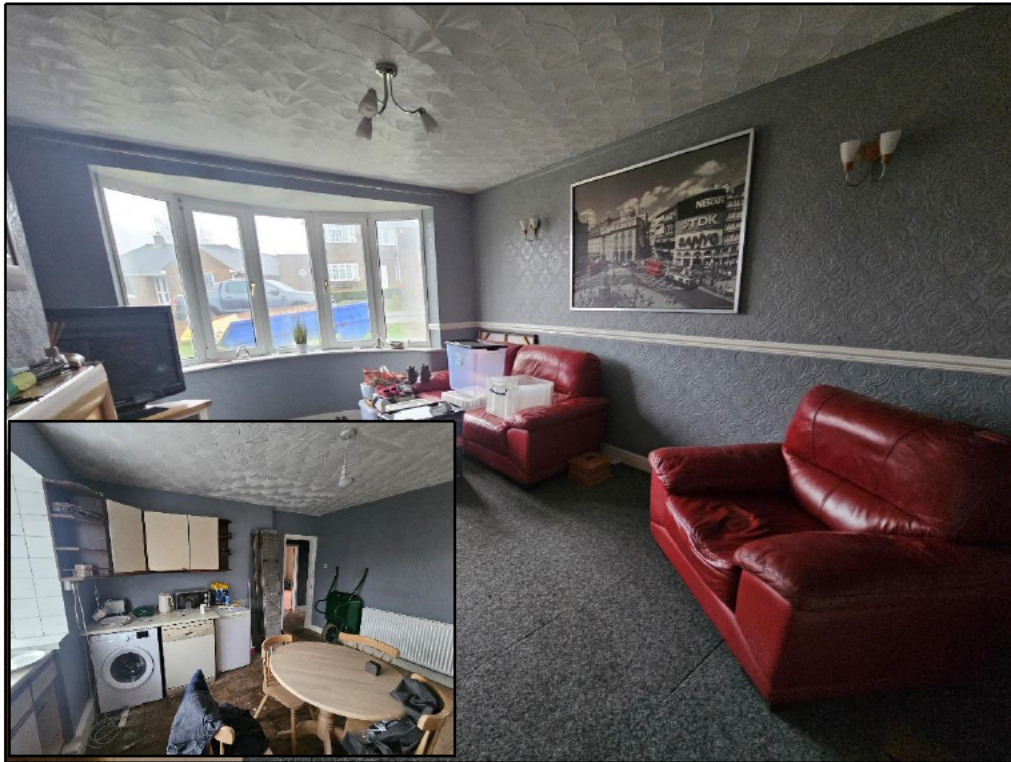
Date	Building	Floor Level	Area / Room
12 th Feb 2026	6 Bourne Walk	Ground Floor	Lounge & Kitchen
Feature/Item	Material Type	Sample No.	ID Type
Ceiling	Textured Coating	004	Sampled

Product Type	Damage	Surface Treatment	Asbestos Type
Textured Coatings (1)	Good Condition (0)	Composite Materials (0)	Chrysotile (1)

Extent	Unit	Material Risk Score	Exposure Potential
40	M ²	2	Very Low Risk

Recommendation
Remove prior to any disturbance or demolition work

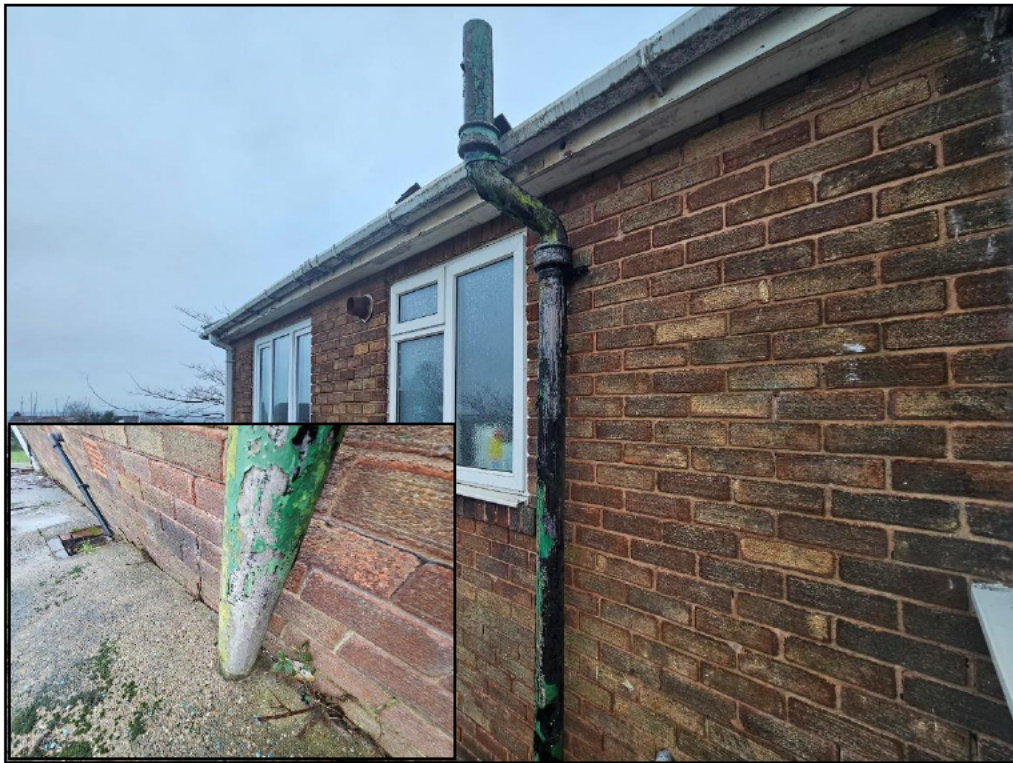
Date	Building	Floor Level	Area / Room
12 th Feb 2026	6 Bourne Walk	Ground Floor	Exterior
Feature/Item	Material Type	Sample No.	ID Type
Downpipe to Wall	Cement	005	Sampled

Product Type	Damage	Surface Treatment	Asbestos Type
Asbestos Cement (1)	Low Damage (1)	Cement Sheets Etc (1)	Chrysotile (1)

Extent	Unit	Material Risk Score	Exposure Potential
3	Linear m	4	Very Low Risk

Recommendation
Remove prior to any disturbance or demolition work

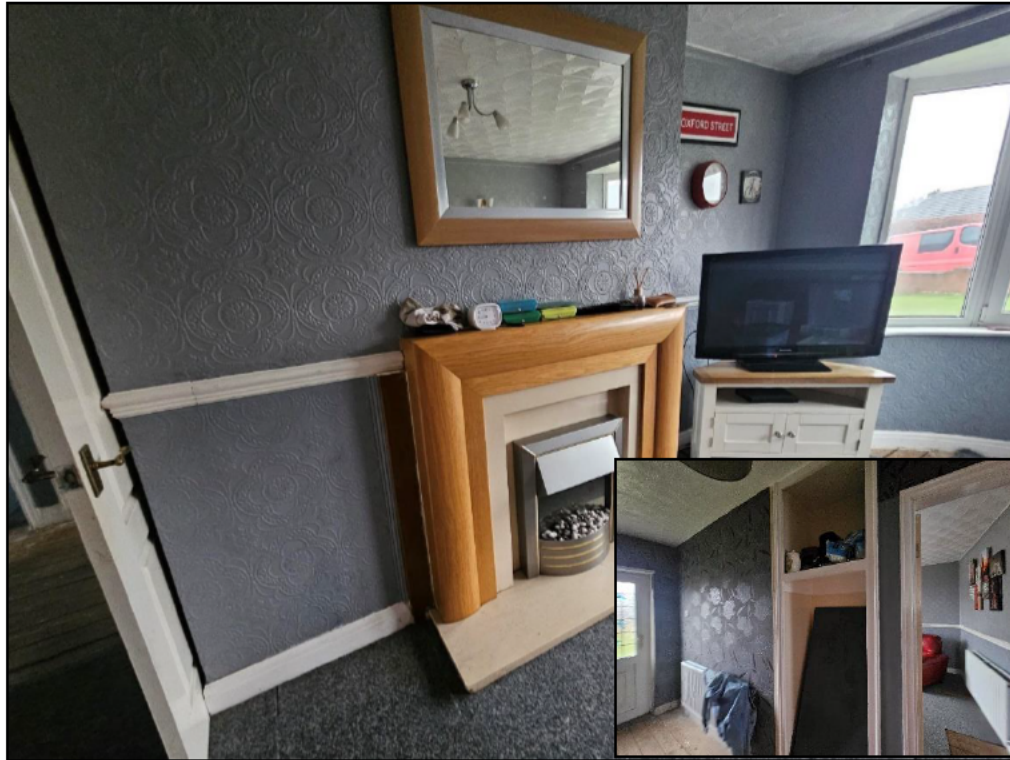
General Inspection Photo 1 – Ground Floor Areas

Product Type	Damage	Surface Treatment	Asbestos Type
N/A	N/A	N/A	No Asbestos Detected

Notes
Modern surfaces, fixtures and fittings.

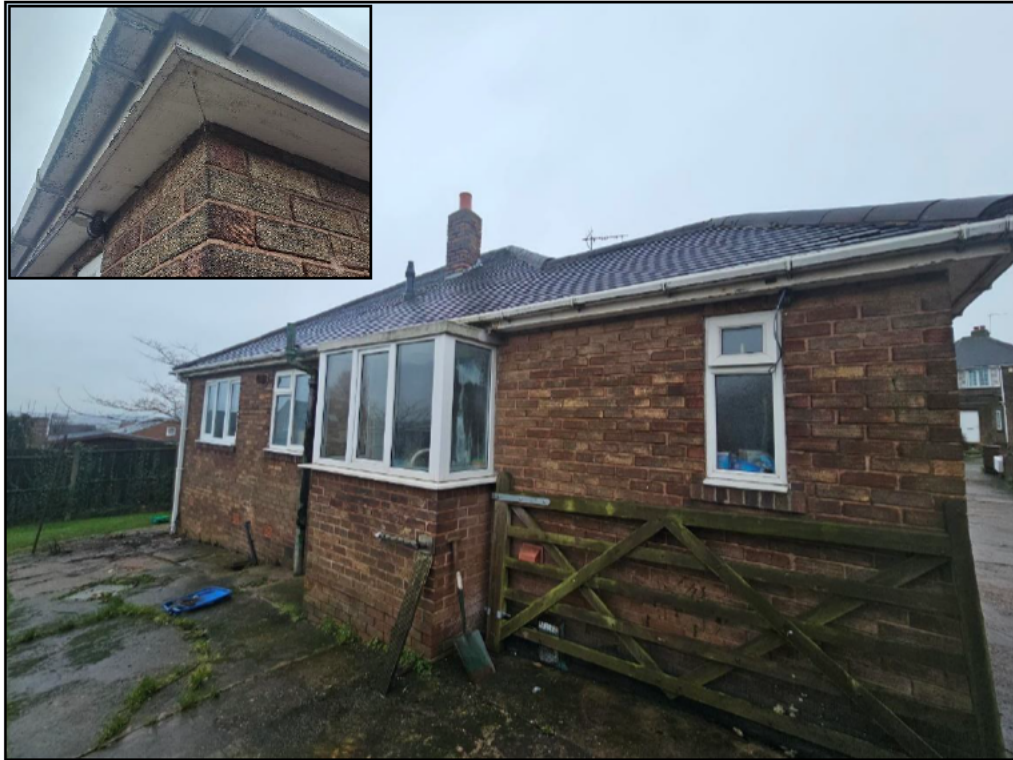
General Inspection Photo 2 – Exterior Areas

Product Type	Damage	Surface Treatment	Asbestos Type
N/A	N/A	N/A	No Asbestos Detected

Notes
Brick construction. Timber and plastic fascias and soffits, clay roof tiles

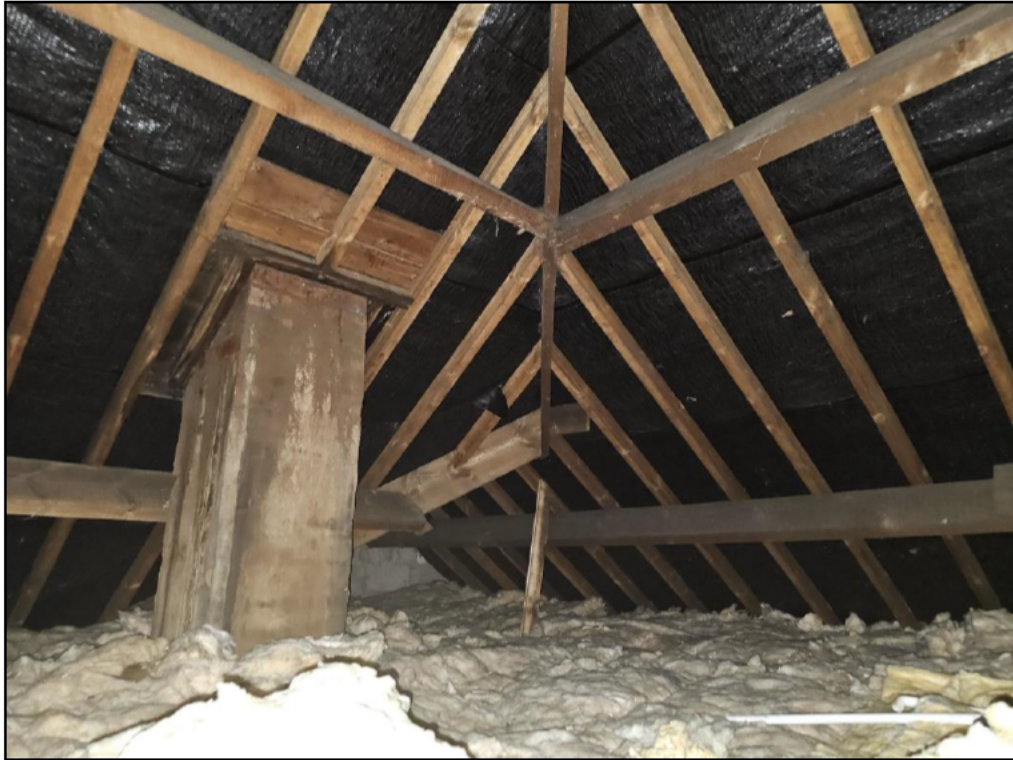
General Inspection Photo 3 – Attic/Loft

Product Type	Damage	Surface Treatment	Asbestos Type
N/A	N/A	N/A	No Asbestos Detected

Notes
Modern sarking felt, mineral fibre insulation

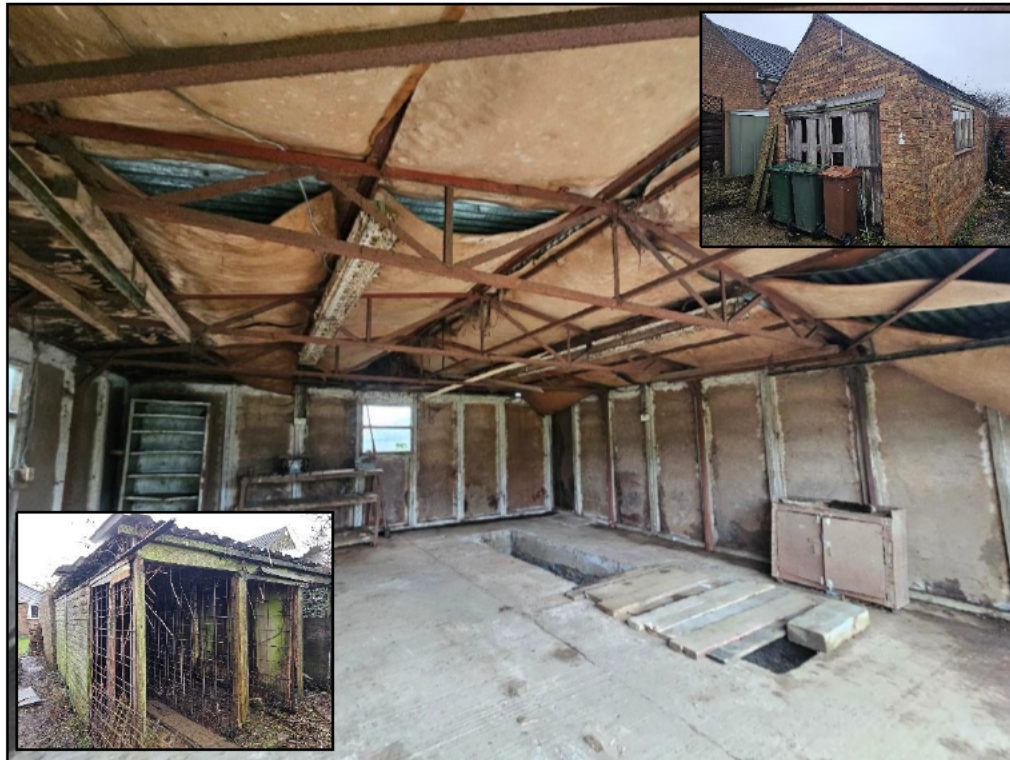
General Inspection Photo 4 – Outbuildings

Product Type	Damage	Surface Treatment	Asbestos Type
N/A	N/A	N/A	No Asbestos Detected

Notes
Mixture of concrete, brick and timber outbuildings with timber, tiled and profiled metal roofs.
