ARBORICULTURAL REPORT

to **BS5837:2012** at:

50 Don Street
Penistone
South Yorkshire
S36 6HA

Reference: *AWA2814.0310.19*

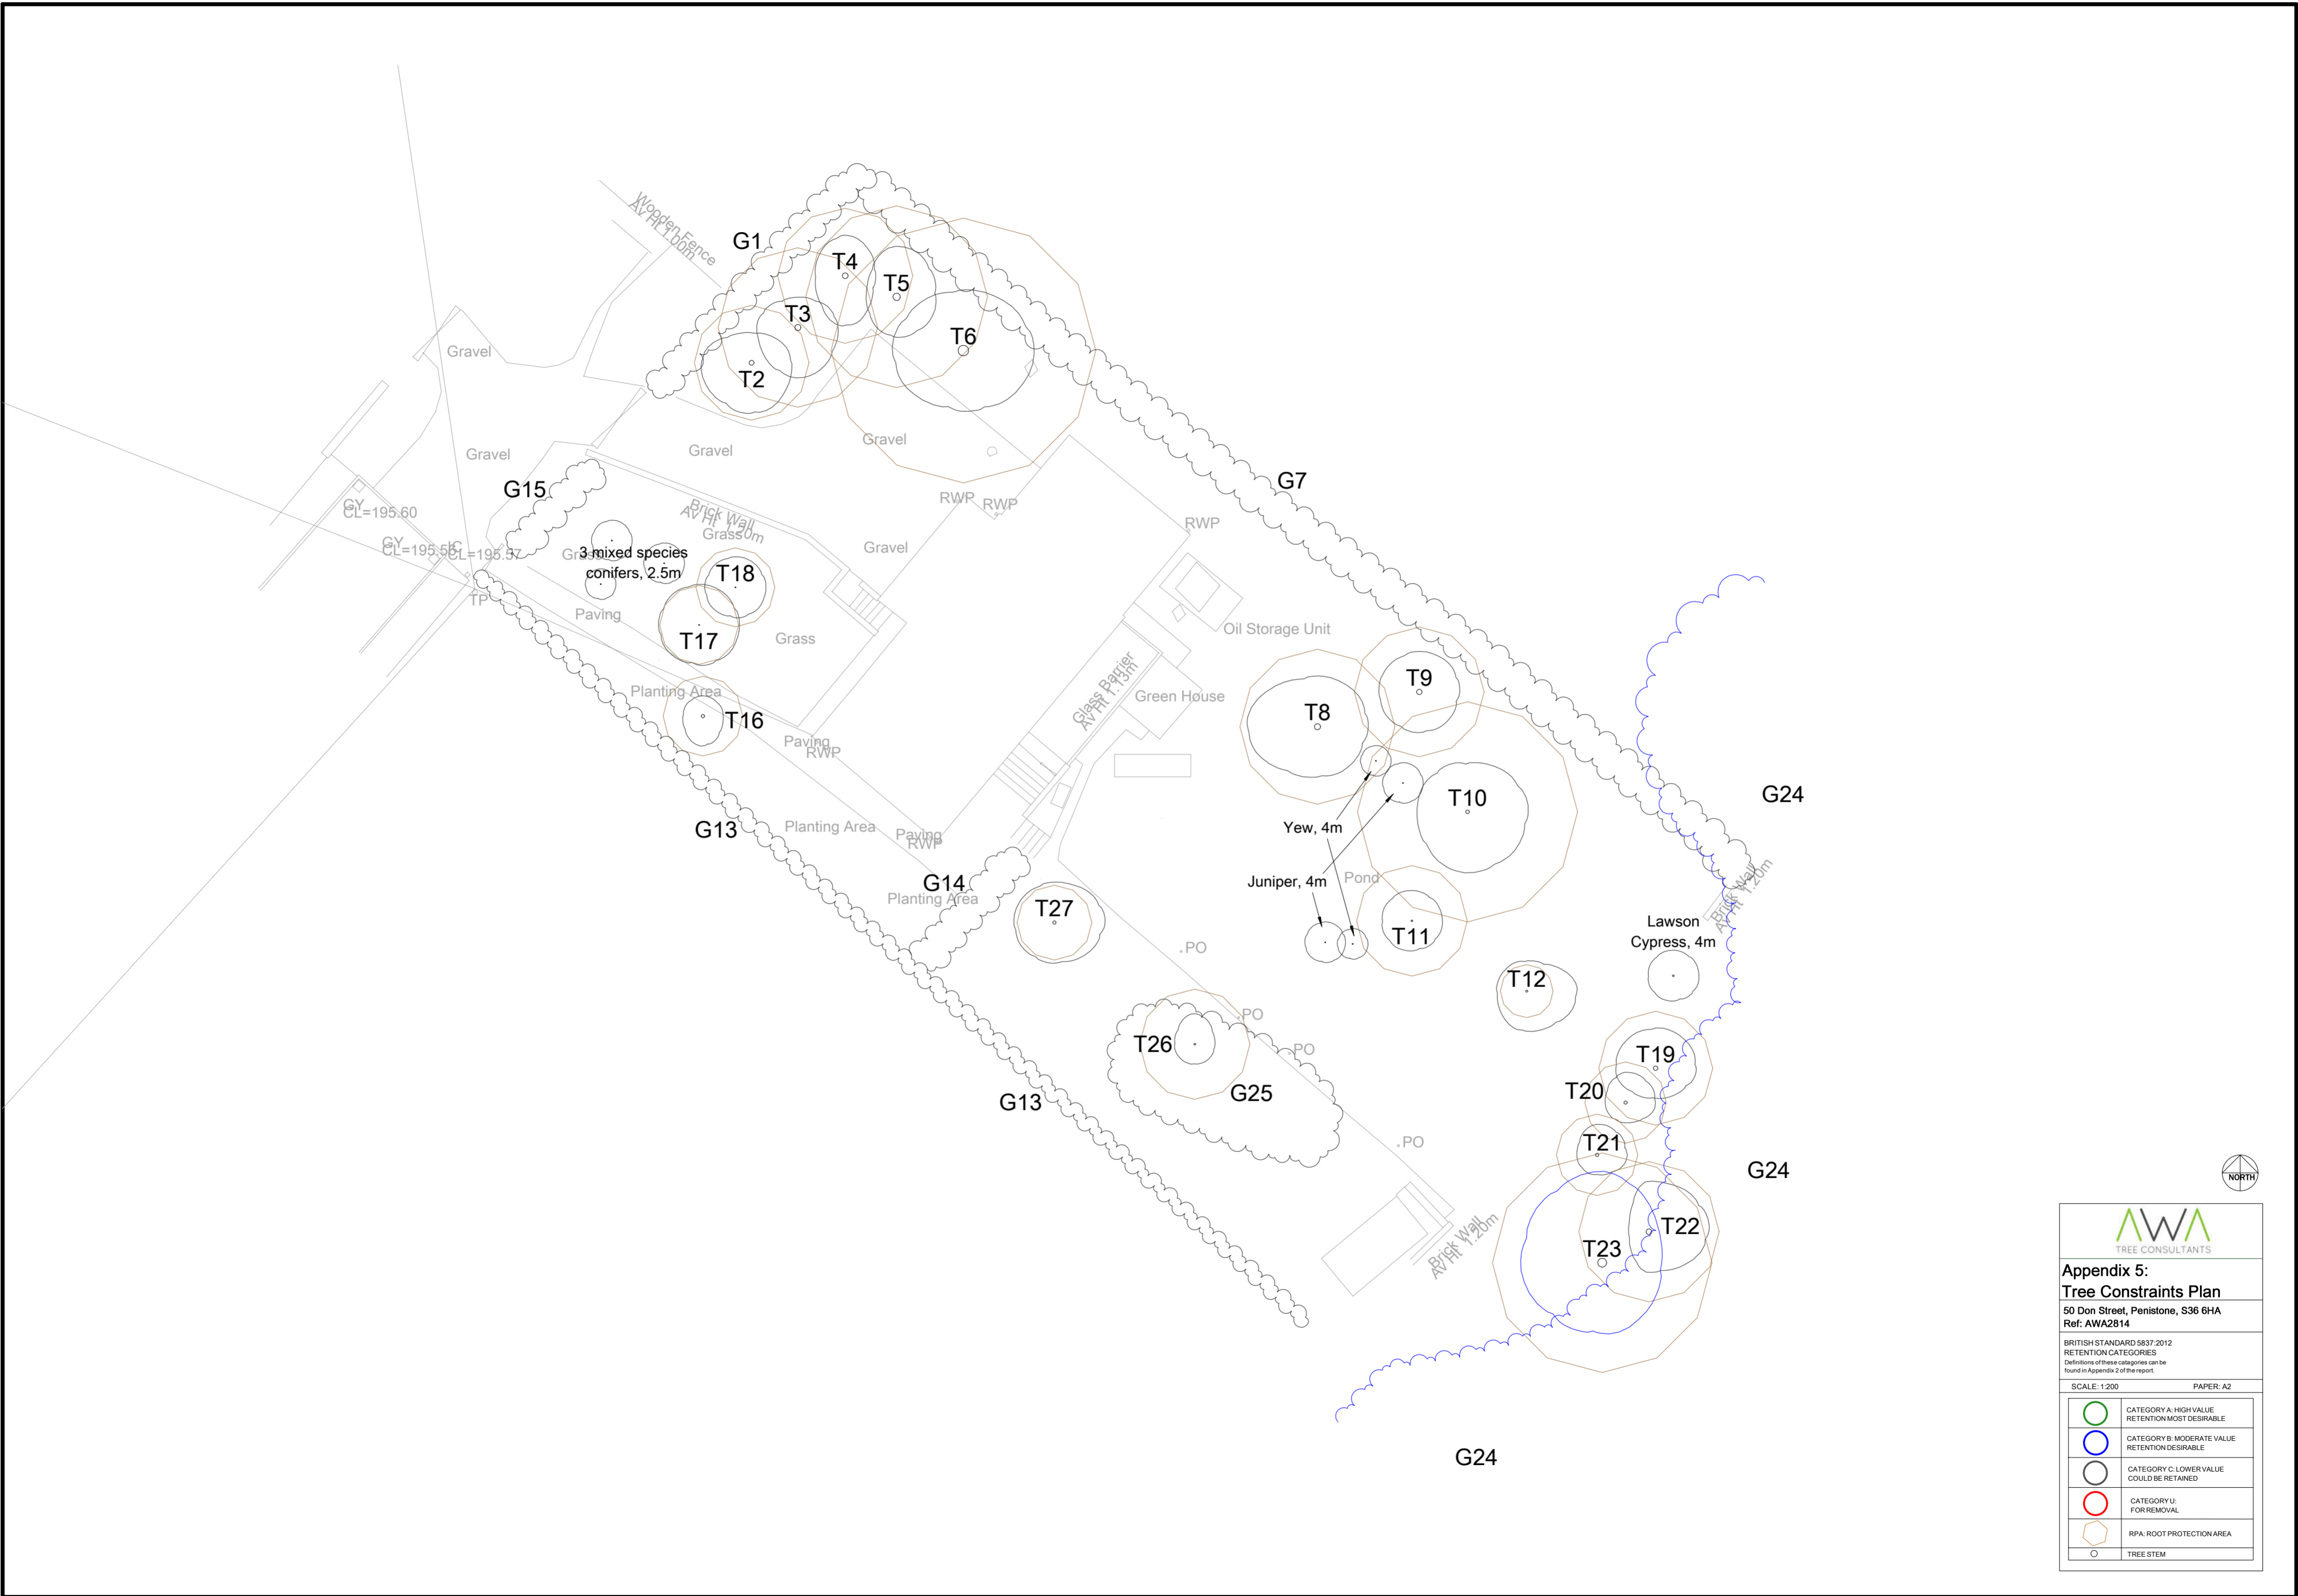
**Appendix 5:
Tree Constraints Plan**

- 3.2.9 The tree Root Protection Area (RPA) detailed on the Tree Constraints Plan at Appendix 5, has been used as a layout design tool, to inform on the area around a tree where the protection of the roots and soil structure is treated as a priority.

- 3.2.11 The RPA for each tree has been plotted as a polygon centred on the base of the stem. Due to the presence of roads, structures, topography (and past tree management) the RPA is likely to be a simplified representation of the tree roots actual morphology and disposition. However, detailed modifications to the shape of the RPA would largely be based on conjecture and so have been avoided.

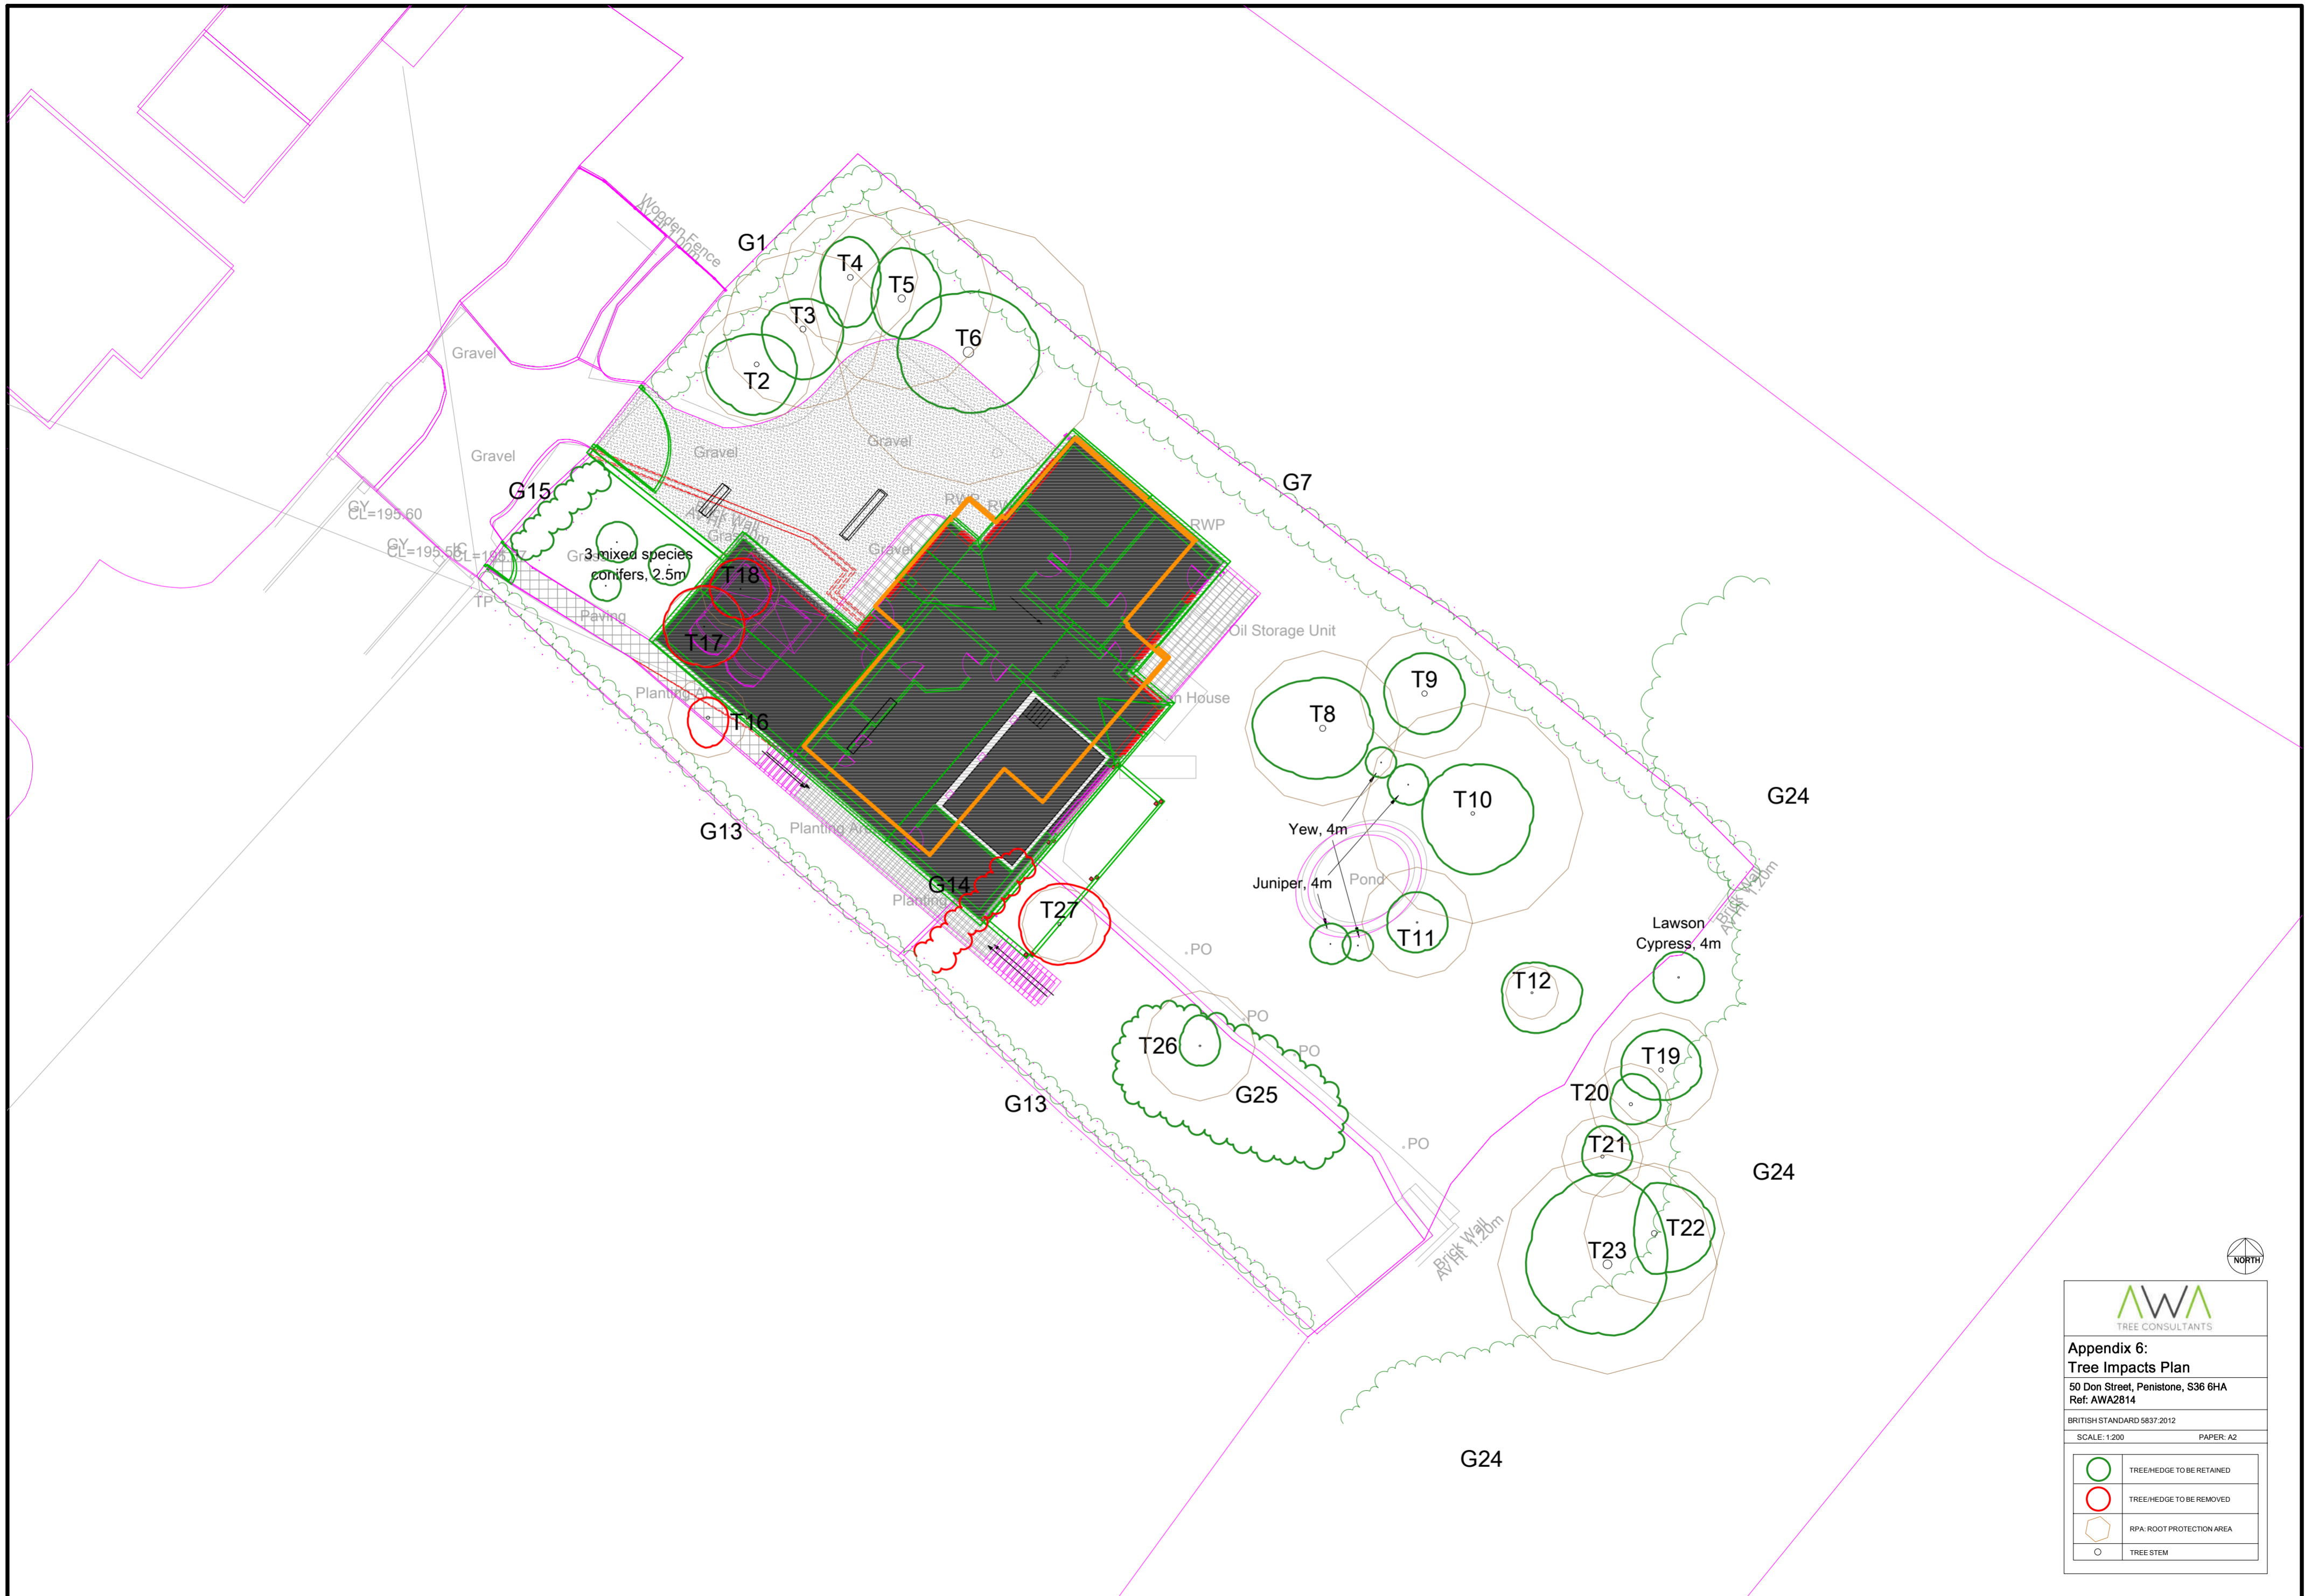
Appendix 6:
Tree Impacts Plan
 50 Don Street, Penistone, S36 6HA
 Ref: AWA2814

- 4.2.1 From assessing the new development proposals, 4 trees and 1 tree group will require removal as they are situated in the footprint of the structure or their retention and protection throughout the development is not suitable.
- 4.2.2 The trees that require removal are G14, T16, T17, T18 and T27.
- 4.2.3 The trees that require removal are lower value, retention category 'C'. T16 and T27 are small fruit trees and T17 and T18 are Lawson Cypress, all of negligible value. G14 is a short section of Beech hedge within the site.
- 4.2.4 The loss can largely be mitigated through the planting of more suitable tree species within the site once construction has been completed.

- 4.3.2 Potentially damaging activities are proposed in the vicinity of retained trees. The widening of the driveway encroaches into the RPA of T5 and T6. Construction within the RPA, can have negative impacts on tree roots. However, a 'no dig' type construction method in this area will minimise any negative impacts to the trees.

- 4.5.1 The retained trees will require protection by fencing in accordance with BS 5837: 2012, during the development phase.
- 4.5.2 If required by the Local Planning Authority, an associated Arboricultural Method Statement, detailing protective fencing specifications and construction methods close to the retained trees can be provided.
