Condition Report
for
HARRAL BUILDINGS, 32-38 ELDON STREET, BARNLSLEY, SOUTH
YORKSHIRE S70 2JB

APRIL 2022

Britt Harwood *PG Dip (Arch) PG Dip (Bldg Cons) RIBA SCA AABC*
inc. architecture ltd, The Barn, Mock Hall Farm, 63 Leeds Road, Mirfield, West Yorkshire WF14 0DA
M: 07831 275394; E-mail: mail@inc-architecture.com

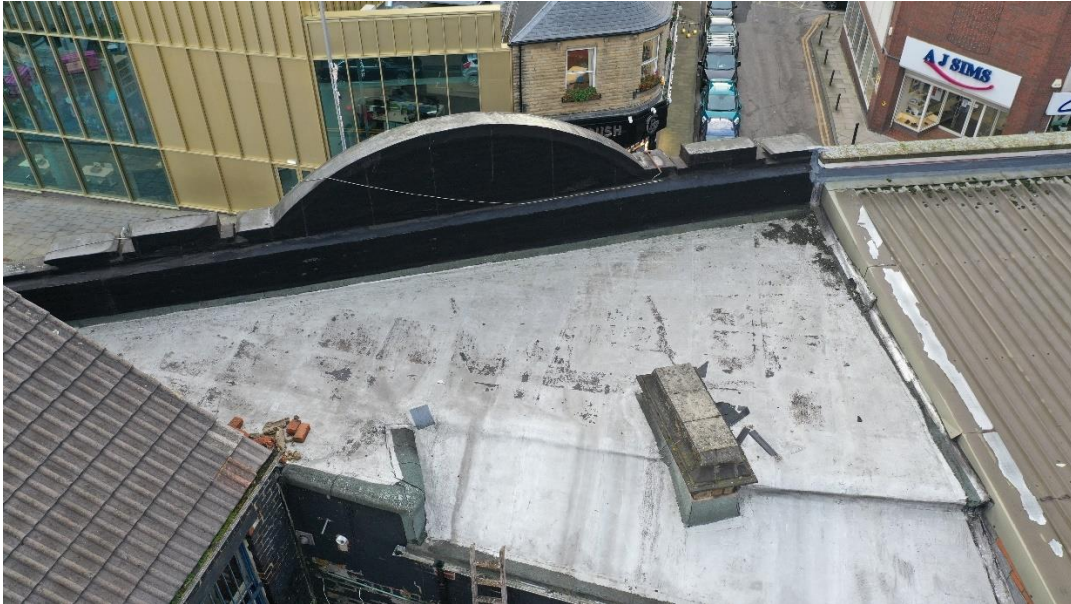
- 2.1.1 **The westernmost block (32 Eldon Street):** The flat roof of 32 Eldon Street (**Fig. 11**) is finished with green bitumen-based roofing felt which appears to have been painted with some type of 'water-proof' paint and there are widespread Flashband patch repairs, both in the body of the flat roof and in particular along the upstands at the abutments with the parapet and the adjoining building. (no. 30 Eldon Street). There is widespread creep and cracking of the roof covering visible.
- 2.1.2 At the back of the building (on the yard side) there is a length of pitch roof (rather like a mansard) which empties into a plastic half round gutter and downpipe. This is also covered with the green bitumen-based roofing felt and paint and again there is widespread creep and cracking of the roof covering.

- 2.1.3 Bitumen-based roofing felt is a cost-effective DIY product commonly used for shed roofs and does not have the lifespan or robustness for this situation and significance of building. The maximum lifespan of the material is max. 10 years (for roofing felt at the top end of the product range) and certainly is not guaranteed in situations like this where there is likely to be regular standing water and ponding. Therefore, its replacement, if grant funded, should be a material/system with a minimum 25 year guarantee which can accommodate this.

Fig 11. The roof of no. 32 Eldon Street (taken by drone from the north).

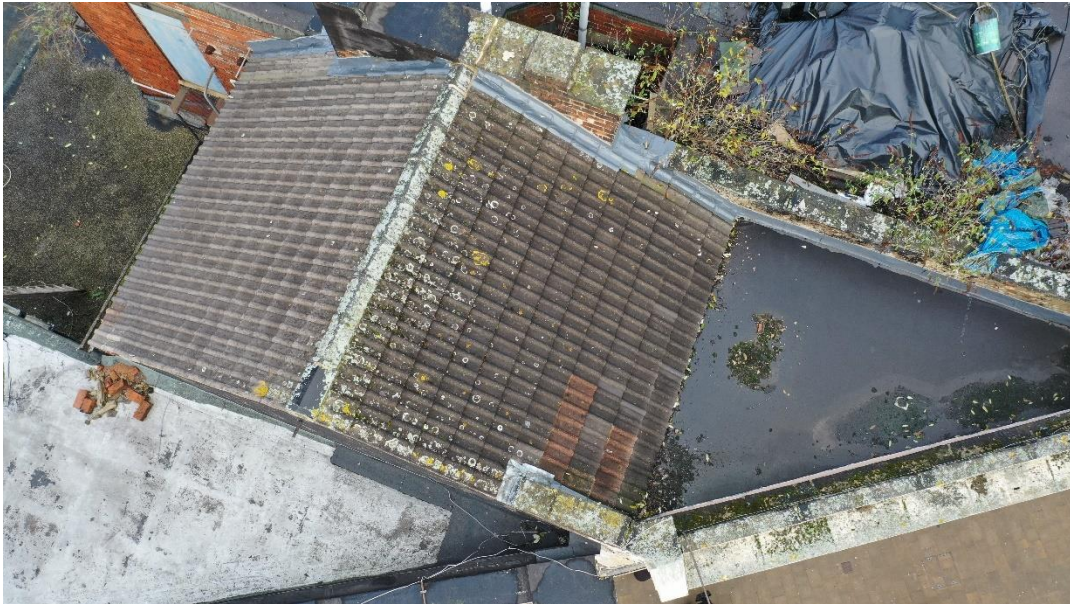
- 2.1.6 **The central block (34 Eldon Street):** The central Eldon Street block (**Fig. 12**) comprises a pitched roof finished with concrete tiles and a small triangular area of

flat roof finished with a black LSFR (low slope fire retardant) synthetic rubber membrane.

Fig 12. The roof of no. 34 Eldon Street (taken by drone from the south).

- 2.1.7 The membrane turns up at the abutments (back of the parapet and the abutment with the easternmost Eldon Street block) and has been (poorly) cover flashed with Flashband (the top of this has then been buttered with mortar, possibly because the joint was leaking). Flashband is a temporary adhesive material used to repair small leaks along lead gutters. It should not be used in such quantities as a replacement to lead flashings and has no place on a building of this significance.

- 2.1.9 The concrete tiling covering the pitched roof has been patch repaired with tiles of a red rather than grey colour and some of these appear to be delaminating or have cracked on the lower edges. This indicates the concrete tiles are nearing the end of their lifespan. There is moss and green algae on the east facing pitch and one of the concrete ridge tiles has been replaced with what looks like a black plastic ridge tile.

- 2.1.10 There is a raised gablet where the pitched roof meets the adjoining parapet of the easternmost Eldon Street block and the concrete tiles are finished along this abutment with Flashband. Again, this is not a robust enough material and should be replaced with lead soakers and a stepped lead flashing.

- 2.1.11 The timber gutter serving the pitch facing the yard is filled with debris, moss and vegetation and at one end has completely rotted. This should be replaced in its entirety.

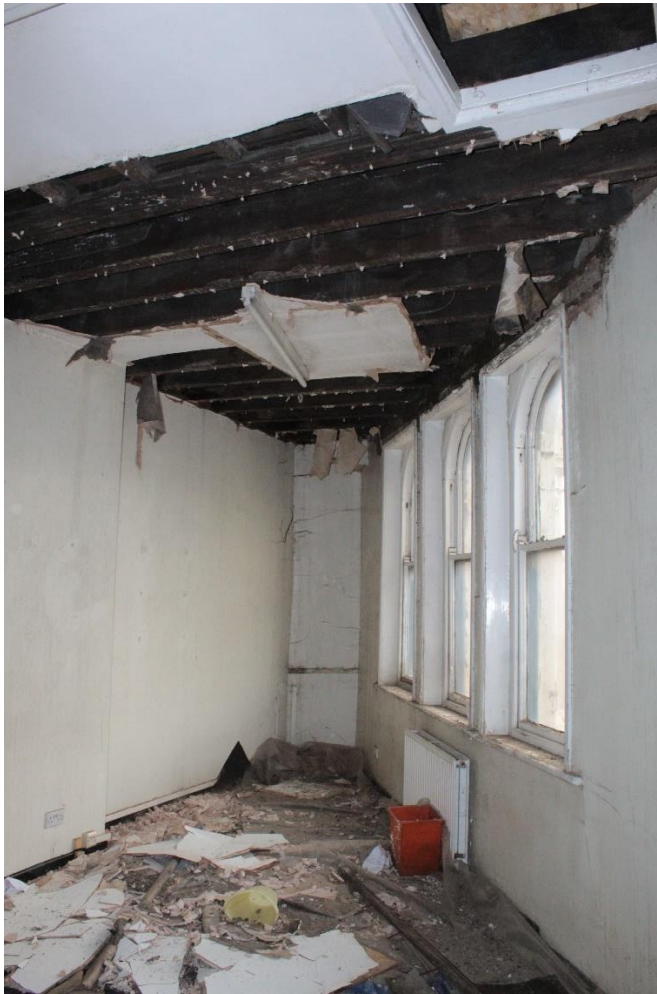
2.1.12 Internally the full extent of damage caused by recent failure of the flat roof covering (now replaced by the synthetic rubber membrane) is evident, the entire lath and plaster ceiling having collapsed (**Fig. 13**).

Fig 13. The collapsed ceiling under the flat roofed section of the central block.

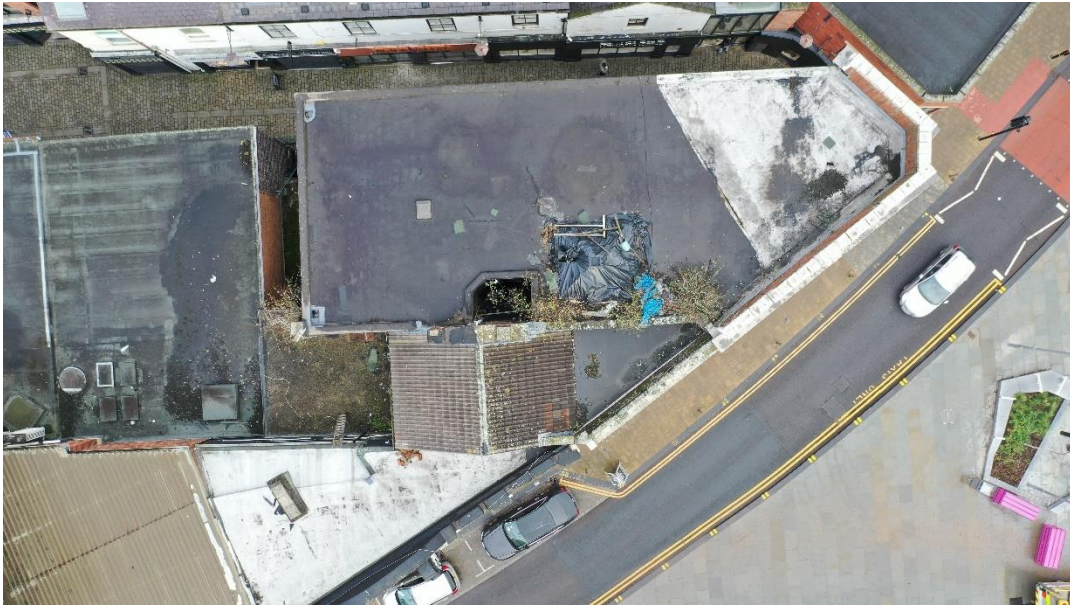
2.1.13 **The easternmost block** (36 & 38 Eldon Street and 39 & 41 The Arcade): The flat roofed block containing no's 36 & 38 Eldon Street and no's 39 & 41 The Arcade (**Fig. 14**) is finished with black bitumen/asphalt which has substantially cracked (the cracks have weeds growing in them) and there are widespread patch repairs with green bitumen-based roofing felt indicating failure of the material. At the eastern end of the roof an area has been finished with 'water-proof' paint. In places the roof covering has been damaged and there are patch repairs and creep visible.

2.1.14 Along the upstand/abutment with the parapet the junction between the two has been finished with Flashband, indicating potential leakage. Again, this is not a long-term solution and should be replaced with a more robust and appropriate material.

2.1.15 There are buddleia's and other vegetation growing along the parapet at the abutment with the central block, along the southern side of the glazed lantern (this has been temporarily covered with black visqueen sheeting) indicating long term rainwater ponding and possibly standing water caused by a blocked outlet. The

Fig 14. The roof of all three Haral Building roofs (the flat roof of the block containing no's 36 & 38 Eldon Street and no's 39 & 41 The Arcade is the large flat roof top and central).

vegetation and debris should be cleared to allow the condition of the roof covering to be fully inspected.

- 2.1.17 This entire flat roof should be stripped, the substrate inspected and repaired with like for like and the roof covering replaced with a more effective long-term material which needs to be robustly flashed along all parapets and abutments in the correct manner

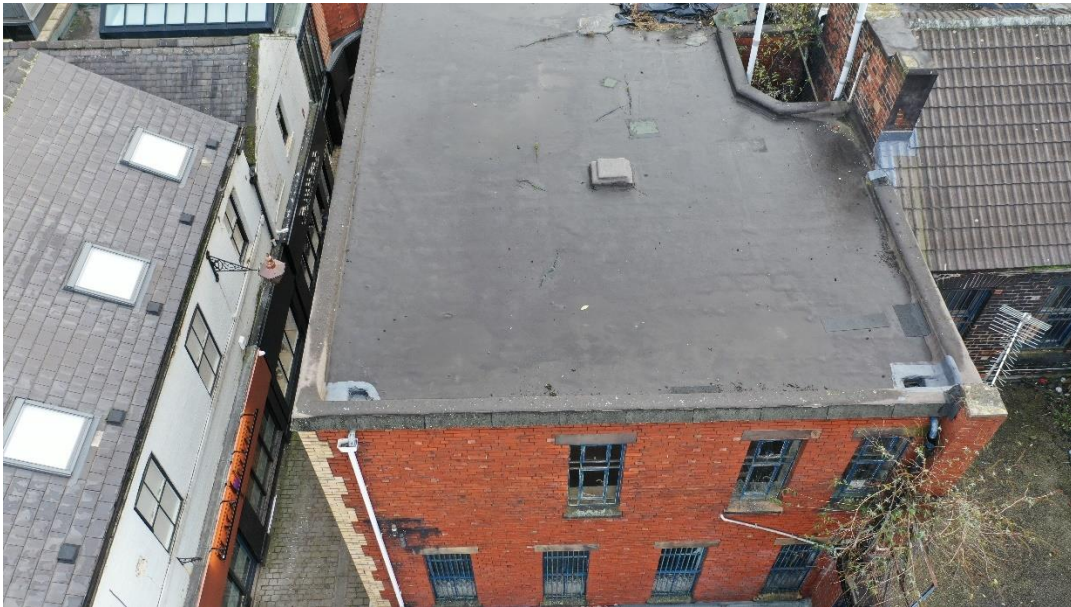
- 2.1.16 There are repairs visible around the two outlets at the western end of the roof (**Fig. 15**), again indicating possible leaks. The LH hopper and downpipe have been replaced with white PVC-u alternatives but the RH cast-iron hopper and downpipe appear to be cracked/corroded as there is substantial vegetation growing in the brickwork or on the window cills corresponding with the uppermost section of downpipe. The cast-iron hopper and downpipe should be replaced with like for like.

Fig 15. The roof above 39 & 41 The Arcade. Note the fresh paint around the outlets and the quantity of cracks in the bitumen/asphalt roof covering (taken by drone from the west).

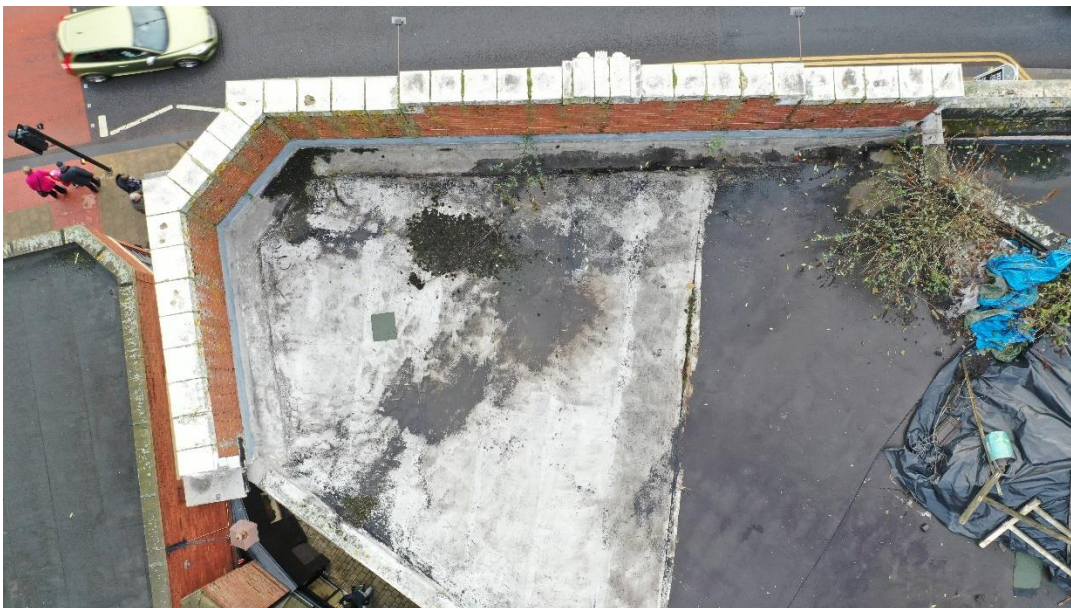
- 2.1.18 The parapets throughout this block do not have lead flashings (**Fig. 16**) and this is allowing rainwater to wash the mortar from the joints and has the potential to enter the wall core and damage the faience infill. There is vegetation growing the joints of the blocks forming the parapet and areas of pitting visible indicating over-saturation and failure of the tops of the blocks. Long term rainwater ingress in this way will cause frost damage as the face of the faience blocks crack or the protective glaze delaminates. A cover flashing should be incorporated to all parapets and pediments following repair of the pitting using small white glazed terracotta tiles (use a specialist terracotta and faience manufacturer to establish an exact match).

- 2.1.19 There appears to be a parapet gutter around the perimeter of the flat roof at the corner of the building above no. 38 Eldon Street (**Fig. 16**) though the outlet

(presumably at the western end – top right of the picture - of the Eldon Street run) is not visible on the drone photographs. Presumably, judging by the vegetation and buddleia's growing in this area, the outlet is blocked.

Fig 16. The roof above 38 Eldon Street. Note the lack of a flashing along the faience parapet and the presence of vegetation and pitting (taken by drone from the north – looking towards Eldon Street).

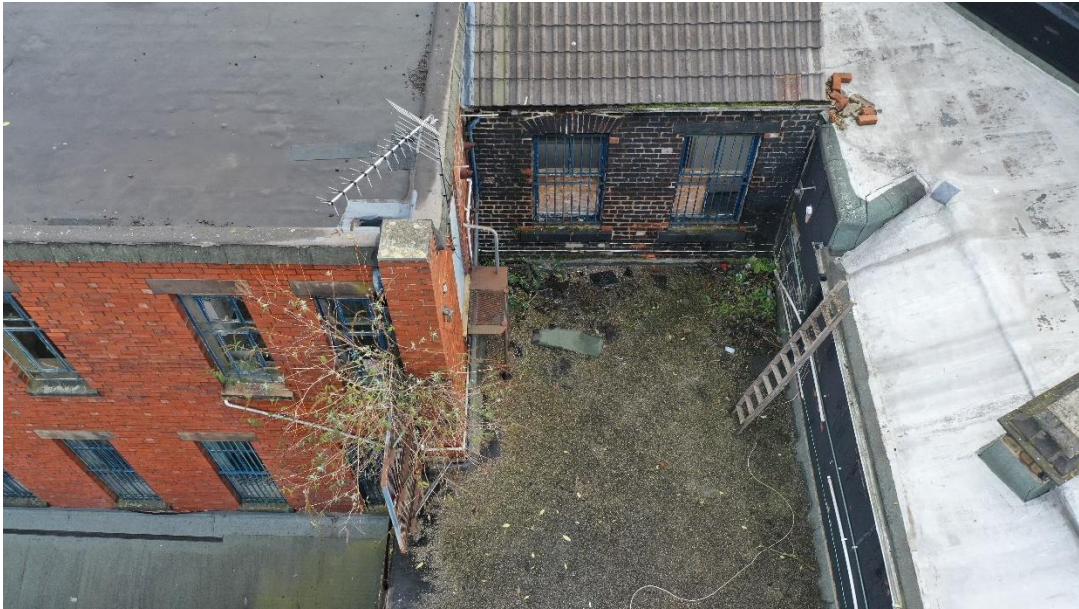
2.1.20 **The flat roofed extensions** (within the former yard): The flat roof of the two-storey extension (**Fig. 17**) is finished with a black bitumen-based roofing felt. Where the downpipe from the roof of no. 32 Eldon Street empties onto this flat roof the

aggregate (which protects the bitumen material from UV damage) has been washed away and there is widespread build-up of moss, algae and vegetation indicating long-term ponding caused by either an undersized or blocked outlet or an inadequately constructed substrate (i.e. the substrate is not laid to an adequate fall towards the outlet).

Fig 17. The flat roof of the two-storey extension within the former yard.

- 2.1.21 There is damage visible to the underlying bitumen material in other areas where rainwater goods are leaking. The roof covering has reached the end of its life and should be stripped and replaced with a more appropriate and robust flat roofing material.

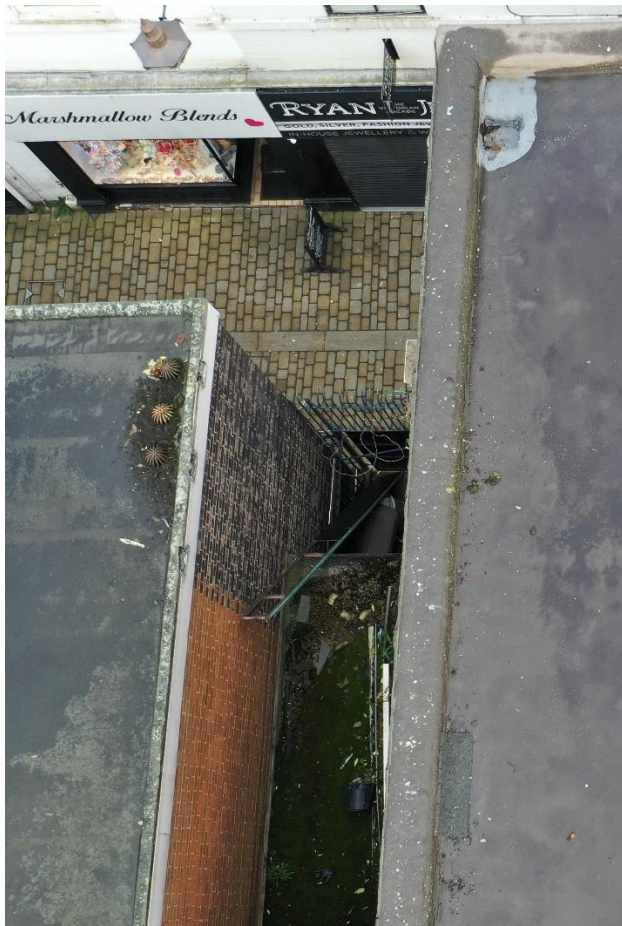
Fig 18. *The flat roof of the single storey extension within the former yard.*

- 2.1.22 The roof of the single storey extension (**Fig. 18**) (containing a small kitchen serving the café at 39 The Arcade) is covered with a carpet of moss indicating long-term rainwater ponding or standing water with inadequate or undersized outlets. Given the downpipes and outlets from the back of all the roofs empty onto these two extension roofs, there is a substantial capacity of water that needs to be accommodated as the water makes its way to the ground.

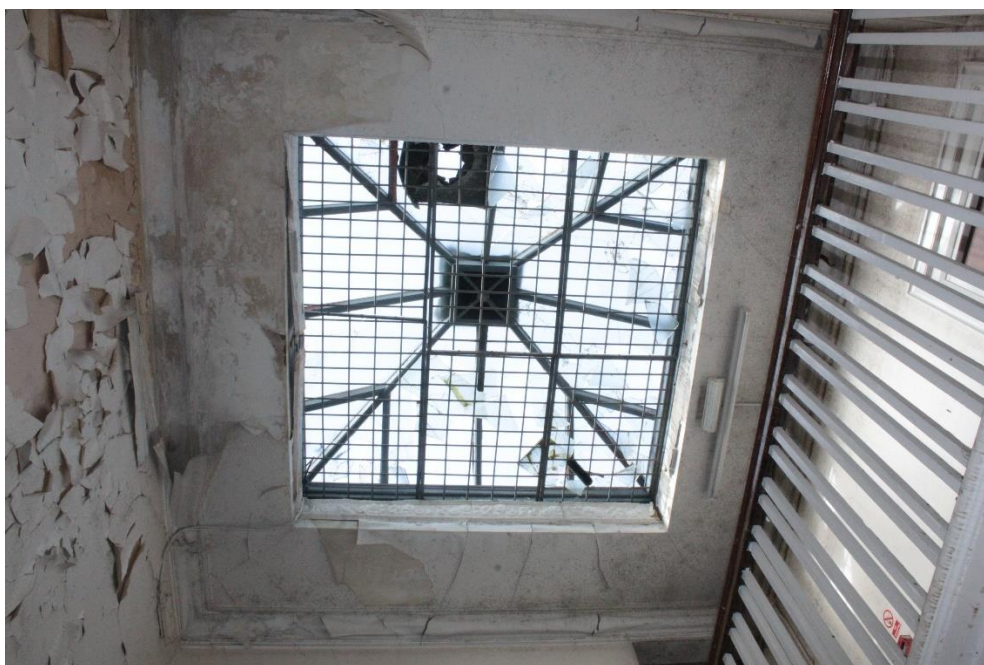
- 2.1.25 Internally there is evidence of long-term rainwater ingress (**Fig. 19**) which is manifest in flaking paint and friable plaster, and cracked panes (caused by vandals on the roof) have allowed pigeons to enter the building.

Fig 19. *The damaged glazed lantern over the internal stair well.*

2.1.27 The lantern glazing bars, cap and seals are to be repaired/replaced (using like for like) along with any rot or damage to the upstand at the base of the lantern where it meets the flat roof. The cracked/broken panes of Georgian wired glass are to be replaced with like for like.

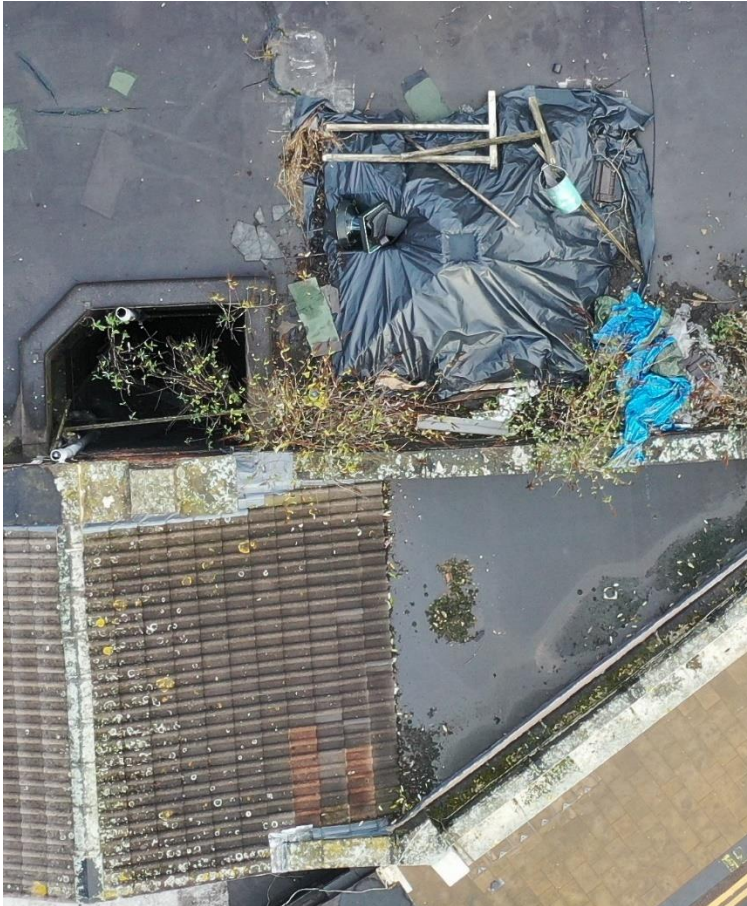
- 2.1.26 Since **Fig. 19** was taken, the lantern has been temporarily covered with black visqueen sheeting (**Fig. 20**).

Fig 20. The glazed lantern has been temporarily covered with black visqueen sheeting.

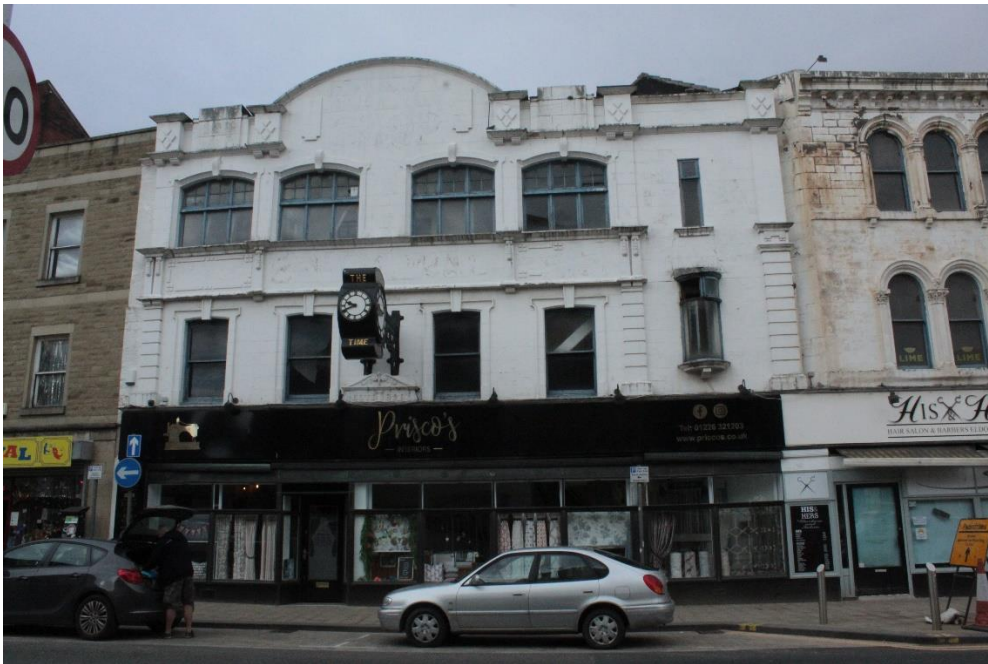
with a white modern masonry paint and this is compromising the ability of the faience to naturally evaporate and regulate moisture (**Fig. 21**).

- 2.2.3 The reasoning behind the paint application is likely to be an attempt to regulate the frontage when the raised Harral lettering and swags were ground flush with the face of the adjoining blocks. This single act has compromised the fire glaze of the faience blocks, allowing rainwater to enter the core of the block and the subsequent potential to cause expansion of the fill material. There is no apparent blowing of the surface of the blocks visible, however, once safe access has been erected and the paint finish removed, the condition of the blocks can be more closely inspected.

Fig 21. The Eldon Street frontage of no. 32 at the western end of the Harral Buildings.

- 2.2.14 The repair strategy, therefore, is (once a scaffold has been erected) to carefully removed the modern masonry paint (using a Doff steam-based system or poultice) to allow the condition of the damaged faience blocks to be fully assessed. It will be essential to minimize the quantity of water during the paint removal to reduce the potential of encouraging corrosion of any metal anchors or expansion of the fill material (often clinker was used and this material is particularly susceptible to expansion in the presence of moisture).

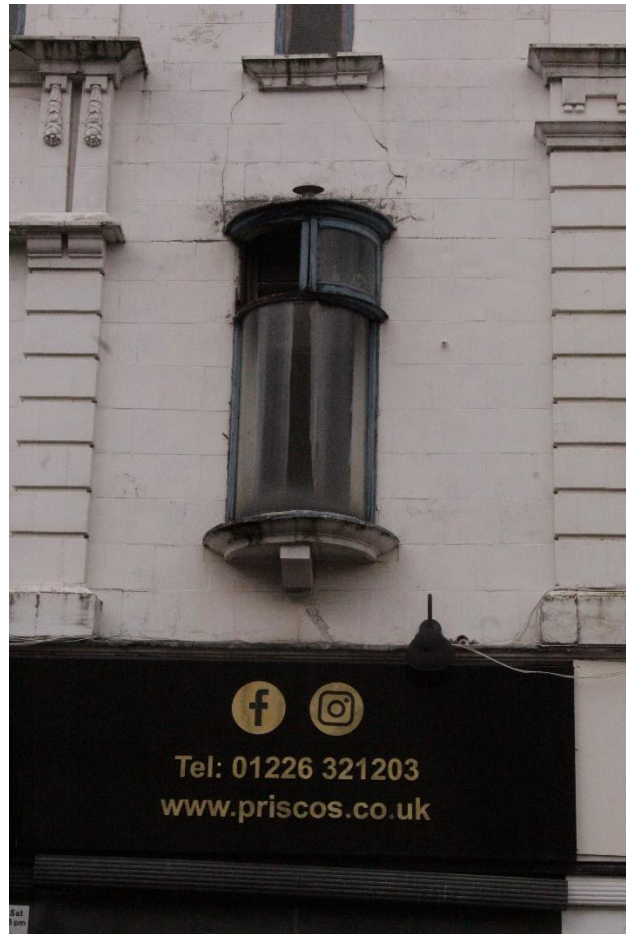
- 2.2.18 The final area of concern is on the eastern bay of this block, between the narrow first and second floor windows (**Fig. 23**) where two vertical cracks are visible. Further

investigations will be necessary to ascertain the source of the movement/moisture, however, it may be necessary to cut out and replace the associated blocks if tile repairs are not practical or would compromise the weathertightness of the blocks.

Fig 23. The cracked faience blocks between the narrow first and second floor windows.

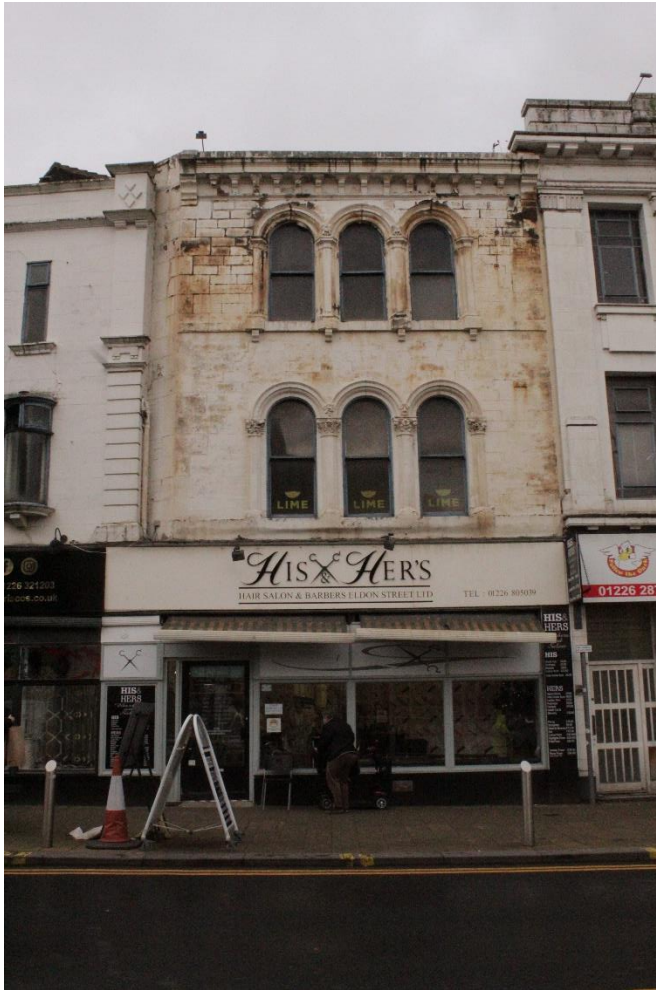
- 2.2.19 **The central block (34 Eldon Street):** As mentioned in the general description, this block is constructed in coursed sandstone with quoins, cill bands, a dentiled and bracketed cornice and semi-circular headed triple windows to the first and second floors (**Fig. 24**). The masonry has been painted with white masonry paint which is trapping moisture and causing over-saturation of the stonework. There is extensive brown staining where moisture is present, and this paint should be carefully removed (using a Doff steam-based or poultice system) as a matter of urgency to allow the stonework to dry out.

Fig 24. The Eldon Street frontage of no. 34 in the centre of the Herral Building.

- 2.2.21 The high moisture levels in the masonry are most likely caused by failure of the flat roof covering along the back of the cornice described previously (refer to **Fig's 12 & 13**) or by blocked outlets causing long-term standing water or ponding which has breached the cover flashing at the abutment.

- 2.2.22 The staining along the top of the cornice is the result of lack of an adequate flashing incorporating drips to help shed rainwater away from the masonry beneath.

whether the lime render should be re-applied or the stonework re-pointed and left exposed.

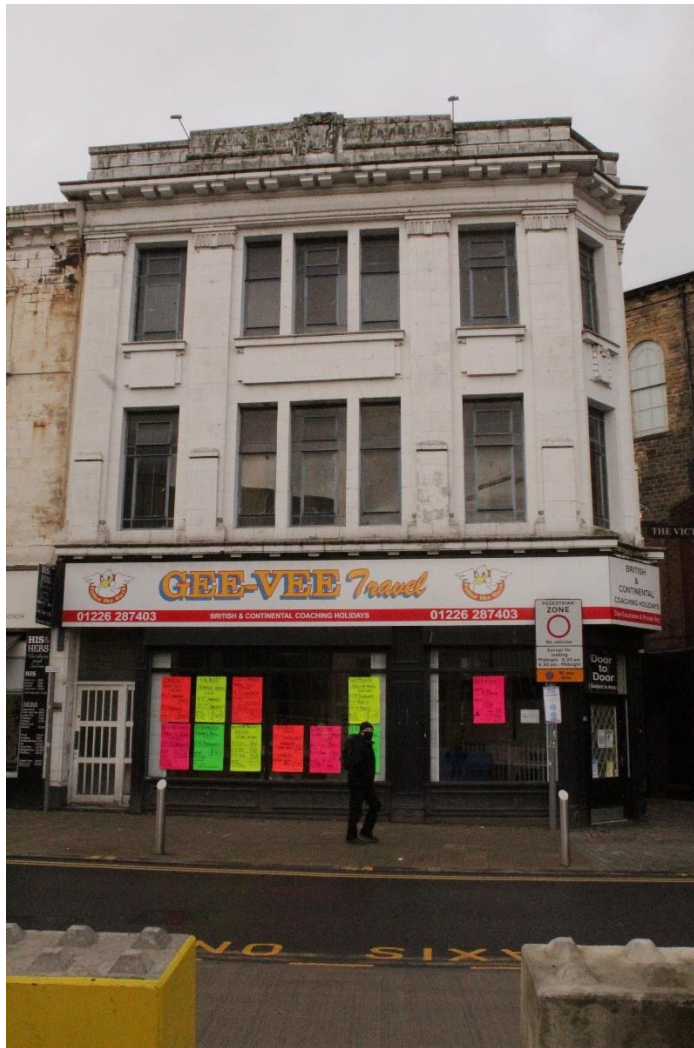
2.2.26 The faience looks to be in reasonable general condition, though along the shopfront cornice there is moss and algae visible and evidence of peeling paint in some areas where the faience has been overpainted with white masonry paint. Again, this is to be carefully removed (using a Doff steam-based or poultice system) to allow the condition of the faience to be fully inspected.

Fig 25. The Eldon Street frontage of no. 36-38 at the eastern end of the Herral Building.

2.2.27 There are two vertical cracks visible on the third of the giant pilasters from the LHS which appear to extend the full height of the second storey. There also appear to be indents or holes in the centre top of all four giant pilasters and this may be the result of signage or lighting fixings which have then allowed rainwater to breach the fire glaze and caused expansion of the fill which has led to the cracking aforementioned.

- 2.2.29 There is extensive moss and algae along the parapet and pediment and dark staining in the joints between the faience blocks caused by lack of a lead flashing which has allowed rainwater to run into the joints and down the face of the blocks. Once the moss and algae have been cleaned off (using a PH neutral soap and stiff bristled brush) the condition of the parapet and pediment blocks can be fully inspected.

2.2.28 Once safe access has been erected and the masonry paint removed, the condition of the faience can be more accurately assessed and a detailed repair schedule

prepared, however, a reasonable assessment/allowance has been made at this stage to allow the works to be tendered to enable a realistic budget to be set aside for the specialist repair/replacement.

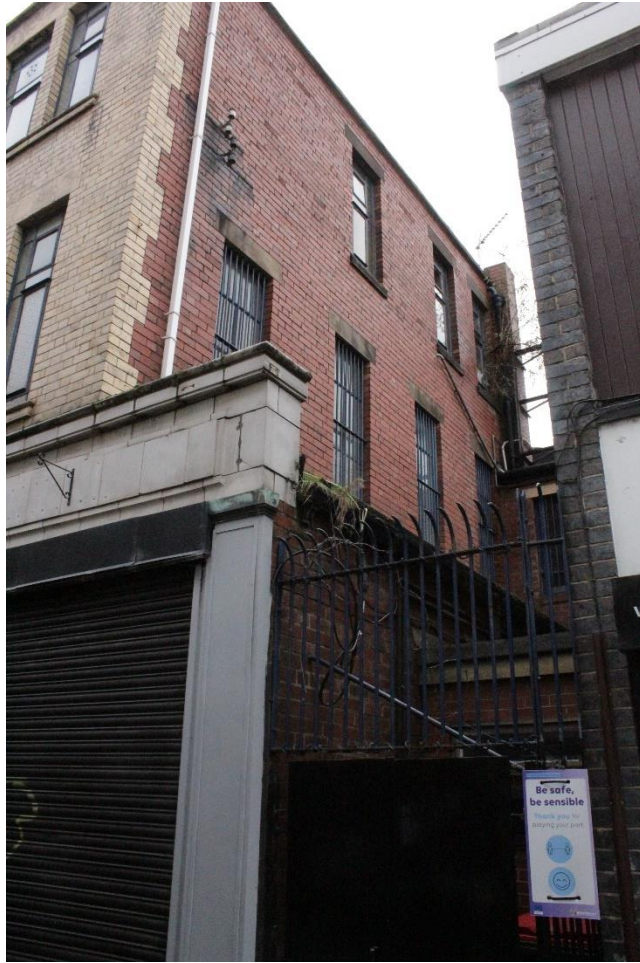
- 2.2.34 **Elevations facing the former yard:** The elevation of the easternmost block facing the former yard is constructed in smooth-faced red brick (*Fig. 26*). As mentioned previously the RH hopper and downpipe (in the internal corner formed by the chimney stack) are broken/corroded and have been causing rainwater to shed down the brickwork causing vegetation, moss and algae growth. Once the rainwater goods have been replaced, the vegetation removed and the brickwork allowed to dry out, any missing mortar can be attended to and any frost damaged bricks cut out and replaced with like for like.

Fig 26. The western gable of the easternmost block (facing up The Arcade)

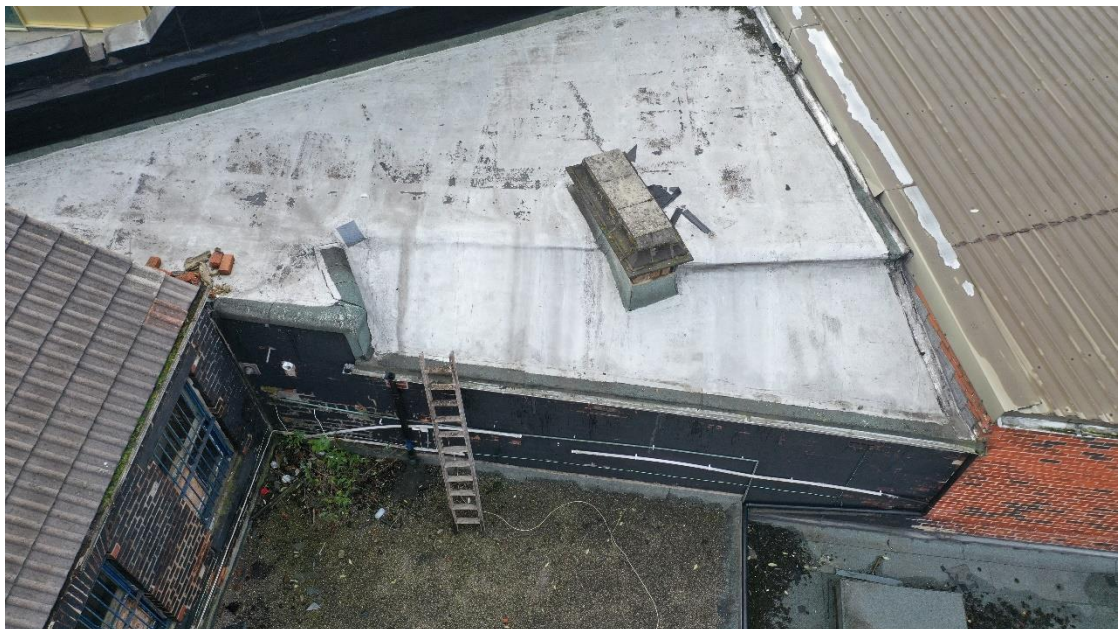
- 2.2.35 The rear elevations of the no. 32 and no. 34 blocks (*Fig. 27*) are again constructed in smooth-faced red brick, but these have been finished with black masonry paint. Carefully remove the black masonry paint (using a Doff steam-based or poultice system) to allow the condition of the brickwork to be fully inspected. Allow to re-point these elevations entirely using a hot mixed quicklime mortar.

Fig 27. The rear elevations of no. 32 and no. 34 blocks which have been painted with black masonry paint.

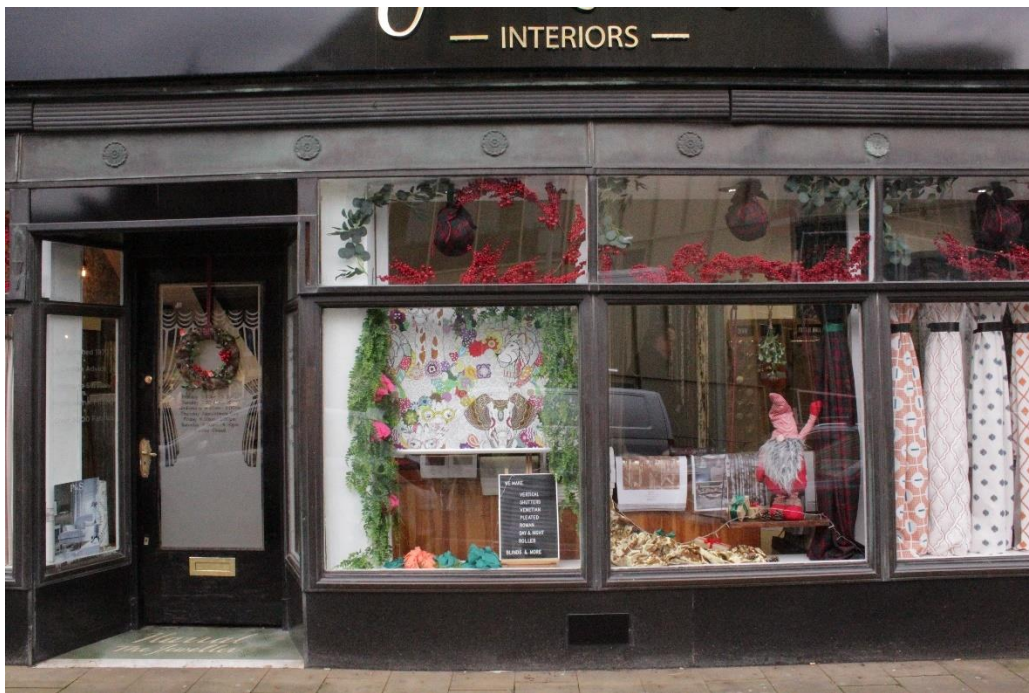
- 2.3.2 **Westernmost block** (32 Eldon Street): The bronze 1950s shopfront has been the subject of structural investigations due to the substantial undulation visible to the windows on the RHS of the entrance into Prisco's (**Fig. 28**). The opening up confirmed the movement was not caused by structural failure of the underlying steel beams and columns supporting the masonry above the shopfront but were most likely damage caused by a vehicle mounting the pavement.

Fig 28. Distortion of the bronze window to the RHS of the Prisco's entrance (32 Eldon Street).

- 2.3.3 The solution proposed is to incorporate a steel transom (universal I section or C channel) along the line of the bottom of the clerestory which will be bolted to the steel columns at either end. This will provide support for the shopfront mullions/transoms and help arrest any further deflection.

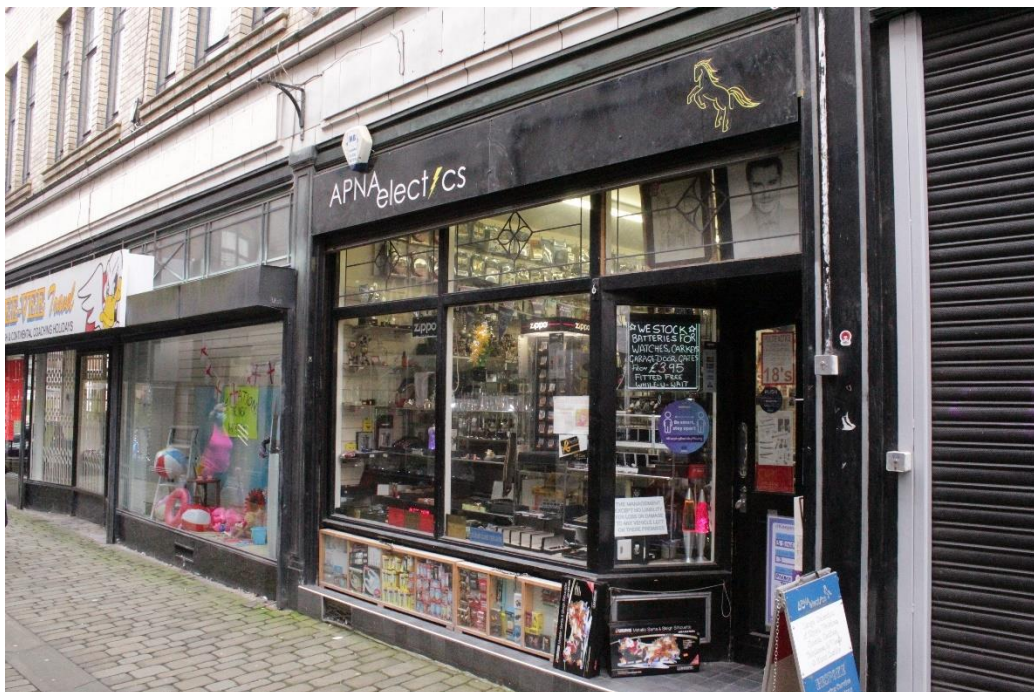
2.3.19 Along the Arcade elevation the historic bronze framed shopfront (back of no. 36-38) with its black granite stall riser and decorative clerestory has been retained (**Fig. 29**). This is to be brought back to full working order and the missing bronze elements along the clerestory reinstated with like for like.

Fig 29. The historic bronze shopfront (far left) on the back of no. 36-38 and the bronze clad pilaster between this shopfront and that of no. 41 The Arcade which is a modern softwood replacement.

2.3.20 The modern shopfront to no. 41 The Arcade is to be replaced with a bronze shopfront that matches the existing historic shopfront to no. 39 The Arcade, with a central single recessed door, black granite stall riser, symmetrical bronze shop windows set at a slight angle from the line of the street and mosaic/terrazzo threshold to match those to the no. 39 and no. 32 entrances.

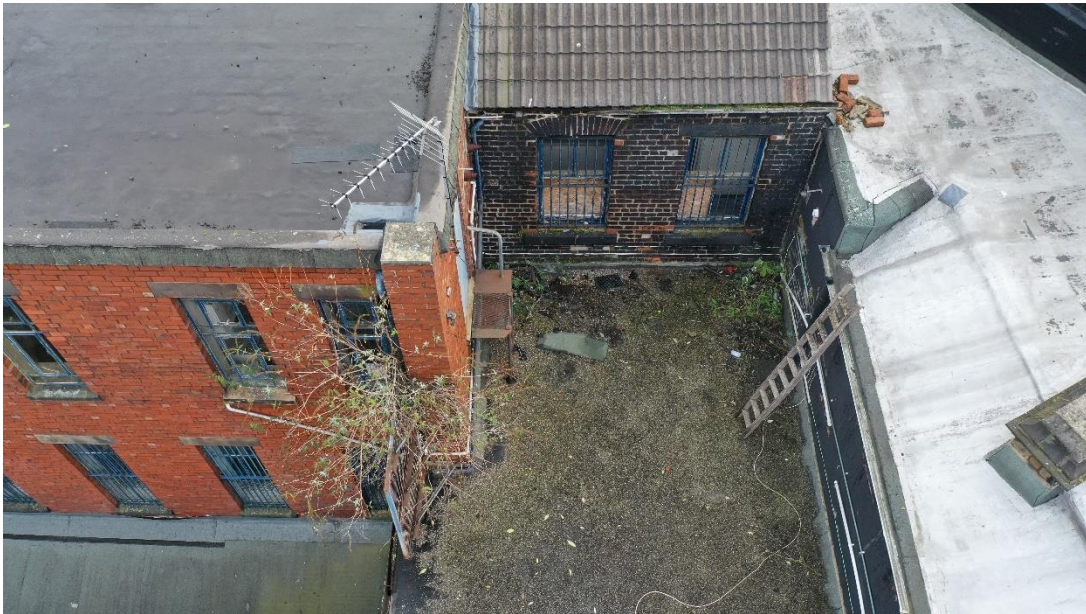
2.3.29 The rear elevation of the no. 34 block (**Fig. 29**) has 2 no. 2-over-2 timber sliding sashes which have been damaged by vandals and are in a poor condition. They are to be replaced with new painted hardwood 2-over-2 sliding sashes.

Fig 29. *The rear elevation of the no. 34 block.*
