**STRUCTURAL
CONDITION SURVEY
AT
EASTFIELD FARM
EASTFIELD LANE
THURGOLAND**

**DATE : SEPTEMBER 2012
REF : 1427/DRH/WARHURST**

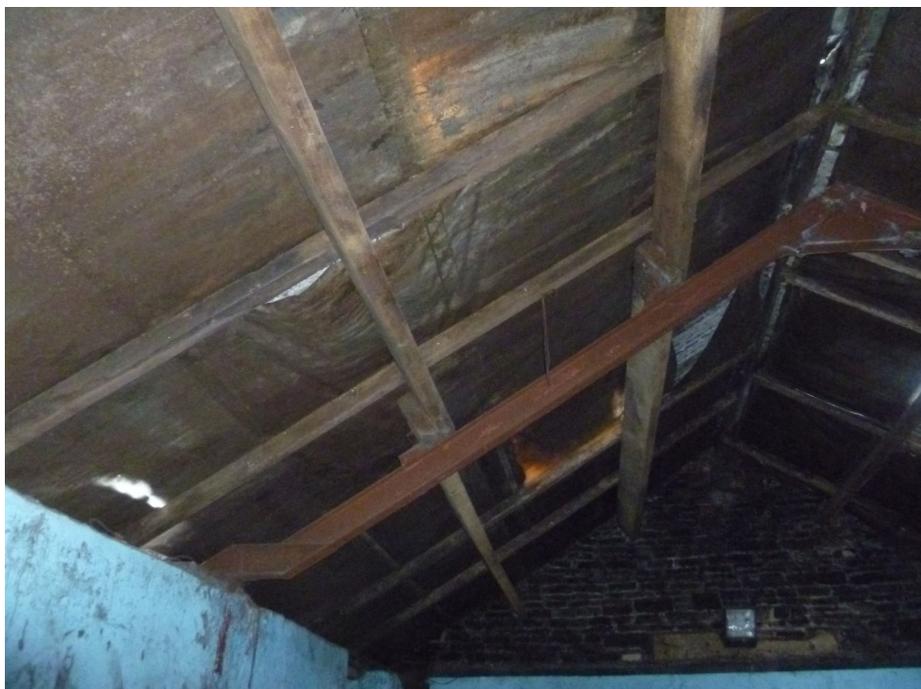
At one location the purlins are supported on steel rafters instead of a king post truss (See photo 1). These steel rafters are corroded and also appear to be undersized if the roof covering is to be changed to tiles/slates. It is thought that these steel rafters will be removed and changed to a king post truss to match.

PHOTO 1 (STEEL RAFTER FRAME TO BARN 1)

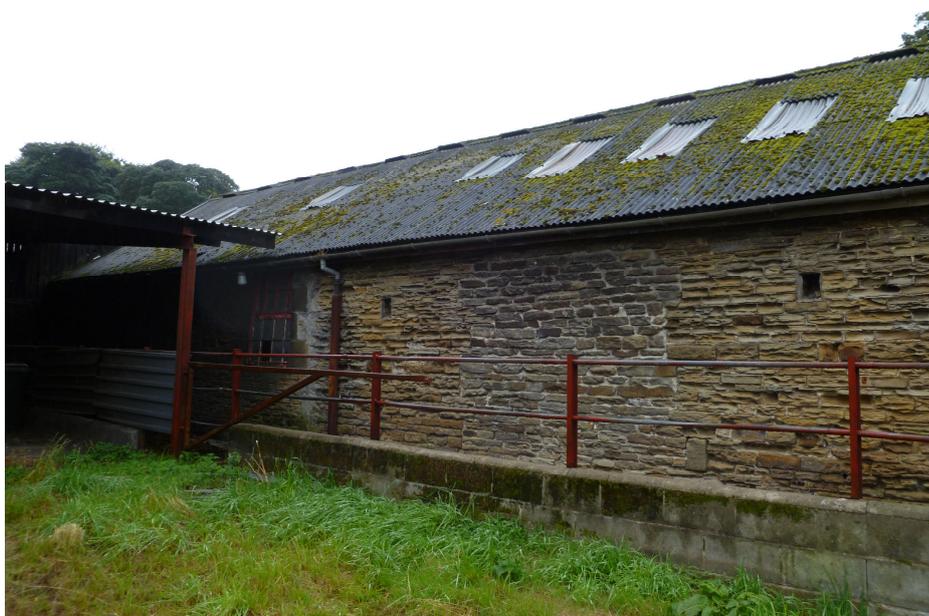
In certain areas the stone is heavily weathered and will need to be partially rebuilt (See photos 2 and 3). The mortar is also worn and will need to be repointed throughout.

PHOTO 2 (WEATHERED STONE TO BARN 1 SOUTH EAST ELEVATION)

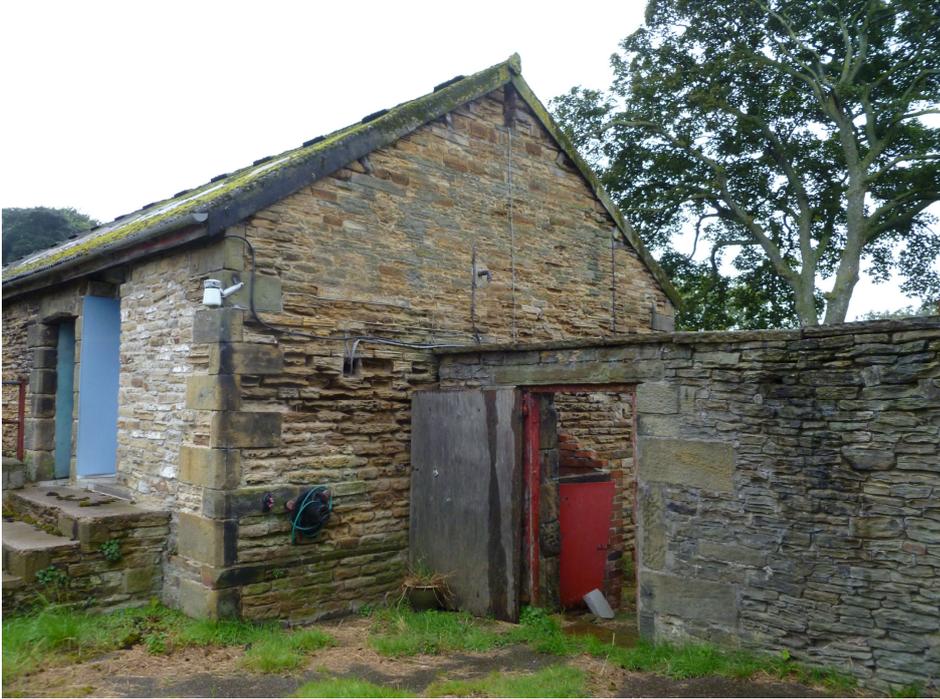
PHOTO 3 (WEATHERED STONE TO BARN 1 NORTH EAST ELEVATION)

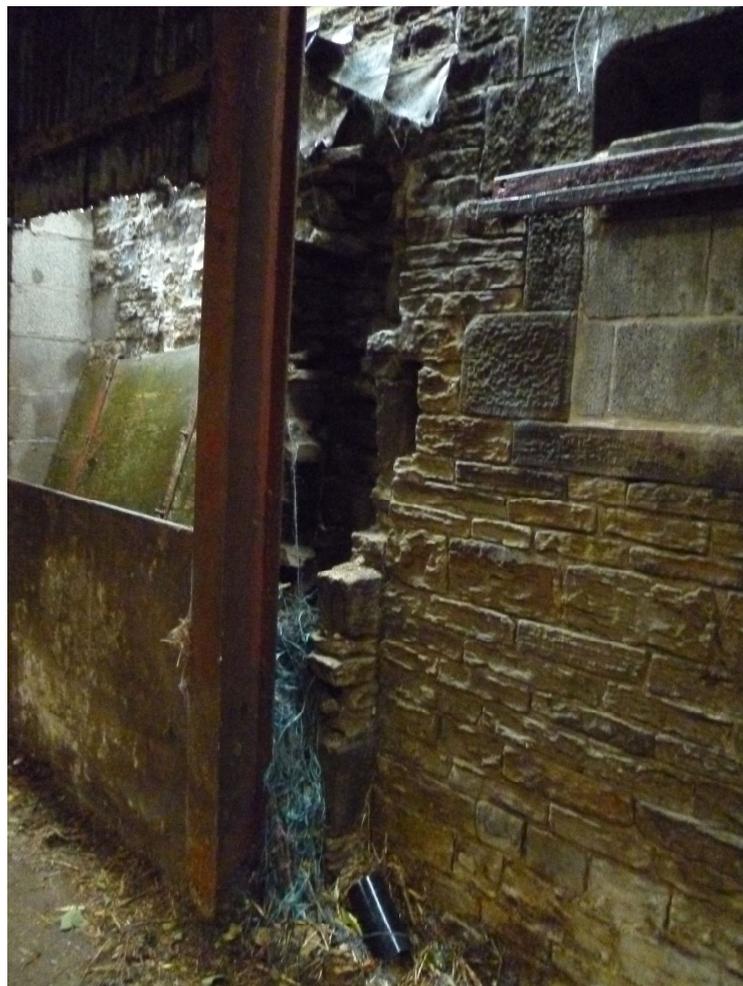
A section of stone is missing to the south western gable wall (See photo 4). This will need to be rebuilt.

PHOTO 4 (MISSING STONE TO BARN 1 SOUTH WEST ELEVATION)

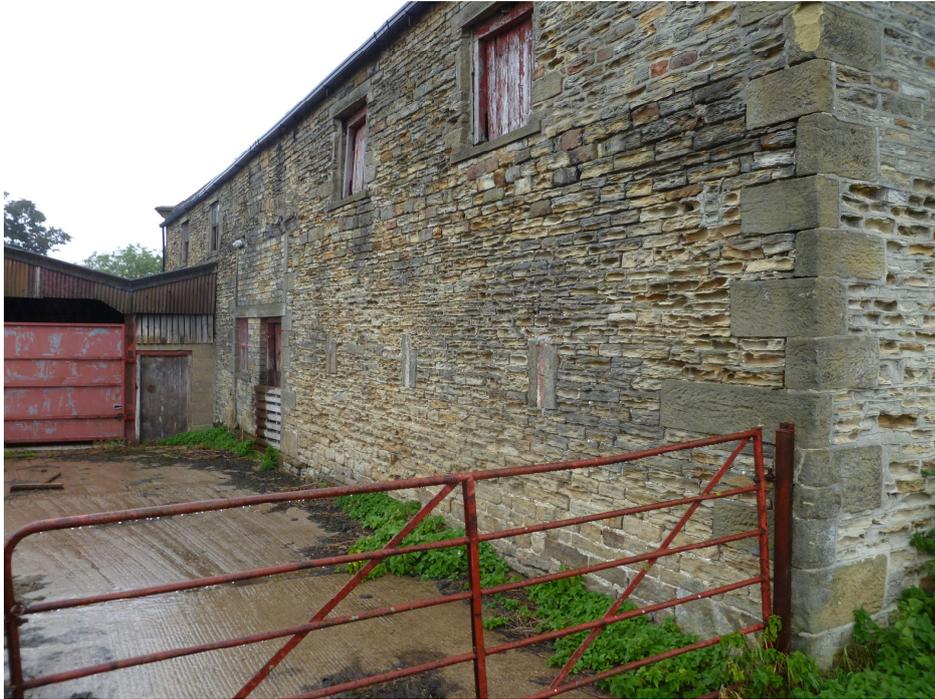
In certain areas the stone is heavily weathered and will need to be partially rebuilt (See photos 5, 6 & 7 and 8). The mortar is also worn and will need to be repointed throughout.

PHOTO 5 (WEATHERED STONE TO BARN 2 SOUTH WEST ELEVATION)

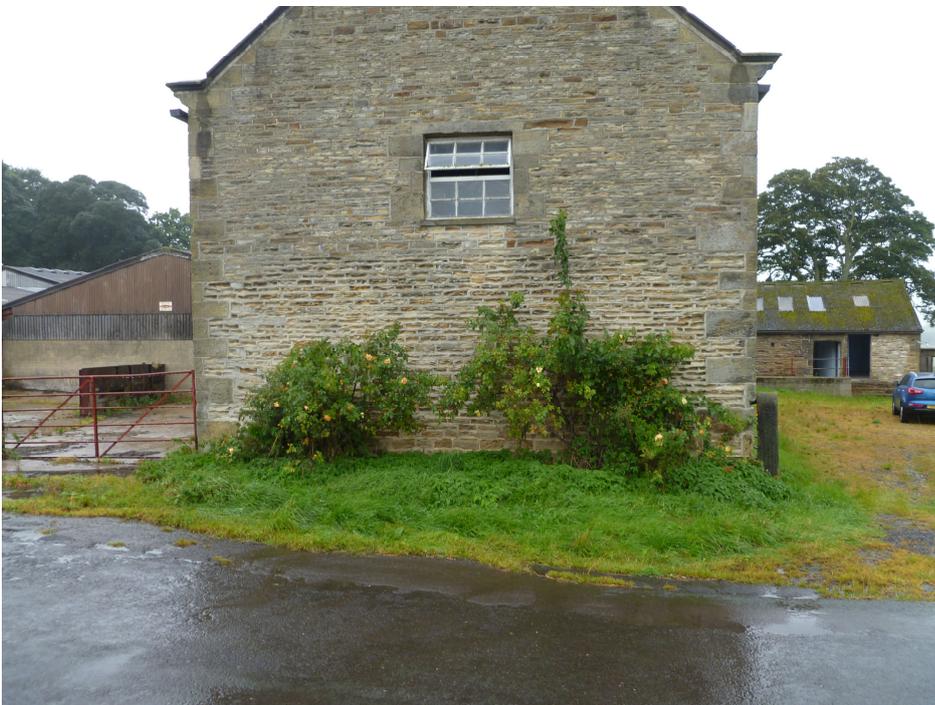
PHOTO 6 (WEATHERED STONE TO BARN 2 SOUTH EAST ELEVATION)

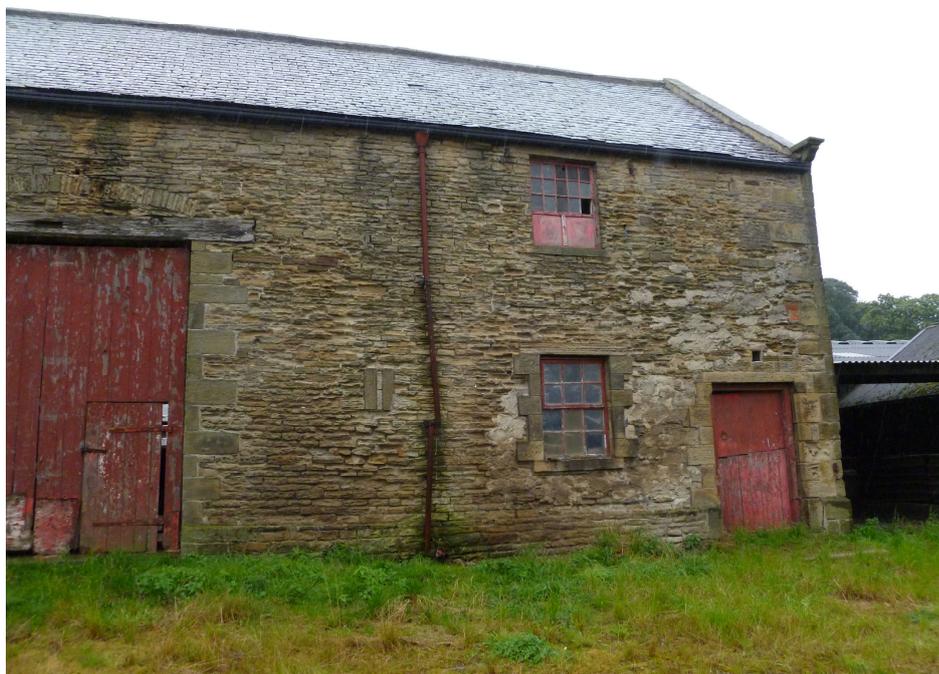
PHOTO 7 (WEATHERED STONE TO BARN 2 NORTH EAST ELEVATION)

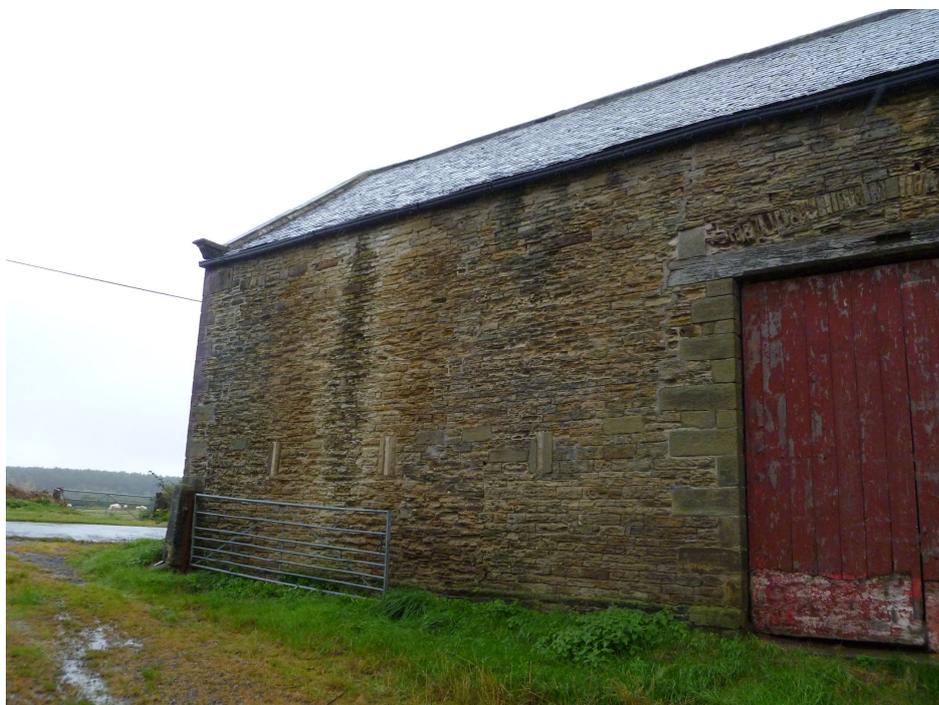
PHOTO 8 (WEATHERED STONE TO NORTH EAST ELEVATION)
