# **ADOPTED HIGHWAY DELAPIDATION SURVEY REPORT**

Development Name: Land off Calver Close, Dodworth and Smithywood Lane, Dodworth

Date of Survey: 2<sup>nd</sup> October 2024

Report Completed 10<sup>th</sup> October 2024

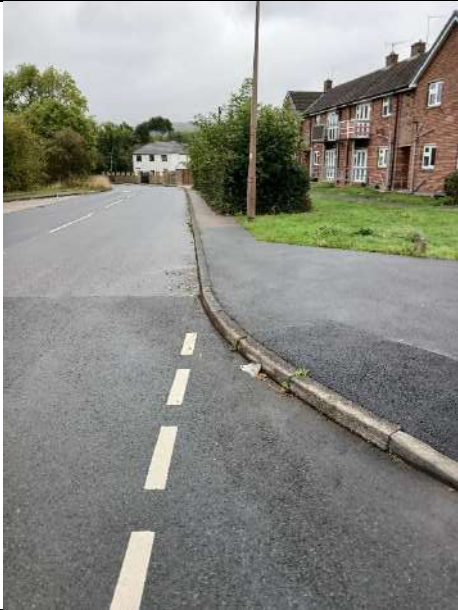
Photo 4  
Saville  
Road /  
Gilroyd  
Lane

Footpath scarring.

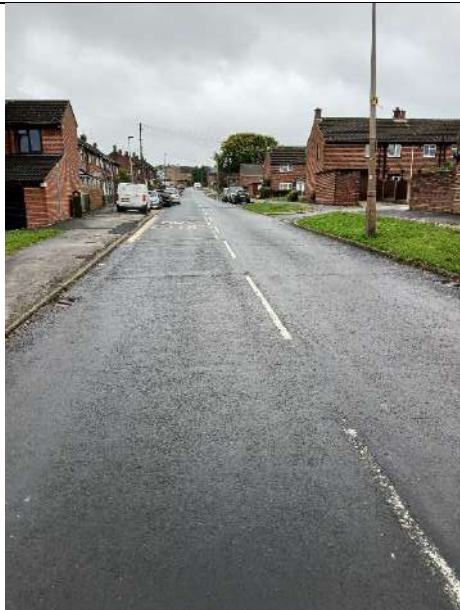
Photo 7  
Saville  
Road /  
Gilroyd  
Lane

Minor areas of surface course deterioration. Footway scarring.

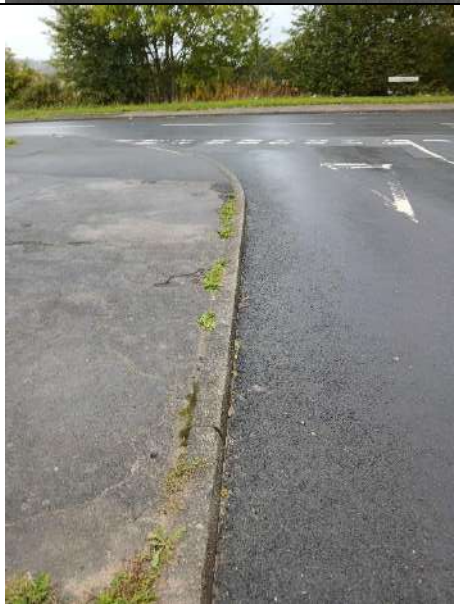
Photo 8  
Saville  
Road /  
Gilroyd  
Lane

Footway surface course deterioration.

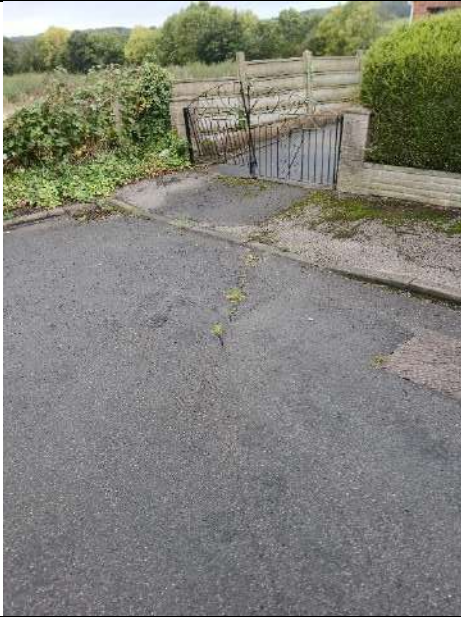
Photo 10  
Calver  
Close

Carriageway surface cracking (area proposed for resurfacing).

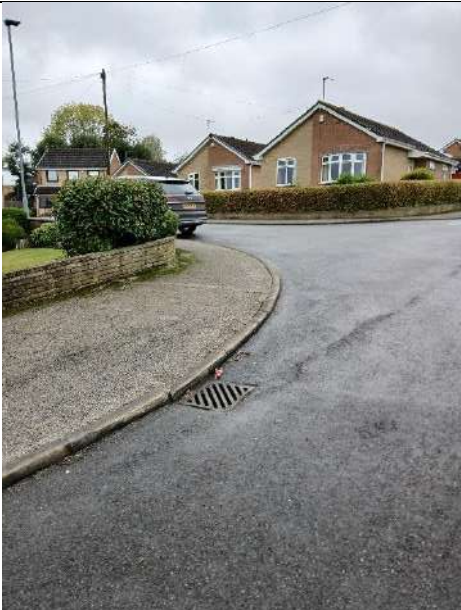
Photo 12  
Calver  
Close

Carriageway and footway surface course deterioration. Kerb damage.

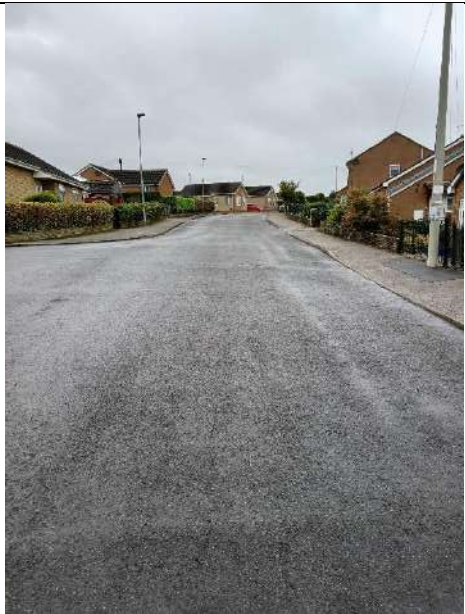
Photo 13  
Calver  
Close

Uneven carriageway levels.

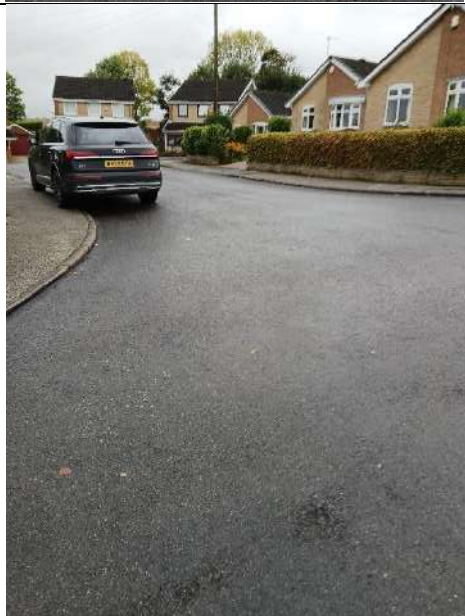
Photo 14  
Calver  
Close

Minor carriageway surface course damage.

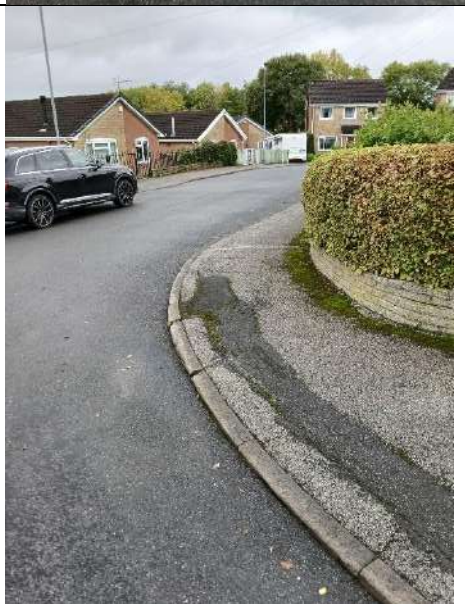
Photo 15  
Calver  
Close

Footway scarring and kerb damage.

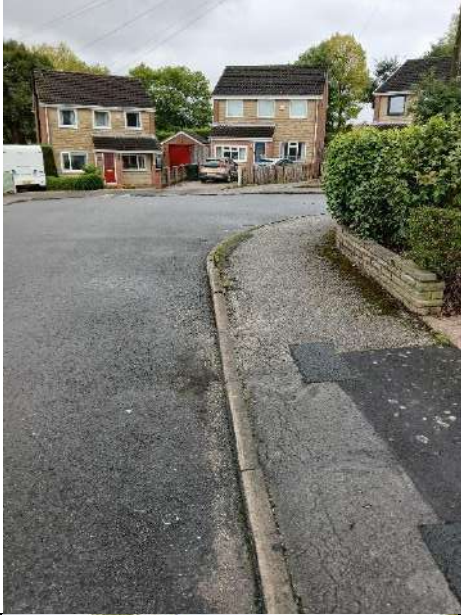
Photo 16  
Calver  
Close

Footway scarring, cracking and kerb damage.

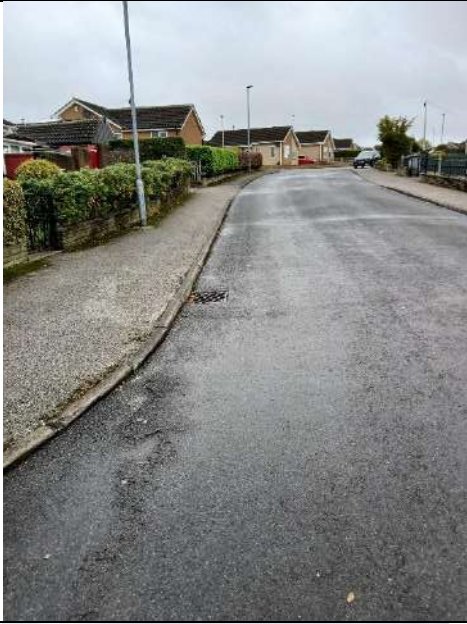
Photo 19  
Calver  
Close

Damaged kerbs. Carriageway surface course deterioration. Uneven levels.

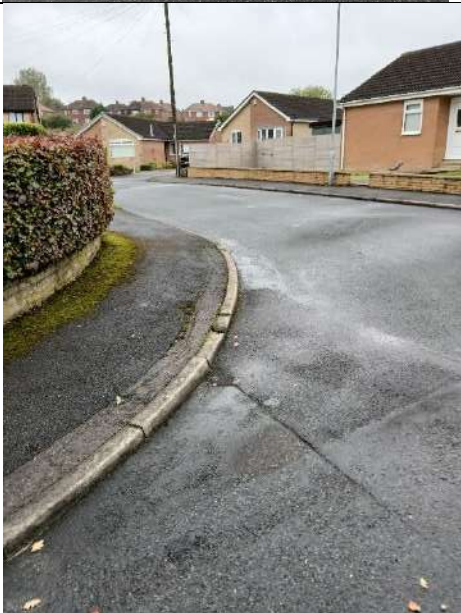
Photo 21  
Calver  
Close

Footway and carriageway scarring. Kerb damage.

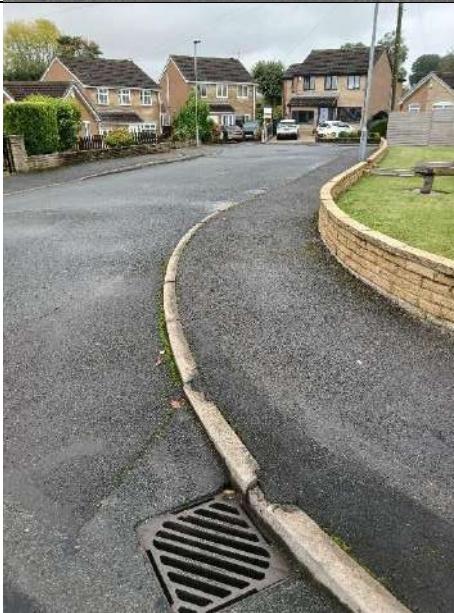
Photo 23  
Calver  
Close

Footway and carriageway scarring. Kerb damage.

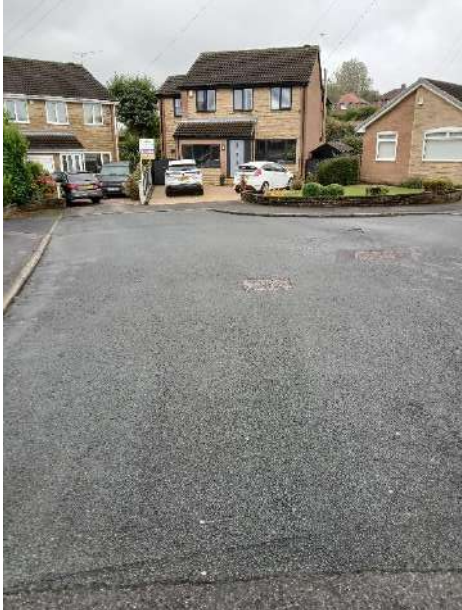
Photo 25  
Calver  
Close

Minor carriageway damage.

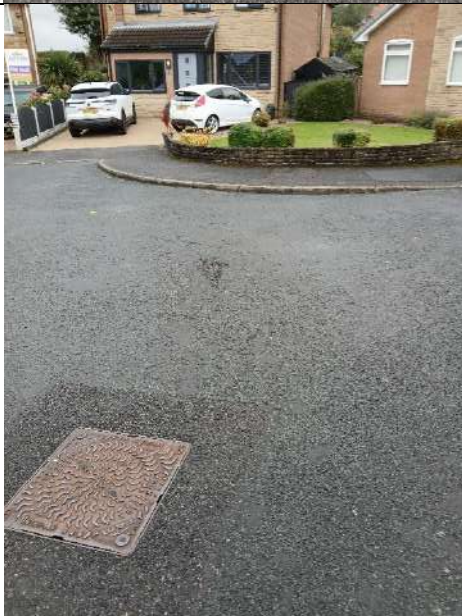
Photo 26  
Calver  
Close

Minor carriageway damage.

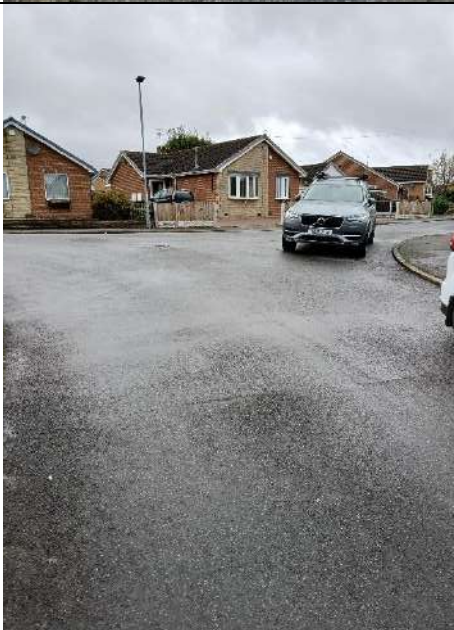
Photo 30  
Calver  
Close

Minor surface course damage.

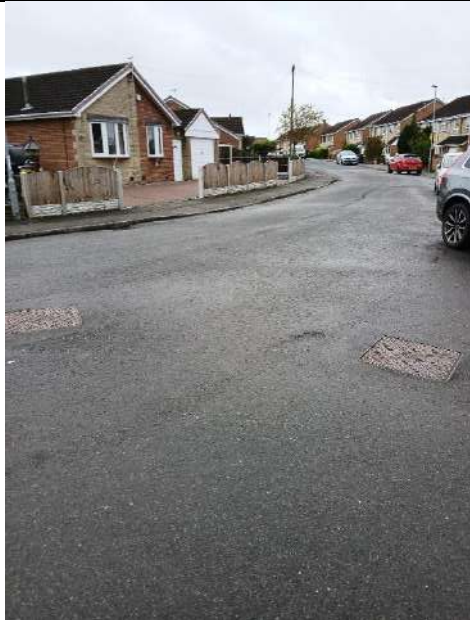
Photo 32  
Calver  
Close

Slight surface course damage. Uneven carriageway levels.

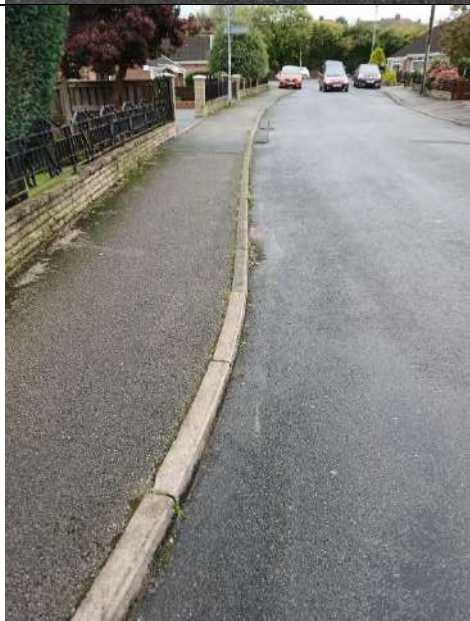
Photo 33  
Bradwell  
Avenue

Footway and carriageway scarring.

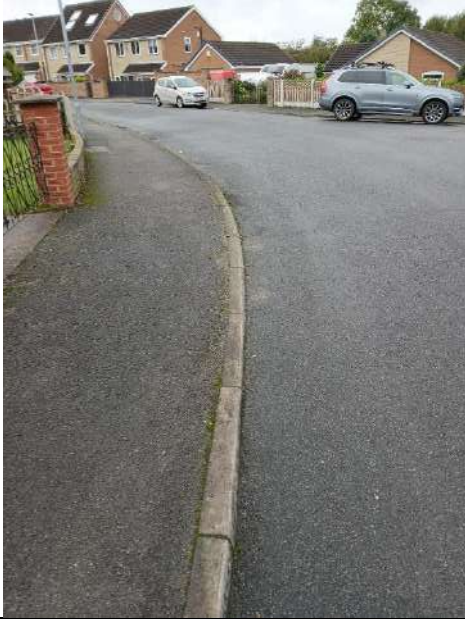
Photo 34  
Bradwell  
Avenue

Minor footway damage.

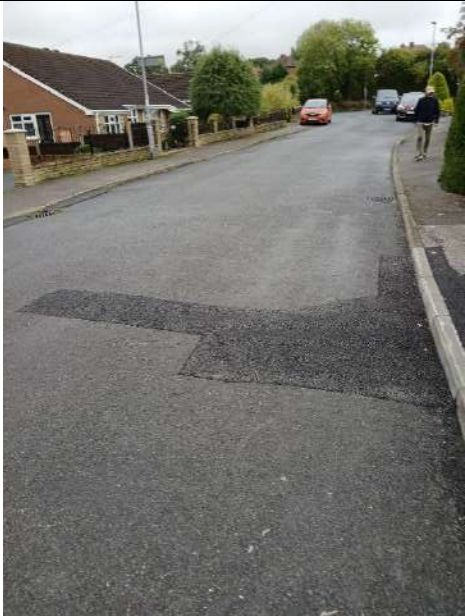
Photo 35  
Bradwell  
Avenue

Carriageway and footway scarring.

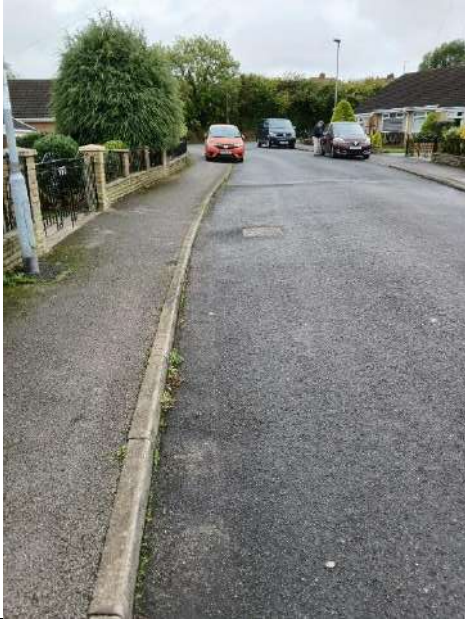
Photo 37  
Bradwell  
Avenue

Minor carriageway damage. Uneven carriageway surface.

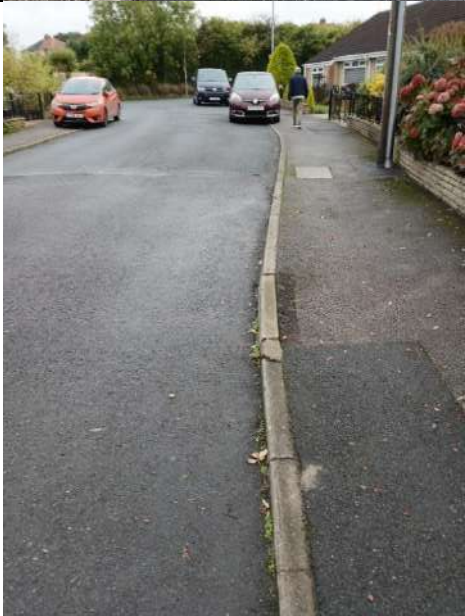
Photo 38  
Bradwell  
Avenue

Footway scarring. Kerb damage.

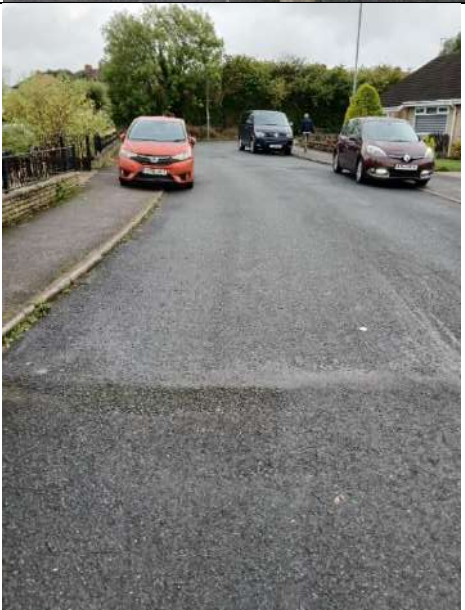
Photo 39  
Bradwell  
Avenue

Minor carriageway surface course damage.

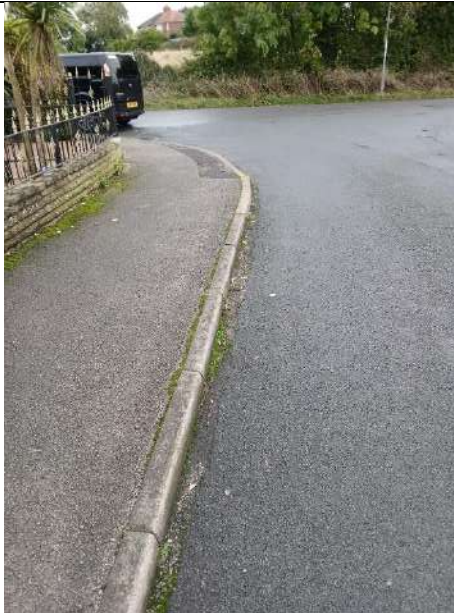
Photo 41  
Bradwell  
Avenue

Minor carriageway damage. Footway scarring.

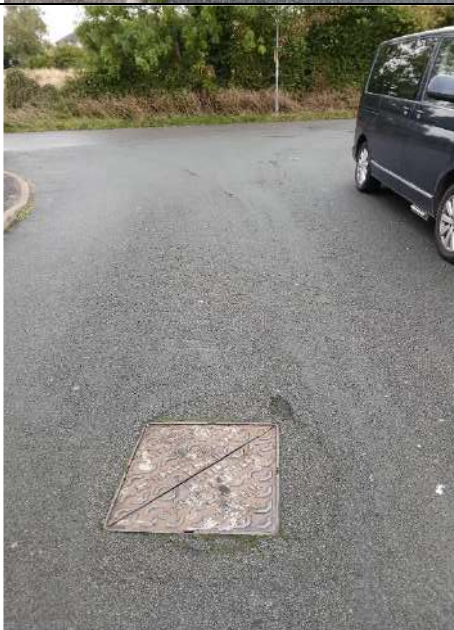
Photo 42  
Bradwell  
Avenue

Minor carriageway surface course damage.

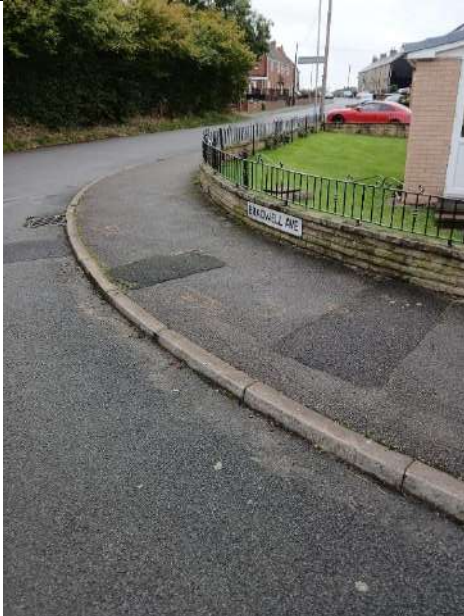
Photo 44  
Bradwell  
Avenue

Footway scarring, cracking. Kerb damage.

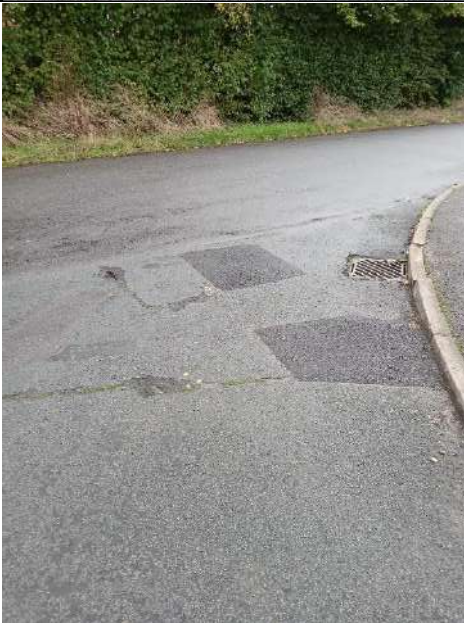
Photo 45  
Bradwell  
Avenue

Carriageway scarring, cracking, deterioration. Kerb damage.

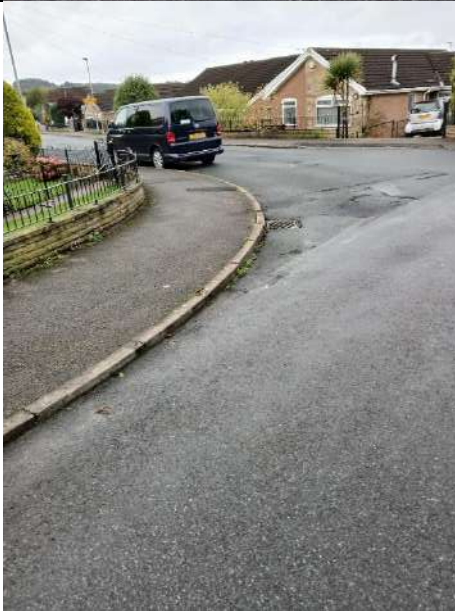
Photo 47  
Smithy  
Wood  
Lane

Carriageway scarring, cracking, deterioration. Kerb  
damage. Footway scarring.

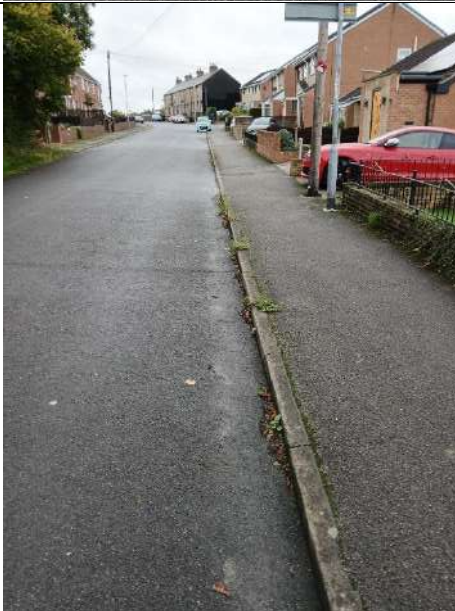
Photo 48  
Smithy  
Wood  
Lane

Minor carriageway damage.

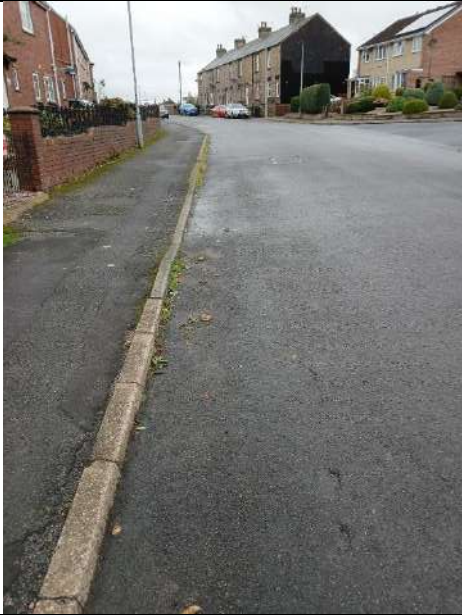
Photo 52  
Smithy  
Wood  
Lane

Kerb damage. Footway scarring. Minor carriageway damage to surface course.

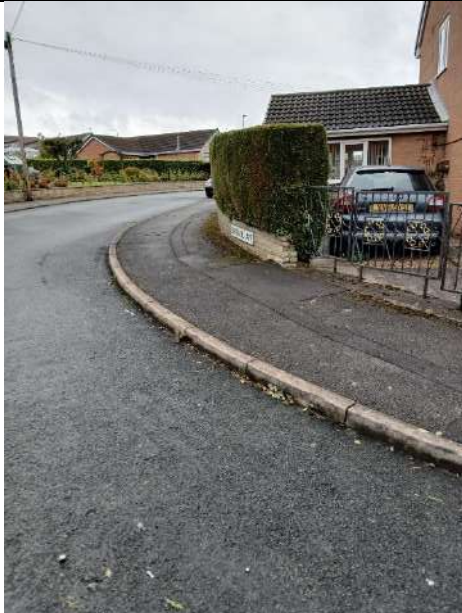
Photo 53  
Smithy  
Wood  
Lane

Footway scarring. Minor kerb damage.

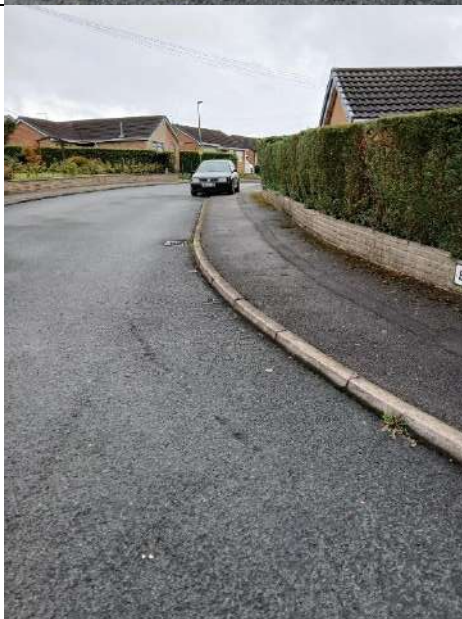
Photo 54  
Bradwell  
Avenue

Footway scarring. Minor carriageway surface course damage.

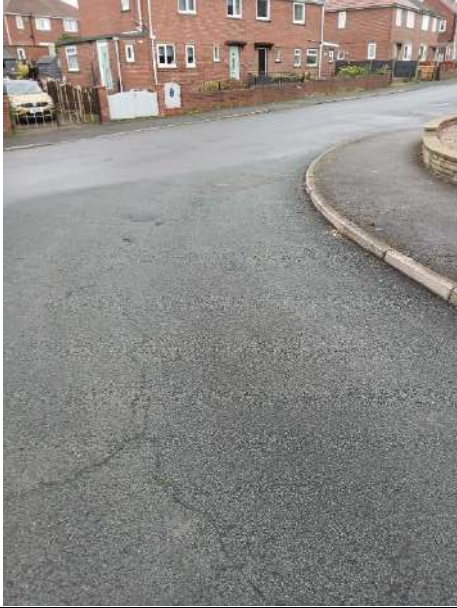
Photo 55  
Bradwell  
Avenue

Carriageway surface course deterioration. Scarring.  
Footway surface course damage.

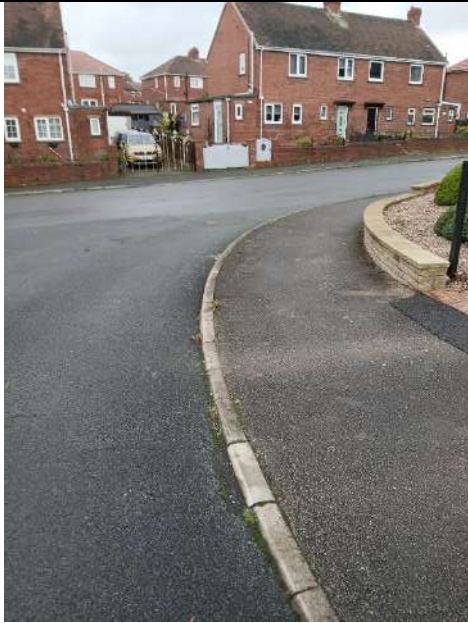
Photo 56  
Bradwell  
Avenue

Carriageway surface course deterioration. Scarring.  
Footway surface course damage.

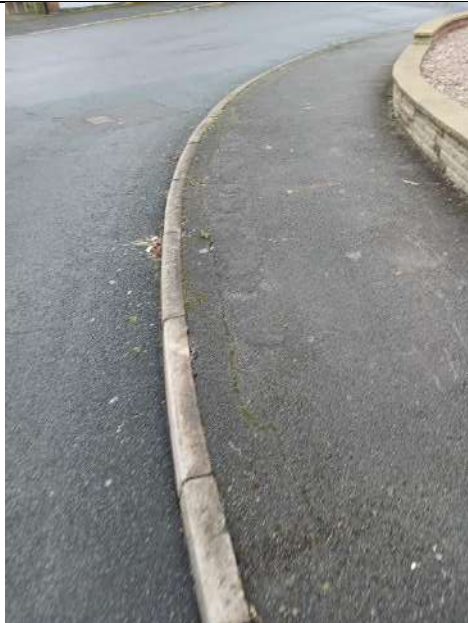
Photo 57  
Bradwell  
Avenue

Footway surface course damage.

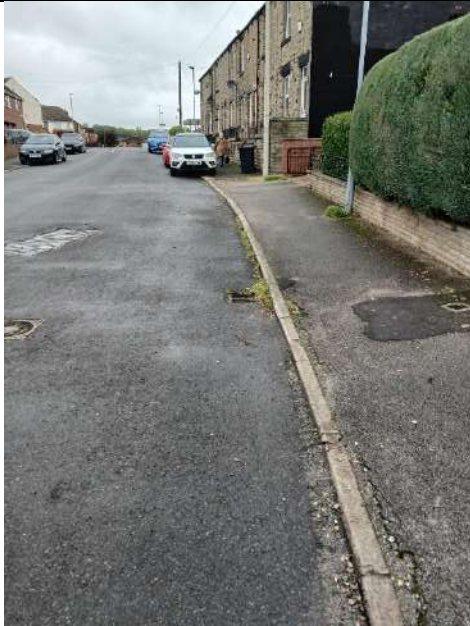
Photo 58  
Smithy  
Wood  
Lane

Carriageway and footway deterioration. Scarring.  
Kerb damage.

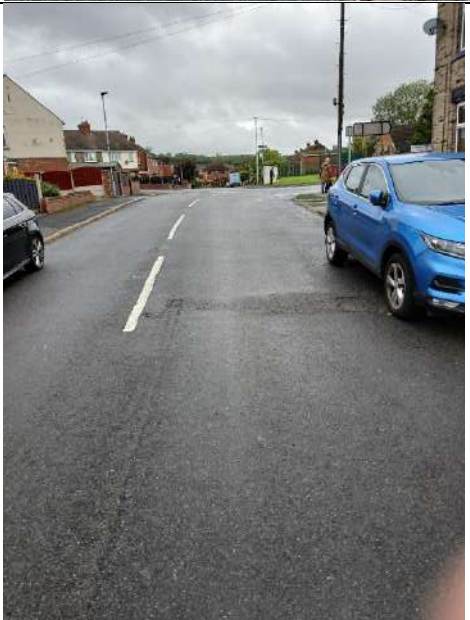
Photo 59  
Smithy  
Wood  
Lane

Carriageway surface course damage.

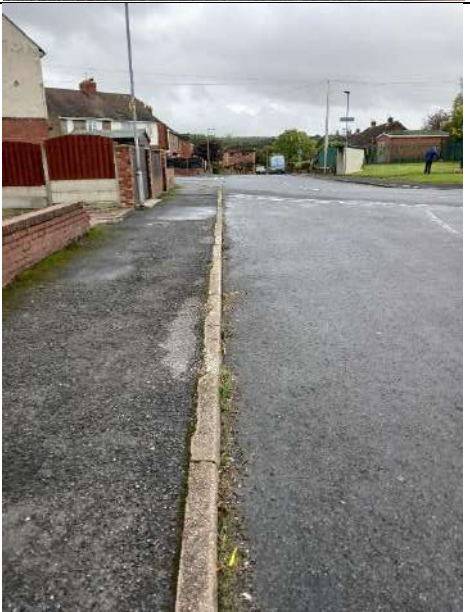
Photo 60  
Smithy  
Wood  
Lane

Kerb damage. Footway surface course deterioration.

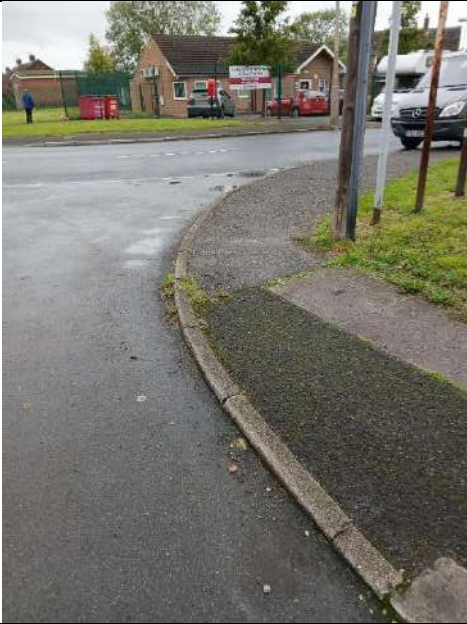
Photo 61  
Smithy  
Wood  
Lane

Footway scarring. Kerb damage.

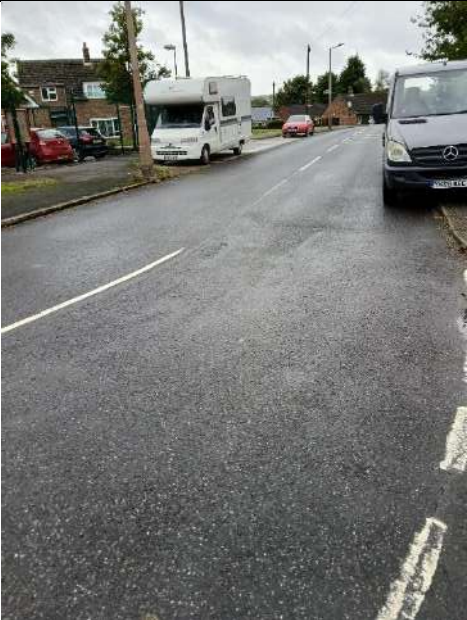
Photo 62  
Saville  
Road

Minor carriageway surface course damage.

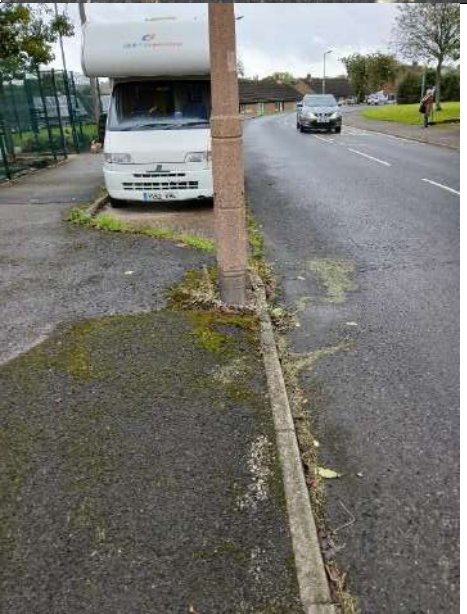
Photo 63  
Saville  
Road

Footway deterioration.

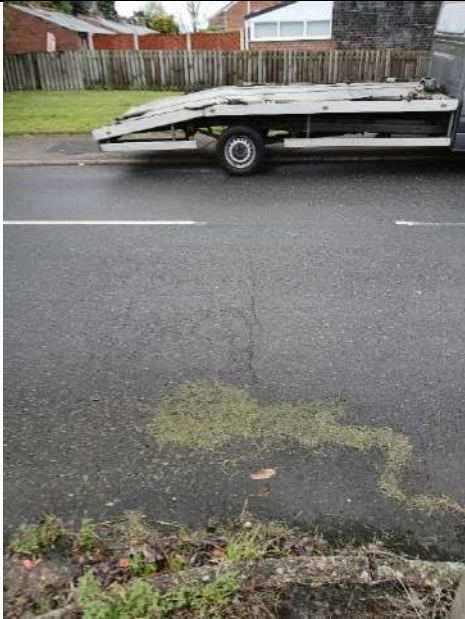
Photo 64  
Saville  
Road

Carriageway surface course cracking.

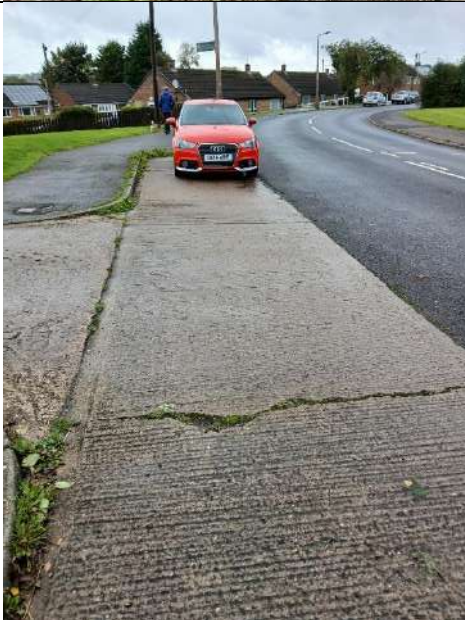
Photo 65  
Saville  
Road

Lay-by deterioration.

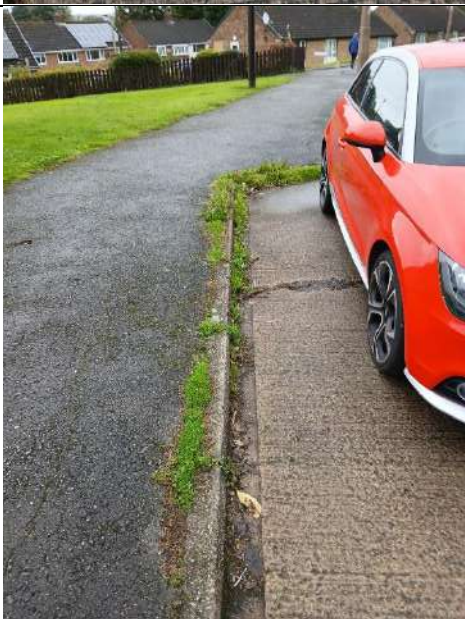
Photo 66  
Saville  
Road

Lay-by deterioration.

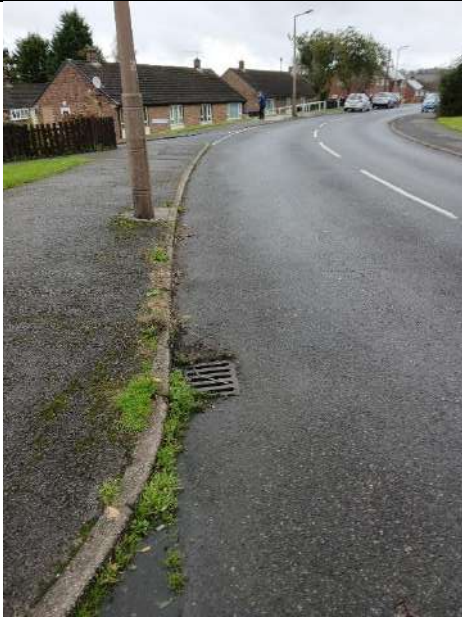
Photo 67  
Saville  
Road

Kerb damage.

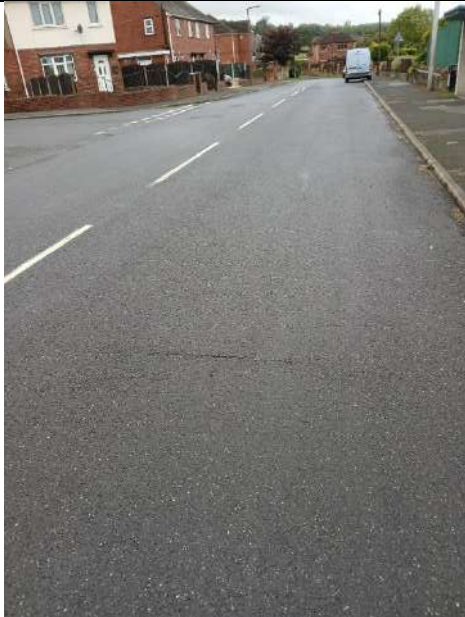
Photo 70  
Smithy  
Wood  
Lane

Minor carriageway surface course cracking. Footway scarring.

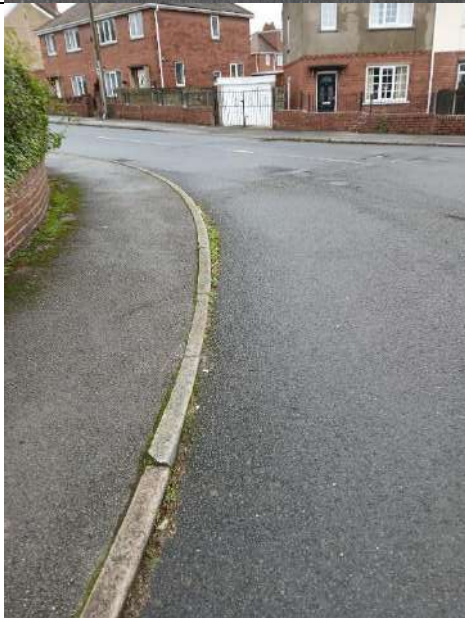
Photo 71  
Smithy  
Wood  
Lane

Kerb damage. Carriageway surface course damage.

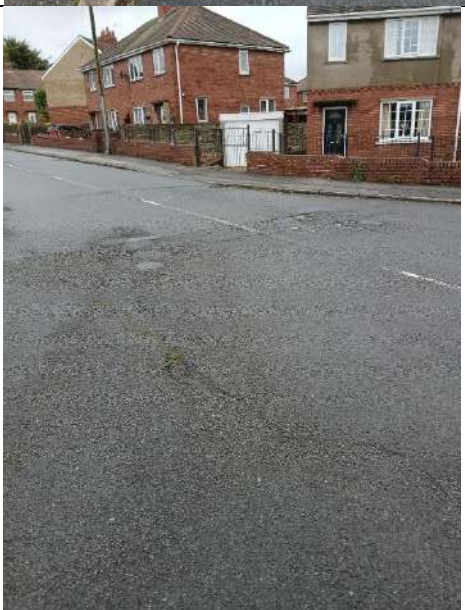
Photo 72  
Smithy  
Wood  
Lane

Carriageway surface course damage.

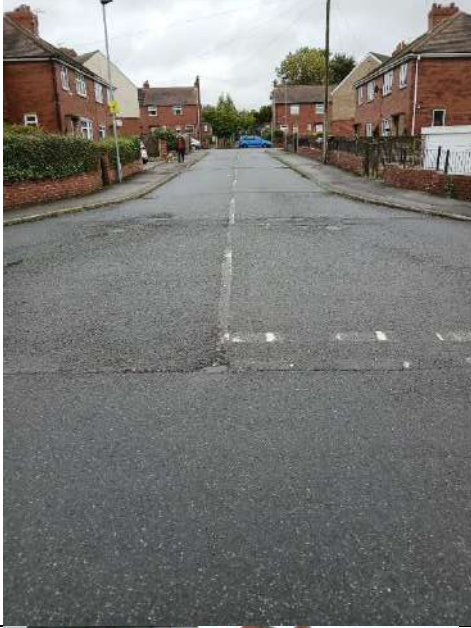
Photo 73  
Smithy  
Wood  
Lane

Carriageway surface course damage.

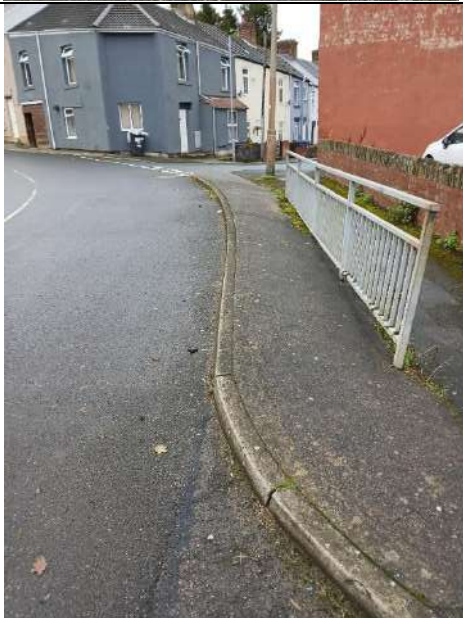
Photo 77  
Stainboro  
ugh Road

Footway / concrete verge cracking

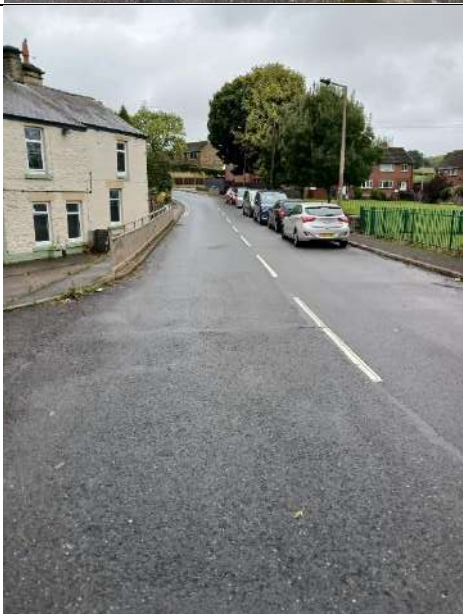
Photo 78  
Stainboro  
ugh Road

Minor carriageway surface course damage.

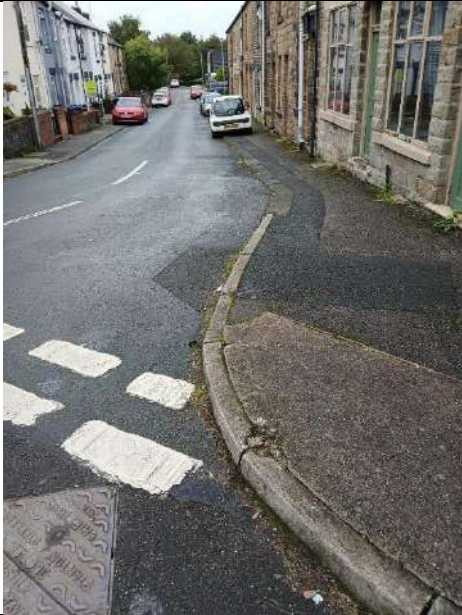
Photo 79  
Stainborough Road

Footway scarring / damage. Kerb damage.

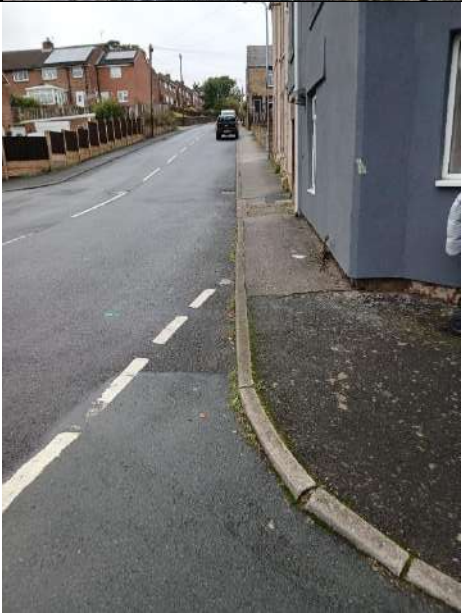
Photo 80  
Stainborough Road

Footway scarring / damage.

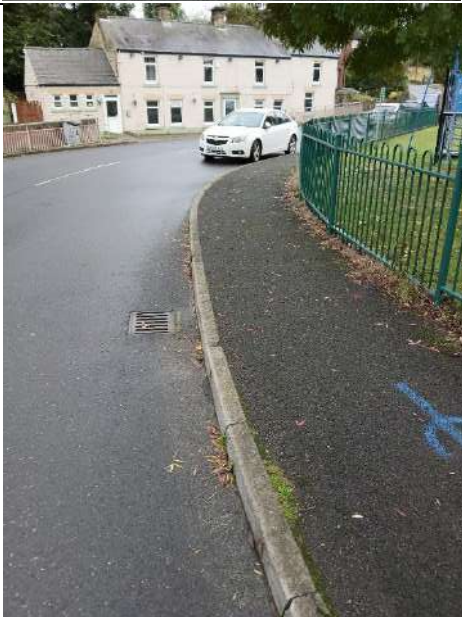
Photo 81  
Stainborough Road

Minor kerb damage.

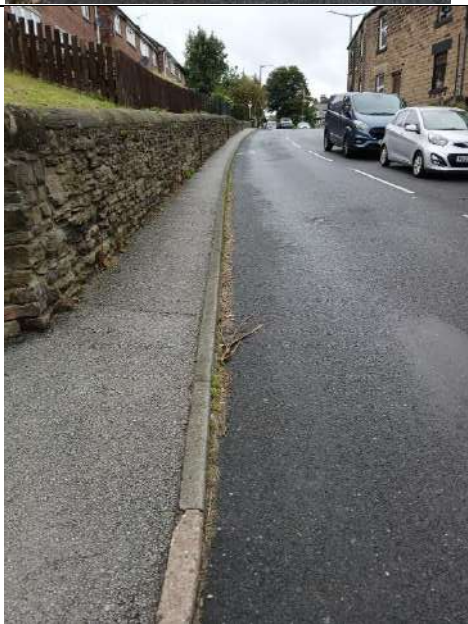
Photo 87  
Stainborough Road

Minor kerb damage.

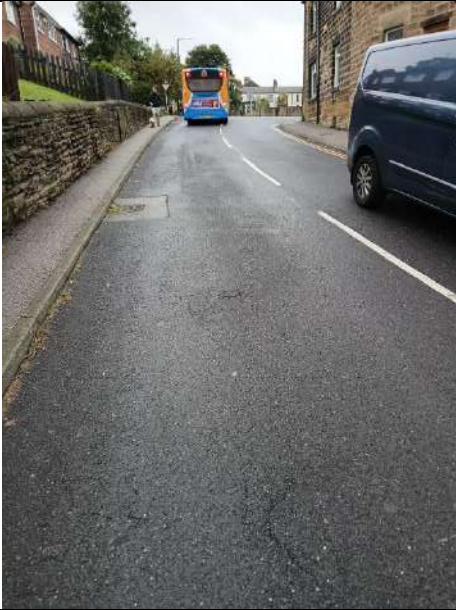
Photo 88  
Stainborough Road

Minor carriageway surface course damage.

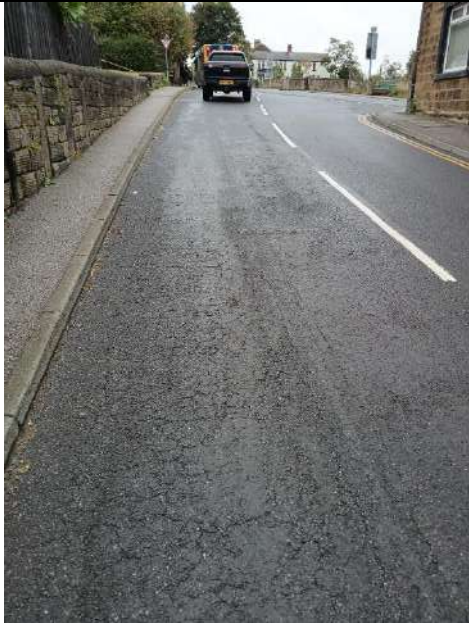
Photo 89  
Stainborough Road

Carriageway surface course deterioration.

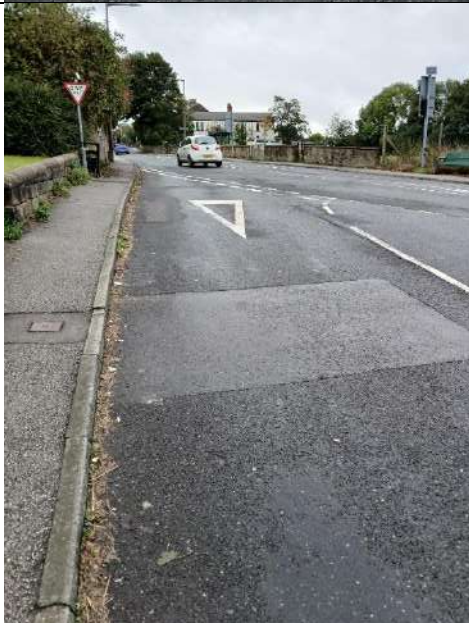
Photo 90  
Stainborough Road

Carriageway scarring. Kerb damage and scarring.

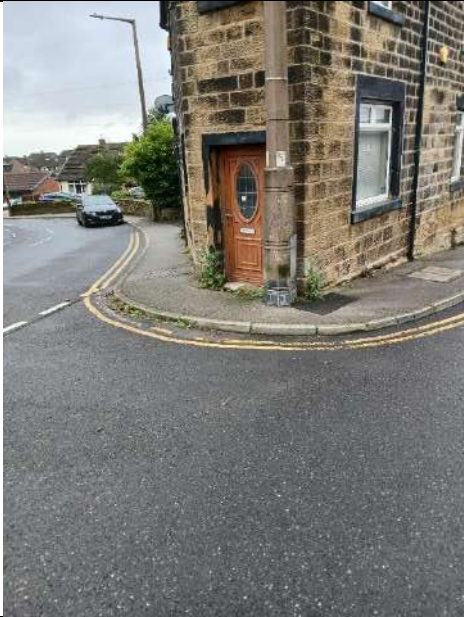
Photo 91  
Stainborough Road

Minor carriageway damage. Lining is wearing.  
Footway scarring.

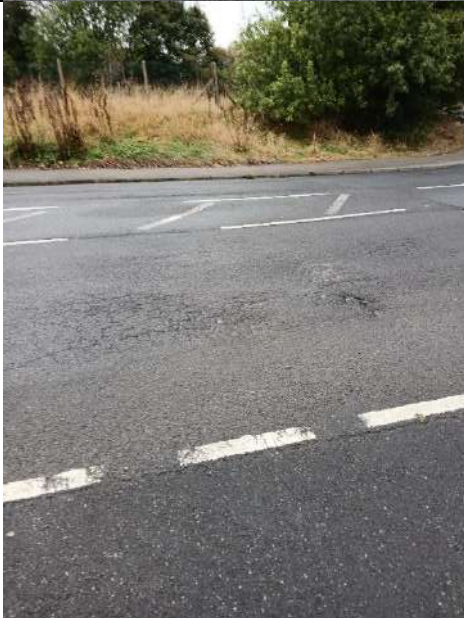
Photo 92  
Keresforth Road

Carriageway surface course deterioration. Lining is wearing.

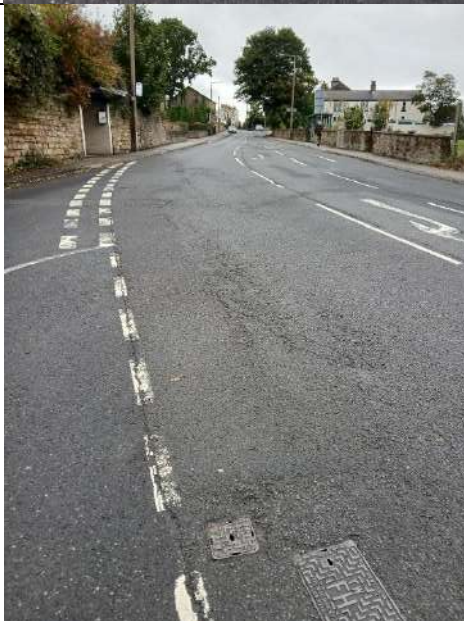
Photo 93  
Keresforth Road

Carriageway surface course deterioration. Lining is wearing.

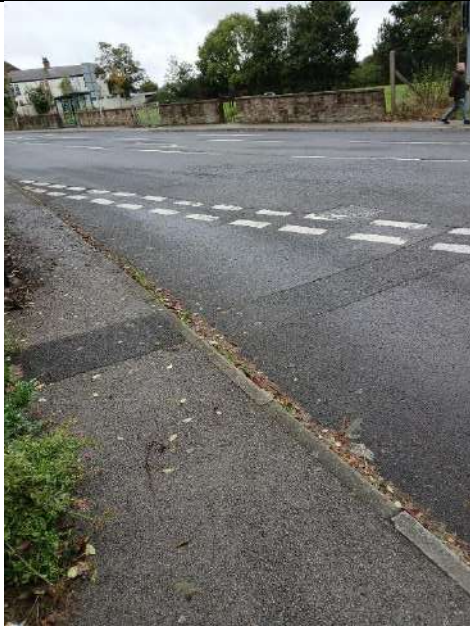
Photo 94  
Stainborough Road

Footway / carriageway scarring.

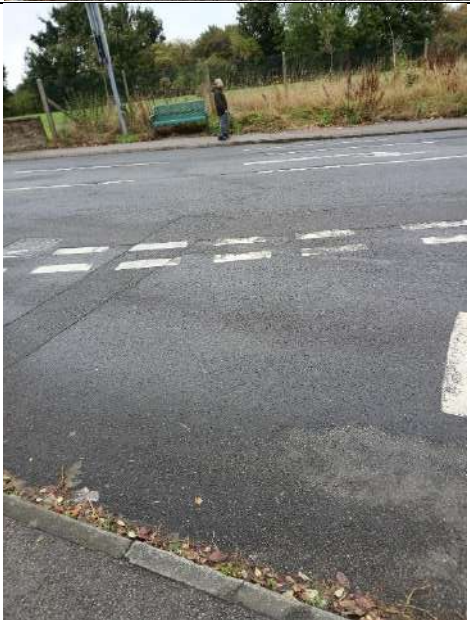
Photo 95  
Stainborough Road

Carriageway scarring. Lining is wearing.

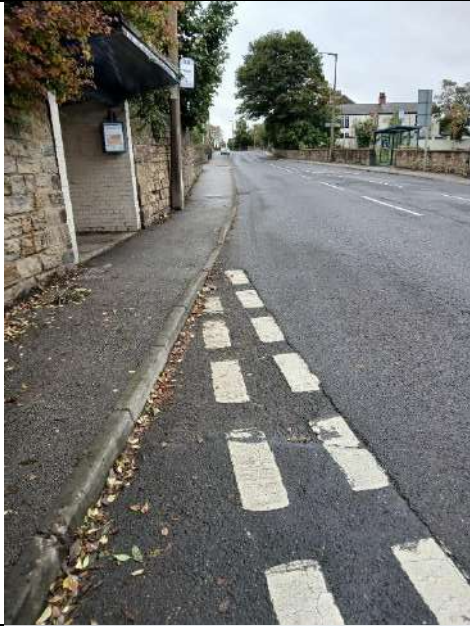
Photo 97  
Stainborough Road

Kerb damage. Minor carriageway surface course damage.

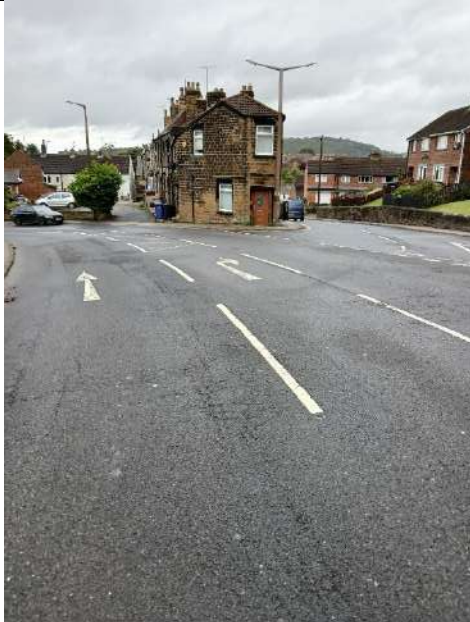
Photo 98  
Keresforth Road

Carriageway surface course deterioration.

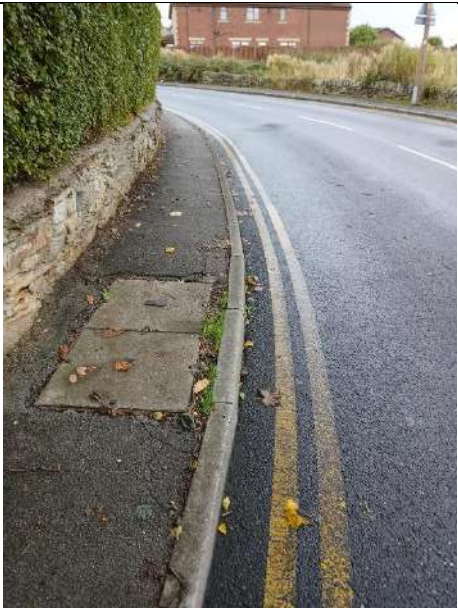
Photo 103  
Stainborough Road

Footway surface course damage around chamber. Lining wearing.

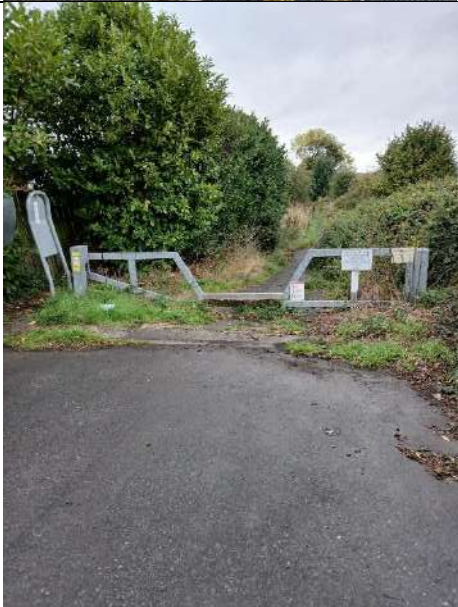
Photo 104  
Smithy Wood Lane

Vegetation on highway. Likely to be causing damage to surface course.

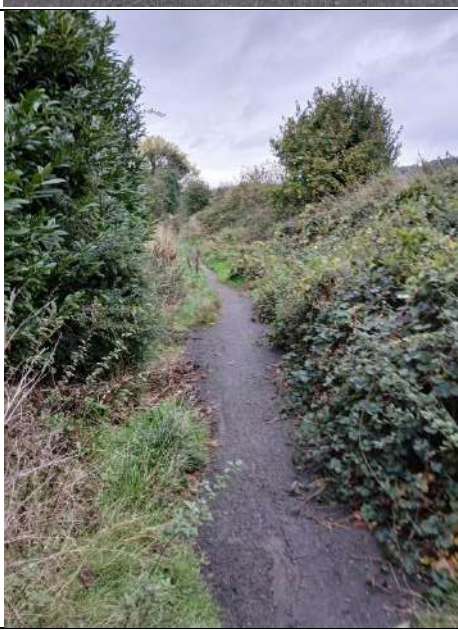
Photo 105  
Smithy Wood Lane (track)

Overgrown vegetation and uneven / unmade surface.
