# Mitchells Way / Barnsley Road, Wombwell

Road Safety Audit  
Stage 1  
October 2018

Project No: 1386

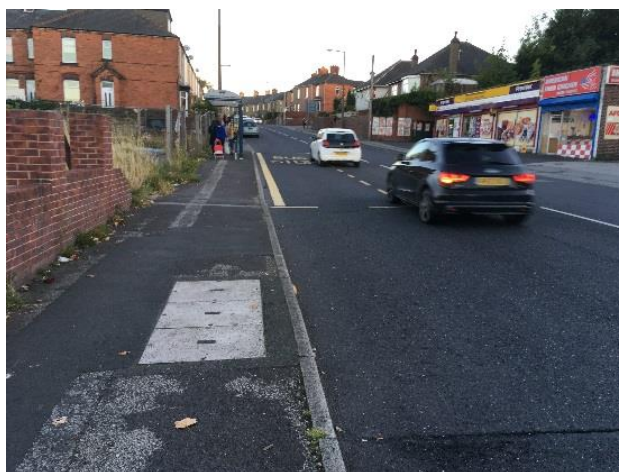
**Location:** East side of Barnsley Road at new access to Petrol Station

**Summary:** Risk of carriageway failure at new vehicular dropped crossing.

**Detail:** There is evidence of statutory undertaker's equipment in the footway at unknown depths along the frontage of the site where the new vehicular access is proposed. (See Image below)

Drawing No. P100D indicates that the BT manhole will be lowered with a heavy duty cover in a reinforced tarmac surface; however, there is no detail that any further equipment and associated ducts are being adjusted to an acceptable level. If vehicles are overrunning this area, especially larger vehicles it may cause the carriageway to fail resulting in exposed services and/or an uneven surface.

**Recommendation:** Ensure the services and all statutory undertakers equipment is lowered and protected to an adequate standard.

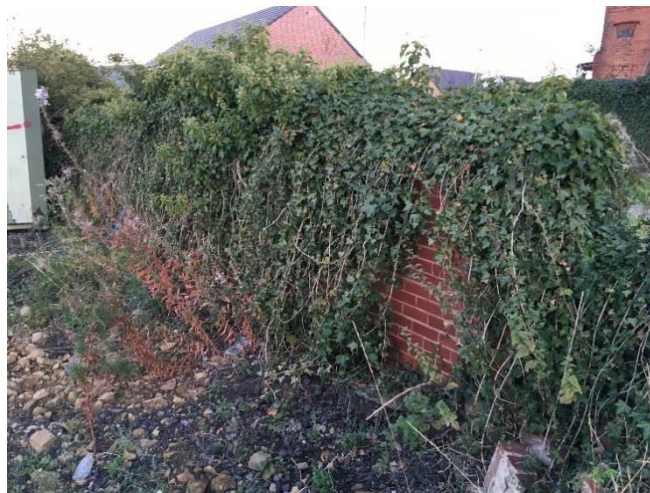
**Location:** South side of site boundary behind proposed new shop building.

**Summary:** Risk of movement of land/private access due to inadequate containment.

**Detail:** The boundary wall on the south side of the site appears to be retaining the land and access road above it, (See Image below). The ground is lower within the site and if the land is not retained sufficiently there is a risk of movement making it unstable. There is also the added risk, depending on the height of the proposed building, of security. If the roof is not significantly higher than the adjacent land, it may be possible to climb on it from the private road at the side of house no. 216.

**Recommendation:** Ensure the land is retained sufficiently and security of the building is not compromised.

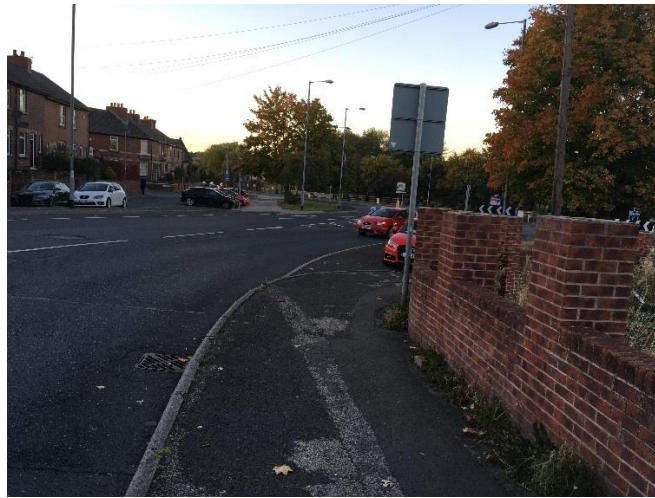
**Location:** Barnsley Road at new access to Petrol Station.

**Summary:** Risk of collisions due to inadequate sightlines.

**Detail:** The sightlines to the north, when exiting the petrol station are restricted by the boundary wall and the bend in the road. (See Image below). Landscaping is also proposed in the corner of the site which could also restrict visibility. No visibility splays have been shown and the distance from the roundabout to the access is approximately 40 metres. With limited visibility there is also the risk that slower vehicles turning into the petrol station may be hit from behind.

**Recommendation:** Ensure the sightlines are adequate and comply with local standards.

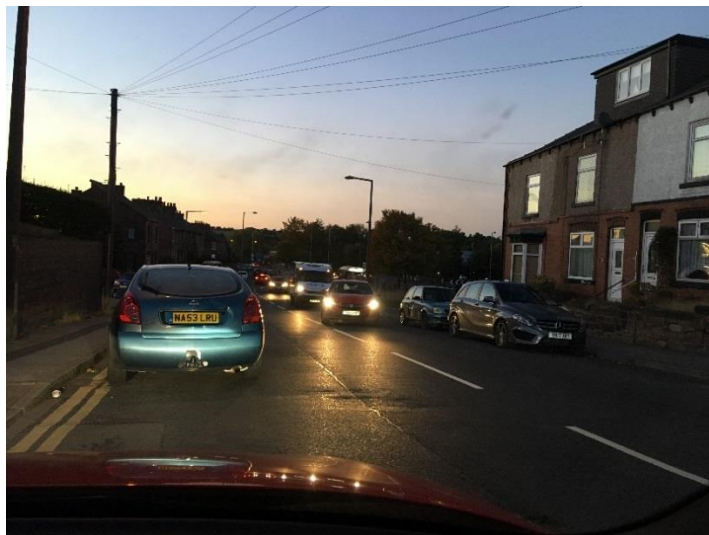
**Location:** Barnsley Road, south of new access.

**Summary:** Risk of collisions due to parked vehicles & congestion.

**Detail:** It was observed on site that parking occurs on the road especially at night by residents to the south of the access road and customers to the shop and take-away opposite, (See Image below). This parking may obstruct sightlines when accessing and egressing the new petrol station. The addition of a new access will generate more vehicle movements at this point and could increase the risk of collisions at this location.

**Recommendation:** Monitor the parking and review the restrictions in the vicinity of the proposed access.

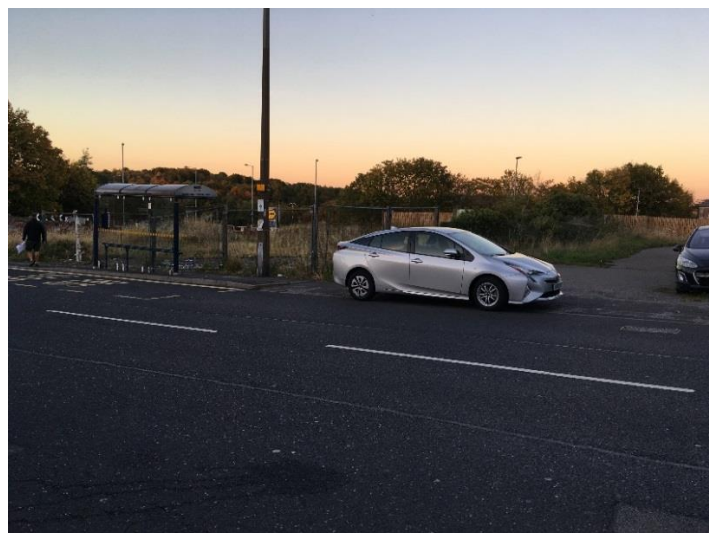
**Location:** Barnsley Road at proposed access to Petrol Station.

**Summary:** There is a risk of collisions due to location of existing bus stop and shelter.

**Detail:** There is an existing bus stop and shelter (See Image below), located at the proposed location of the new access to the petrol station. There is no mention of the bus stop or shelter being relocated and if it remains in its present position could obstruct movement to and from the access and obstruct sightlines creating a potential hazard for egressing vehicles.

**Recommendation:** Relocate the bus stop & shelter to a more suitable location.

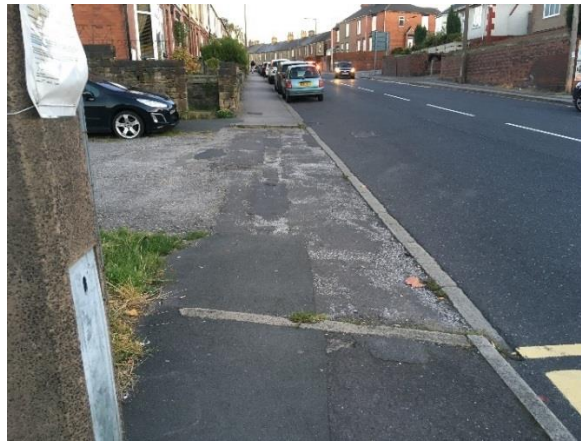
**Location:** Barnsley Road at new access to Petrol Station

**Summary:** Risk of collisions between vehicles and pedestrians.

**Detail:** The proposals do not show any provision of dropped crossings on the proposed access to the Petrol Station, within the site at the entrance to the shop or at the existing private access above the site (See Image below). There will be an increase in pedestrian activity due to the provision of the new shop and failure to provide crossing points could lead to trips and falls or crossing at inappropriate locations resulting in collisions with vehicles.

**Recommendation:** Ensure there is adequate provision for pedestrians at this location.

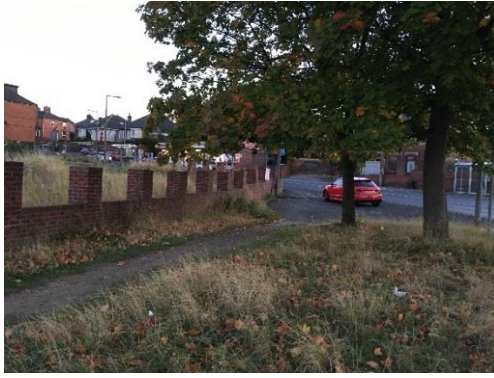
Picture 1

**Location:** Barnsley Road J/W Mitchells Way (North West of site boundary)

**Summary:** Risk of pedestrian trips and falls due to uneven ground.

**Detail:** There are two mature sycamore trees on the north-west side of the site where an informal footway has been formed through the grass verge, (See Images below).

**Recommendation:** The route for pedestrians outside the site boundary should be improved and consideration given to removing the trees if it is thought they may affect the ground or infrastructure within the site.

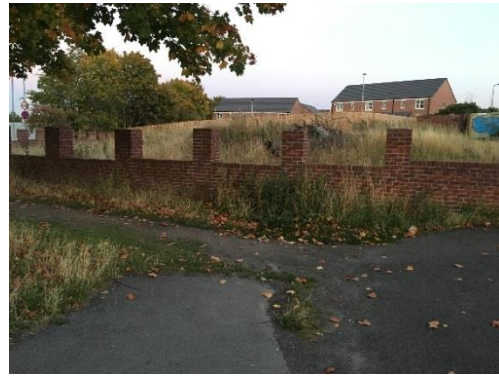
The ground is already uneven and if the trees are allowed to grow bigger the roots may start to affect the ground even further. There is a low spot at the end of the formal footway where there is a disused access which looks like it floods during heavy rainfall (See Picture 2 above).

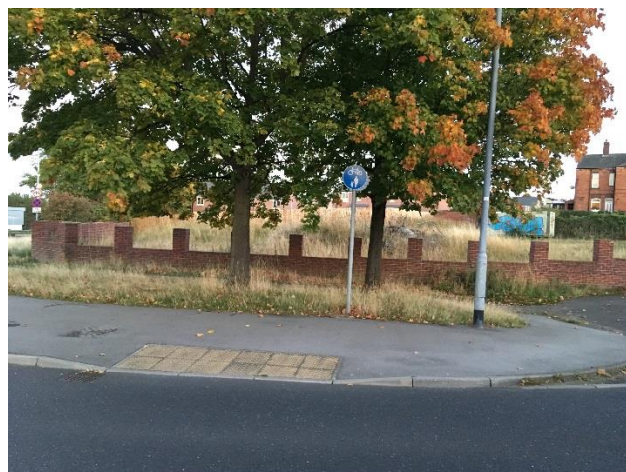
**Location:** Barnsley Road J/W Mitchells Way (North West of site boundary)

**Summary:** Risk of collisions between pedestrians & cyclists.

**Detail:** There is a shared route sign on Barnsley Road near to the junction with Mitchells Way (See Image below). It is unclear from the angle of the sign which direction the shared route goes or where it starts and ends. If cyclists are allowed to use the footway travelling south up Barnsley Road towards the entrance to the petrol station, there is a risk of a collision with pedestrians due to the bend and increased activity in this area.

**Recommendation:** Ensure the shared use footway is properly signed and it is clear where it starts and ends.

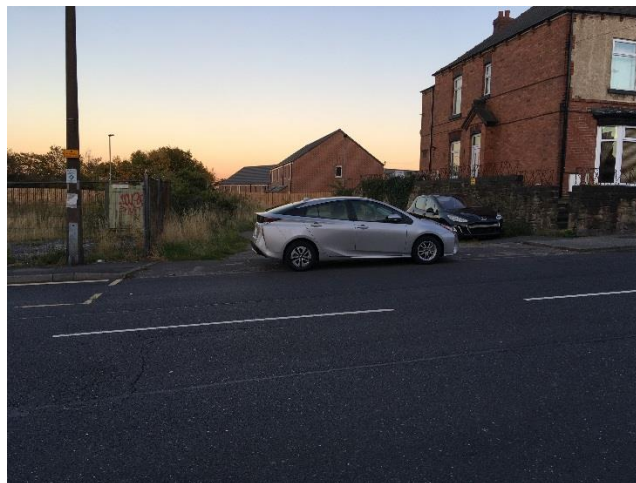
**Location:** Barnsley Road at junction with new access.

**Summary:** Risk of collisions between pedestrians & vehicles due to inadequate lighting.

**Detail:** No lighting details on the highway have been included in the proposals to serve the new access road and junction. There is an existing lamp column (See Image below) on the south side of the site boundary but no details have been provided to suggest it is being relocated or if the new access is sufficiently illuminated. If the junction is not suitably illuminated there is a risk that vehicles may not see pedestrians.

**Recommendation:** Provide adequate street lighting for the proposed development and at the junction.
