**LOWFIELD ROAD, BOLTON UPON DEARNE  
for Gleeson Homes & Regeneration**

**TREE SURVEY**

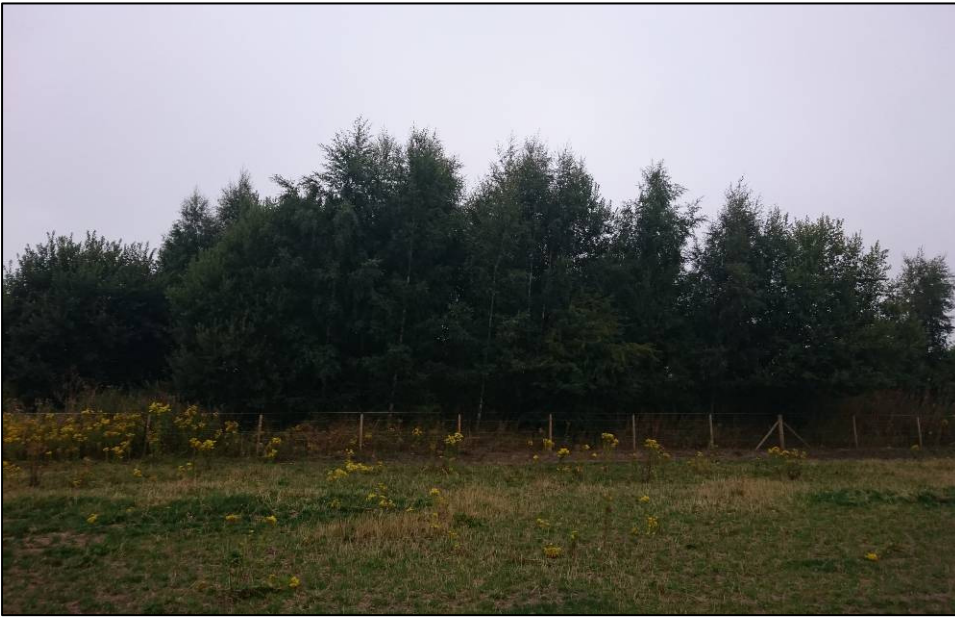
Photo 1:

View West showing area of self sown trees (group G1 – Birch and Goat Willow) which lies immediately to West of site.

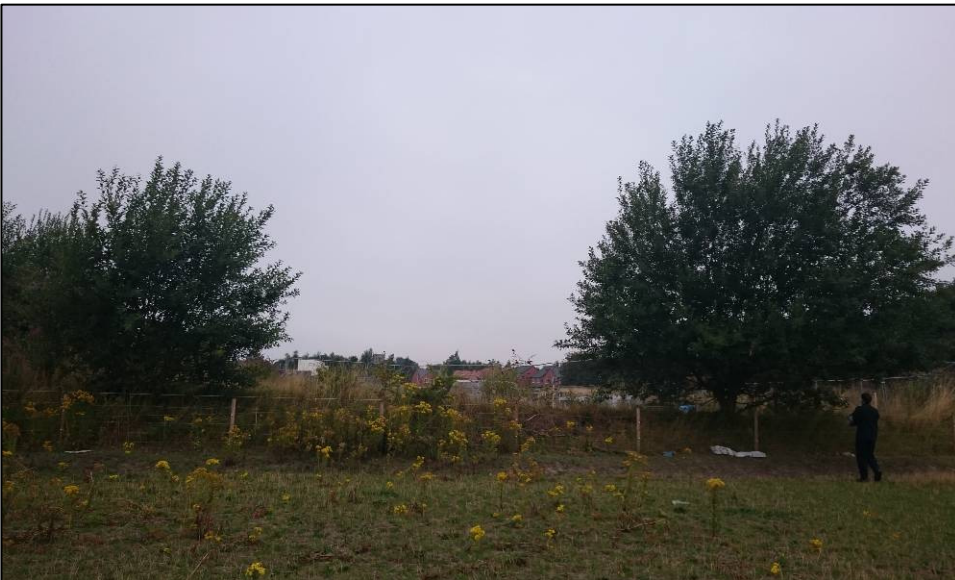
Photo 2:

View West showing pair of isolated Goat Willows (T2 on left, T3 on right) which lie immediately to West of site.

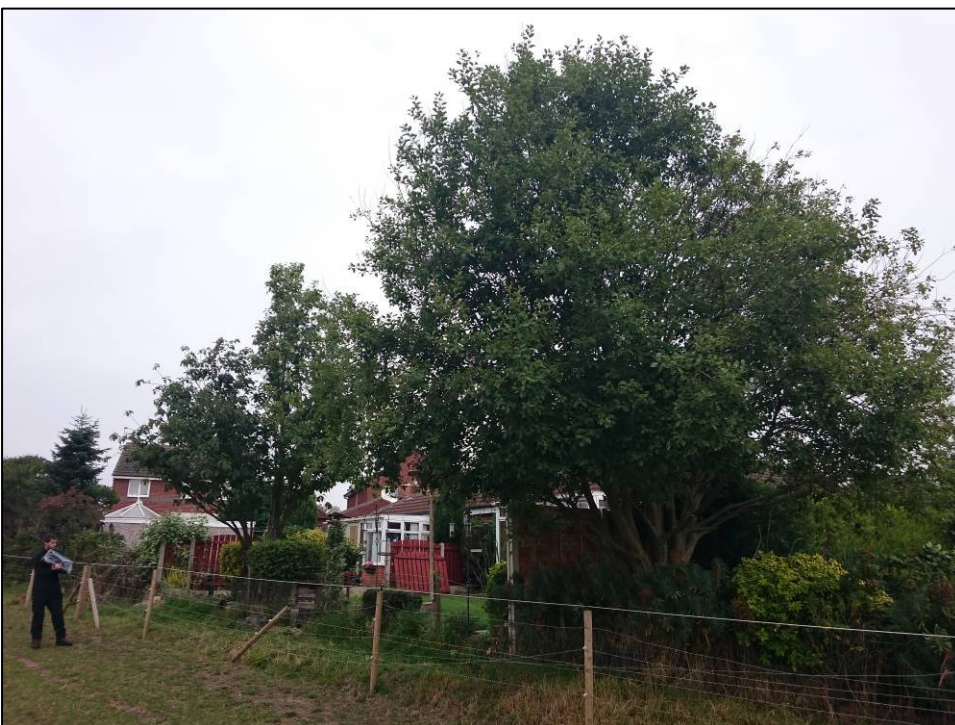
Photo 3:

General view of planting within adjacent gardens to north of site - Staghorn Sumac (T5) and Spruce (T6) on extreme left, Cherry T7 in centre and Goat Willow T8 centre right.

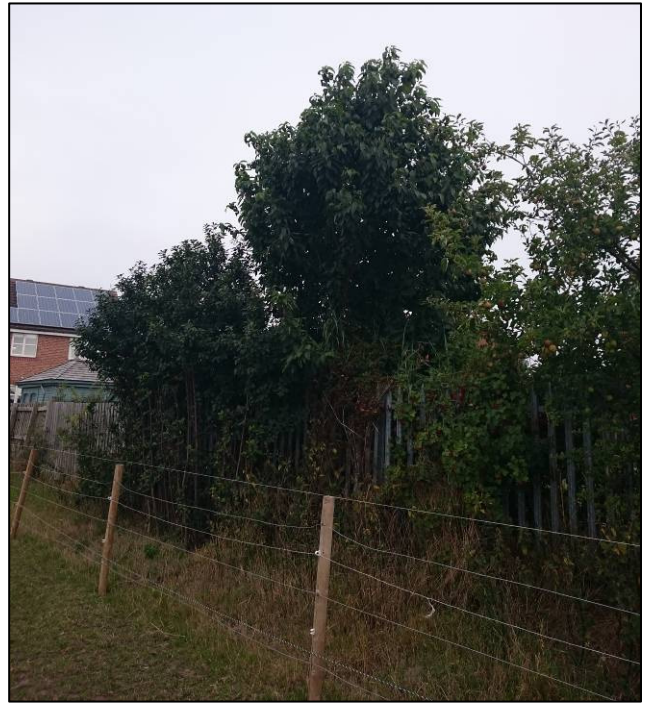
Photo 4:

View north showing ornamental trees in adjacent gardens - Cherry T9 centre with suckers on left and Apple T10 on extreme right.

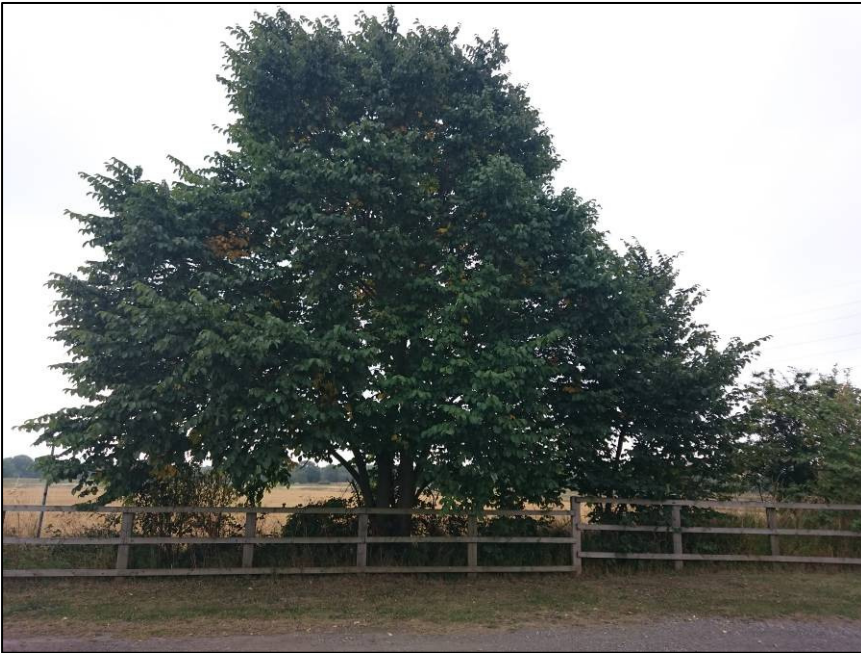
Photo 5:

T10	Apple	4	7	2.5 m rad	SM	1	Good	10-20	C1	Small ornamental tree lies within adjacent garden. Straight main stem and rounded compact Crown. Limited arboricultural value.	No action
T11	Wych Elm	9	29, 27, 16, 13	N 7 S 7 E 6 W 6.5	EM	2	Good	20-40	B1	Multi-stemmed tree lies just beyond fence to East side of access drive. Wide spreading dense low Crown. Slightly rubbing stems at base but no major visible defects.	No action
T12	Ash	9	25	N 6.5 S 5 E 6.5 W 5.5	EM	2.5	Good	20-40	B1	Multi-stemmed tree on edge of access road; dense rounded Crown. Minor wounding at base noted and Deadwood in Crown.	No action

View east showing early mature Elm T11 lying just beyond roadside fence.

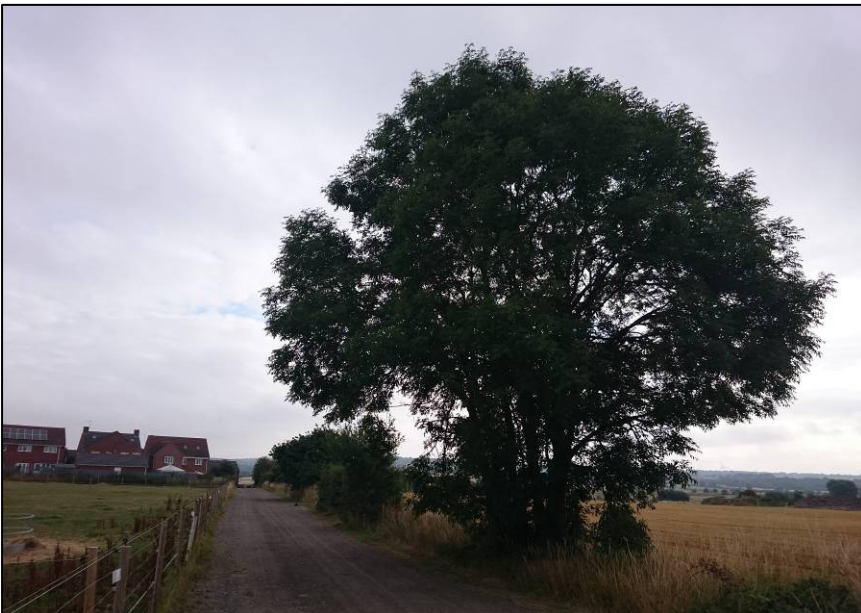
Photo 6:

General view northwards along track showing Ash T12 centre right with Hawthorn hedge H13 beyond and Oak T14 in middle distance.
