**Wentworth Castle Gardens
Park Drive,
Barnsley**

Pre-development Arboricultural Report

13 December 2018

Treescapescap Consultancy Ltd.

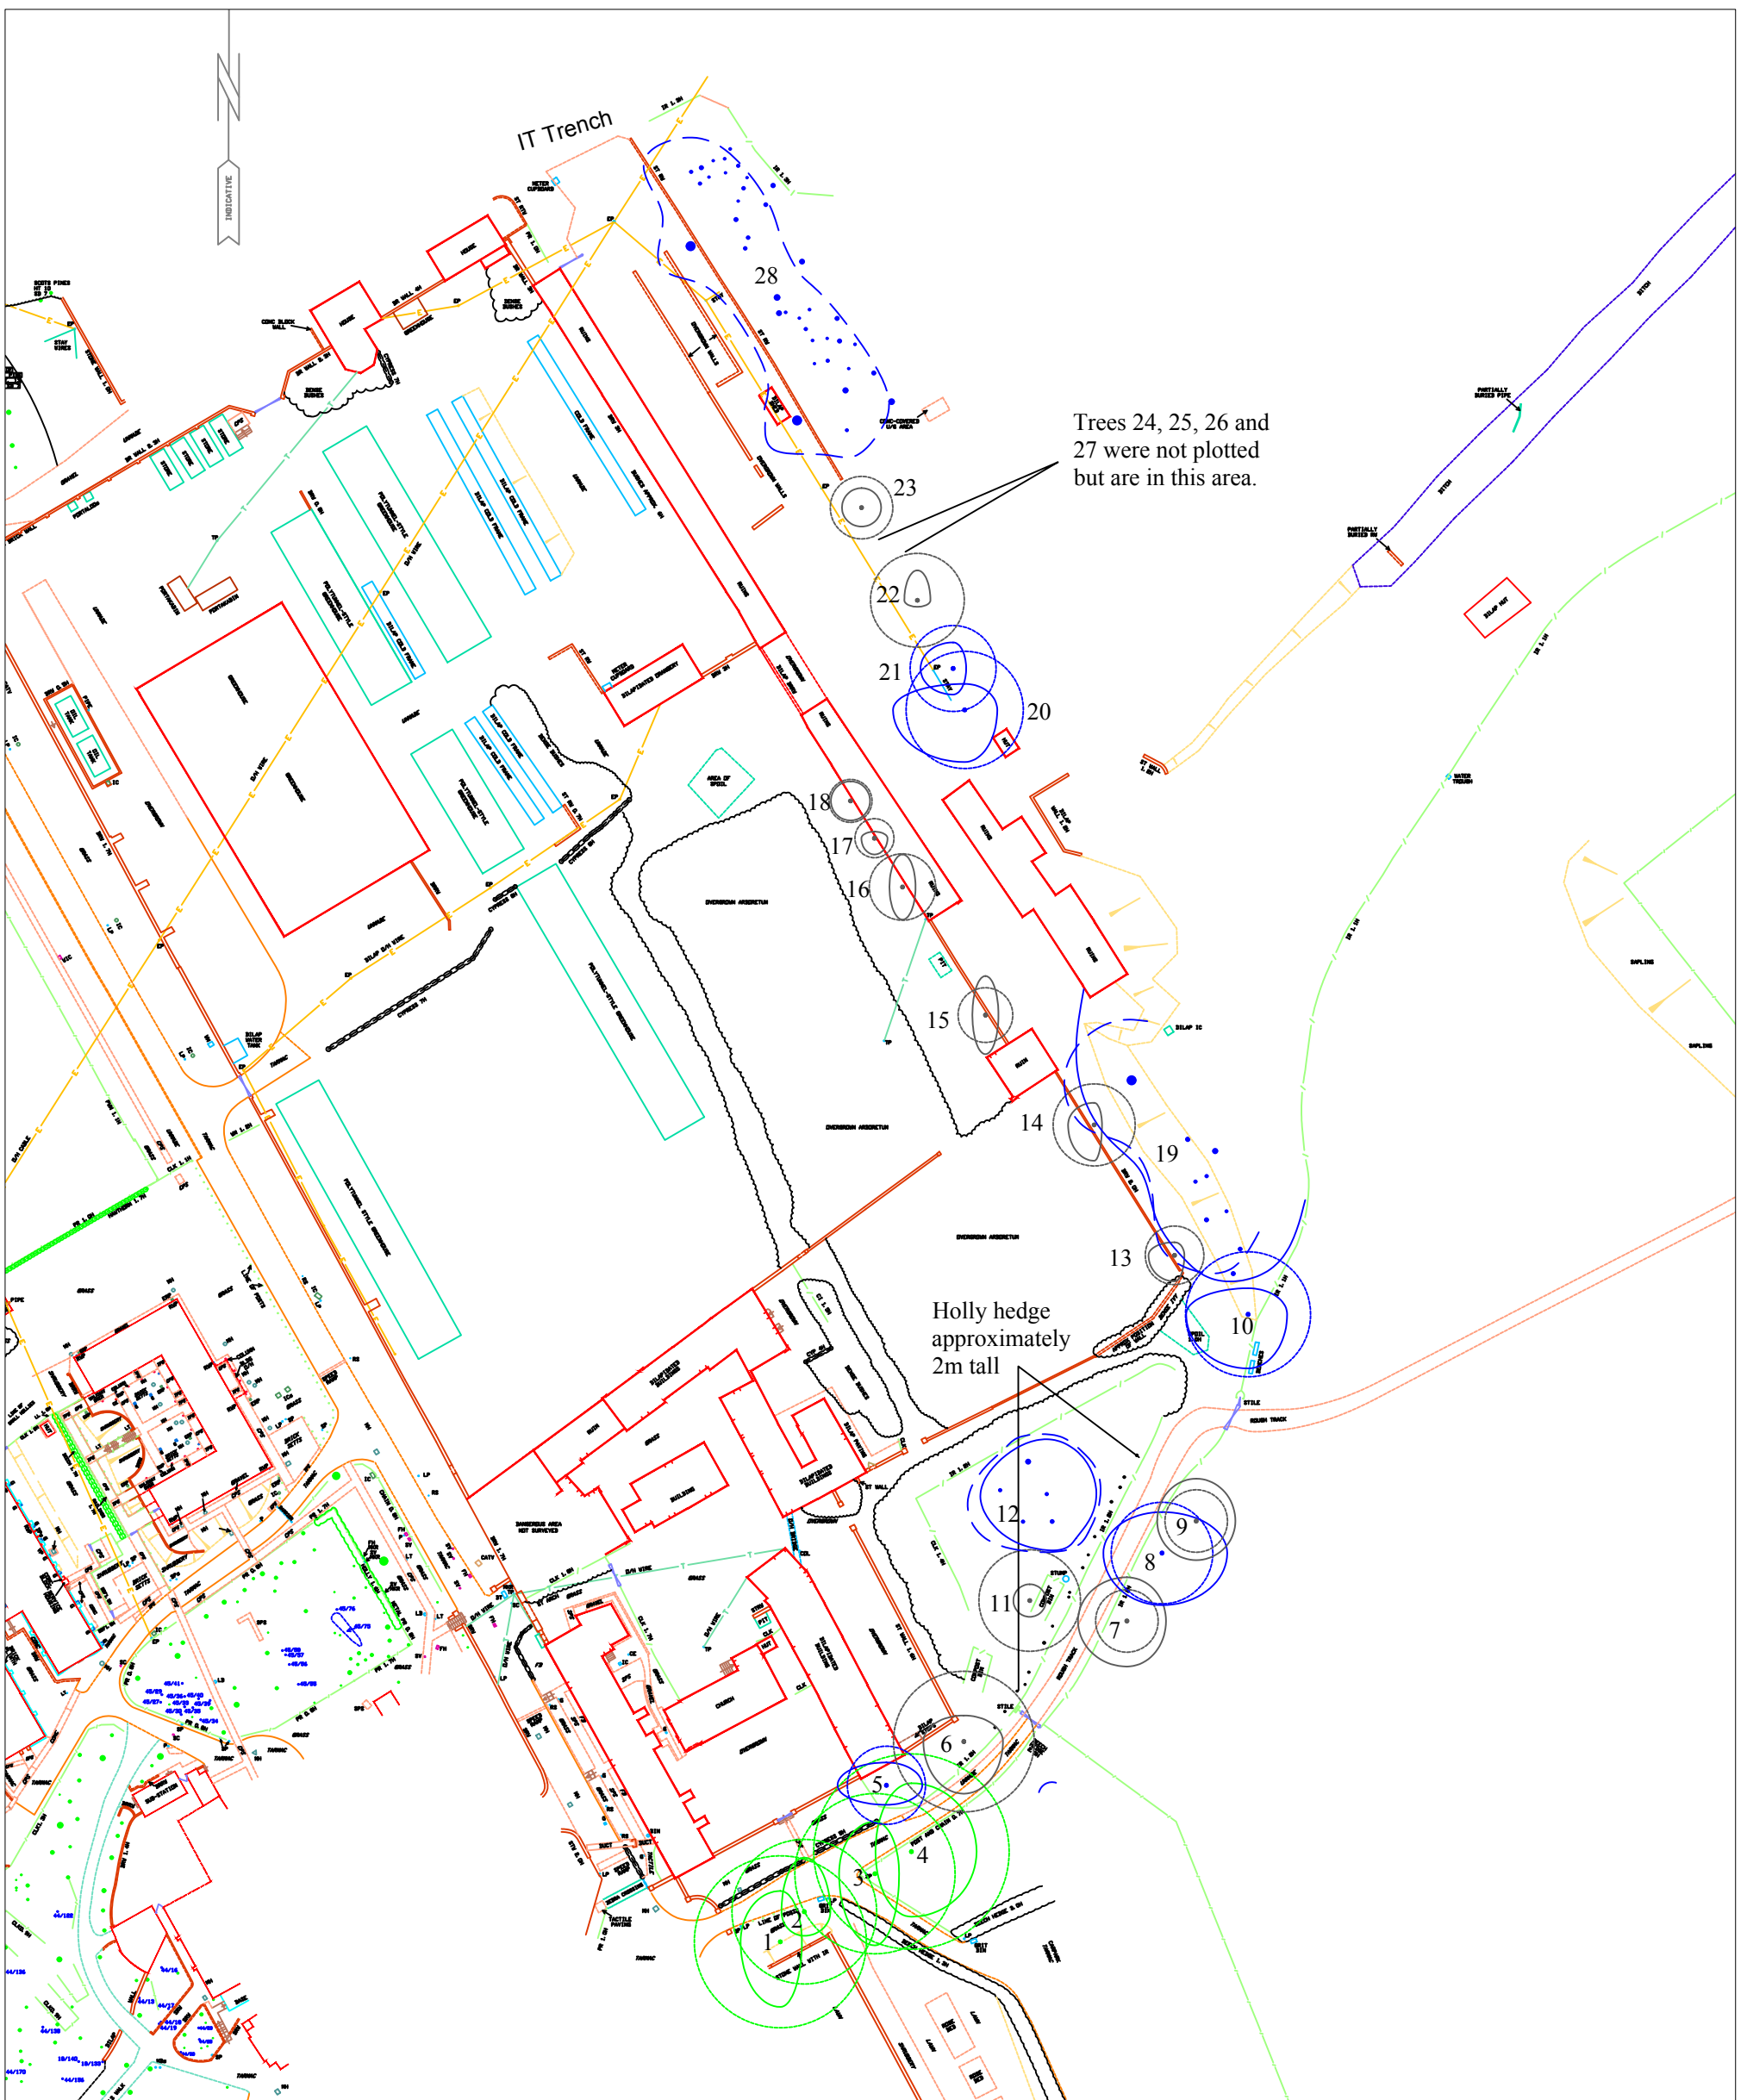
Plan 1 Tree constraints plan showing the existing site layout

Trees 24, 25, 26 and 27 were not plotted but are in this area.

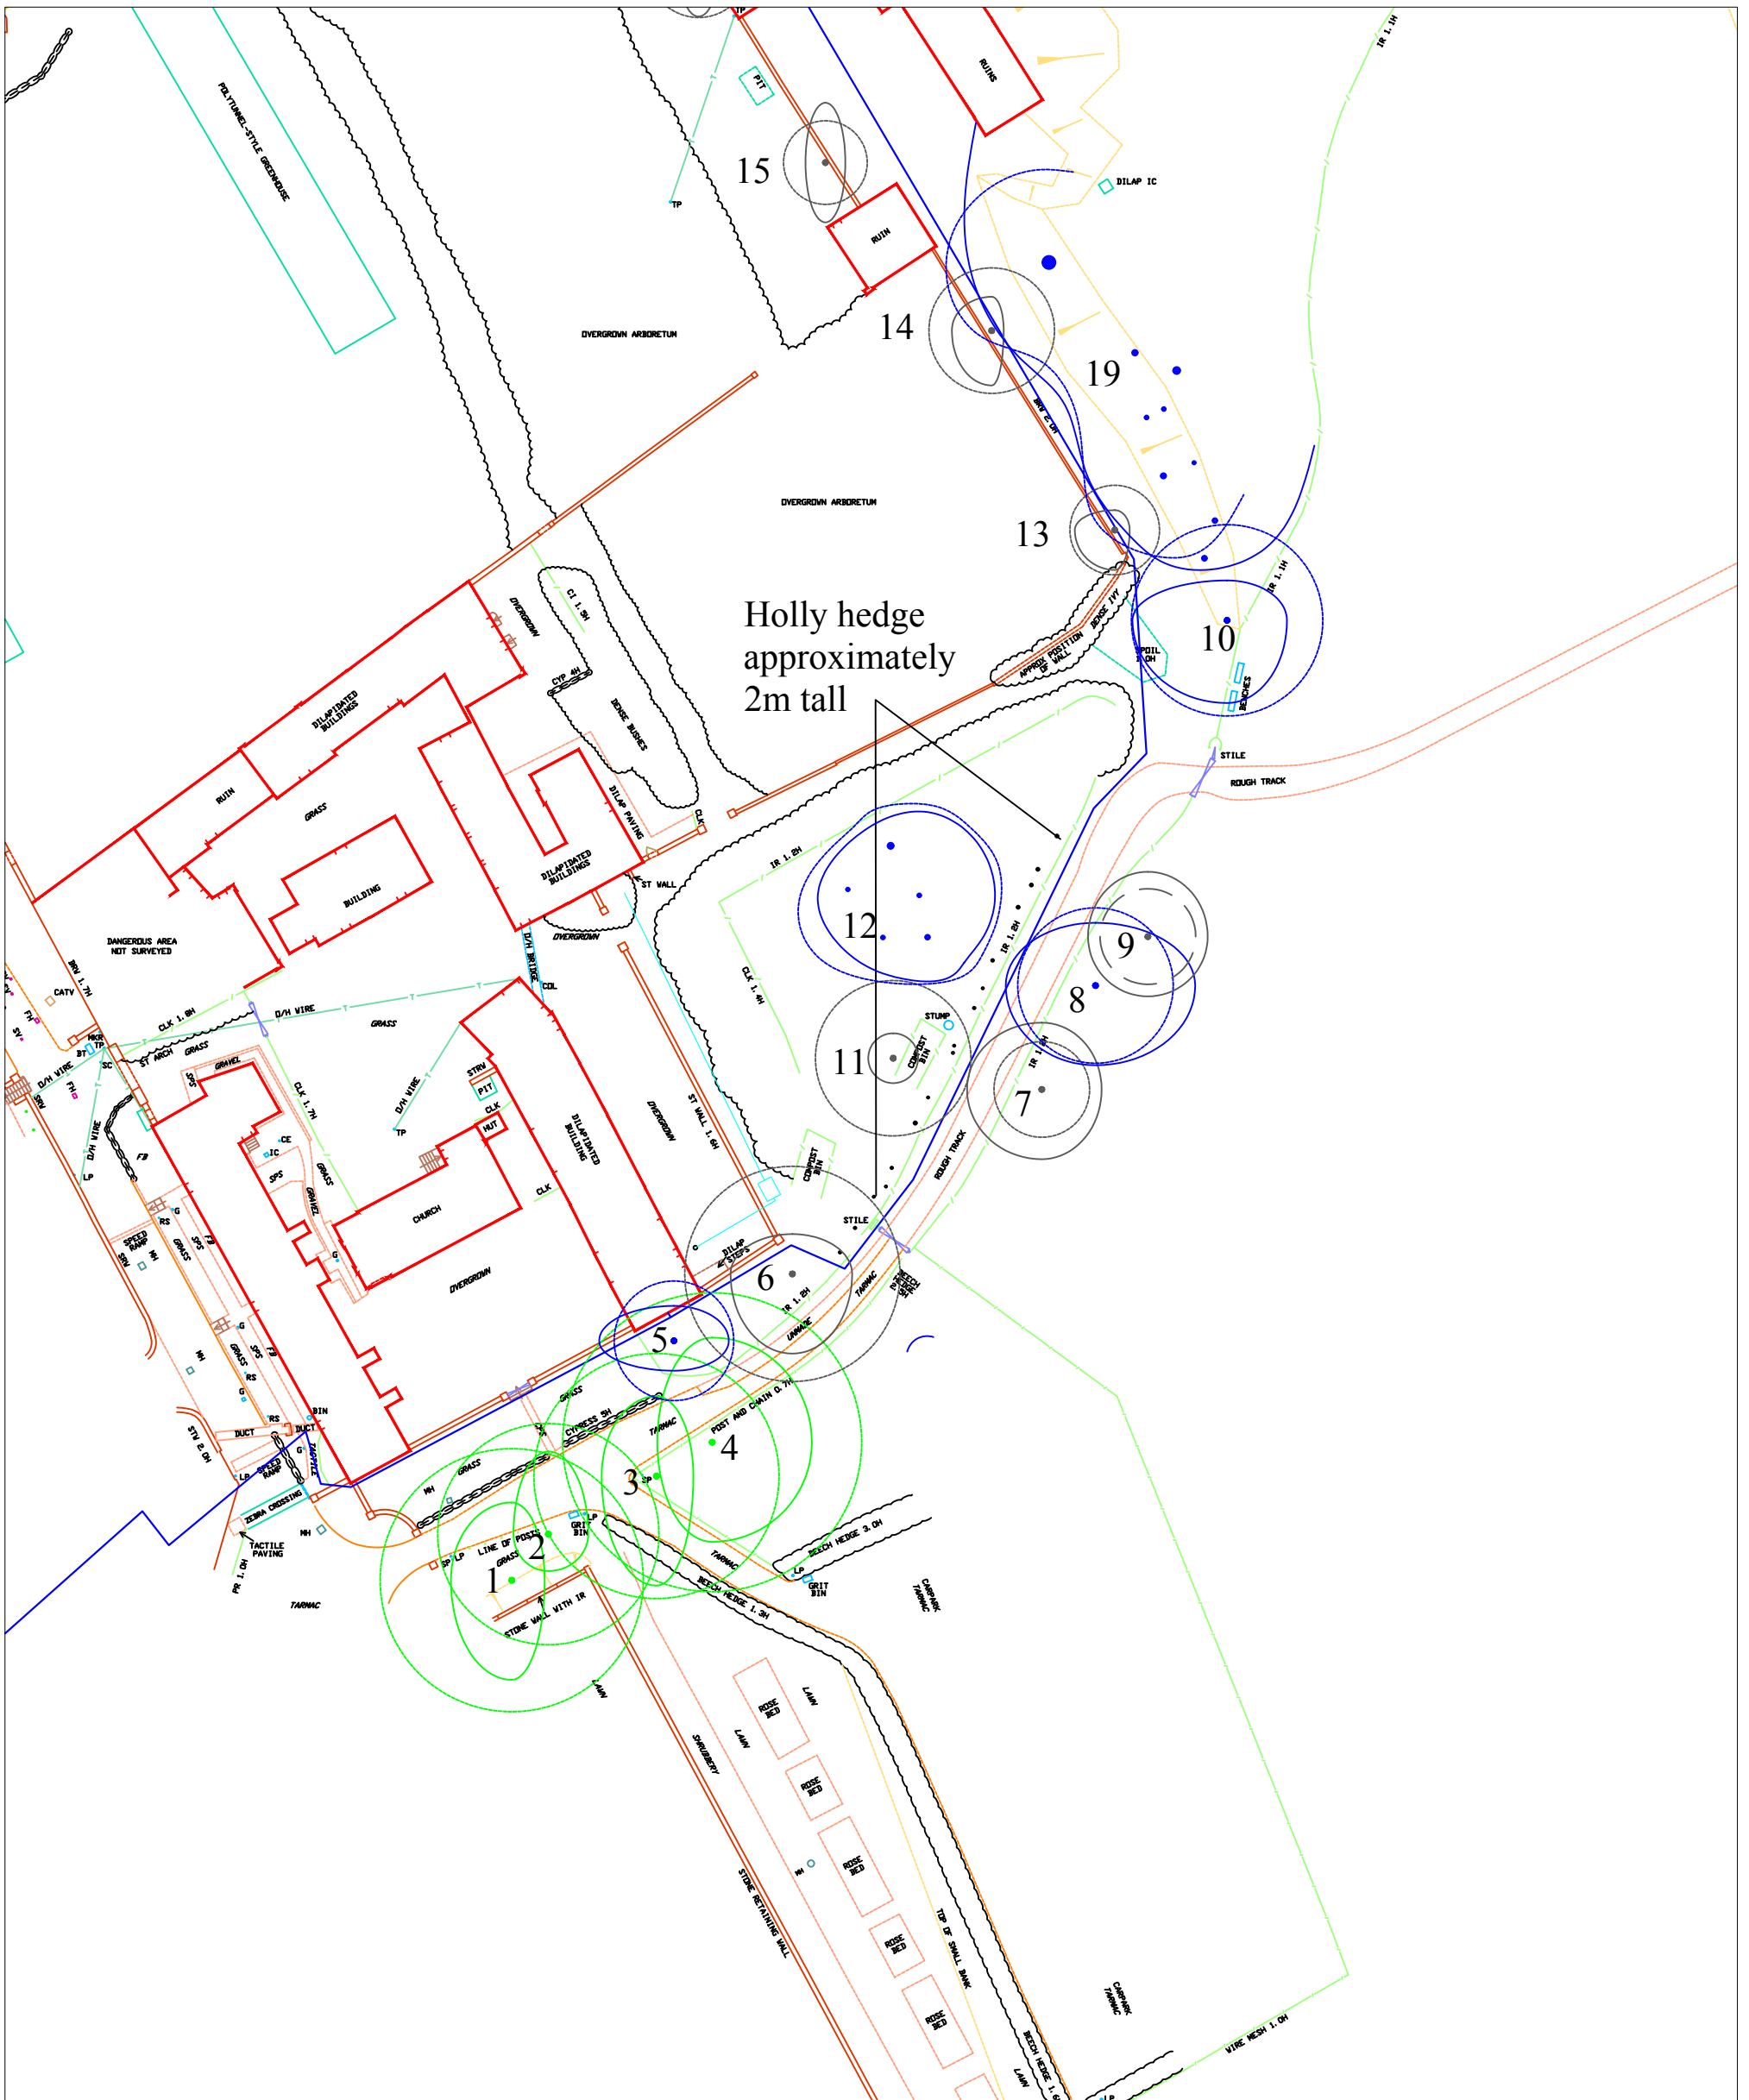
Plan 2 Tree constraints plan showing the proposed site layout

Plan 2 shows that the IT trench will encroach marginally onto the edge of the RPA of four trees – 4, 5, 10, 11 and one woodland area (19). The IT trench will encroach significantly into the RPA of Trees 6, 13 and 14. The trench would need to be carefully hand dug or the trees removed. These are category C trees. The trench will need to be hand dug through the second woodland area (28). The guidance contained within the National Joint Utilities Group Volume 4 (Guidelines for the Planning, Installation and Maintenance of Utility Apparatus in Proximity to Trees (Issue 2, 2007); (<http://streetworks.org.uk/>)) should be followed when installing underground services within the RPAs of these trees.

The proposed location of the new grease trap would be within the RPA of Tree 6. It is proposed to remove this tree to accommodate the grease trap and service trench. Whilst this is a large and significant tree it has been included in the lowest retention category (C) because of the significant damage to the main stem associated with fire damage.

The proposed visitor kiosk will encroach slightly into the RPA of Tree 22. Trees 24, 25 and 26 would need to be removed. These are small, young recently established trees. These could be readily replaced elsewhere with new planting.

I recommend that trees 13 and 14 should be removed to allow the proposals to be implemented and to avoid potential for damage to the wall as the trees grow.

I recommend that consideration is given to removal of Trees 22 and 23 to accommodate the visitor kiosk.

I recommend that Trees 24, 25 and 26 are removed to accommodate the visitor kiosk.
