Belle Green Court Care Home, Cudworth

Bat Survey Report

24th January 2024

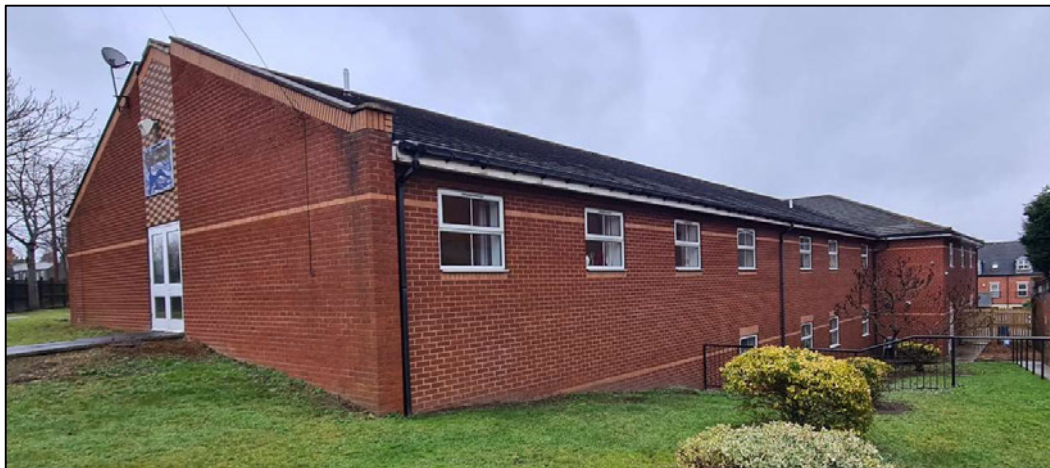
Plate 2. The southern elevation and southernmost gable of the care home

- 5.2.2 The care home was in good condition, the only potential bat roost features were gaps behind roofing felt on the parapet walls at the western gable ends. However, the felt was located over lead flashing and therefore overall, these features were considered to be of negligible suitability. The building was warm and dry.

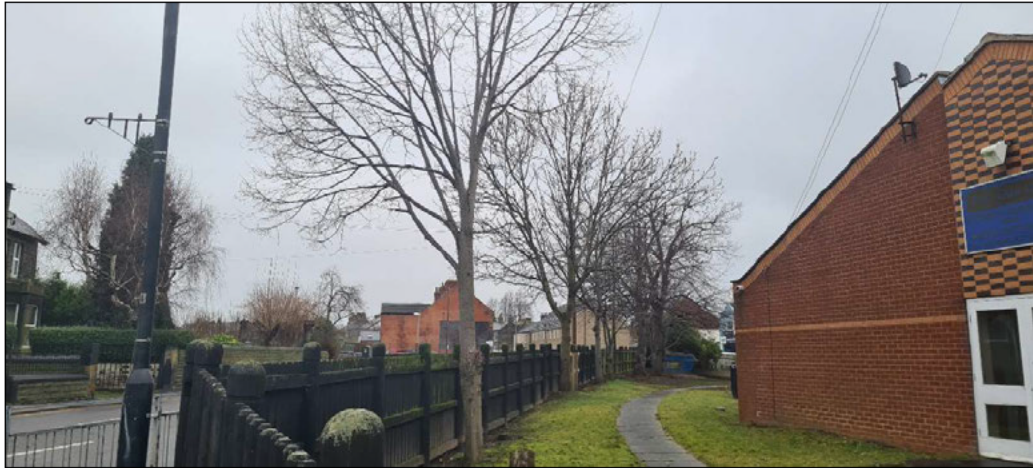
Plate 3. Semi-mature trees along the western site boundary

- 5.2.4 No bats or signs of bats were recorded in either building and the suitability of both was considered to be negligible.
- 5.2.5 The trees present within the site were considered unsuitable for use by roosting bats but were likely to be used by nesting birds.

5.2.8 The garden of the care home included semi-mature trees along Barnsley Road to the west and semi-mature shrubs in the centre of a patio area for residents which was sheltered to the north, east and south by the building (Plate 3). A line of Leyland cypress *Cupressus × leylandii* was also present along the eastern end of the former cinema.

6.2.2 It is recommended that vegetation clearance / demolition takes place outside the nesting bird season (March to August inclusive). If this is not possible a nesting bird check should be completed by an experienced ecologist within 48 hours of the work commencing.

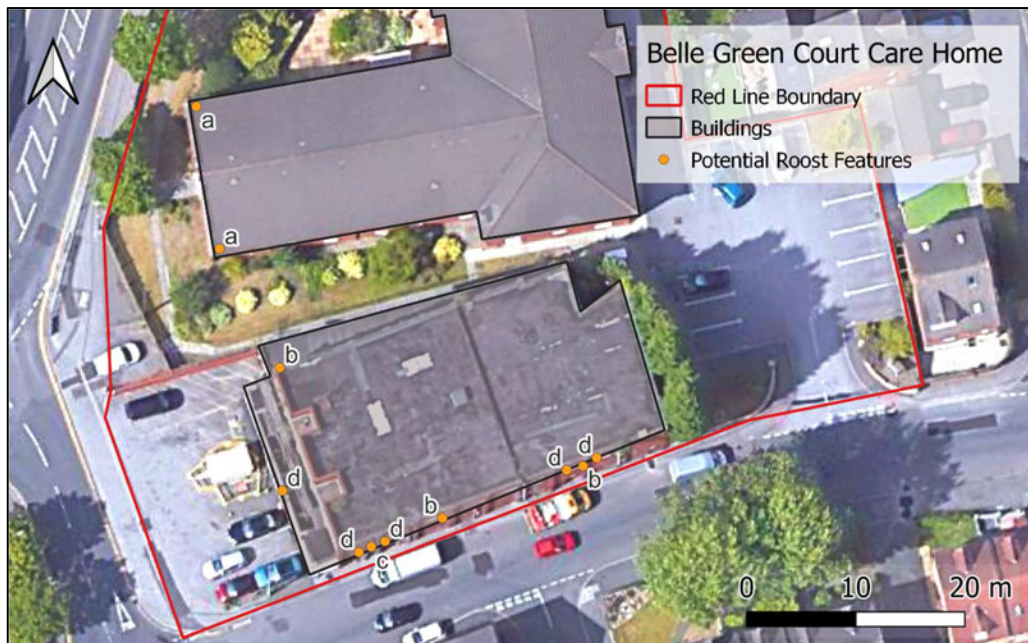
Figure 3. PRF Locations

5.2.9 The only potential bat roost feature identified on the care home were loose flashing on the back of the parapet walls on the gables. The potential roost features (PRFs) are shown in Table 3 and Figure 3 below.

PRF	Photo	Description
A		<p>Gap beneath flashing on the back of the gable parapets.</p>

5.2.10 While it is acknowledged that loose flashing in this sort of location can occasionally be used by roosting bats, it was considered that the lead soakers behind and below the flashing significantly reduced its suitability. Overall, these features were considered to be of negligible suitability.

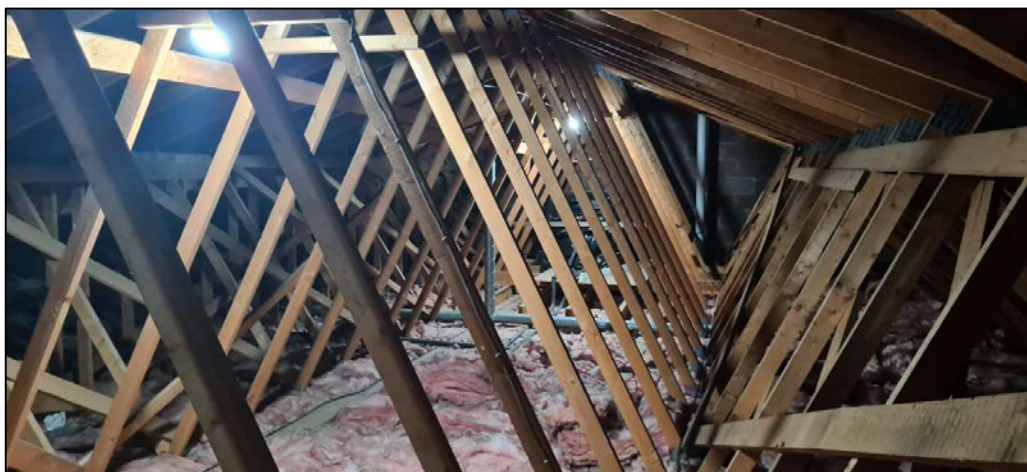
Plate 4. A typical roof void

- 5.2.11 The roof voids were approximately 3 m high and supported by modern prefabricated 'W' trusses (Plate 4). The tiles were backed by Type 1F bitumen felt. A small amount of damage to the felt was present below the valley at the southern end of the building but the lead within the valley appeared to be sufficiently tight to the tiles to prevent any access for bats.
- 5.2.12 Approximately 300 mm of insulation was present above the ceilings. No bats or signs of bat activity were recorded.

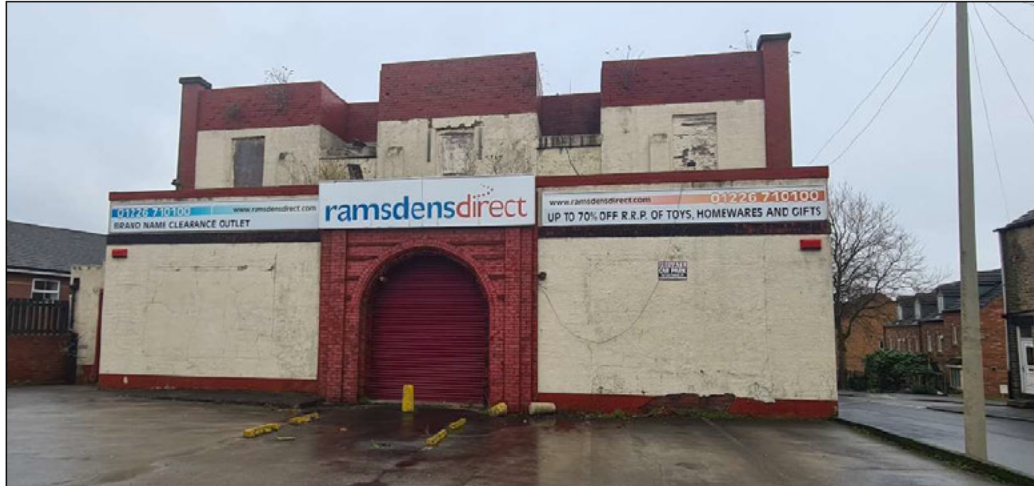
Plate 5. The façade of the former cinema (viewed from the west)

roofing felt. Parapet walls surrounded the roof. A single storey foyer was present on the front of the building. This section also had a flat roof (Plate 5).

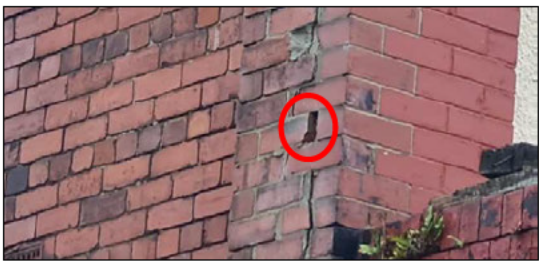
Cracks in the brickwork. The crack on the northern side of the building (pictured) was at a height of approximately 3 m, the cracks on the southern elevation were all at low level – approximately 1m.
C

5.2.16 The crack in the brickwork pictured as PRF B in Table 4 was checked with binoculars and a high powered cluelight torch and considered to have been thoroughly checked, the other low-level cracks in the brick work were inspected thoroughly at close range with a torch and endoscope.

6.1.1 The PRFs on the care home were located on the western gables. These features are unlikely to be impacted by the proposed works. The PRFs on the former cinema were considered to be of negligible suitability to be used by roosting bats. The cracks in the brickwork narrowed quickly and were mostly located at a low level. The barred open window and the gaps above the roller doors potentially allowed bats into the interior of the building but no signs of bat presence were visible and it is considered likely that bat droppings on walls would have been present if bats were using the interior of the building.

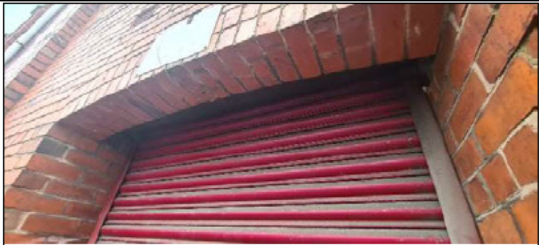
Gaps above roller doors.

5.2.17 PRFs C and D allowed bats access into the building but did not provide a suitable roost in themselves.

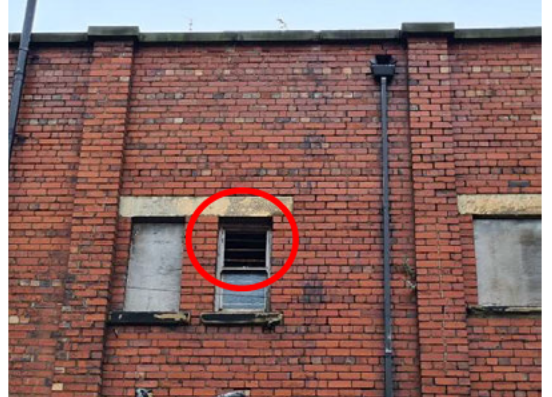
Open, barred window leading into the former cinema building.

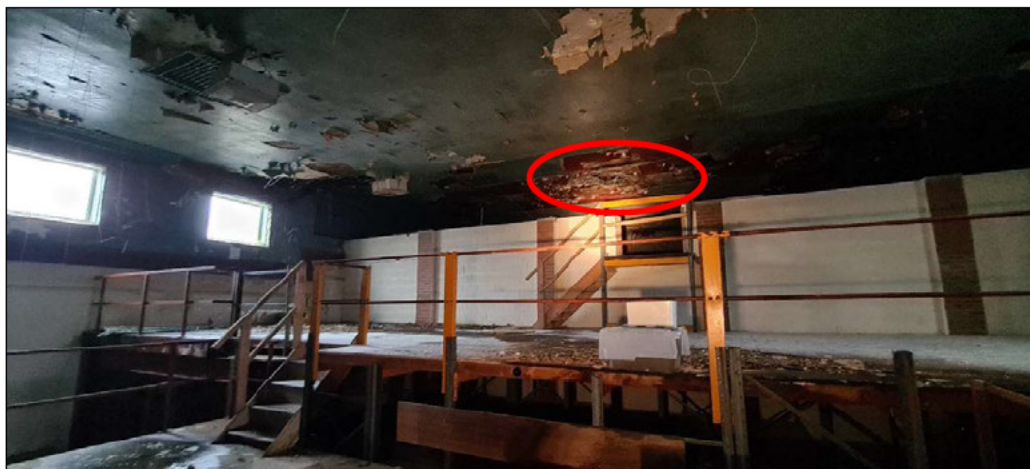
Plate 6. damaged ceiling with laths (circled red) visible

5.2.18 The interior of the building was very wet. The ceiling had been damaged and in places the plaster had fallen off exposing the laths above (Plate 6). The roof was constructed from concrete and the internal floors included steel and wooden beams. The foyer at the front of the building had a suspended ceiling which had almost entirely fallen down (Plate 7). Hanging cobwebs were present in that area.

5.2.19 Although rotten flooring and ceiling meant that health and safety concerns prevented access onto the platform (shown in Plate 6), the space could be viewed relatively clearly from the safely accessible areas and the white painted walls meant that it was considered relatively likely that any droppings on the walls in these inaccessible locations would have been recorded.
