## Tree

| Tag Number: | T3 |
| Common Name: | Lombardy poplar |

| Location | |
|---|---|
| Address: | 51 High Street |

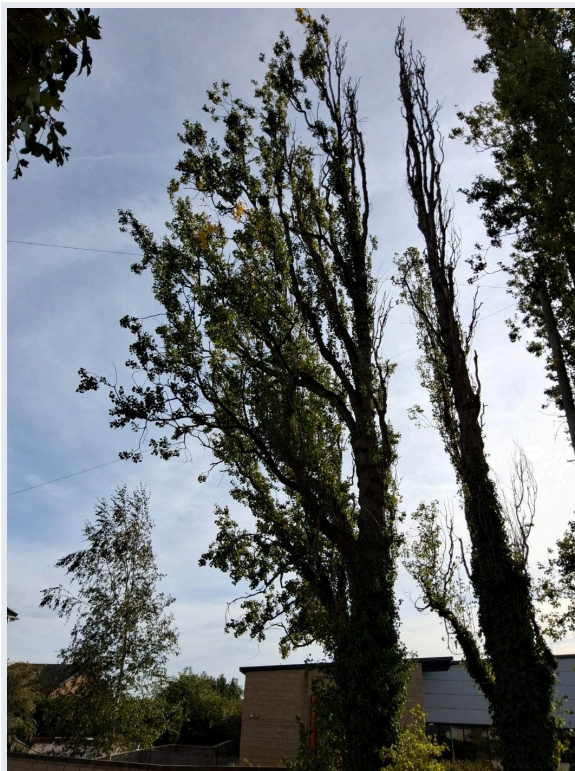
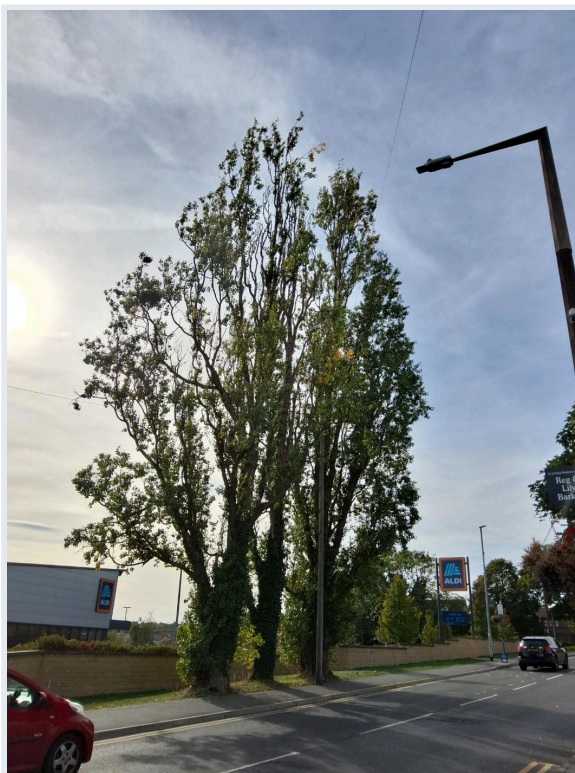
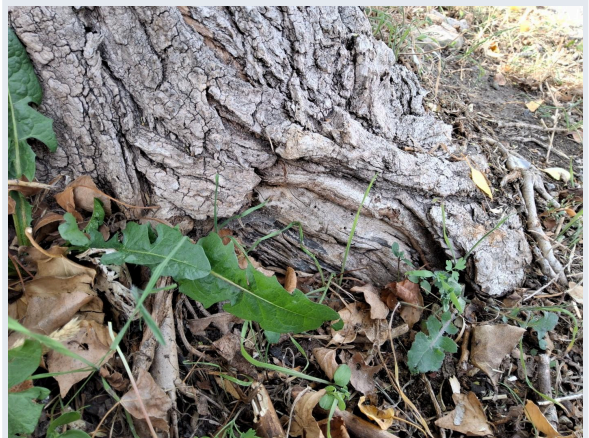
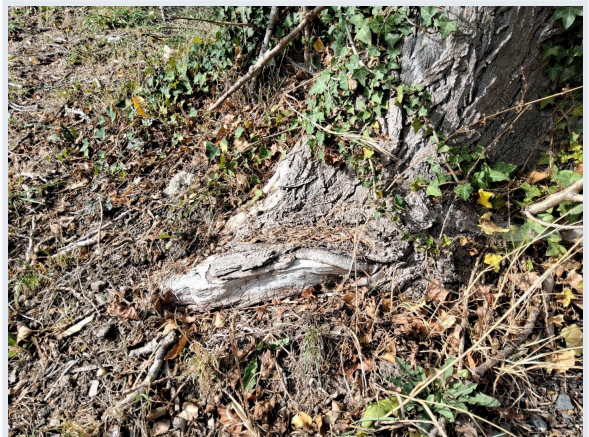
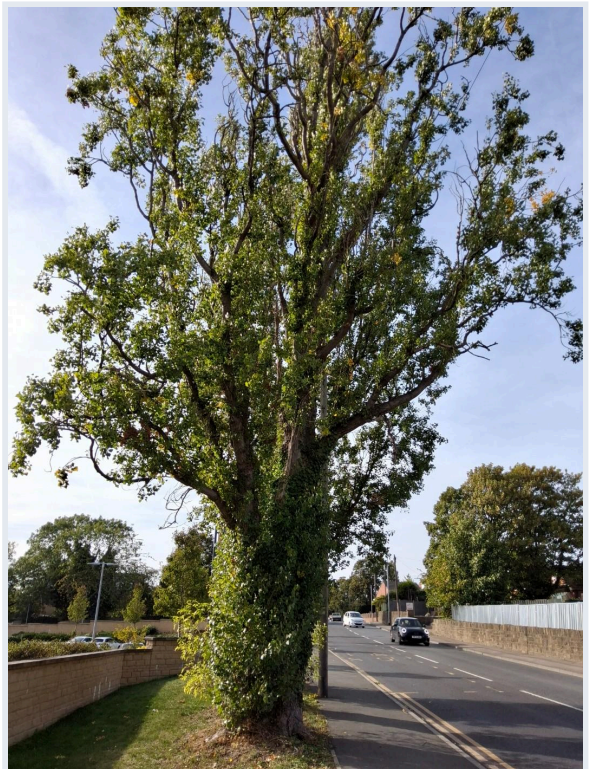
| Vitality: | Poor |
| Structural Condition: | Poor |
| Percent Dieback (%): | 50-75% |

| Observations | |
|---|---|
| Crown Observations: | Included Bark, Major deadwood |
| Crown Comments: | Snapped off dead branch hung up over pavement |
| Trunk Observations: | Climber Restricting Inspection, Epicormic Growth at Base |
| Trunk Comments: | 5 - 10% lean to west |
| Root Observations: | Decay, Excavation Damage, Exposed Roots, Surface Root Damage |
| Root Comments: | Sounding suggested significant decay to buttress root closest to pavementLikely from Aldi carpark construction and wall approx 3m from edge of stem |
| PPD Comments: | All 3 trees were completely defoliated in 2025 due to a satin moth infestation |

| Tree Comments: | Recommend Felling and Stump Grinding due to poor condition of tree crown and roots and its co-dominant neighbours, resulting in high exposure if some trees are removed and not others, combined with extremely high target high street location between busy public highway and supermarket carpark and in falling distance of housing, telegraph lines, street lighting, carpark and store. |
