# TREE REPORT

Land at Polar Ford  
Dodworth Road  
Barnsley

To carry out an inspection of the trees at the former Polar Ford site as shown on the attached drawing and record information in relation to BS 5837: trees in relation to construction (2005).

The trees were inspected on the 28<sup>th</sup> June 2011.

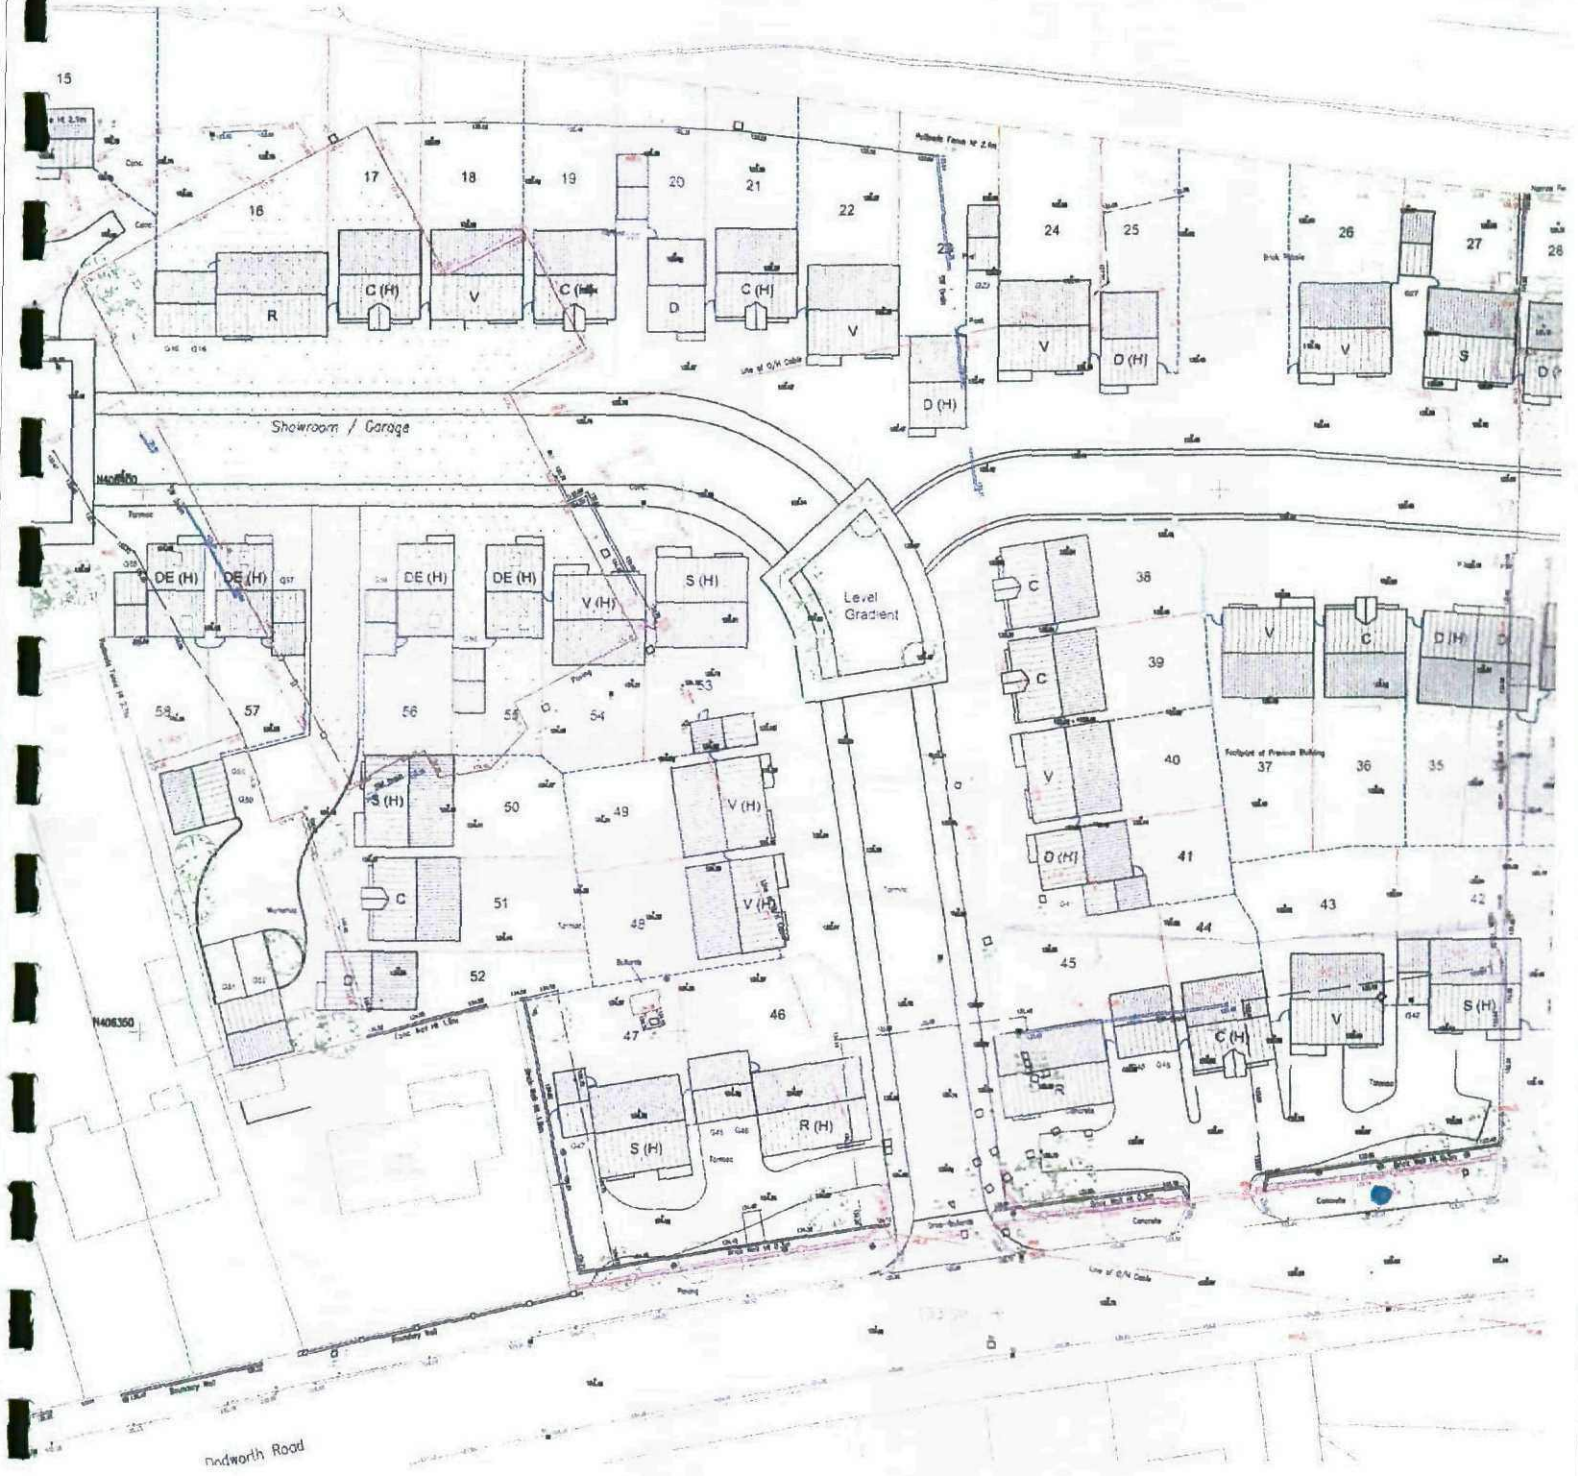
Root Protection Areas ---  
Construction Exclusion Zone

The locations of the trees are shown on the attached drawing along with my grades for each tree as shown in Appendix No.1 and in relation to BS5837 (2005). Those of grades A and B are normally considered as features to be retained in any development proposals with grade C trees

I have indicated my considered Root Protection Areas on the attached drawing for the possible protection of all grade B and C trees that could be affected by the works.

The root protection areas are based primarily on the stem diameters of the trees but root restrictions such as ground compaction and steep banks have also been taken into consideration.

When trees are retained then the Root Protection Areas indicated on the attached drawing should be protected during development. The protected areas will be the *Construction Exclusion Zones*. Fencing must be erected prior to any demolition or construction works commencing. No storage of materials, mixing of concrete, parking of vehicles etc is to take place within the protected areas designated on the attached drawing. These areas to be protected with secure fencing which will prevent access throughout the development and which will be installed prior to starting and not be removed until completion. Depending on the scale of the development and the trees to be protected, the protection fencing should be appropriate to the degree of protection required. I would recommend that the fencing be 'Heras-type' fencing some 2m tall with supports *driven* into the ground to prevent them being moved.
