Alfa Homes

PROJECT Cote Lane, Thurgoland  
TITLE Delapidation Survey – Sheet 2  
DATE 07.10.2019 SCALE NTS@A1  
DWG. No 002 REVISION —  
DRAWN BT CHECKED

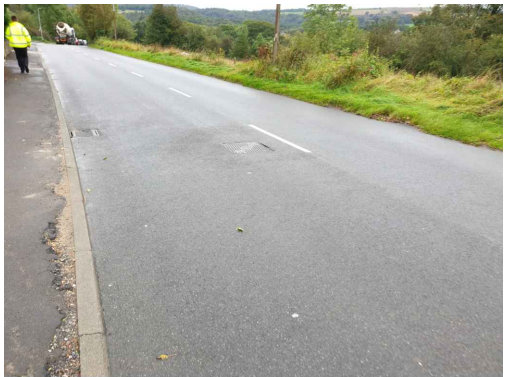
17 -Verge in tact

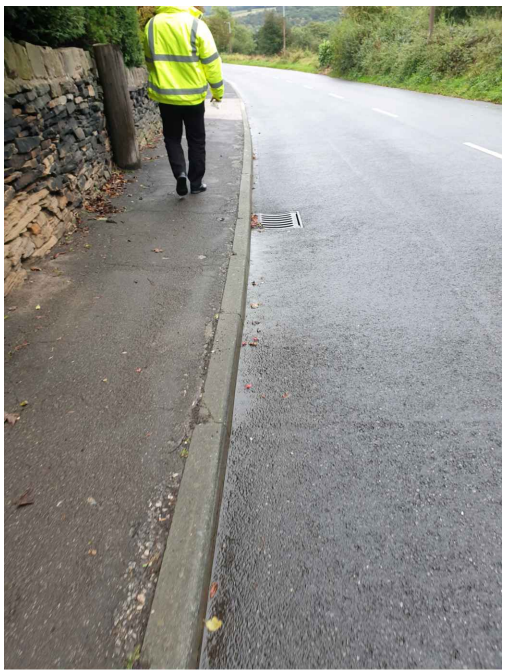
18 - Scarring and fretting on footway. Kerbs damaged and misaligned. Footway tarmac cracking and damaged

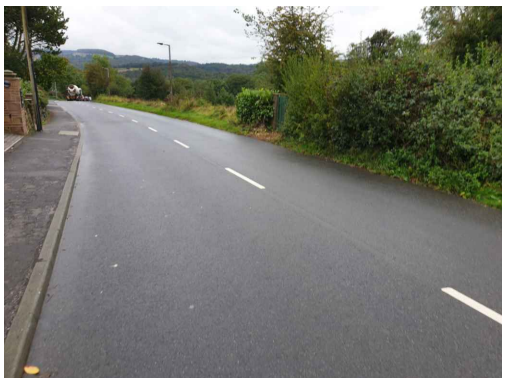
19 - Scarring and fretting on footway. Kerbs damaged and misaligned. Footway tarmac cracking and damaged

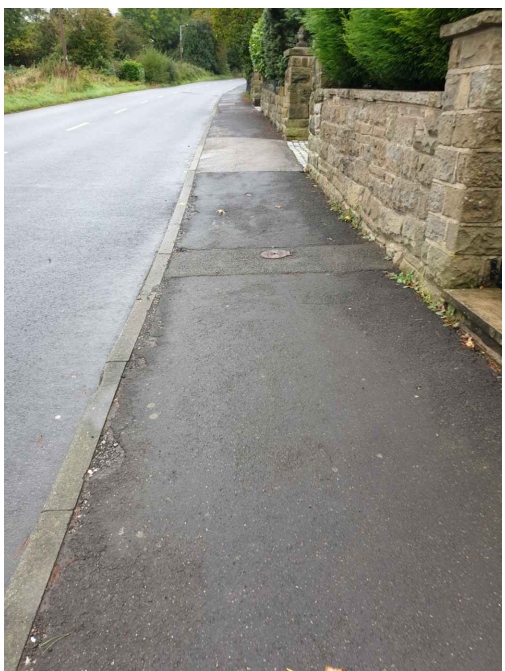
20 - Scarring and fretting on footway. Kerbs damaged and misaligned. Footway tarmac cracking and damaged

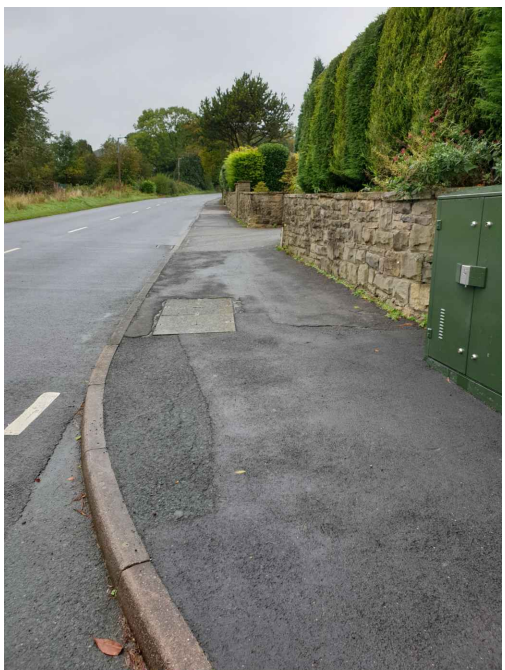
21 - Joint on junction is fretting. Kerbs damaged and misaligned. Footway tarmac cracking and damaged

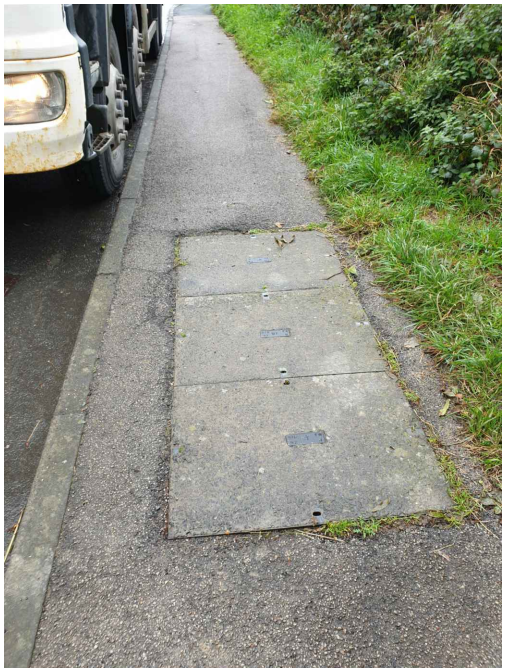
22 - Footpath around BT chambers badly damaged. Kerbs damaged and misaligned. Footway tarmac cracking and damaged

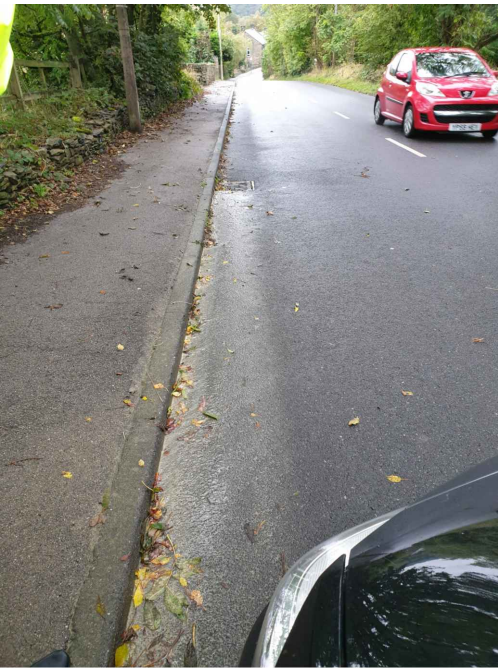
22 - Kerbs damaged and misaligned. Footway tarmac cracking.
