**ARBORICULTURAL REPORT**  
**to BS 5837:2012**  
**at**  
**94 Wood Walk**  
**Wombwell**  
**Barnsley**  
**South Yorkshire**  
**S73 0NF**

**Client:**  
George Nicholson

**JCA Ref:**  
12381/ChC

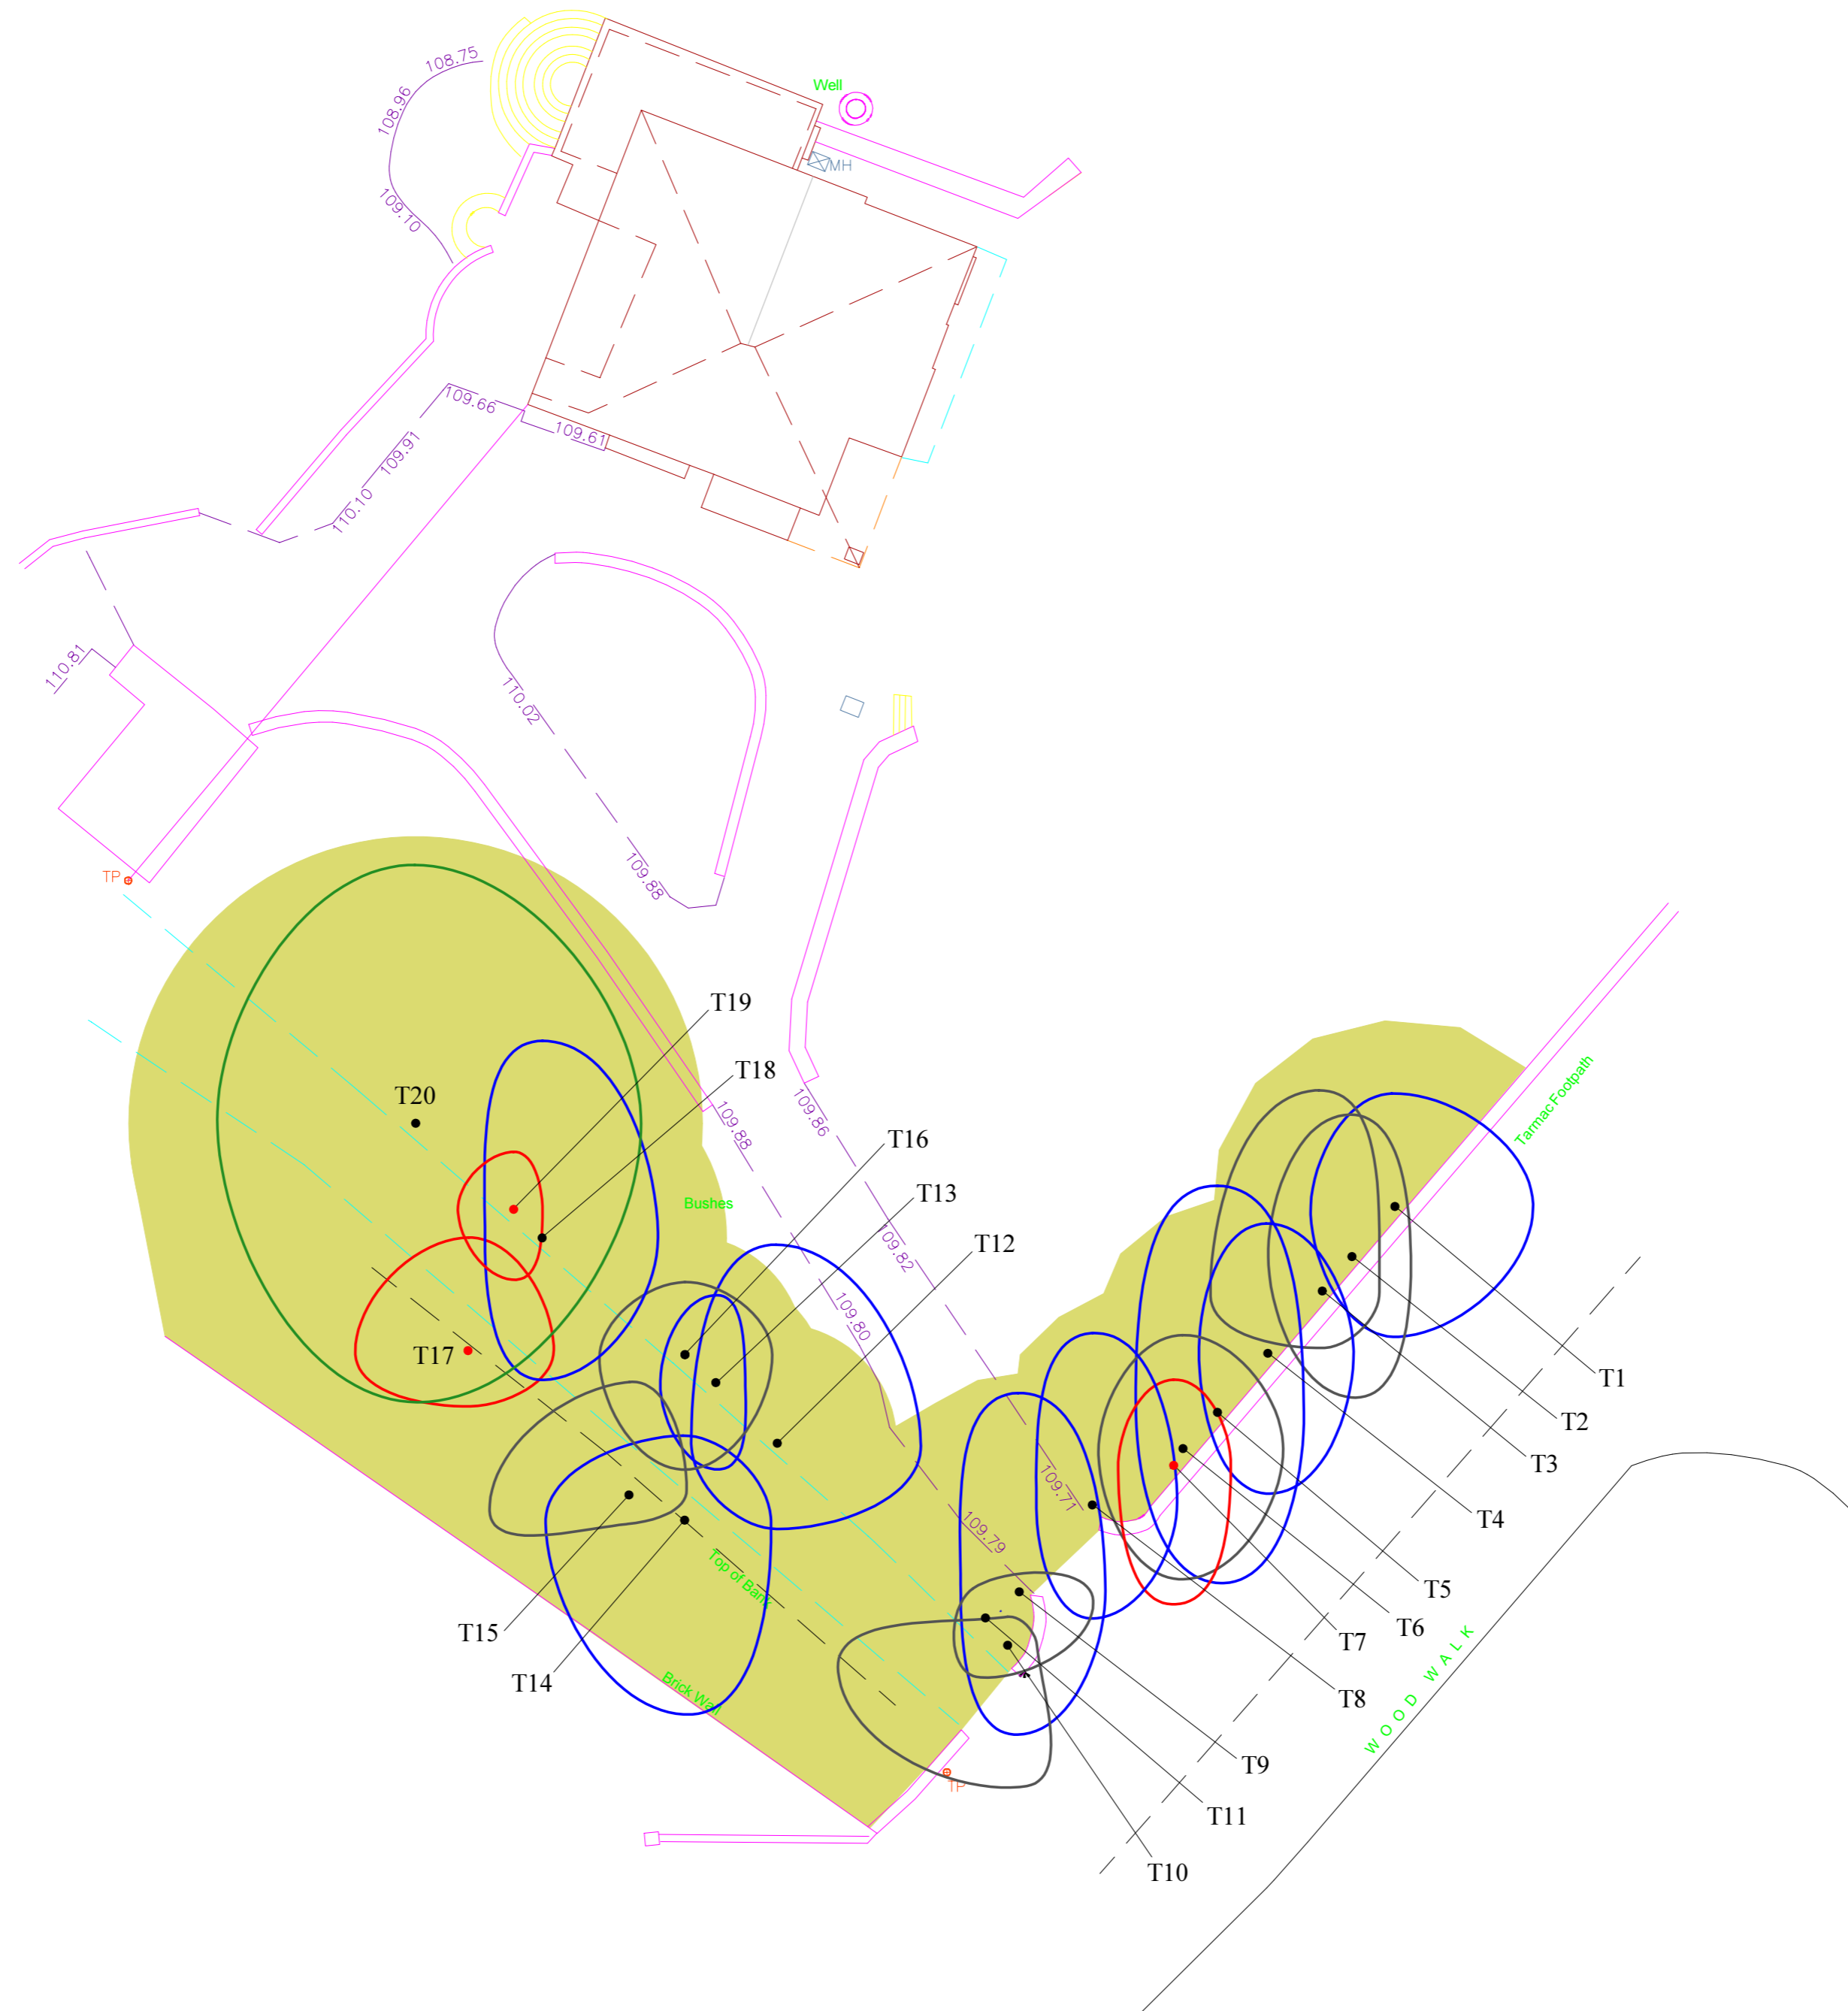
**Appendix 6:  
Tree Constraints Plan**

- 5.1.2 **T7, T17** and **T19** were identified as retention category 'U'. These trees require removal for arboricultural reasons regardless of any on site development, as detailed below:

- **T19** is considered to be unsafe and should be removed as a matter of **moderate priority**.
  - **T17** has been recommended for removal to prevent it from becoming a dangerous tree. Its removal is of a **lower priority** at present.
