**Pear Tree Farm  
Church Street  
Brierley**

**Structural Inspection Report**

PC/7520  
Oct 2025

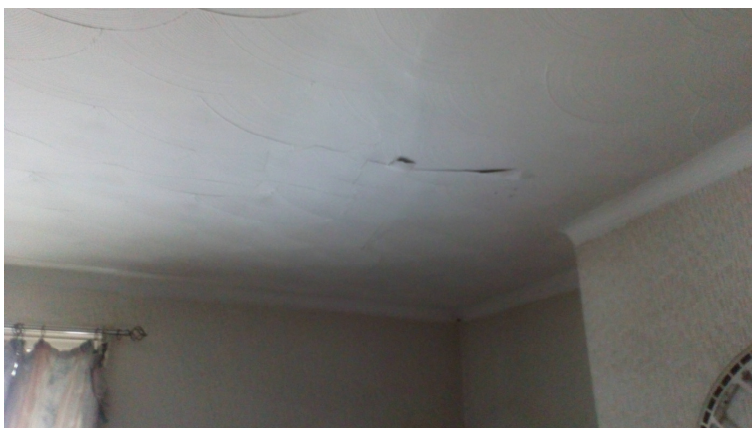
Photograph 1

Internally at first floor level there was cracking and sagging of the ceiling over the front left hand bedroom and some loose plaster and sagging of the ceiling over the right hand bedroom [Photograph 1]. The lightweight stud partition in the rear rooms had a 3mm wide vertical crack due to normal thermal and moisture movement. There was damp staining to several areas of ceiling indicating that the roof had leaked in the past and may still have been leaking [Photograph 2]. There was also damp to a number of external walls. The rear rooms had limited headroom.

- Checking the condition of the ceiling structure in the area of sagging. It is probable that timbers will need replacing or strengthening in this area. The ceiling plaster to the right hand bedroom will require replacement.

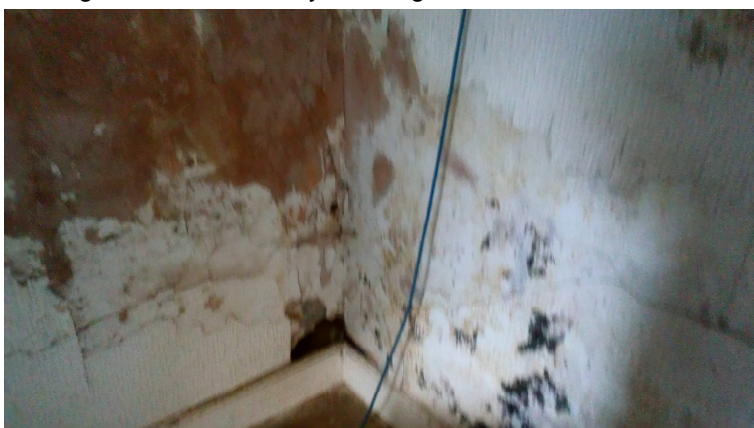
Photograph 3

Internally at ground floor level there was horizontal and vertical cracking up to 0.5mm wide in the walls of the lounges, kitchen and dining room. This appeared to be due to normal thermal and moisture movement rather than any significant structural movement. There was damp to several walls [Photograph 3]. This damp may have affected the ends of the ground floor timber joists. Again the rear rooms had limited headroom.

- Checking the condition of the ground floor joists where they are sat in the outer walls.
- Repointing the chimney stacks and replacing the worst eroded bricks.

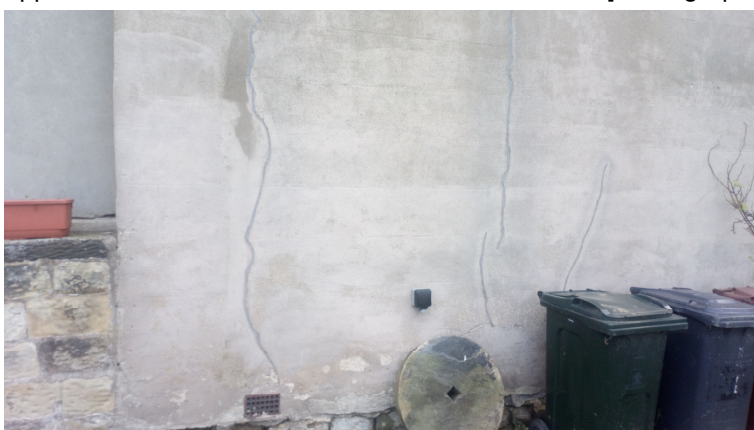
Photograph 4

Externally the render was in poor condition with extensive cracking, the majority of which had been poorly filled with mastic, and spalling [Photograph 4, 5 and 6]. This cracking appeared to be due to normal thermal and moisture movement, particularly at junctions of the original building with the extensions and at positions of infilled openings, combined with age related failing of the render and expansion forces from corrosion of embedded metal fixings in the walls. No evidence of any significant foundation movement was observed. There had been some movement of the top of the external wall to the rear right hand corner resulting in a 50mm wide gap at the end of the bedroom window lintel and deviation in the line of the wall [Photograph 7]. The cause of this movement was unclear but may have been due to either roof spread or a lack of tie between the outer leaf of stone and the inner leaf. However this damage appeared to be old as the eaves soffit had been cut to suit the deviation several years ago. The brickwork to the chimneys above roof level appeared to have undergone significant erosion. In addition the stonework to the rear of the building had been repointed with cement mortar. This appeared to have accelerated erosion of the stone [Photograph 8].

The farmhouse is structurally stable at present. However at some stage it will require extensive refurbishment including replacing the render and mortar with lime based

materials and damp treatment. In addition structural repairs will consist of:

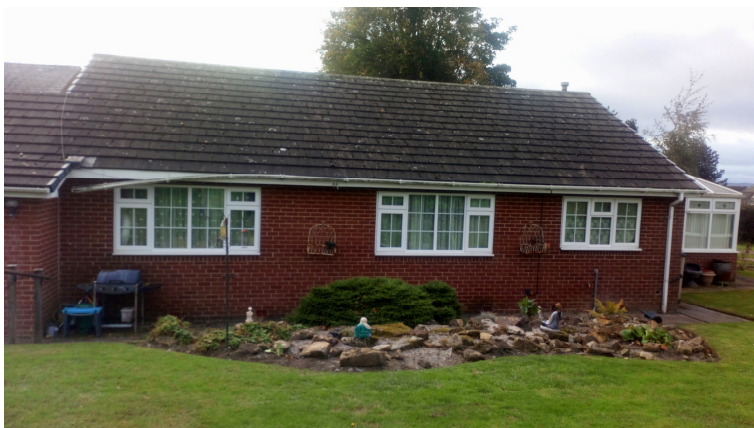
Photograph 9

No significant structural defects were observed in the external walls. A gutter was loose and was discharging rainwater against the building [Photograph 9]. This should be repaired.

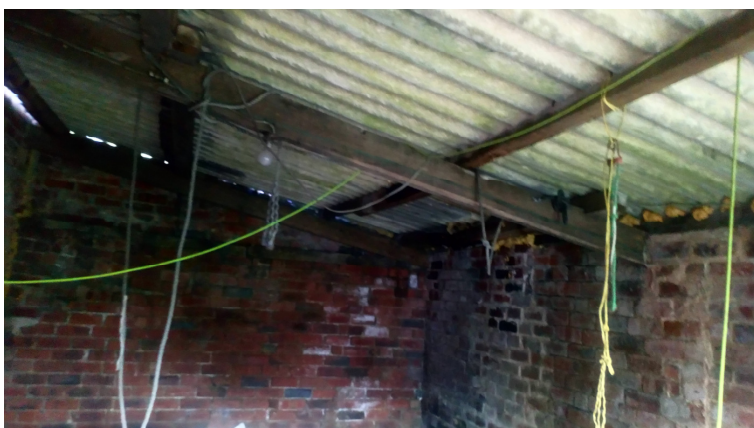
Photograph 10

All roofs were covered by lightweight asbestos cement sheeting. This sheeting was supported by timber purlins spanning between walls and, on the larger buildings, timber trusses. It was apparent that some of the purlins were undersized for the span and loading and had deflected although not to an extent that compromised the structural integrity of the roof [Photograph 10].

- Strengthening or replacing all structurally inadequate trusses, purlins, rafters and lintels.
- Repairing or replacing all rotten sections of timber.
- Replacing the missing diagonals to the trusses in the front outbuilding.
- Strengthening the poorly bonded sections of masonry with steel ties and straps.
- Replacing the ground floor with a suitably dampproofed and insulated floor slab.
- Cutting out and replacing the worst areas of frost damaged brickwork.

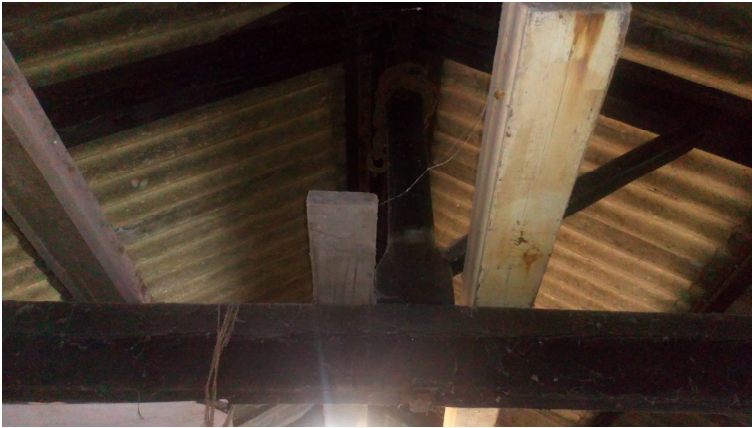
Photograph 11

Internal diagonals had been removed from the trusses in the front outbuilding [Photograph 11]. This would reduce the load capacity of the trusses.

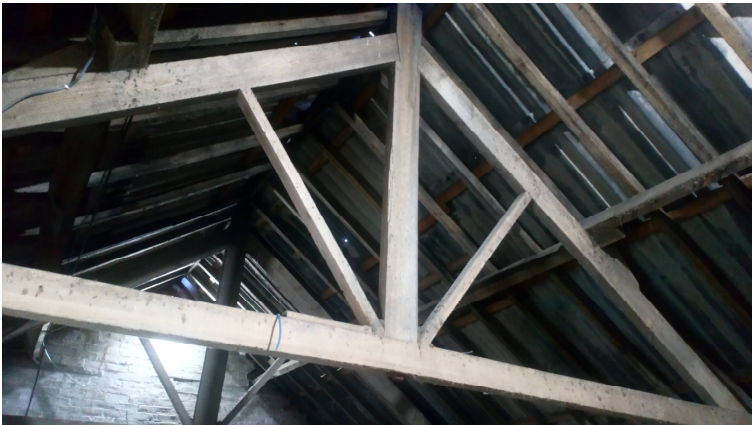
Photograph 12

The trusses to the middle outbuilding were undersized for the span and loading and had deflected [Photograph 12]. There was also evidence of rot to the ends of the trusses and to the lintel over the main doorway [Photographs 13 and 14].

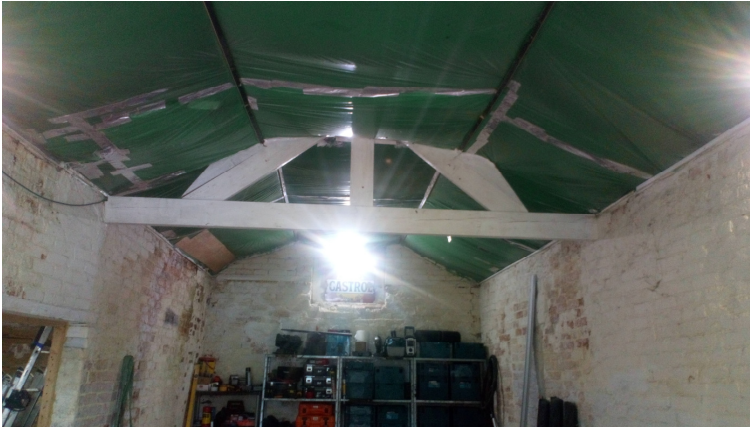
Photograph 15

The roof to the rear workshop was covered in sheeting and could not be inspected. An internal wall had been removed and a timber truss installed [Photograph 15]. The configuration of the truss would result in excessive deflection under heavy roof loading. A timber lintel over an opening between the middle outbuilding and workshop was undersized and had deflected [Photograph 16]

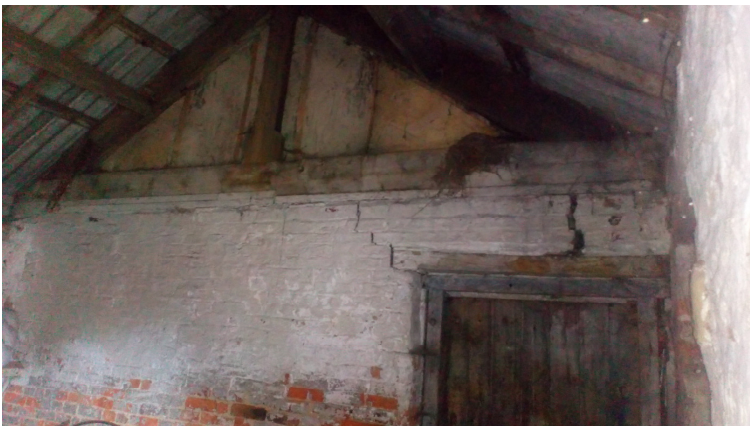
Photograph 17

There was limited access to the right hand projecting outbuilding but it was apparent that the roof sheeting was missing over one end and therefore it is probable that the roof timbers have deteriorated. There was a 50mm wide vertical crack above the internal doorway of the outbuilding, probably due to an inadequate timber lintel combined with some lateral movement of the external wall due to deflection of undersized purlins [Photograph 17].

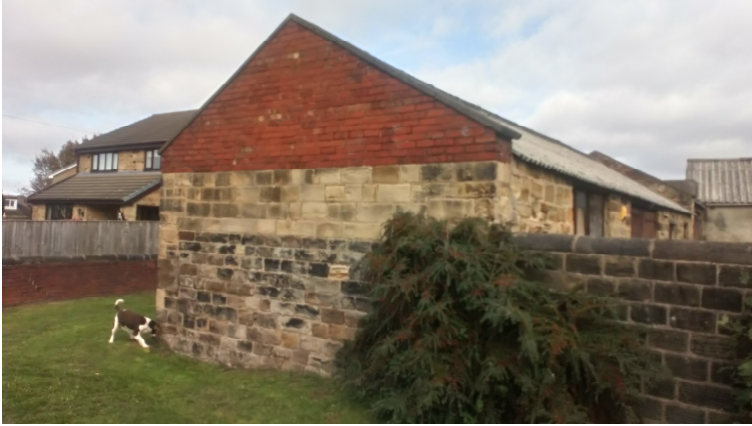
Photograph 18

The walls were a mixture of stone and brick [Photographs 18 and 19]. There was no evidence of any significant cracking to indicate foundation movement was occurring. However there were some vertical cracks up to 25mm wide at poorly bonded junctions between the different walls/materials. There was also some frost damage to areas of masonry [Photograph 20]. Some external walls had been rendered and the render was in poor condition and was spalling in some places [Photograph 21].
