Hoyle Mill, Thurlstone

## **CROMWELL WOOD ESTATE COMPANY LIMITED**

# **PHASE 1 ENVIRONMENTAL REPORT**

## **HOYLE MILL, THURLSTONE**

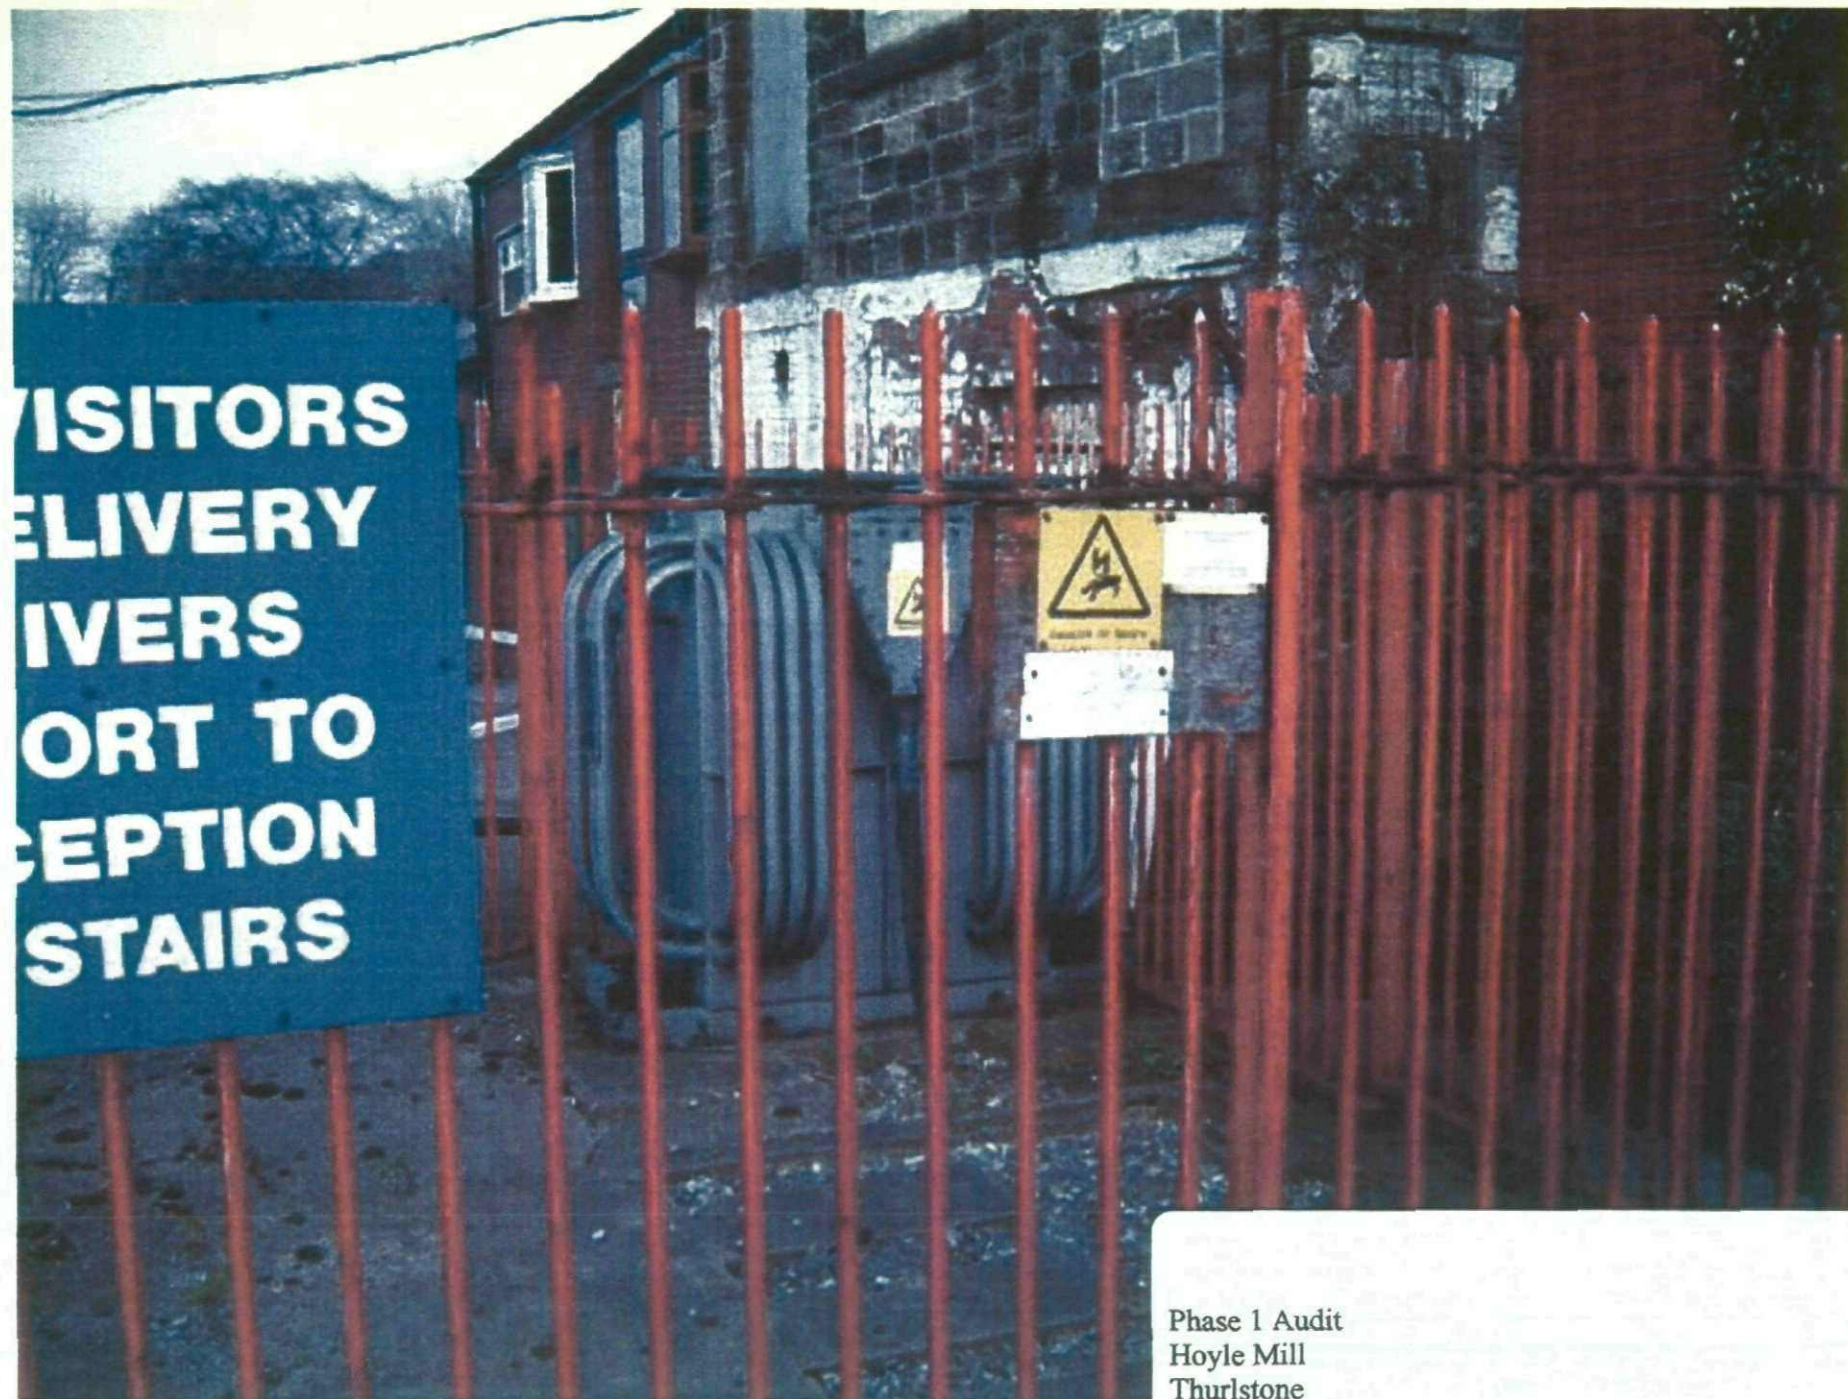
Photograph number 13 shows the sub station for the complex and the fence around it. The transformer is on a sealed base and there are no signs of leakage or spillage. The Electricity Company have a policy of regular maintenance of sub stations which involves checking the cooling oil and testing it for contaminants such as PCBs. The oil used to cool the sub station does not produce PCBs as it was phased out some time ago by the company.
