Technical Note

Project:	P17-176 Athersley RLE		
Subject:	Technical Note – Coal Mining Investigation		
Prepared by:	Adam Taylor MGeol (Hons) FGS Geo-Environmental Engineer	Date:	8 Nov 2019
Authorised by:	Stewart Friel MSc BSc (Hons) MIEEnvSc Director	Status:	S2 - Information
Document Ref:	17176-RLE-19-XX-RP-O-004	Revision:	P01

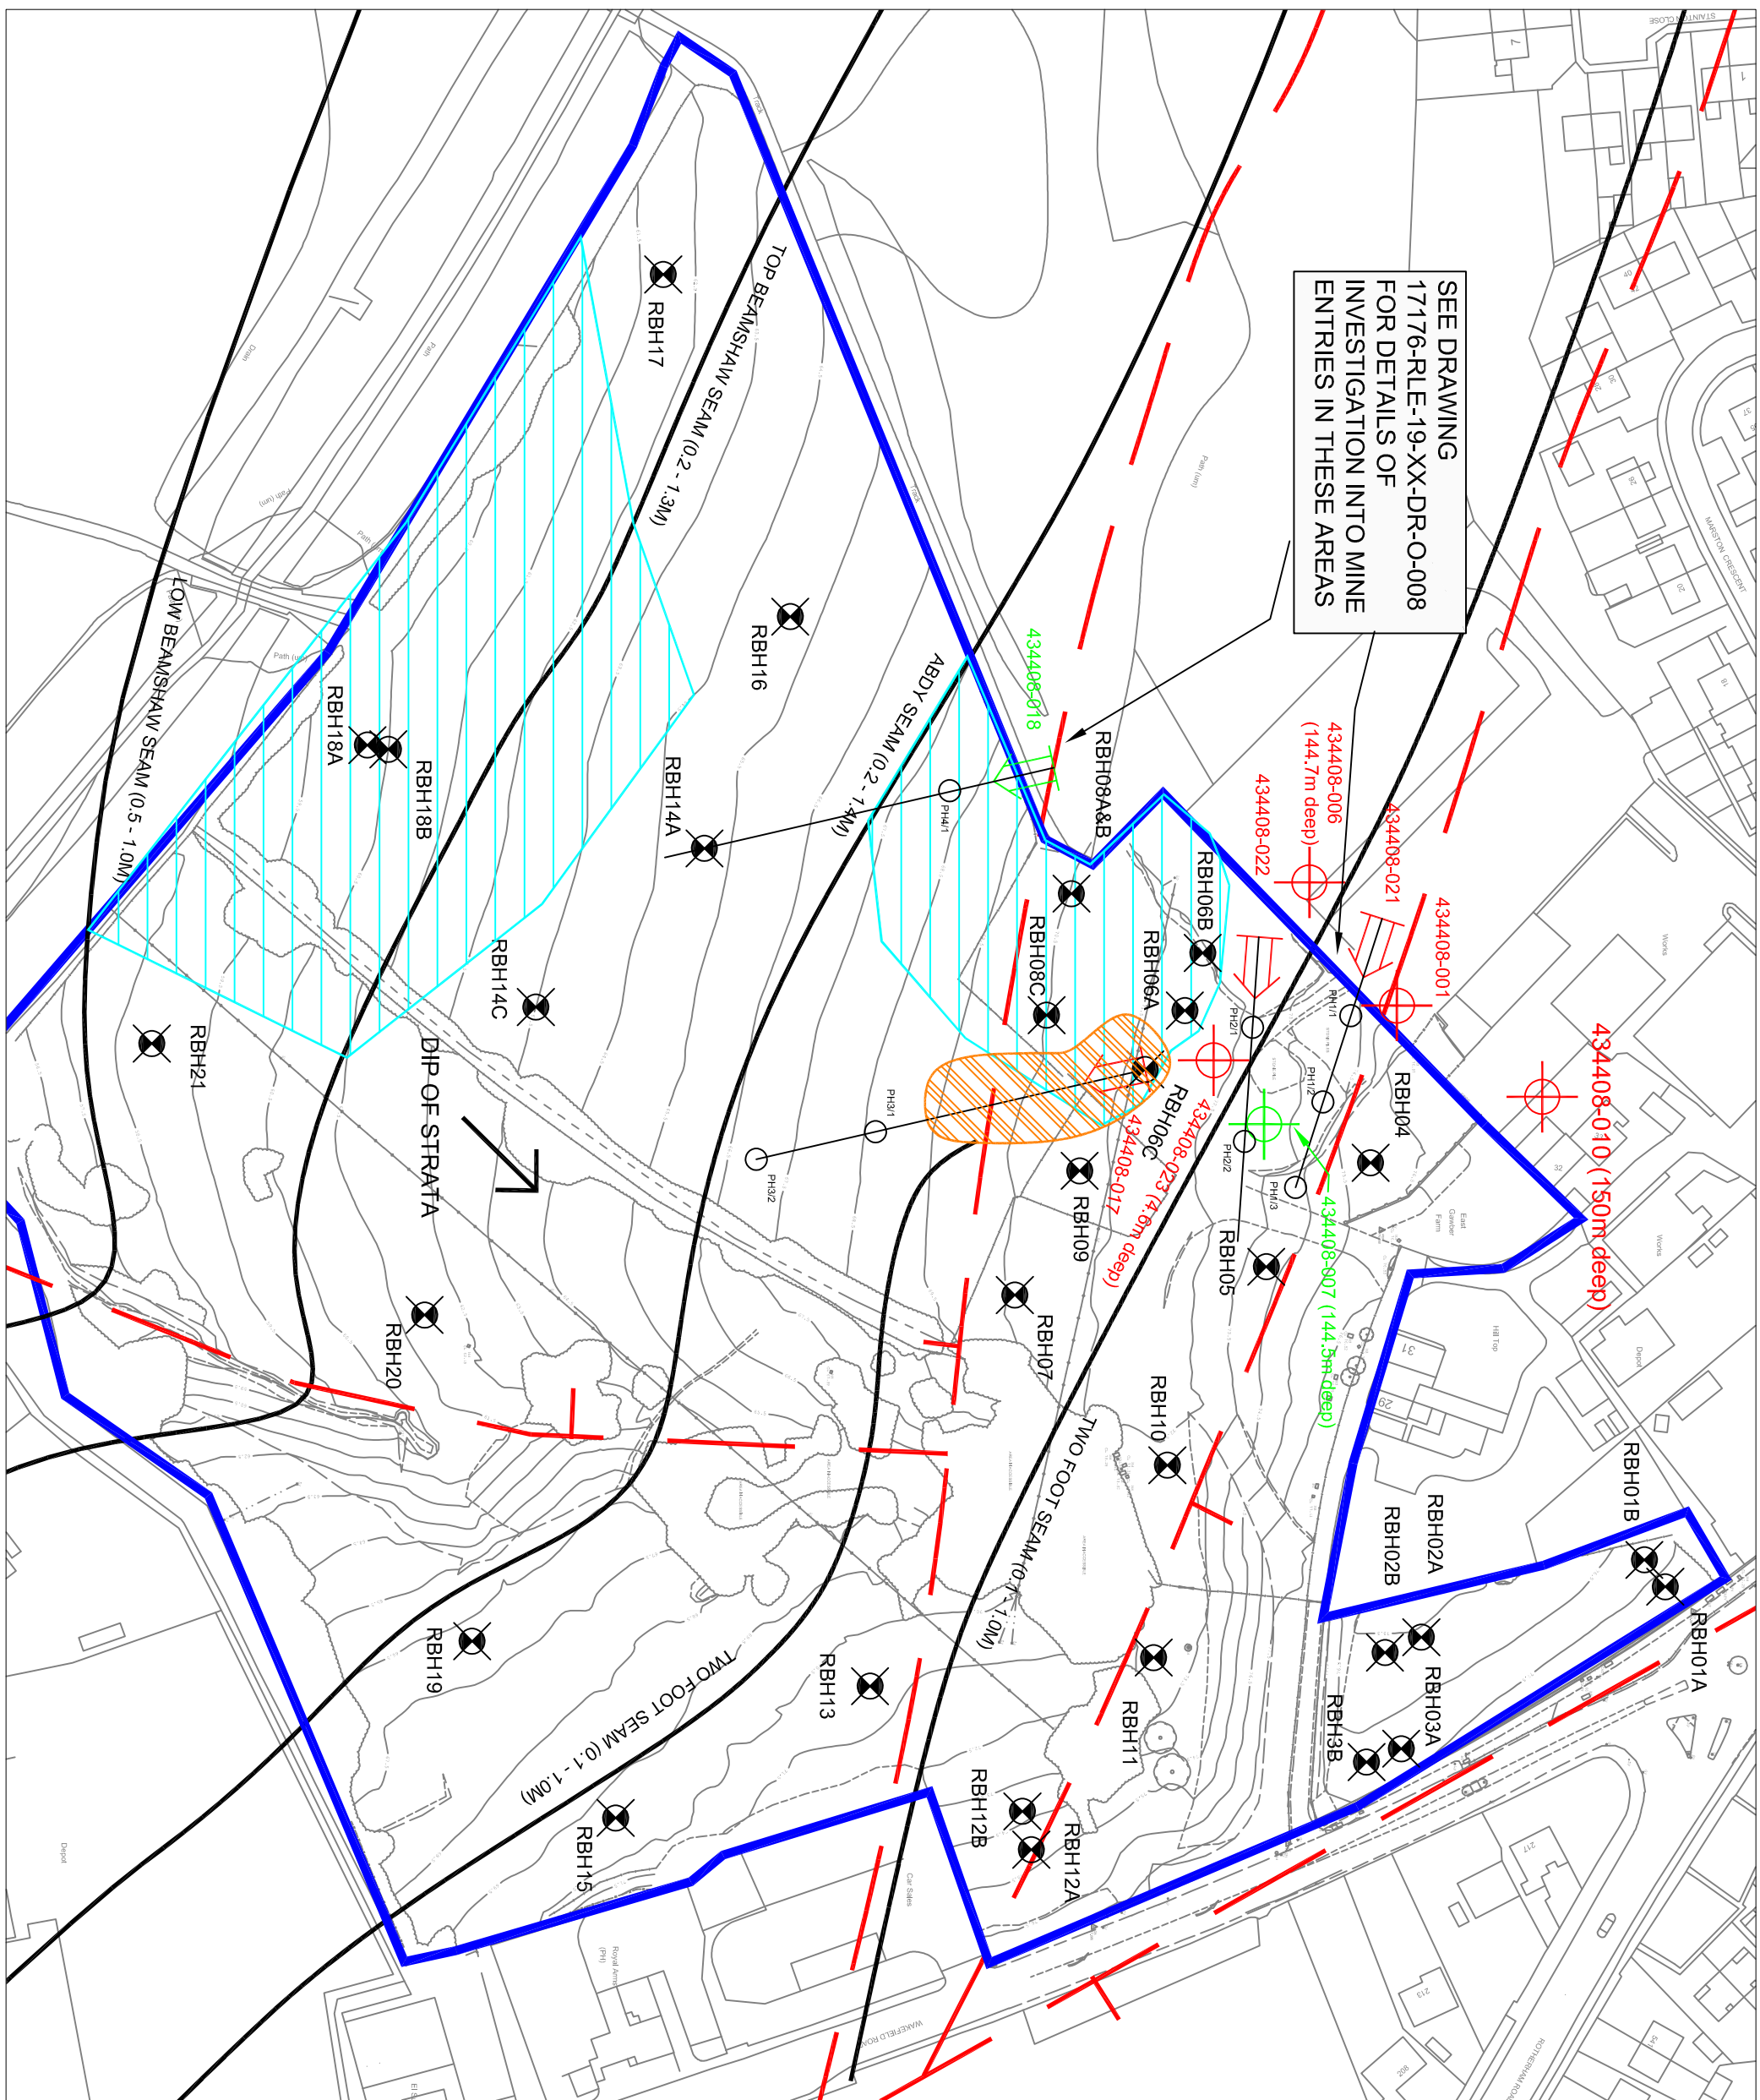
Drawing No: 17176-RLE-19-XX-DR-O-007

The Site is heavily affected by faulting, as indicated on RLE Drawing 17176-RLE-19-XX-DR-O-007 (Appendix B). Three normal faults are inferred to cross the Site, and the depth, thickness and quality of coal seams vary across the fault zones.

Possible unrecorded shallow working near Adit 434408-018	HIGH (hatched area in NW)	Further investigation is recommended, drilling and grouting is likely to be required in hatched area shown on RLE Drawing 17176-RLE-19-XX-DR-007. Voids and backfilled ground were identified at shallow depth close to Adit 434408-018, at depths between the Abdy and Top Beamshaw seams – no coal was encountered at this depth hence this may either be the adit or unrecorded working for another mineral such as fireclay or ironstone.
Shallow working in the Top Beamshaw Seam	LOW	Seam found intact in all boreholes which intercepted it. Extensive working is considered unlikely due to significant faulting in the north and east of Site, and the presence of a split within this seam which separates and reduces the quality of this coal. However, some areas of good quality workable coal were identified at shallow depth, hence small-scale unrecorded working (bell pits) cannot entirely be discounted.

- Treatment of shallow mine workings will be required where identified in the Abdy Seam, Low Beamshaw Seam and an unidentified seam/mineral near Adit 434408-018. These are indicated as hatched areas on RLE Drawing 17176-RLE-19-XX-DR-O-007. Further investigation works and/or a trial drill and grout exercise should be undertaken close to areas of identified working to more accurately constrain the area which requires treatment.

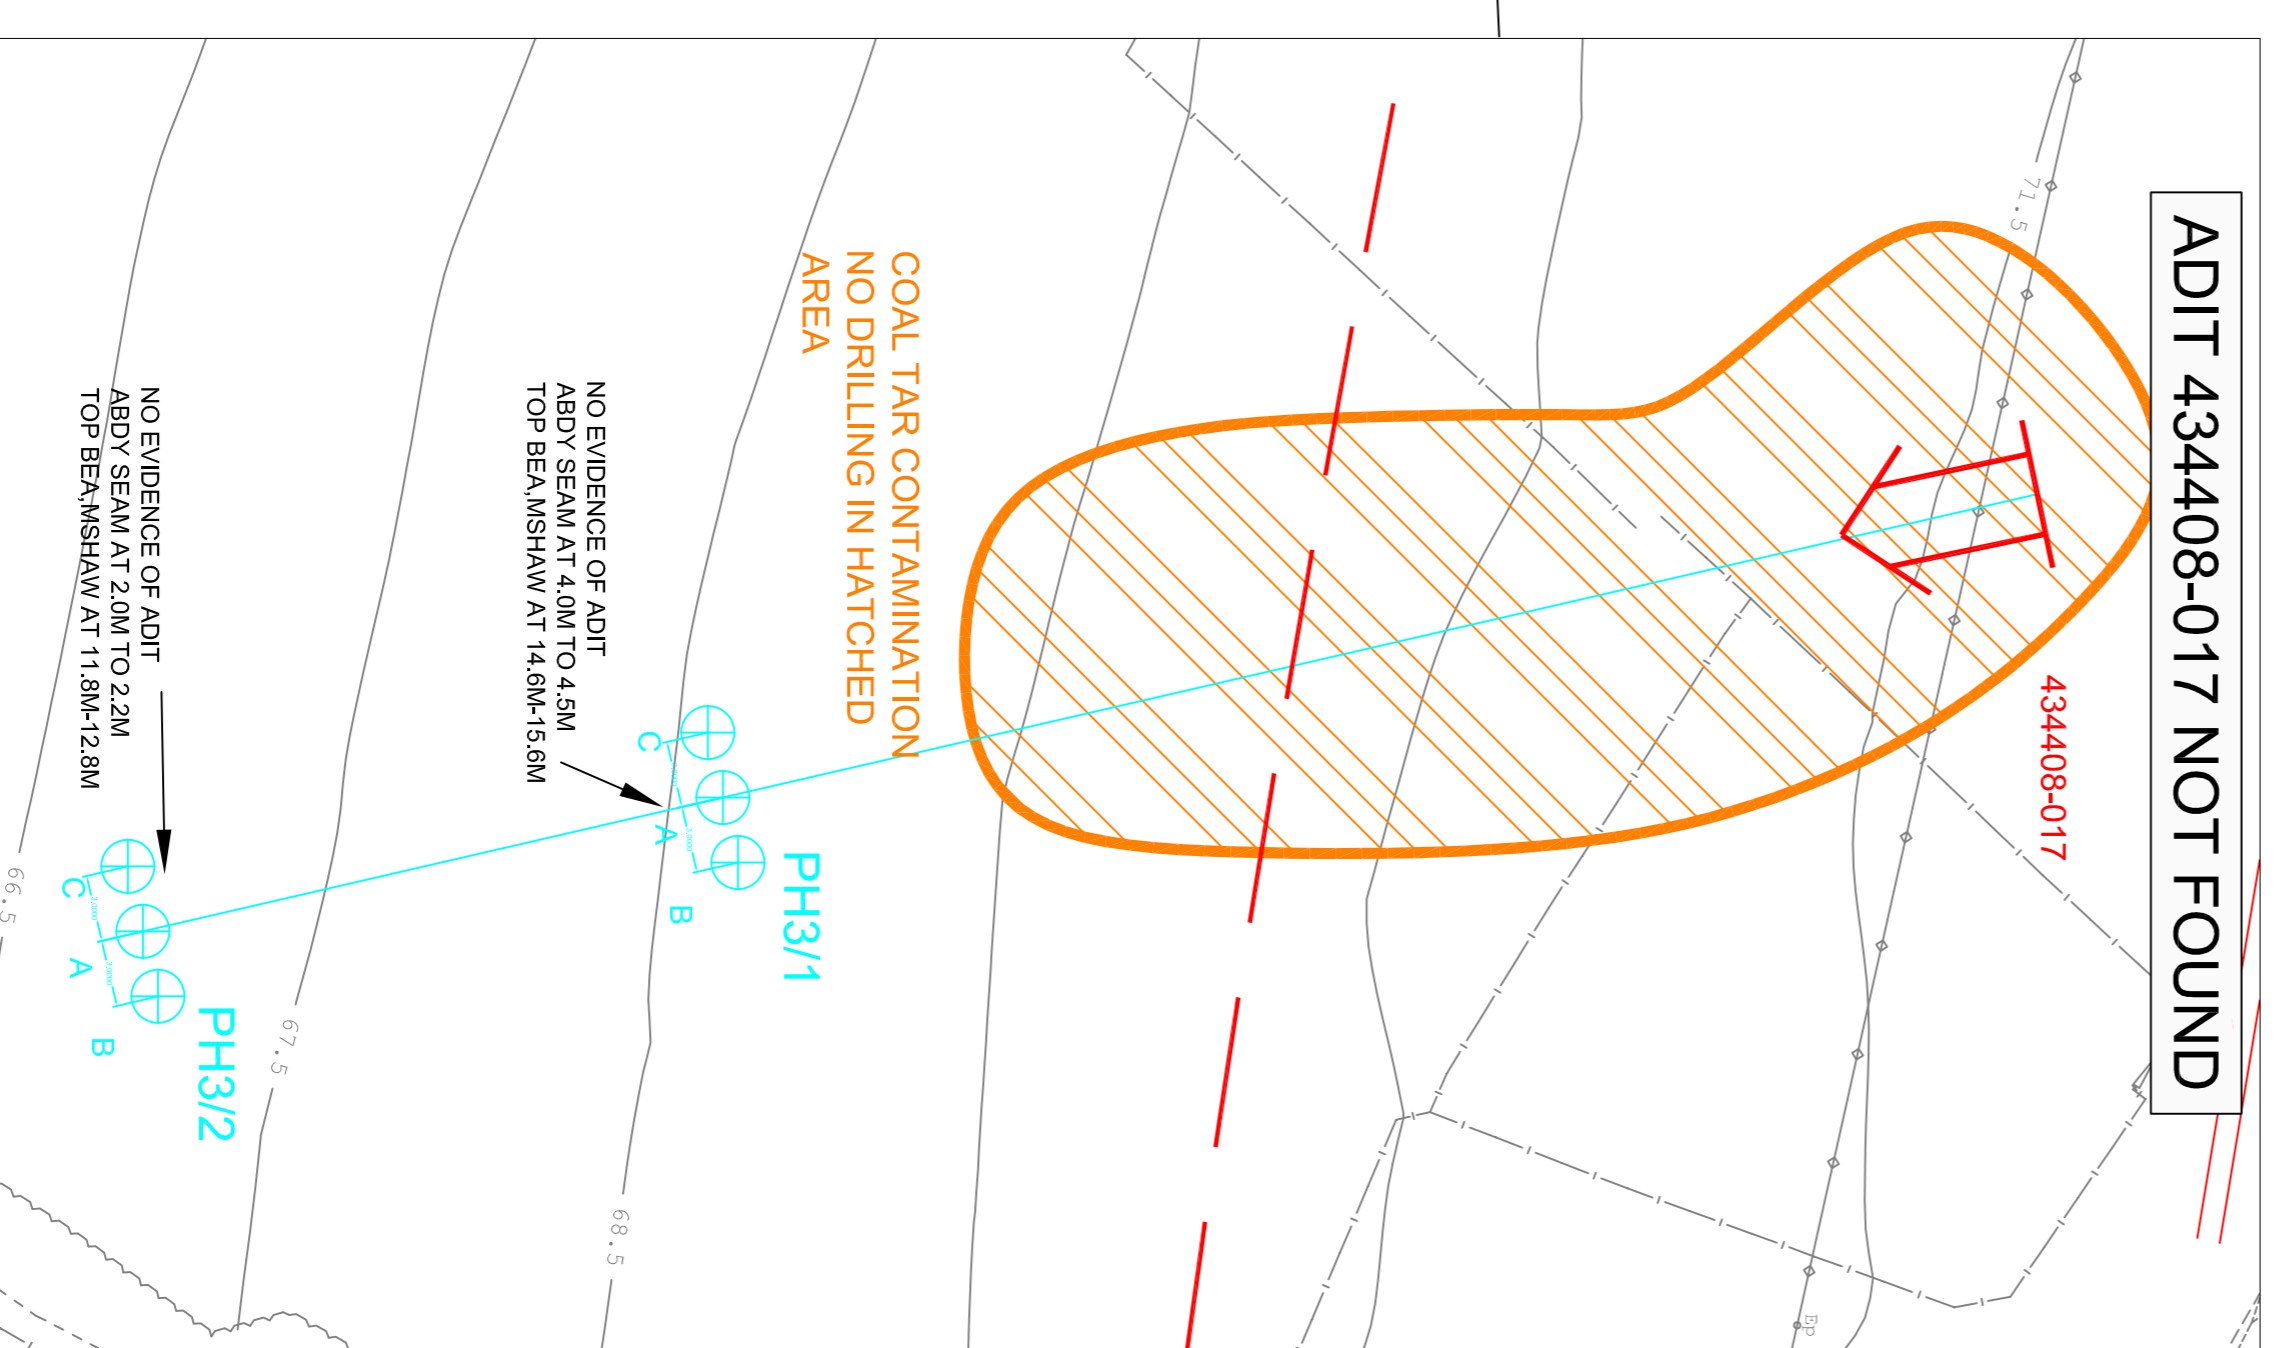
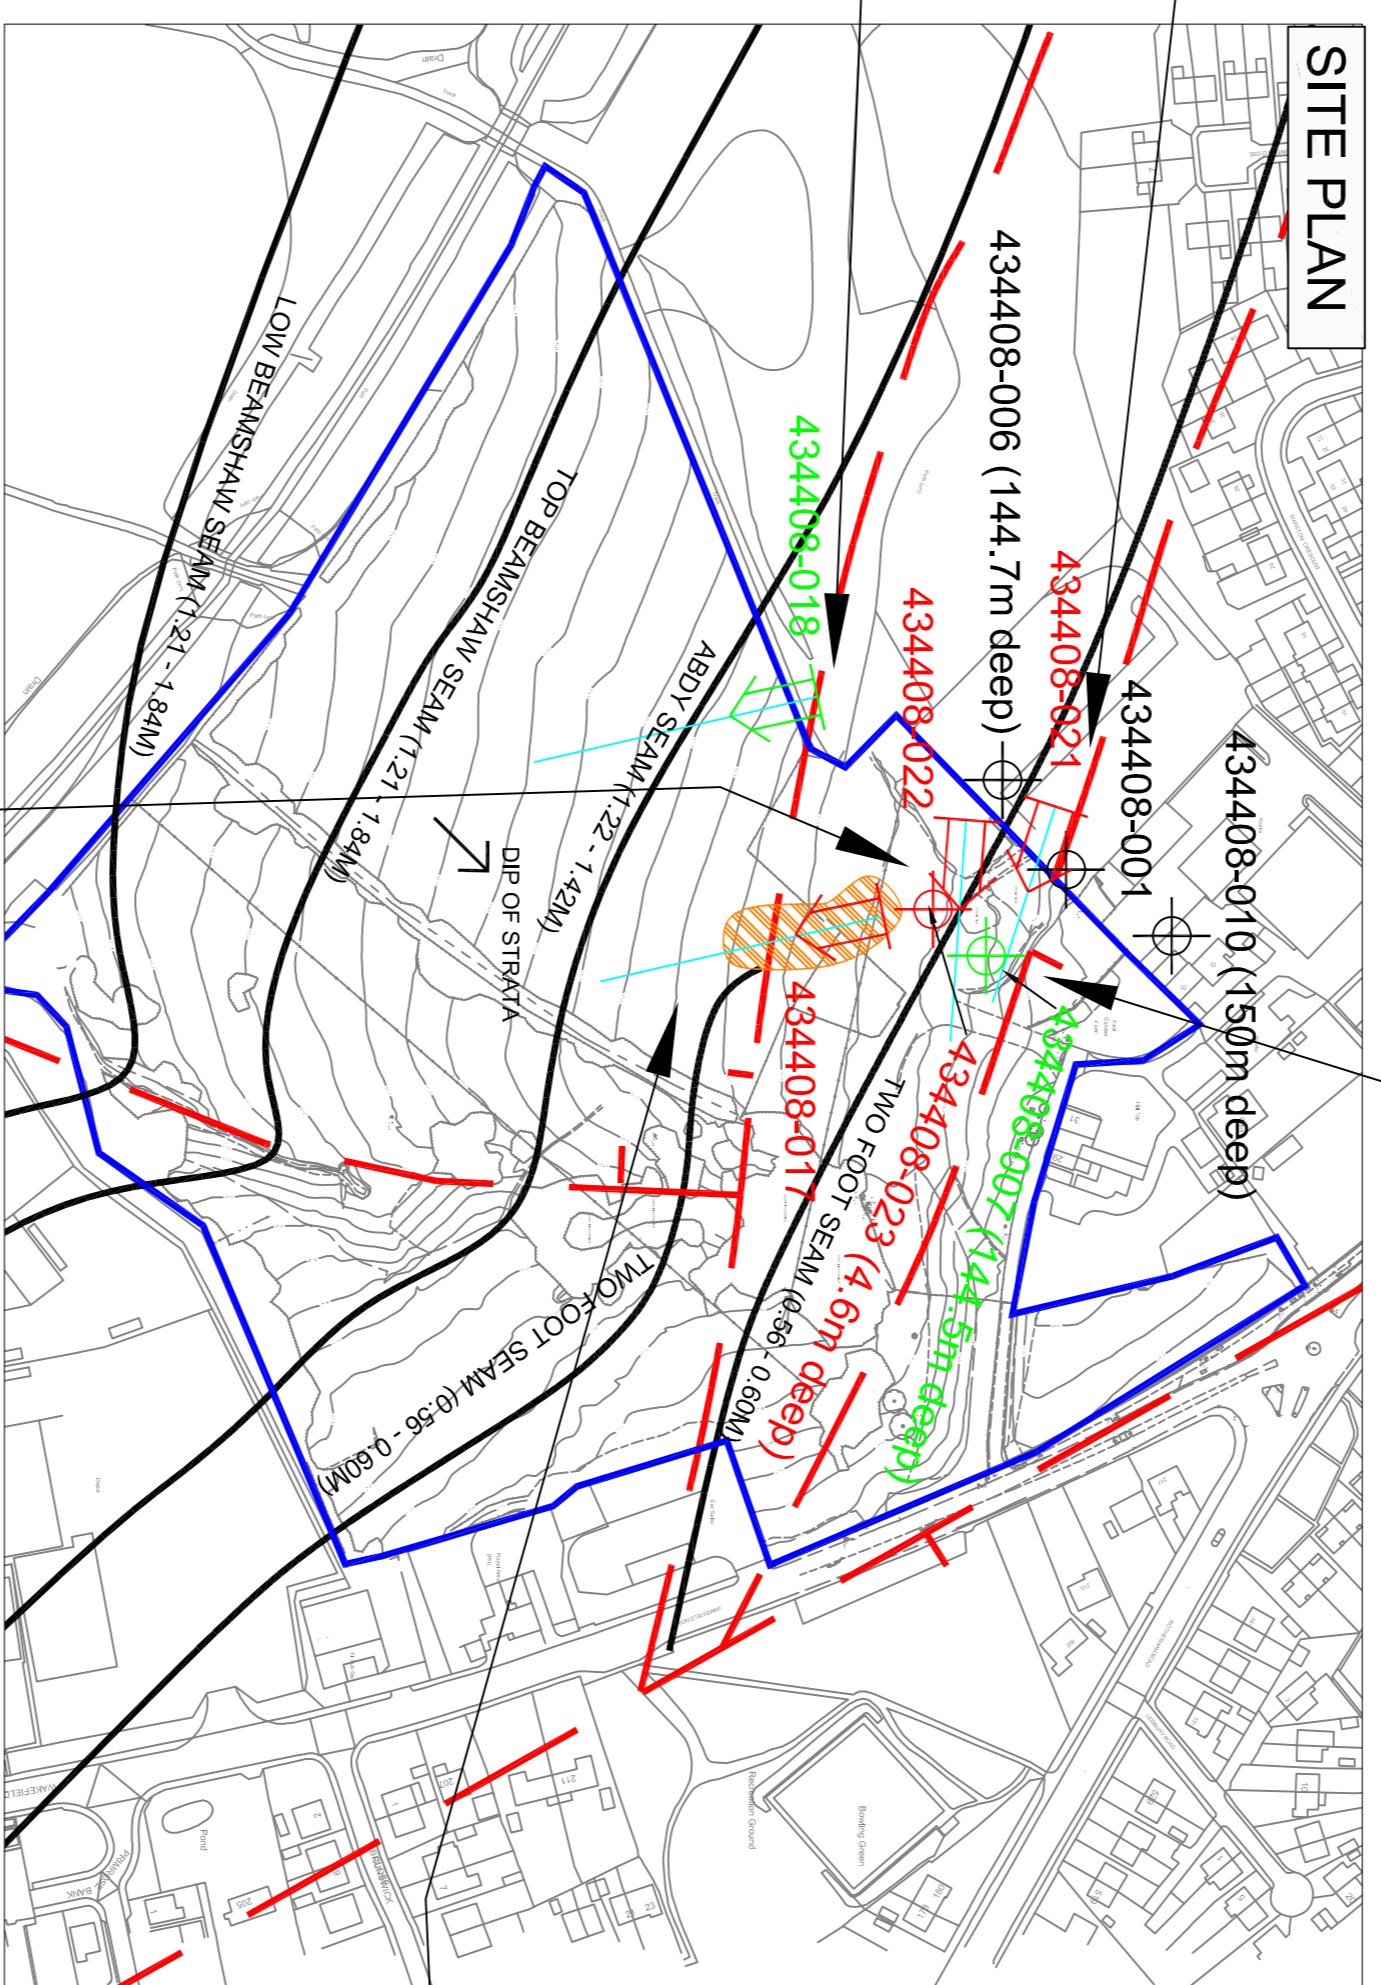
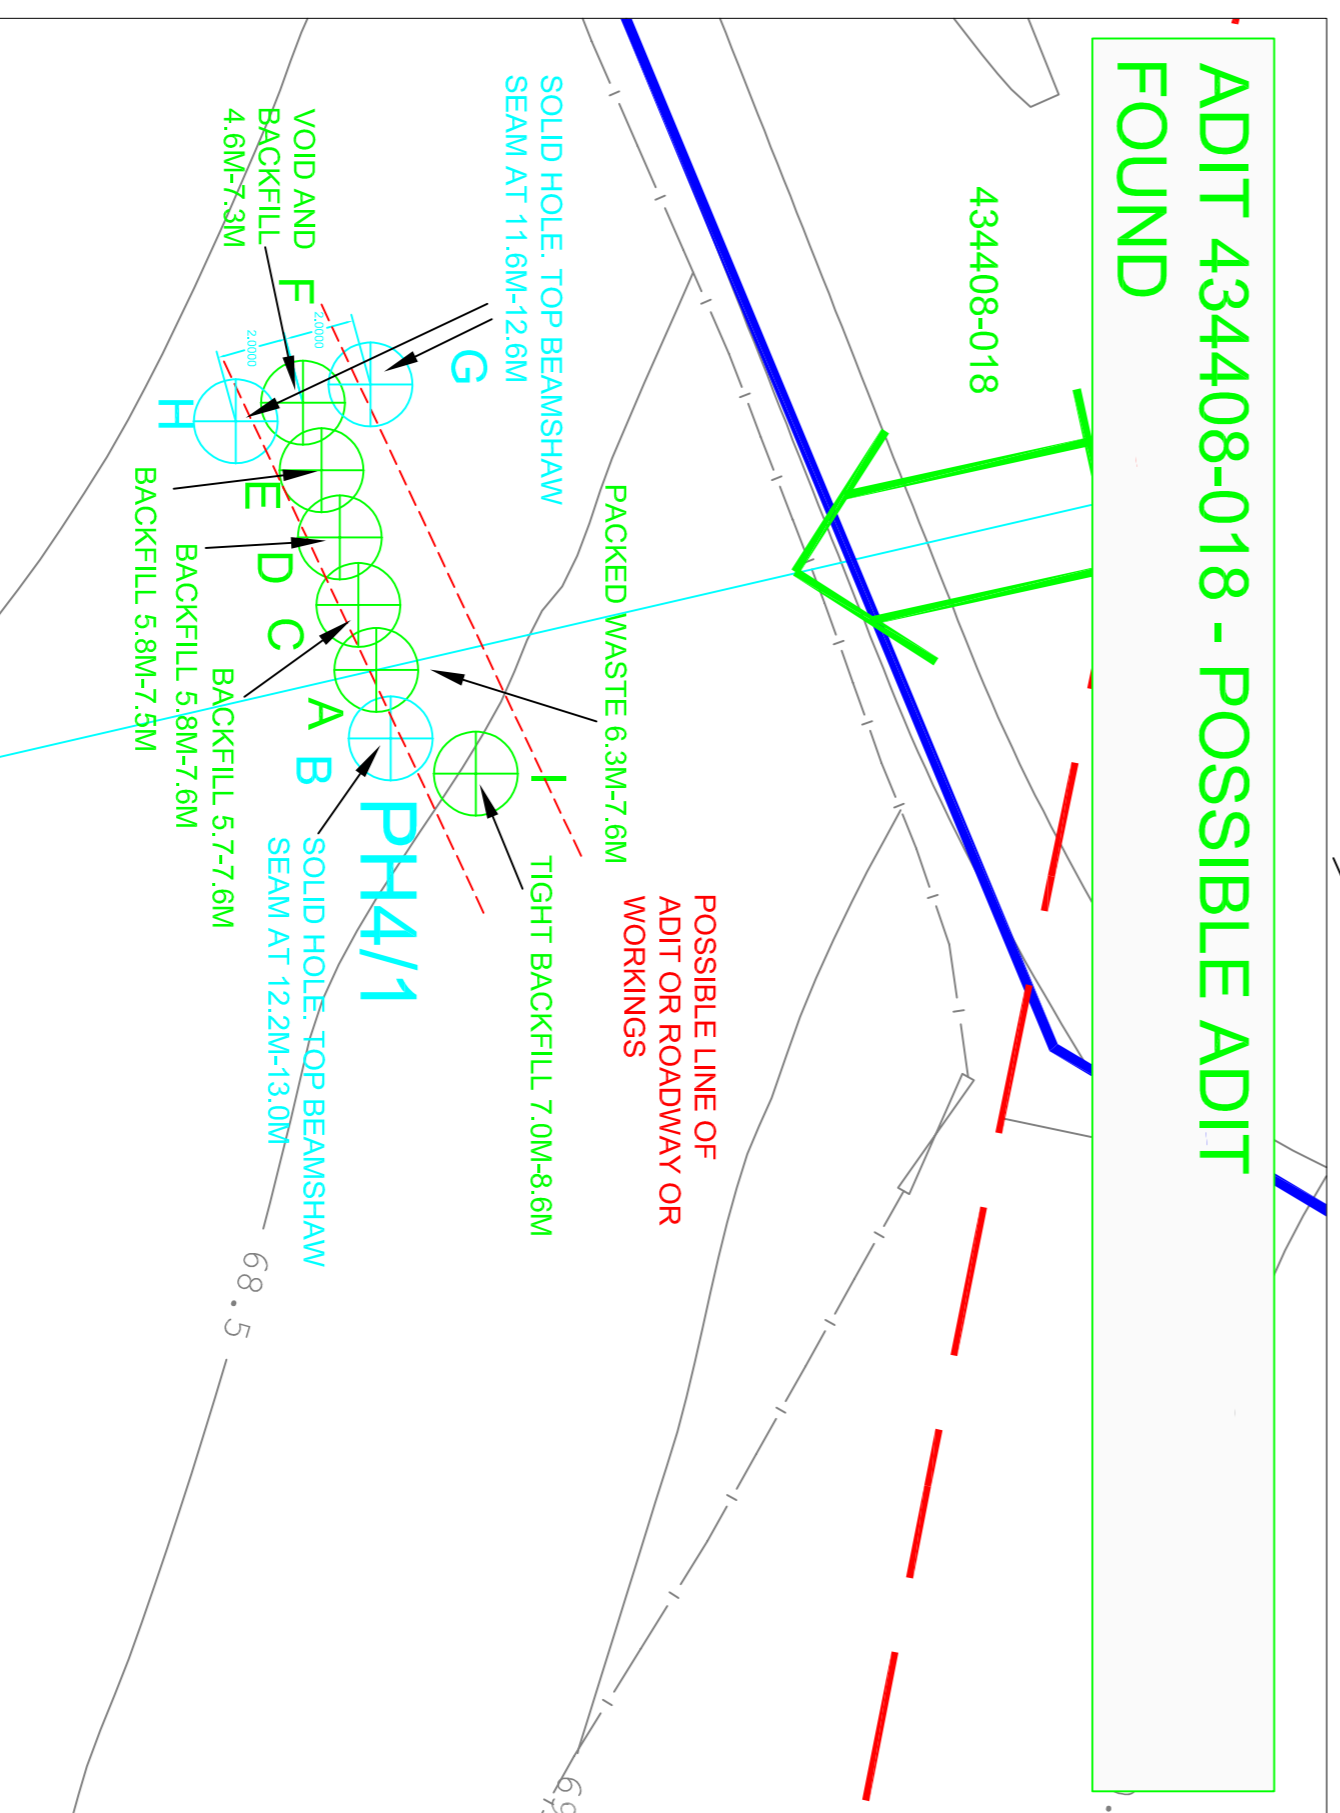
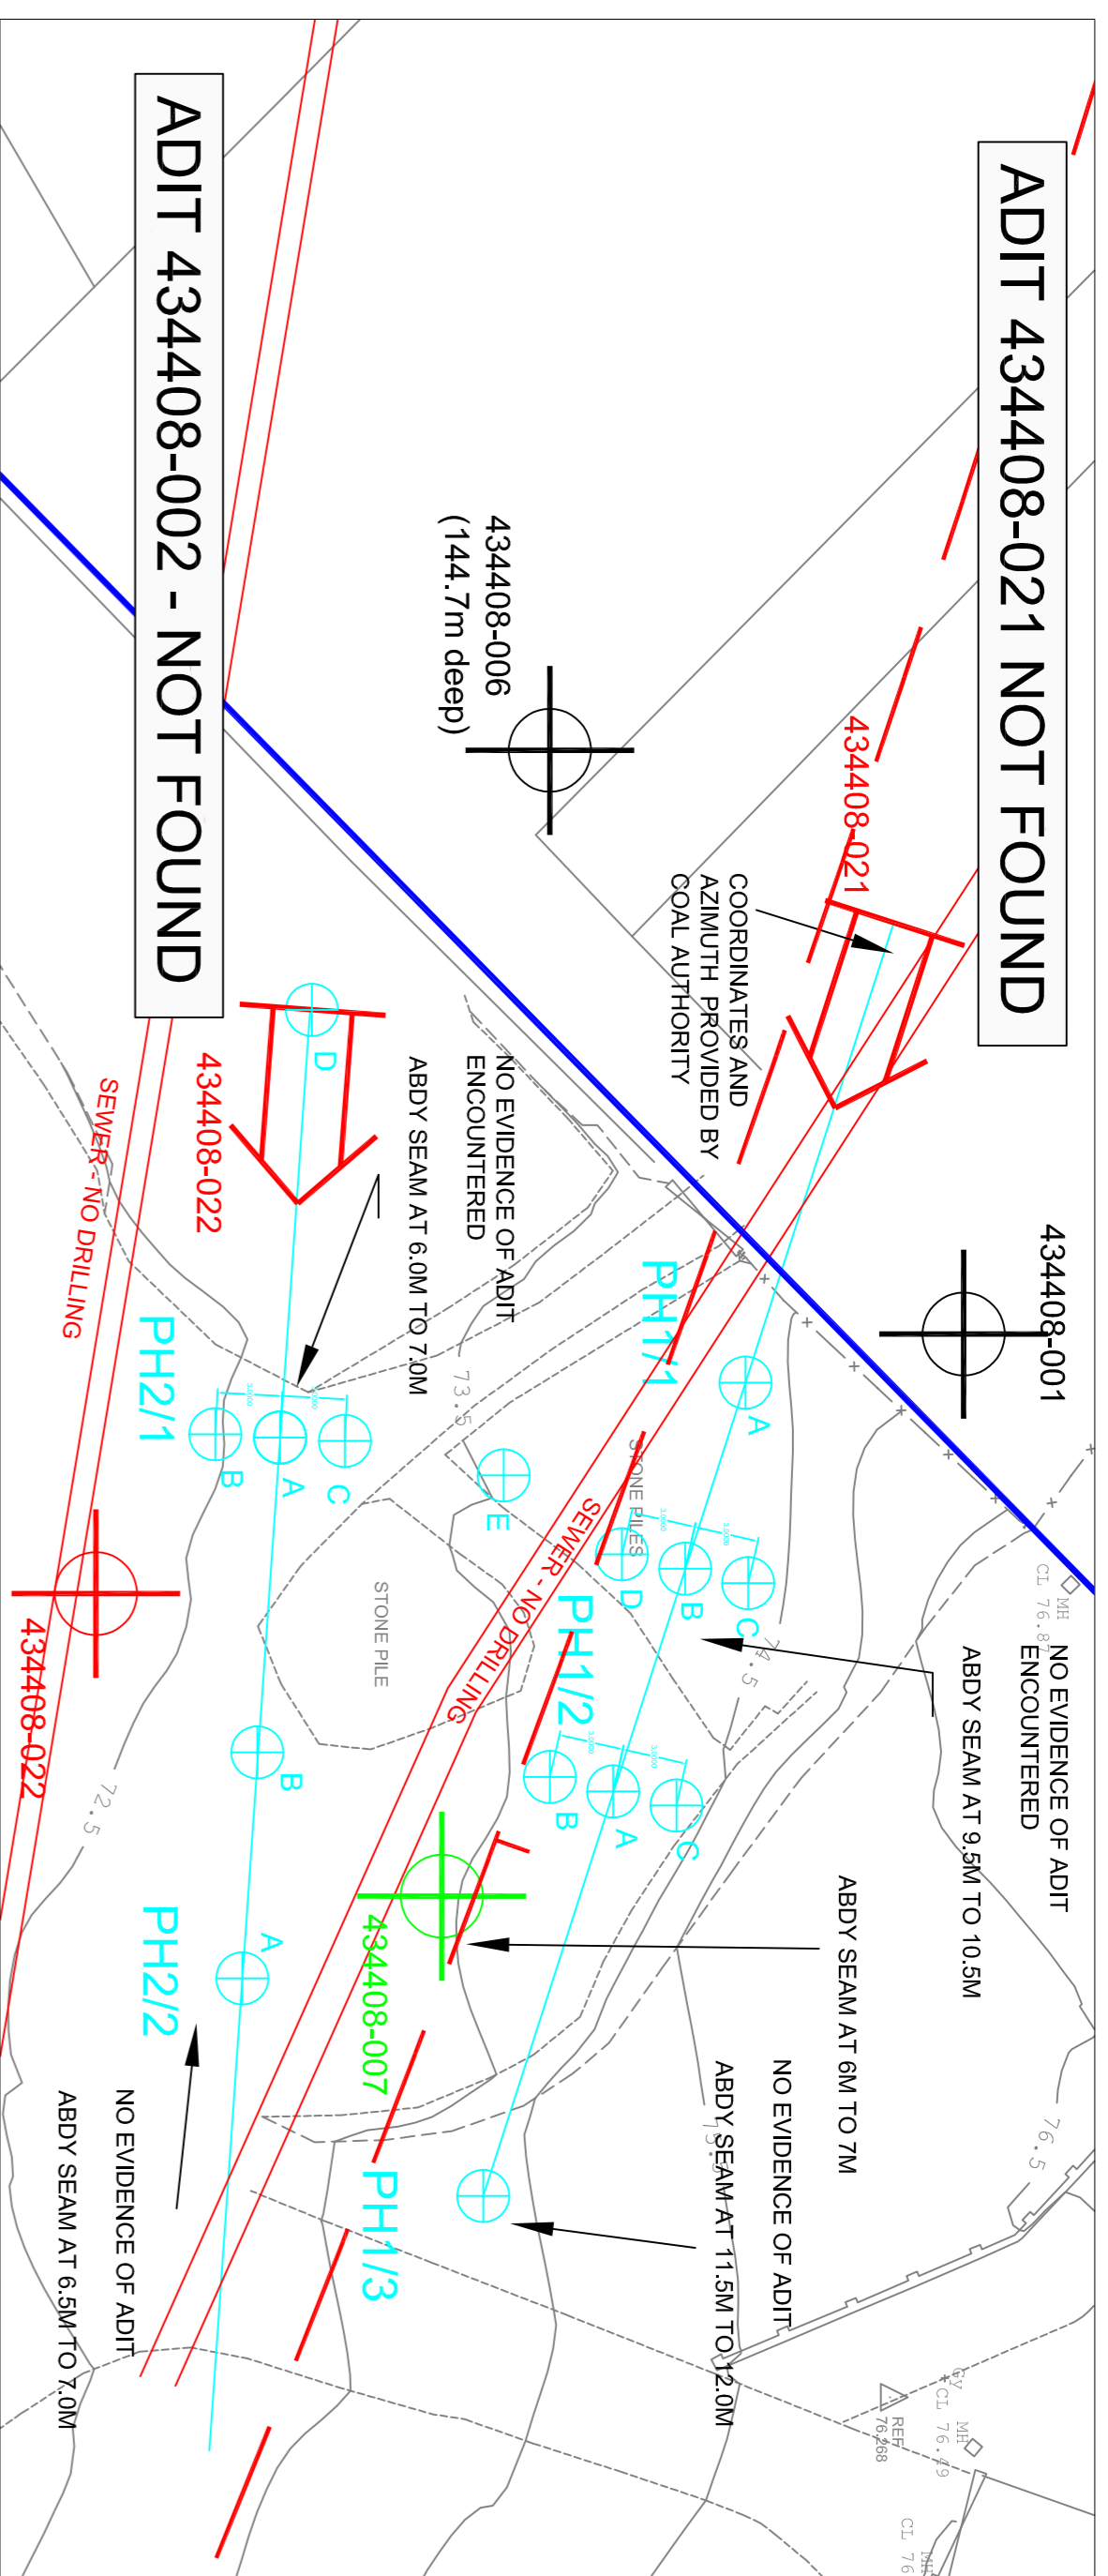
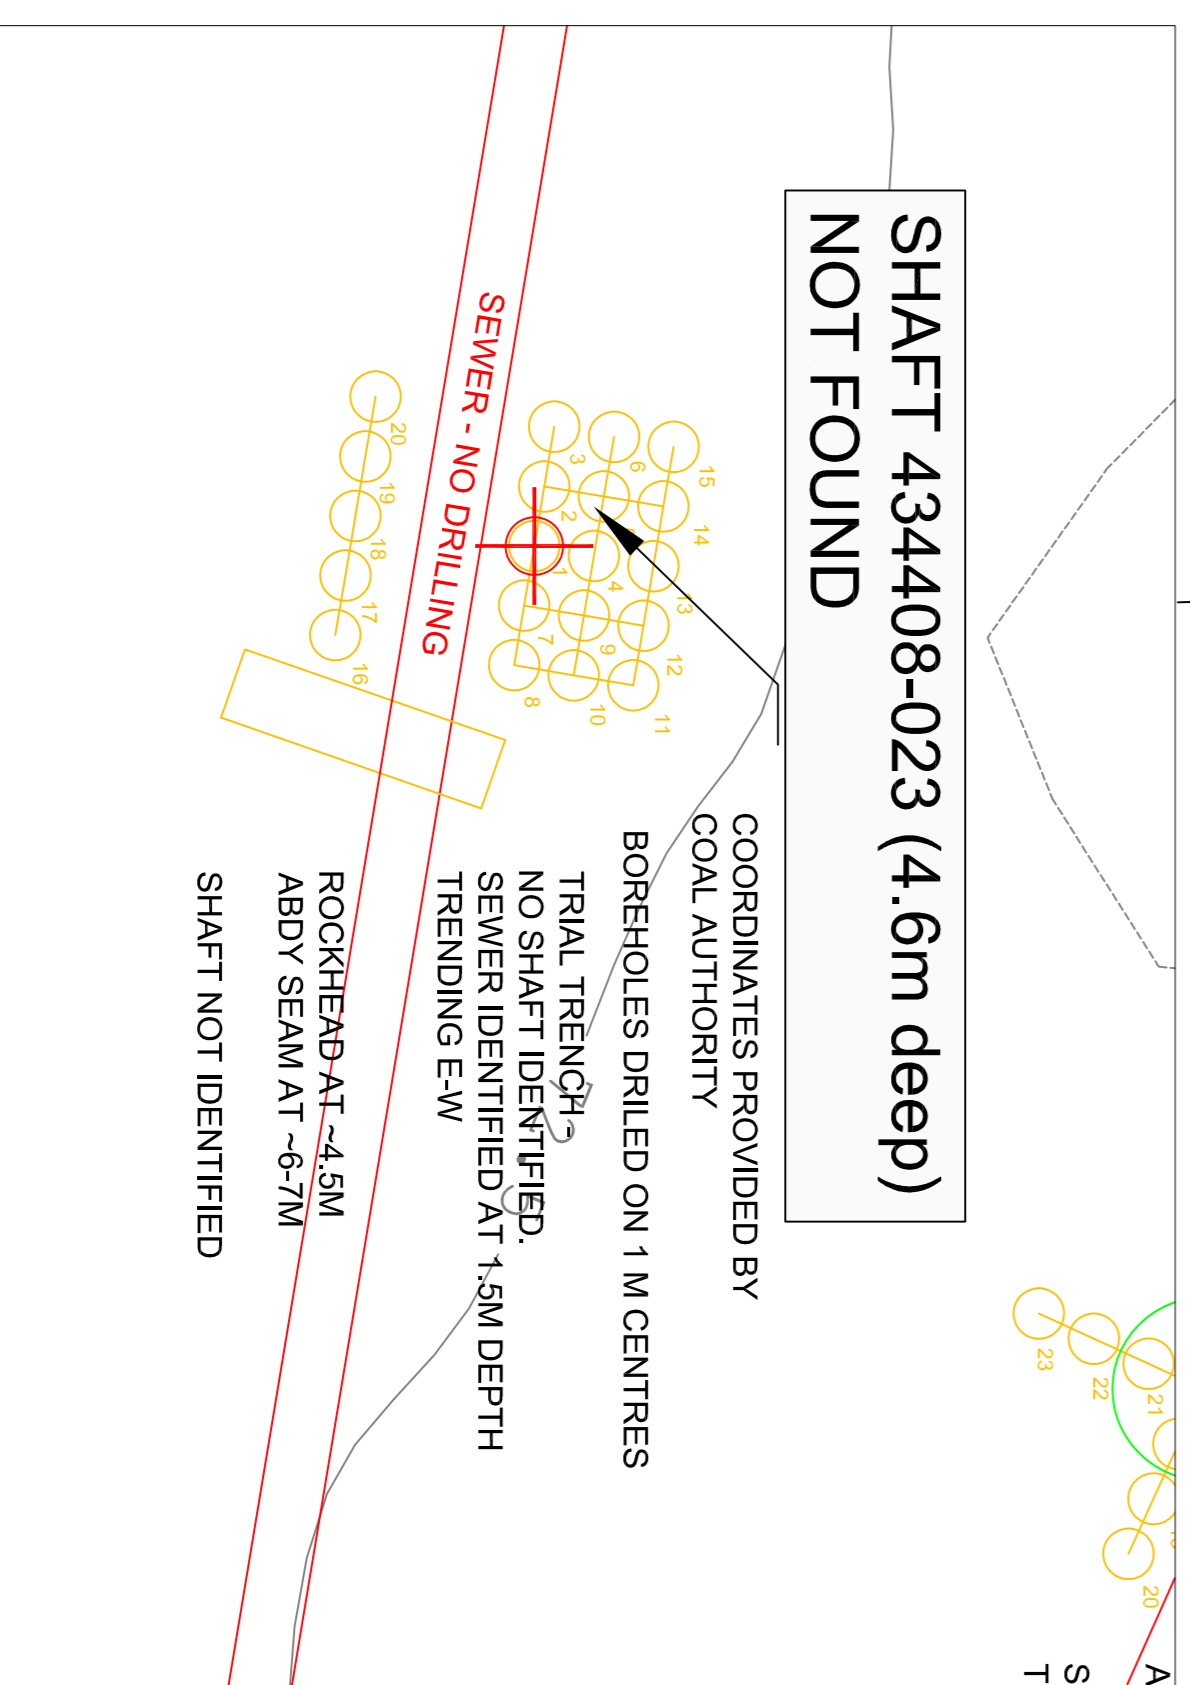
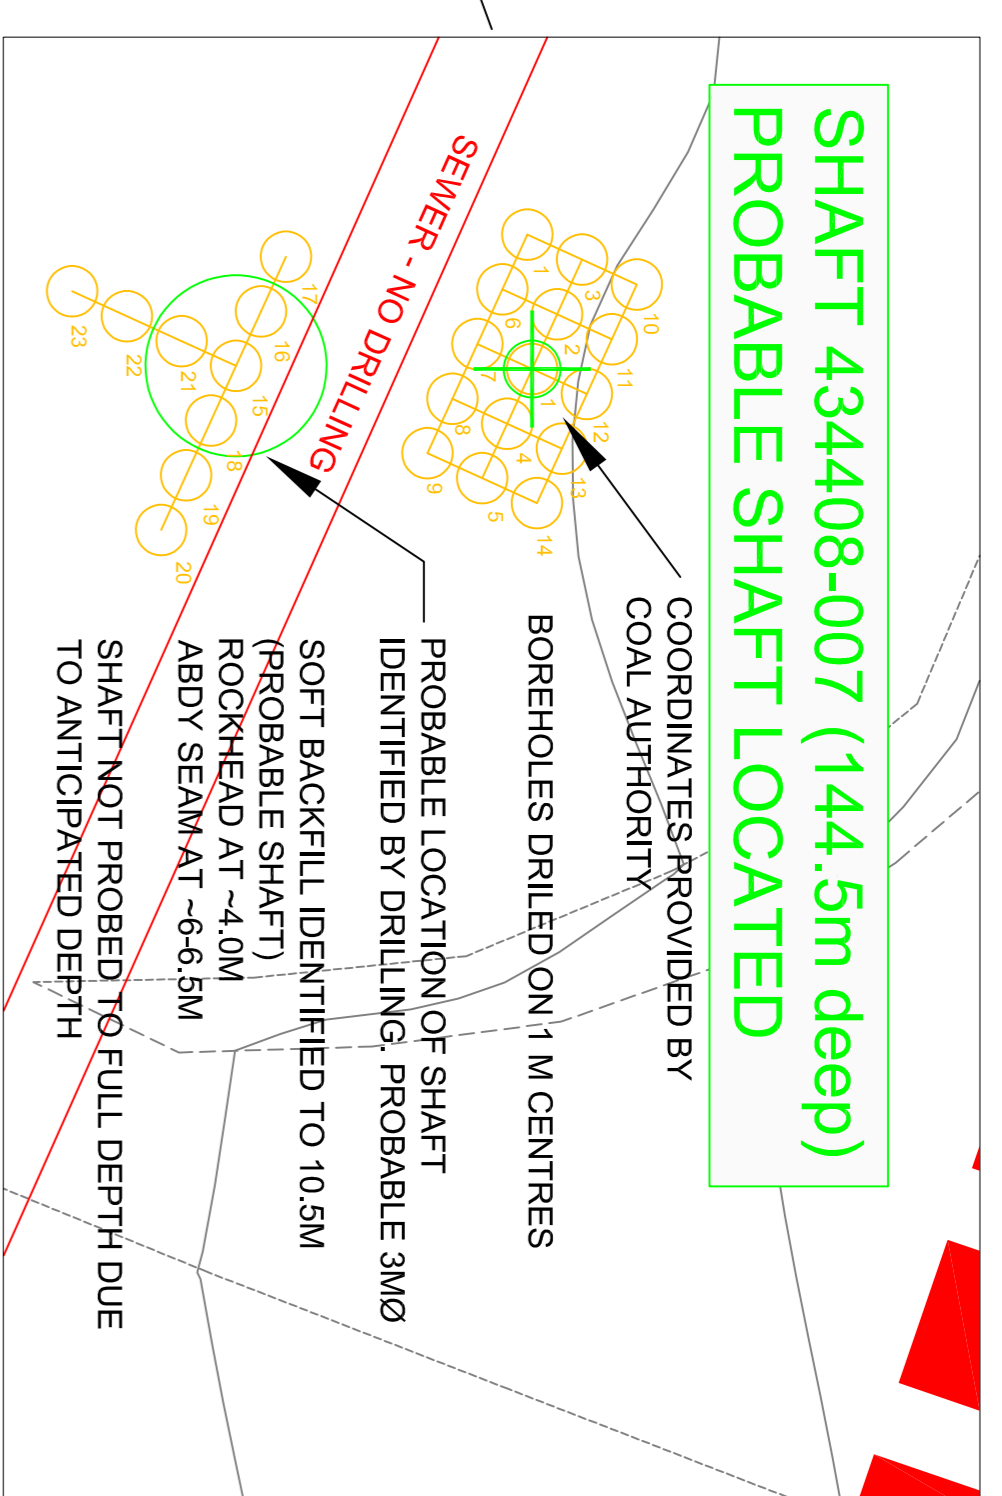
Drawing No: 17176-RLE-19-XX-DR-O-008

Table 2. Summary of findings relating to shafts and adits.			
Mine entry reference:	Investigation Undertaken	Coordinates	Detail / Observations
Shaft 434408-007 POSSIBLE SHAFT IDENTIFIED SEE DRAWING 008 FOR DETAIL	23 No BHs to 12m bgl at 1m centres around shaft coordinates	434707, 408848 Estimated shaft centre	Boreholes drilled on 1m centres in a grid around the anticipated shaft location identified a possible shaft 5m south of the coordinates provided by the Coal Authority. The depth to rockhead was found at 4m surrounding the shaft – soft backfill was encountered to at least 10.5m (base not encountered) in 4 No adjacent BHs, which is interpreted to be a possible shaft of ~3m diameter. This shaft was not probed to full depth as it is expected to be c. 145m deep, descending to the Barnsley Seam which was worked at depth beneath the Site. This shaft will require treatment prior to development.

- Treatment of all mine entries will be required prior to development, typically comprising drilling, grouting and capping onto suitable rockhead.
- Diversion or isolation of the overhead power line and underground sewer, and removal/remediation of coal tar contamination will be required to facilitate the above works in the northwest of the Site. Currently these present a health and safety or environmental constraint to drilling in this area.
