Structural Survey Report

Project 3810

Coal Drops Penistone

<i>Document No: CAS-3810-StructRep-R01</i>		Rev: A	
<i>Status:</i>	For Information	<i>Copy No:</i>	
	<i>Name</i>	<i>Signature</i>	<i>Date</i>
<i>Prepared by:</i>	P Harrison

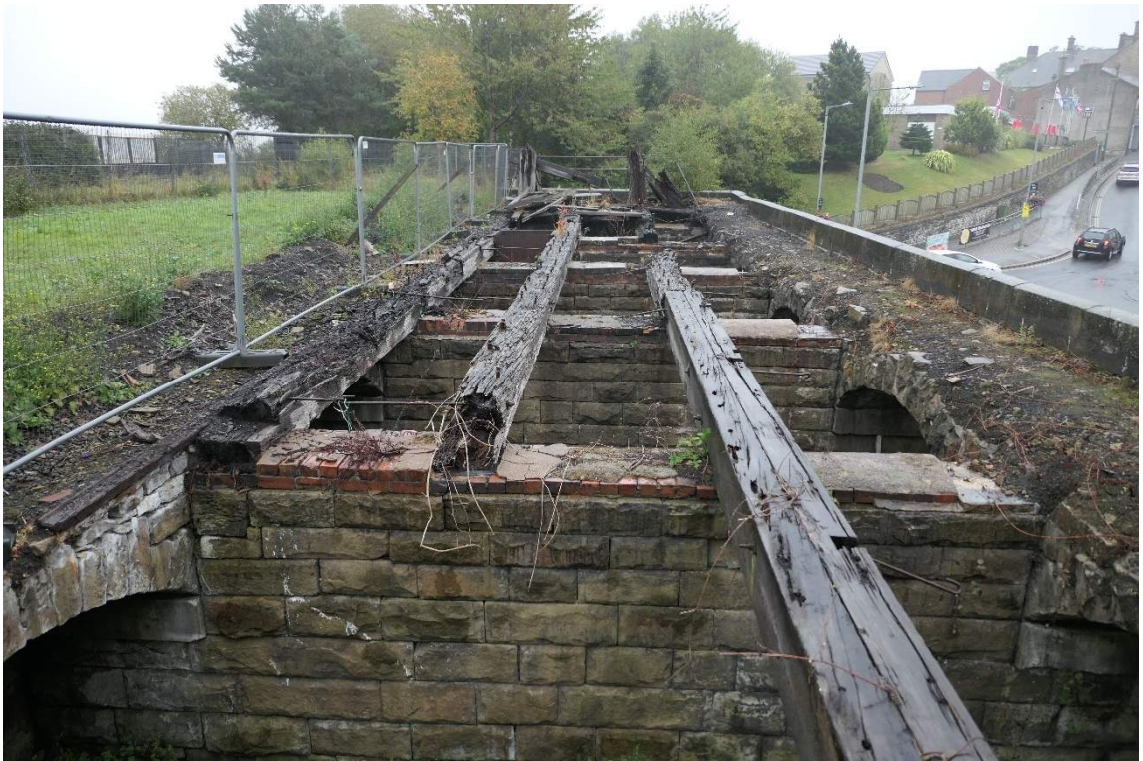
Photo 1

- a) The timber beams are dilapidated, having undergone significant timber decay caused by wet rot. The southern beam has been completely removed exposing the bare earth topping the arches. See Photo 1.

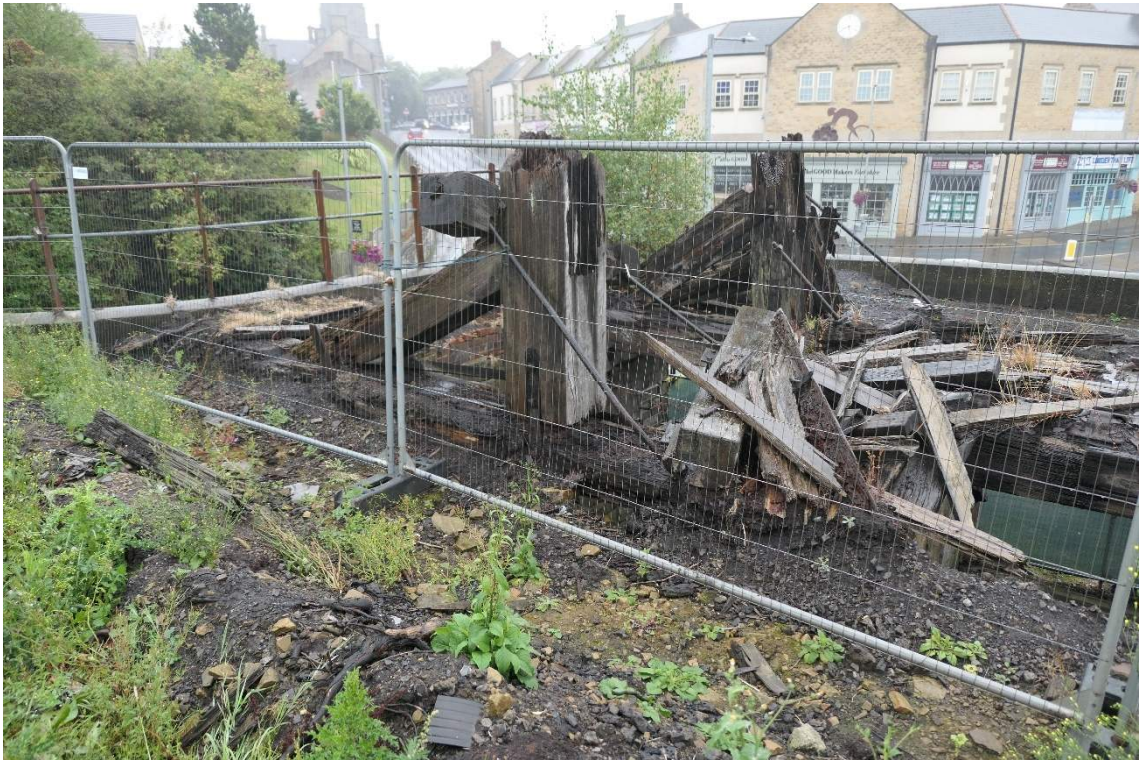
Photo 2

- b) The beams and particularly the buffers are at risk of further collapsing into the coal drops. The remains of the buffers can be seen in Photo 2.

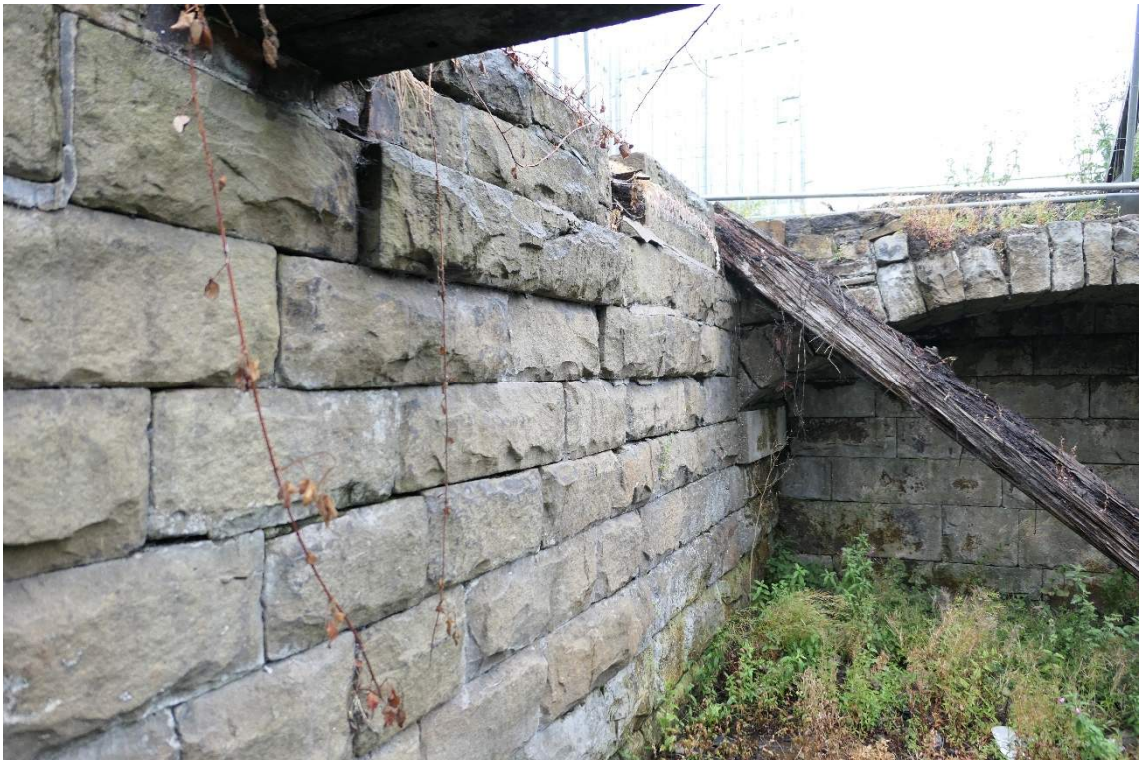
Photo 3

- a) The west wall of bay 1 retains the earth behind the wall. Within the coal drops the wall has undergone some displacement. The displaced masonry can be seen in Photo 3. It is likely the timber beams were restraining the head of the retaining wall, and the removal of some of the beams has resulted in the partial failure of the masonry.

- b) The failure of the masonry appears to have only partially affected the wall, with a section between the remaining timber beams at high level having displaced forward at the bed joints.

- c) It may be the upper section of the wall can be rebuilt, without having to rebuild the lower section. The masonry units could be dowelled together during rebuilding, using stainless steel dowels, to prevent a repeat of the same type of failure occurring. If the wall is to be extended in height as part of the proposed scheme, a trial pit should be excavated to the rear to determine the existing construction and determine whether additional strengthening works are required (see section 5 on the conversion of the structure).

- d) It is proposed to introduce a suspended slab over the open coal drops. This would permanently prop the head of the wall and help prevent a recurrence of this type of failure.

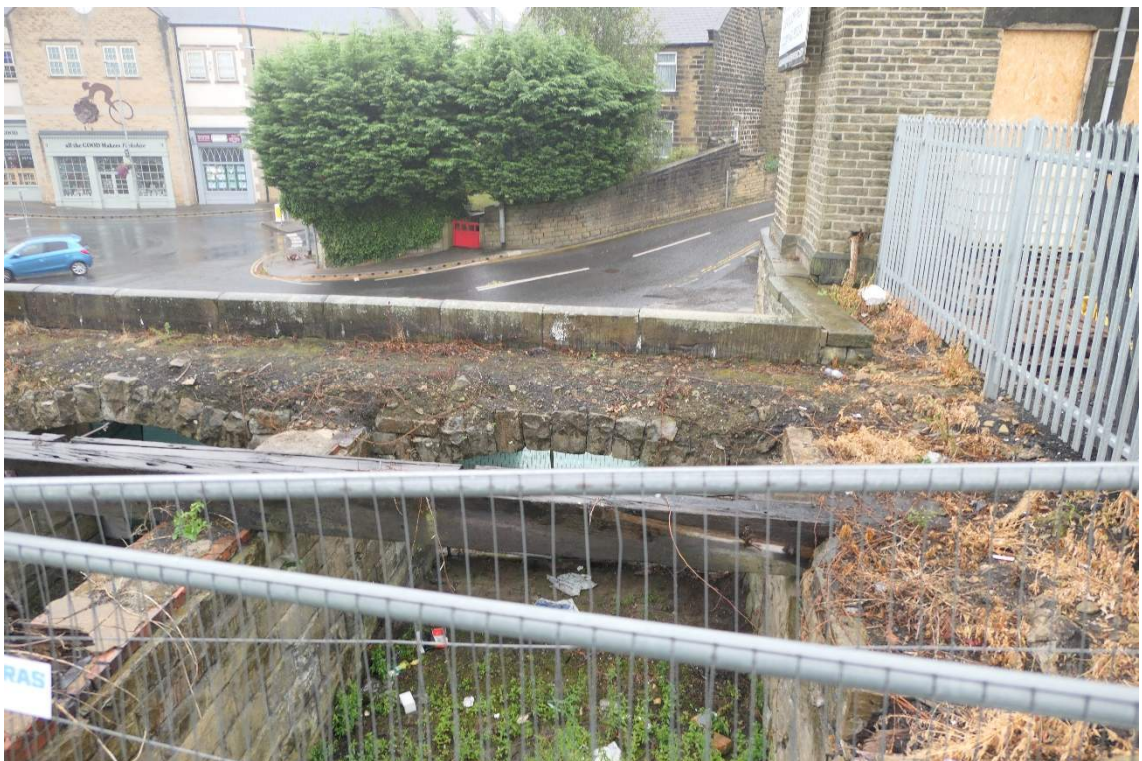
Photo 4

- f) The inner walls supported by the front barrel vault retaining the fill on top of the vaults requires rebuilding, see Photo 4. It is likely some of the masonry here was originally retained by the timber beam which has been removed.

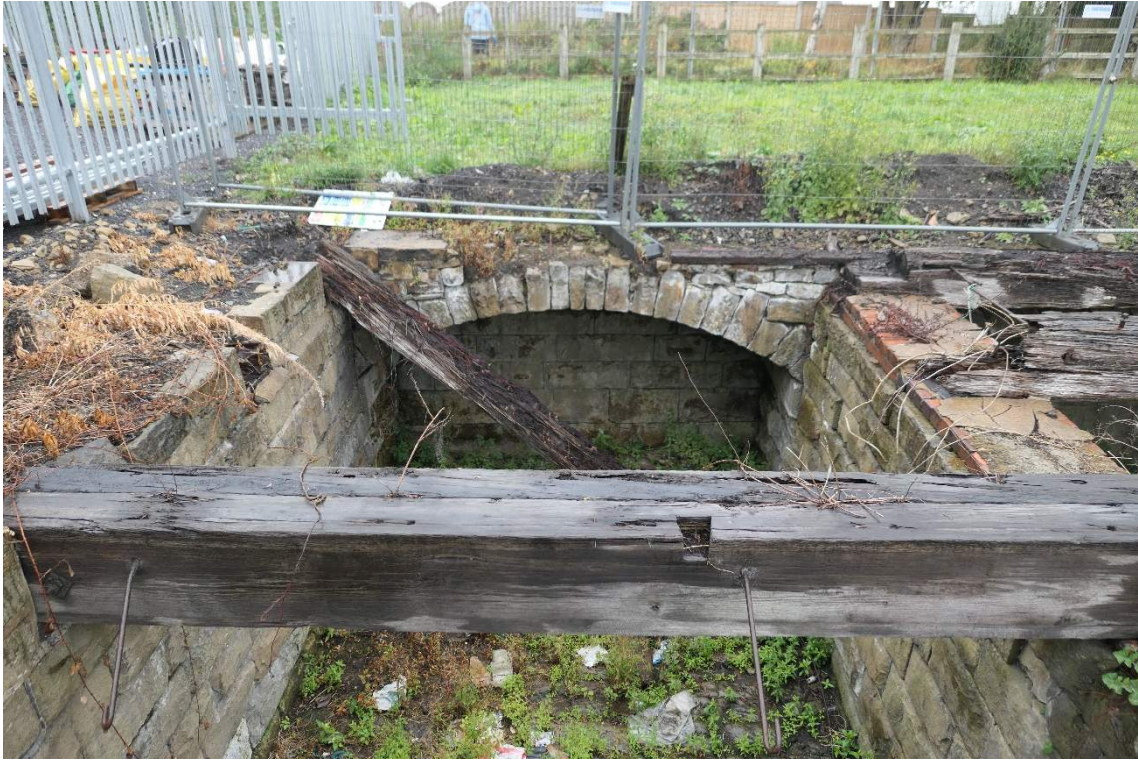
Photo 5

- g) The wall supported by the rear barrel vault retaining the fill requires partial rebuilding, see Photo 5.

- h) The wall between Bay 1 and Bay 2 is plumb. The top of the wall is weathered, but could be consolidated with new mortar and relaying of loose bricks to support a suspended slab. See the right hand side of Photo 5.

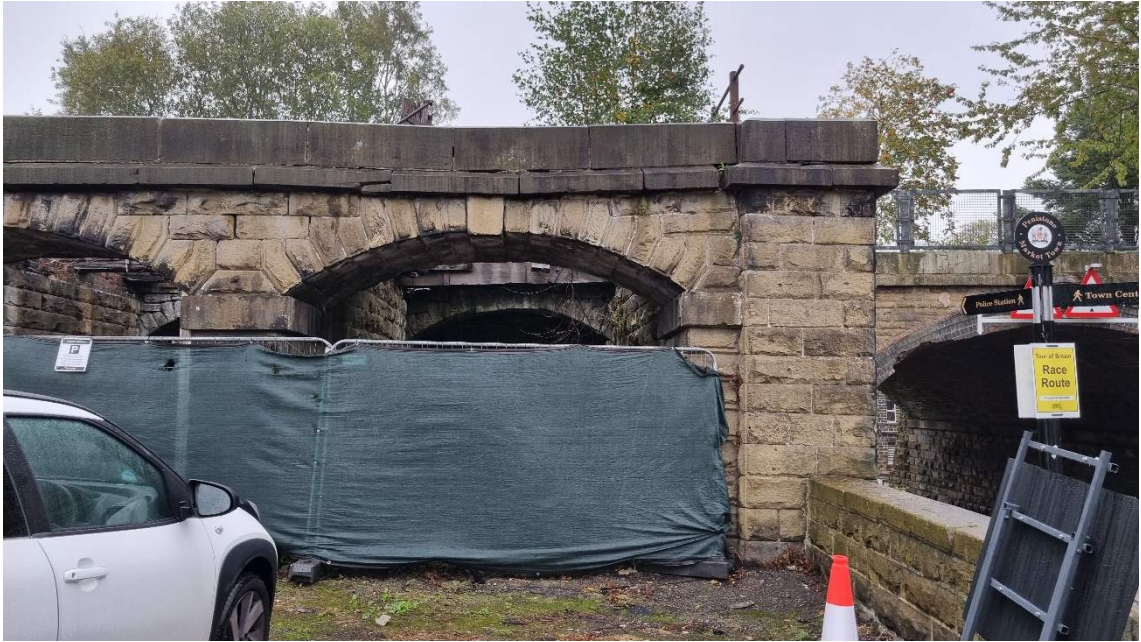
Photo 6

- a) The front arch of bay 6 has partially failed with a significant vertical displacement present. The buttressing pier to the east side of the arch is leaning at a gradient of approximately 25mm lateral displacement per 1000mm height. See Photo 6. The displacement has caused some of the masonry above the arch to crack.

- b) The cause of the vertical deformation of the arch and the lateral displacement of the pier is likely due to one or a combination of the following causes:

- The pier may have insufficient mass to resist the lateral thrust from the arch, which is relatively flat, so is likely to generate a significant thrust even for a relatively short span such as this.

- The pier may have been pushed over by the repeated impact force of the coal wagons striking the buffers.
 - The pier may have inadequate foundations or be supported on ground which is too soft to adequately support the bearing pressures applied.

- e) We do not consider any special works other than repointing are required for the rear arch.
- f) There are options for the remediation of the front arch. These are listed as follows:
 - If the arch and buttressing pier can be justified as stable by calculation, the pier can be retained in its current leaning form, and the arch be rebuilt to its original height. New arch stones would be required as the opening will be slightly wider than it was originally. The temporary stability of the adjacent arch would need to be considered and the supporting wall would probably need to be propped during construction.

- If the arch and buttressing pier can be justified by calculation, they could both be taken down and rebuilt to their original position, using the same construction as the existing. A new foundation will likely be required for the pier, and part of the adjacent wall may also need to be rebuilt.

- If the existing pier has insufficient mass, and cannot be justified by calculation to resist the thrust from the arch, it would need to be taken down and rebuilt with a new foundation of sufficient size and mass to resist the overturning moment generated, with a reinforced concrete column constructed within the core of the wall, in place of the existing rubble fill. The cantilevering concrete column within the pier would resist the thrust from the rebuilt arch.

- g) To determine the suitability of any of the above options, some intrusive site investigation works would be required to determine the size of the existing pier foundation, as well as the competency of the supporting ground, and the size of pier required to prevent a similar failure recurring. This would probably involve a trial pit within the public highway, and possibly a window sample. Permission from the council would be required to carry out the works. For the options where the existing pier is retained, underpinning may be required.

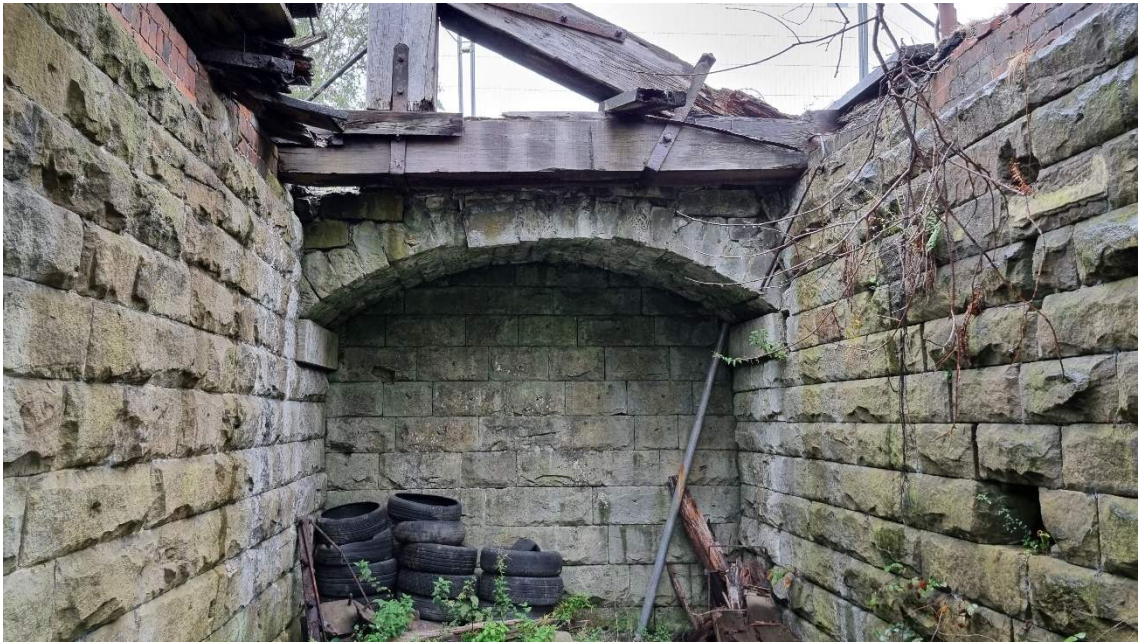
Photo 7

- c) The rear vault also appears to be slightly distorted toward the front of the arch, which is likely to have a similar cause as the displacement of the arch above, but to a lesser extent, as the wall below appears to be relatively plumb. See Photo 7.

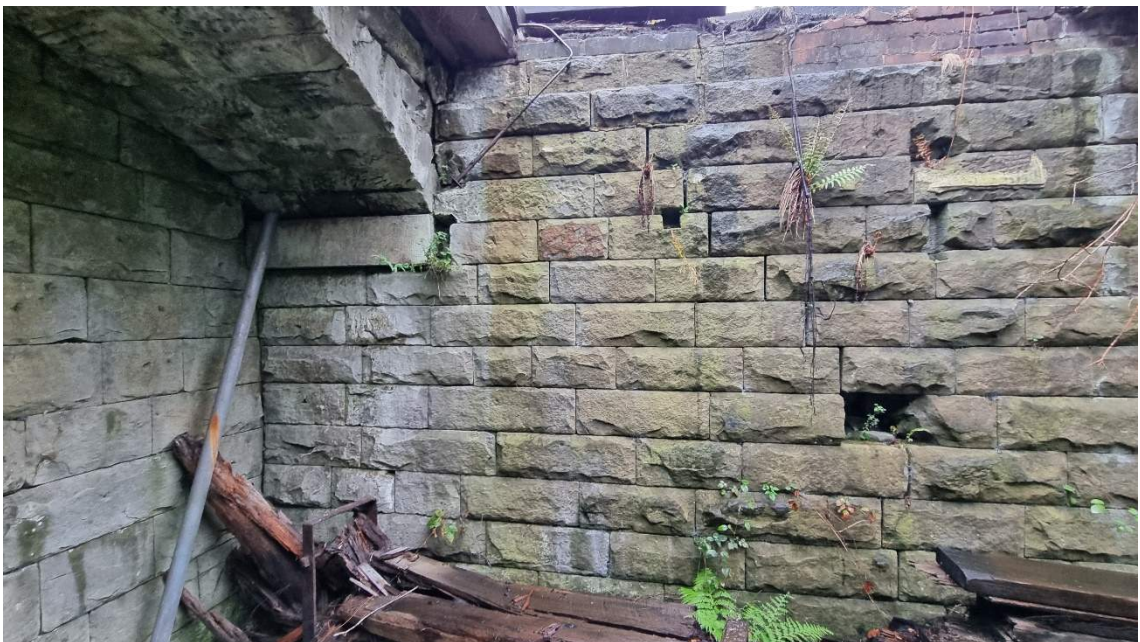
Photo 8

- d) The east wall of the bay has a large diagonal crack at an articulation or yield line where the wall to the south of the crack has moved laterally eastward relative to the section to the north. The crack is clearly visible in Photo 8. The crack does not appear at the other side of the wall, but this could perhaps be expected, as the far face of the wall would be in compression due to the movement of the attached pier, rather than tension at the inner face where the crack has appeared, as the wall has little capacity to resist tension. Alternatively, the wall may be soil filled, and only the inner face has moved.

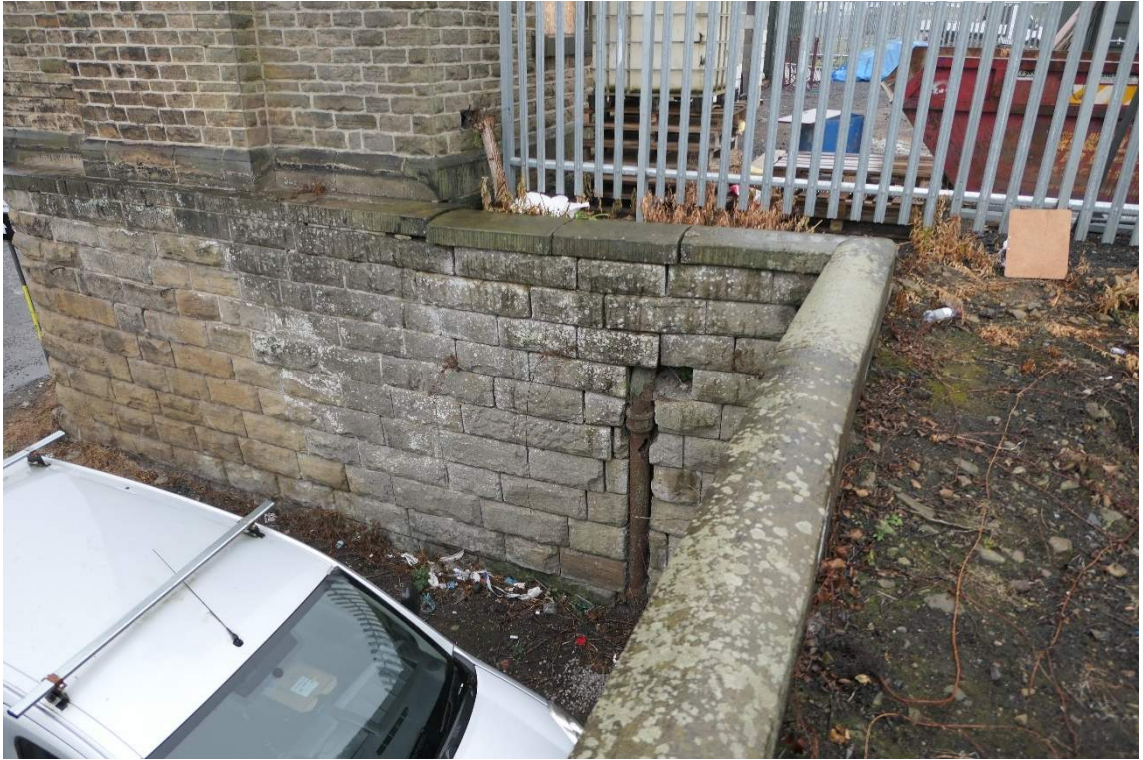
Photo 9

- a) The existing retaining wall between coal drop bay 1 and regency house is deformed, with a prominent bulge, increasing toward the top of the wall. See **Error! Reference source not found..**
- b) The cause of the failure of the wall isn't clear, but it could be related to the rusting pipe built into the wall. Volumetric expansion of the corroding iron/steel may have pushed the joints apart and weakened the wall, contributing to the failure. See Photo 10.

- c) The wall appears to have failed to a significant height, and should locally be taken down and rebuilt between the coal drops and Regency House.
- d) The masonry wall may need to be increased in thickness, or backed with a reinforced concrete retaining wall to comply with modern design standards, and prevent a similar failure happening in future.
- e) The adjacent regency house may need to be locally underpinned to maintain stability of the north wall whilst the wall is taken down and rebuilt, depending on the depth of the existing foundations.

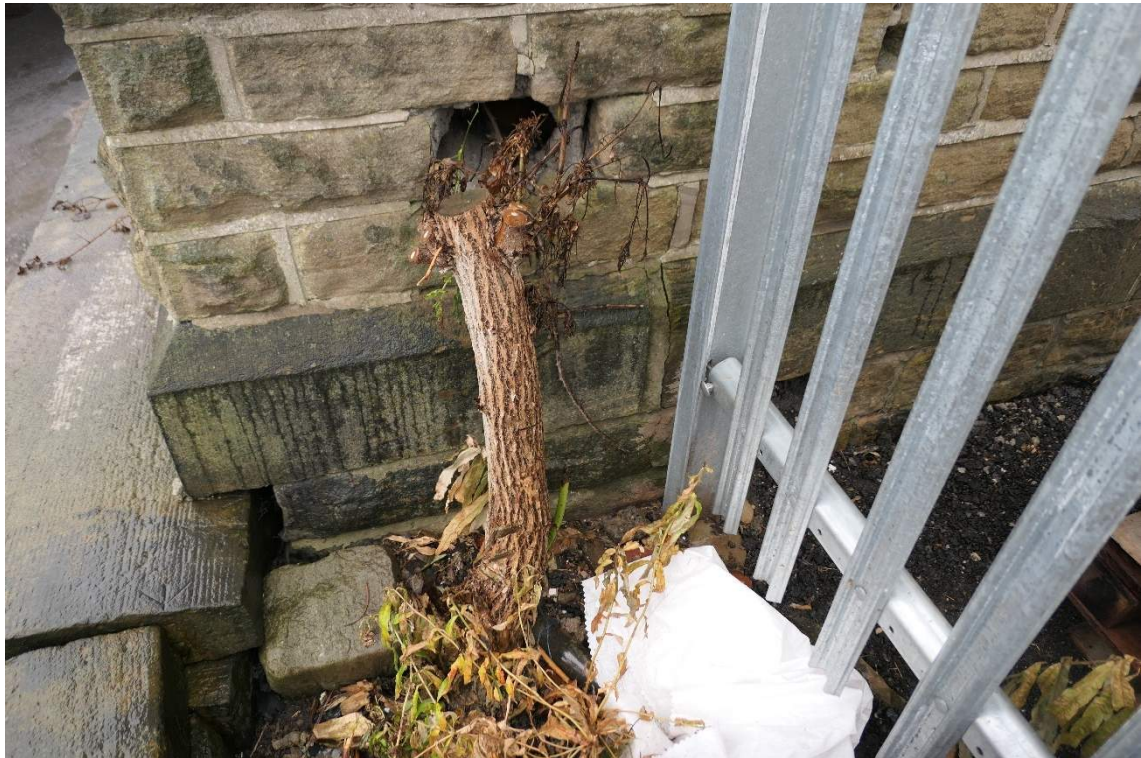
Photo 11

- a) A small crack is visible to the lower east corner of the north wall, where the building appears to be constructed on top of the retaining wall. The crack may have been caused by the partial failure and associated deformation of the adjacent section of retaining wall. The crack is not currently of concern from a structural point of view, but may worsen over time if the adjacent retaining wall failure is not addressed. Movement also appears to have occurred between a coping stone and the corner stone of the building wall. See Photo 11.

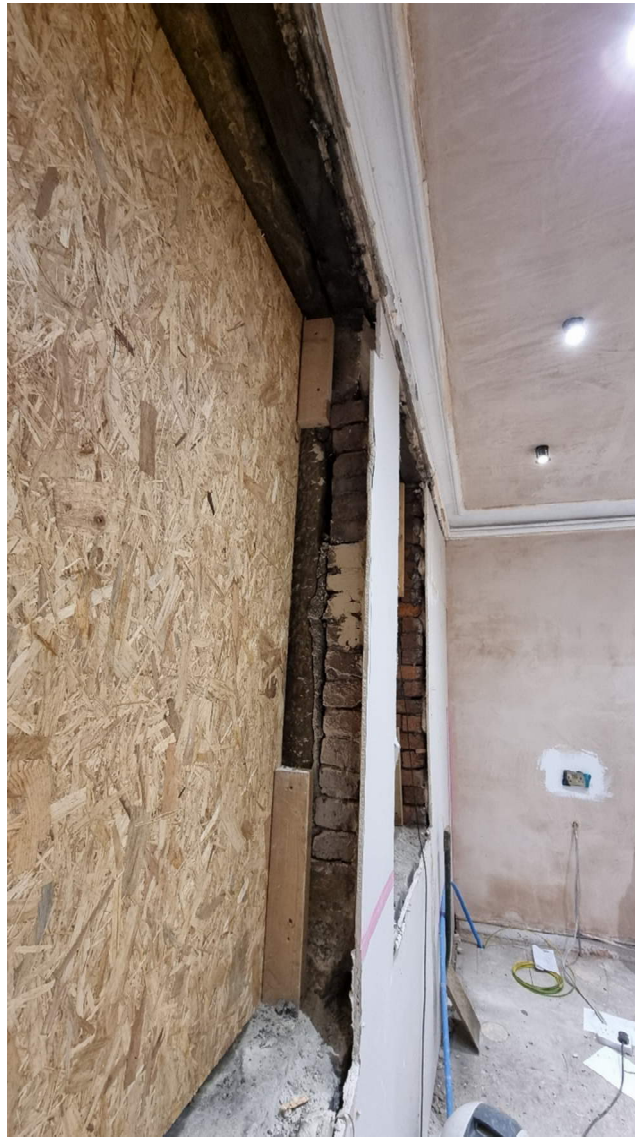
Photo 12

- b) Inside the building the inner brick facing of a stone mullion at the ground floor to the rear of the building has poor pointing and it is not clear whether or not the brickwork is tied to the stone mullion. It was probably originally bonded to the stone with mortar, but the bond has since failed. The brickwork does not appear to be particularly secure, and it should be tied to the stone mullion. This could be achieved by repointing the masonry, filling the gap between the stone mullion and the bricks with new mortar, and securing the brickwork to the stone with some side fixed cut down galvanised steel restraint straps. See Photo 12.
