**Carlton Road**

**Barnsley**

**– BS 5837 (2012) Tree Survey**

Report Title: **Carlton Road, Barnsley  
BS 5837 (2012) Tree Survey**

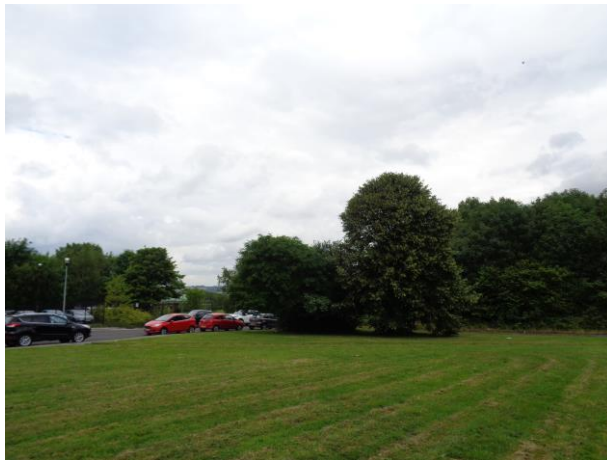
| Tree No | Species | Ht (m) | Stem Diam @ 1.5m (cm) | Canopy Spread (m)<br>N- E- S- W | | | | Height of Crown Clearance | Age Class | Est yrs | Overall Condition | Comments | Management Recommendations | BS 5837 Category | RPA Radius (m) | RPA (m <sup>2</sup> ) |
|---|---|---|---|---|---|---|---|---|---|---|---|---|---|---|---|---|
| T14 | Common lime ( <i>Tilia x europaea</i> ) | 9 | 38 | 5 | 5 | 5 | 5 | 0 | EM | 40+ | Good | - | - | B1 | 4.56 | 65.33 |

Plate 1: Looking east from Carlton Road, lime T14 centre right

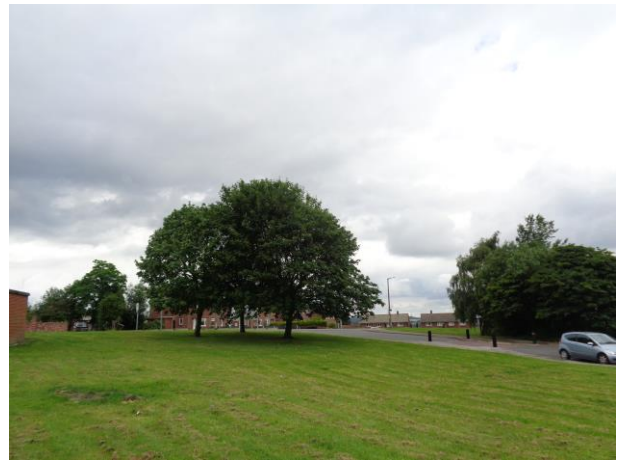
| Tree No | Species | Ht (m) | Stem Diam @ 1.5m (cm) | Canopy Spread (m)<br>N- E- S- W | Height of Crown Clearance | Age Class | Est yrs | Overall Condition | Comments | Management Recommendations | BS 5837 Category | RPA Radius (m) | RPA (m <sup>2</sup> ) |
|---|---|---|---|---|---|---|---|---|---|---|---|---|---|
| T1 | Norway Maple ( <i>Acer platanoides</i> ) | 9 | 35 | 2 6 5 5 | 1.8 | EM | 20+ | Poor | Occluded union at 2m, weep coming from base of occlusion and at ground level on south. | Remove | U | 4.20 | 55.42 |
| T2 | Norway Maple ( <i>Acer platanoides</i> ) | 10 | 44 | 6 6 6 6 | 1.5 | EM | 40+ | Fair | Girdling root on north side | - | B2 | 5.28 | 87.58 |
| T3 | Swedish whitebeam ( <i>Sorbus intermedia</i> ) | 9 | 34 | 5 4 4 5 | 1.8 | EM | 40+ | Fair | Minor mower damage on east side | - | B2 | 4.08 | 52.30 |

Plate 2: Looking west to Carlton Road, T1 to T3 centre

- 4.1.1 There are some trees requiring immediate attention for reasons of health and safety.
- 4.1.2 Only one tree currently poses a risk owing to its location in an area with moderate public footfall. Norway maple T1 has a serious occlusion at 2m on the main stem with associated bleeding. This could lead to crown failure in strong winds, and its removal is recommended within one year. Other trees on site would only become a hazard if they are to be retained within any proposed development. They are clearly marked as category U in table one.
- 4.1.3 The tree works should be specified by an arboriculturist in a schedule of works and carried out by a suitable qualified and experienced tree surgeon.

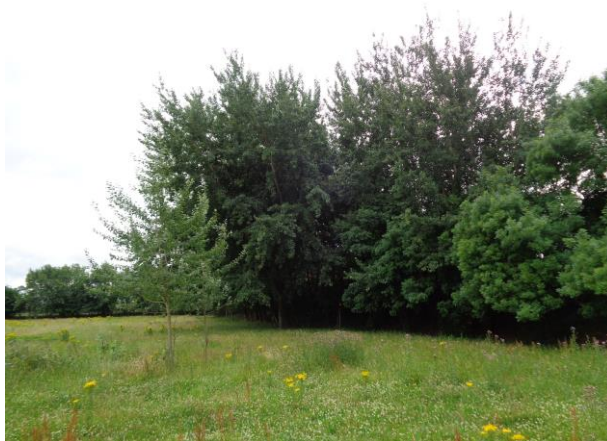
Plate 3: Looking SW, aspen T49 centre, G50 behind

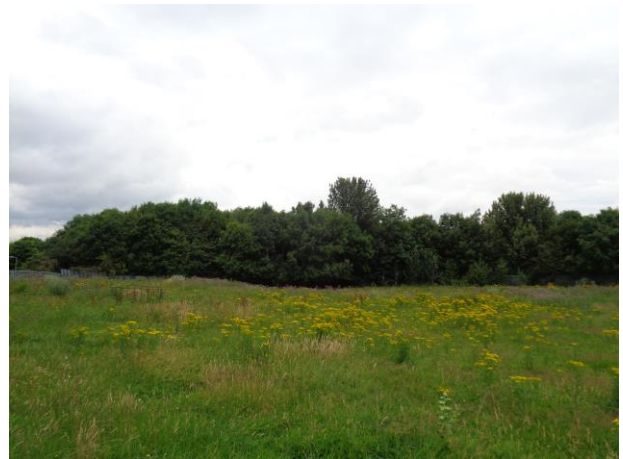
Plate 4: Eastern boundary of former school site, G57 right, G66 left

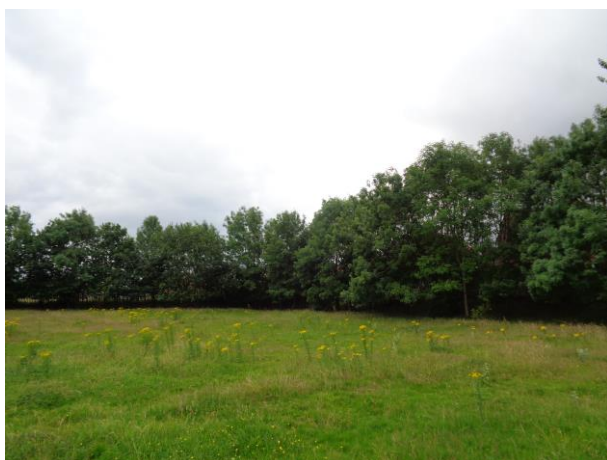
Plate 5: SW corner of site, G54 centre

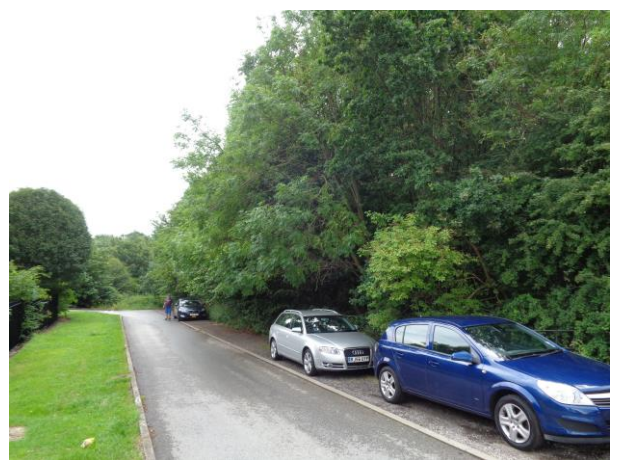
Plate 6: looking east along St Helens Boulevard, G66 left.
