# TECHNICAL REPORT

**Crawford Reference: SU1200023**

**Mr K Firth  
Stonecroft  
Hall Royd Lane  
Barnsley  
S75 4PP**

## **SUBSIDENCE CLAIM**

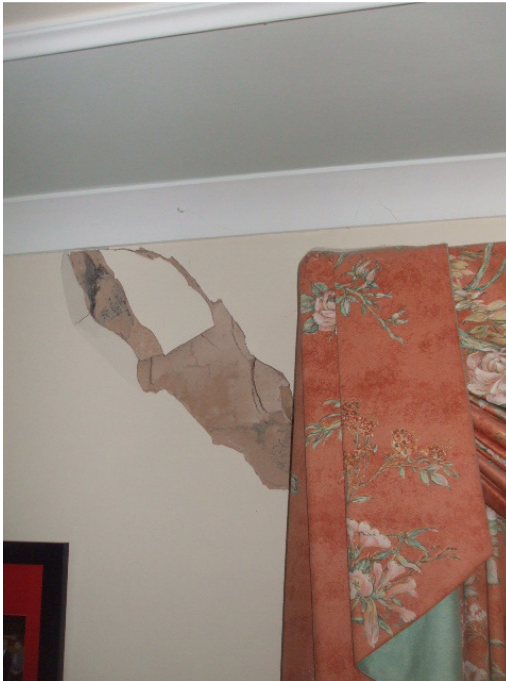
Cracking and de-bonded plaster to left-hand side of window in front left-hand bedroom.

- There is de-bonded plaster and cracking of up to 7mm wide to the top left-hand corner of the window.
- Cracking of approximately 2mm is evident underneath the window.
- There is cracking of up to 2mm wide above the door leading into the en-suite bathroom.

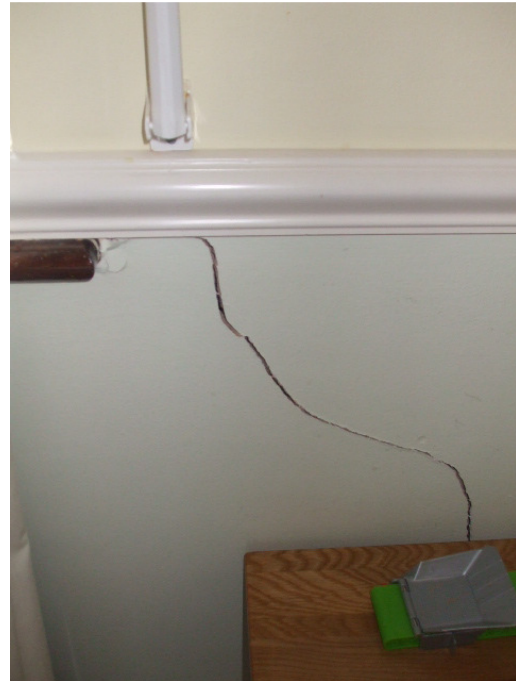
Cracking to bottom right-hand corner of window in front right-hand bedroom.

- Cracking of up to 5mm is evident to the left-hand wall behind the wardrobe.
- There is cracking of approximately 4mm wide to the bottom right-hand corner of the window.
- Vertical tapered cracking of up to 2mm wide is evident to the left-hand wall.

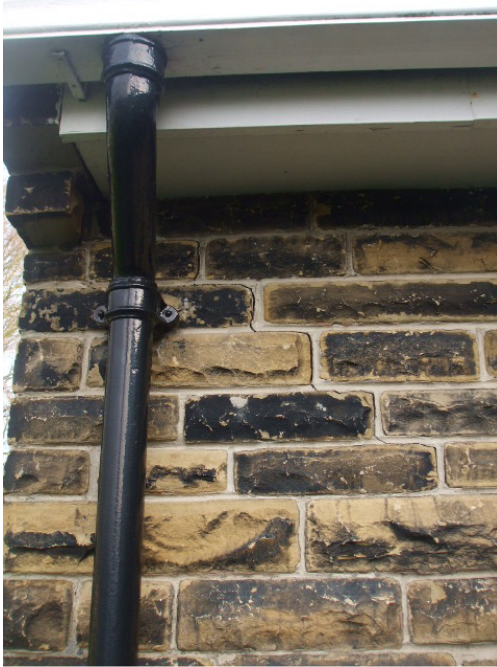
Stepped cracking to right-hand wall of front right-hand projection, where the front right bedroom is located.

- Stepped cracking of up to 5mm wide is evident at high level on the right-hand elevation.
- Stepped cracking of up to 2mm is evident underneath the front right-hand bedroom window.

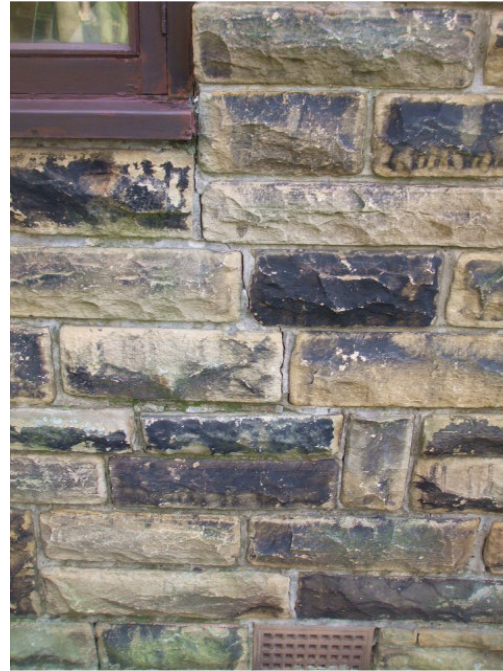
Stepped cracking to front elevation.

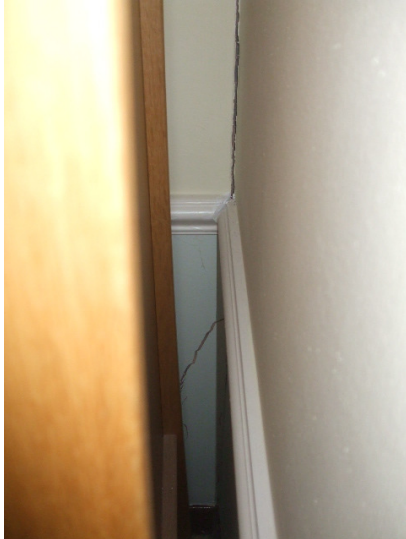
Cracking to left-hand wall in front right-hand bedroom.

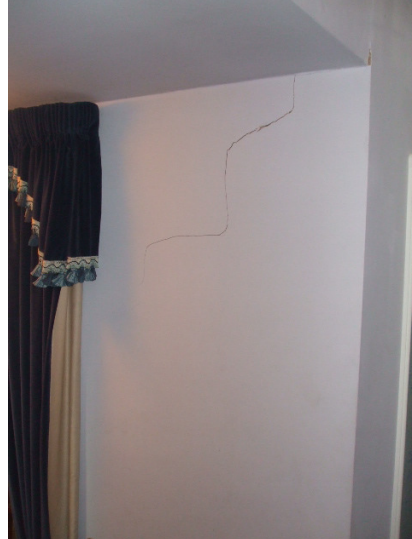
- There is cracking of up to 2mm wide to the right-hand side of the front window to the link section of the hallway adjacent the study area.

Cracking in hallway link / study area.

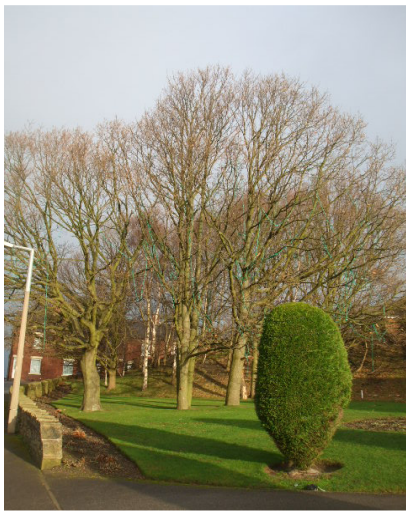
Large Oak trees in the front garden.

Although the cause of the movement needs to be dealt with, we note the vegetation is subject to a Preservation Order. Unfortunately, current legislation requires certain investigations to be carried out to support an application for the tree works.

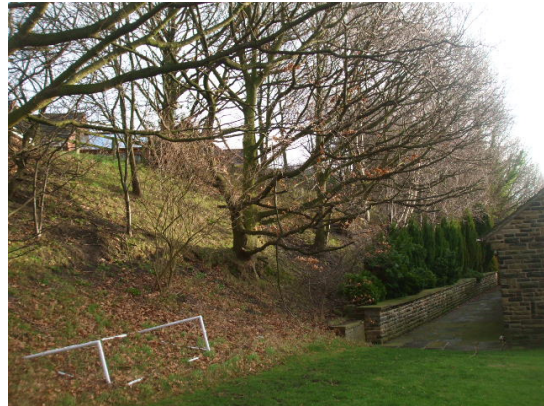
Mixed deciduous trees to left-hand side of property.

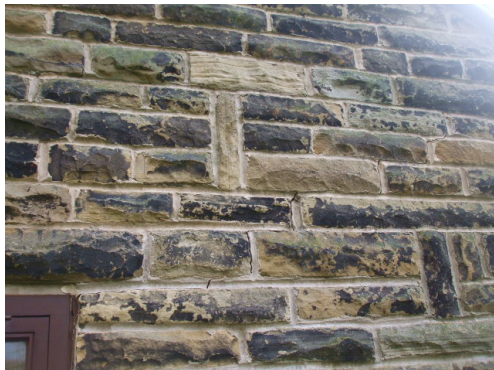
Stepped cracking to front elevation.

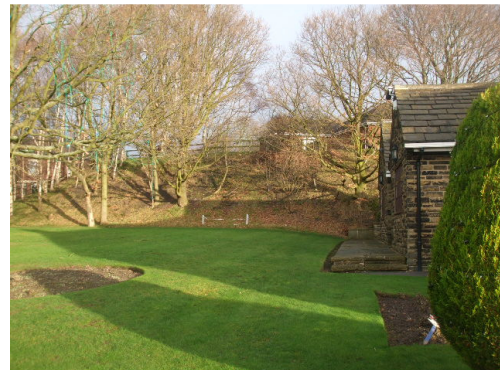
Mixed deciduous trees in front garden.
