LYONS CMC
COAL MINING & GEOTECHNICAL
CONSULTANCY

Date: 12th July 2024
Your ref: (S70 4SP)
My Ref: SI 00357

COAL MINING RISK INTERPRETATION REPORT – FOLLOWING THE SITE
INVESTIGATION FOR PROPOSED RESIDENTIAL DEVELOPMENT AT LAND AT DARLEY
HOUSE, PANTRY HILL, WORSBROUGH DALE, BARNSELY S70 4SP

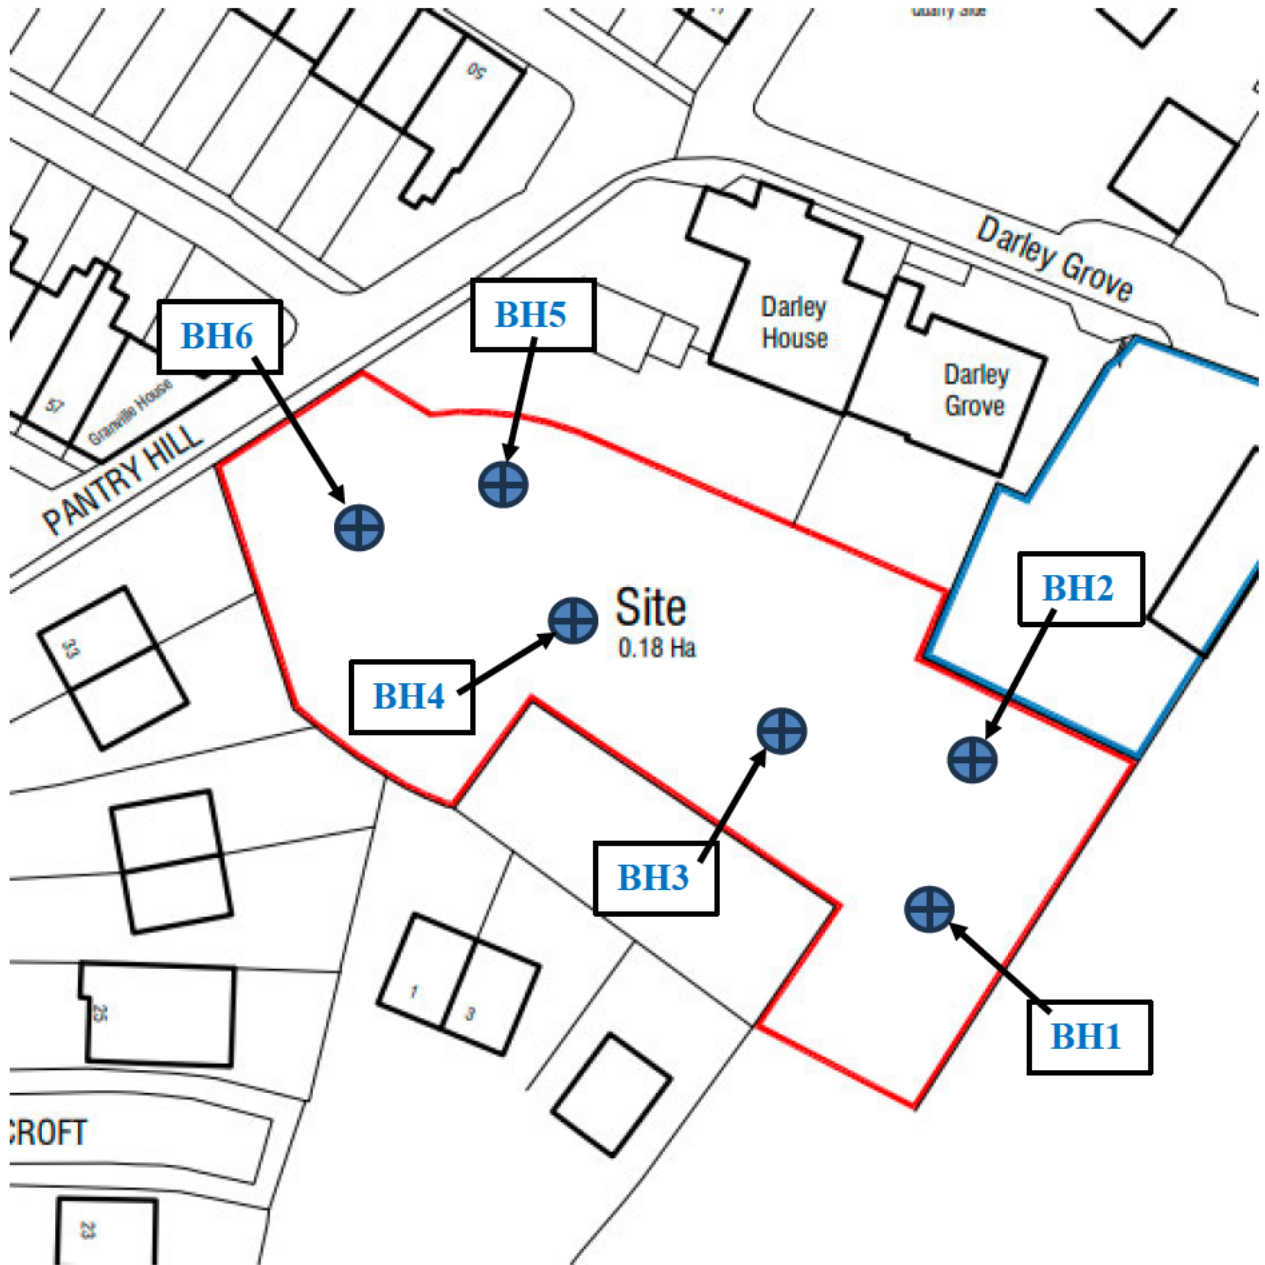
5.2 Borehole Location Plan No. 00357/B

Planning permission is being considered for the development of four detached dwellings at the above location subject to the mining legacy risks been fully realised and mitigated from on site, if necessary. Cape Site Services has now undertaken this work via an intrusive site investigation of 6 boreholes, the location of which is outlined on plan no. 00357/B – as attached and illustrated in appendix 5.2.

Prior to the intrusive site investigation, a search for utilities was undertaken both via online data providers and physically on site using a Cable Avoidance Tool (CAT). Boreholes were marked out with tape measure from boundary lines as illustrated on plan no. 00357/B outlined in appendix 5.2. The process for the intrusive coal seam investigation is outlined via the system chart in appendix 5.4.
