# Highway Condition Survey

Trinity Academy, Barnsley

Highway Condition Survey  
prepared on behalf of Bowmer  
and Kirkland Limited

November 2021

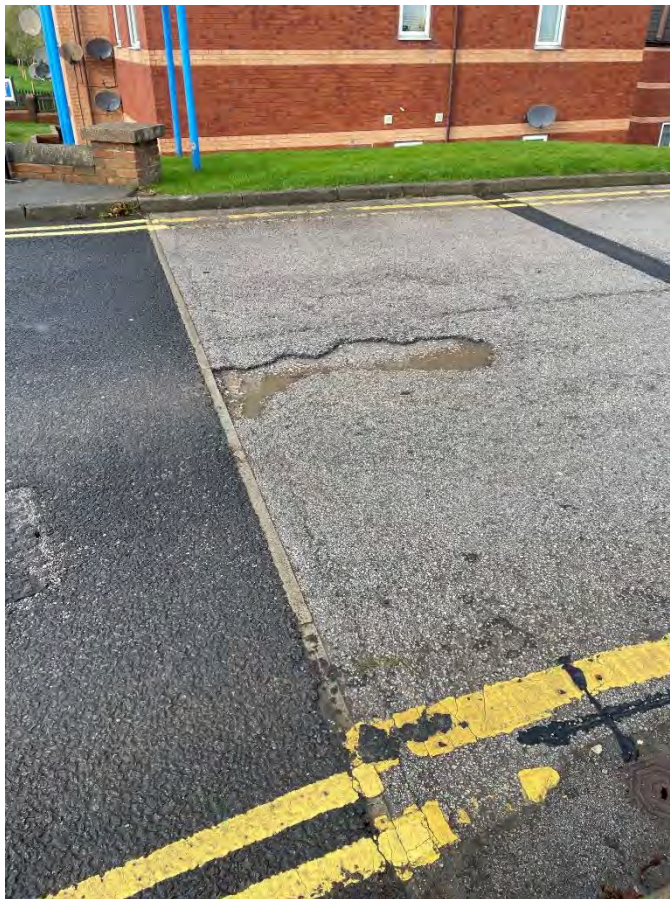
Location: Chainage 0.0 – eastern footway looking west across carriageway

- 2.3 Issue: Large area of carriageway surfacing broken away at centre line away from edging strip and change of surface at junction with Broadway (A6133).

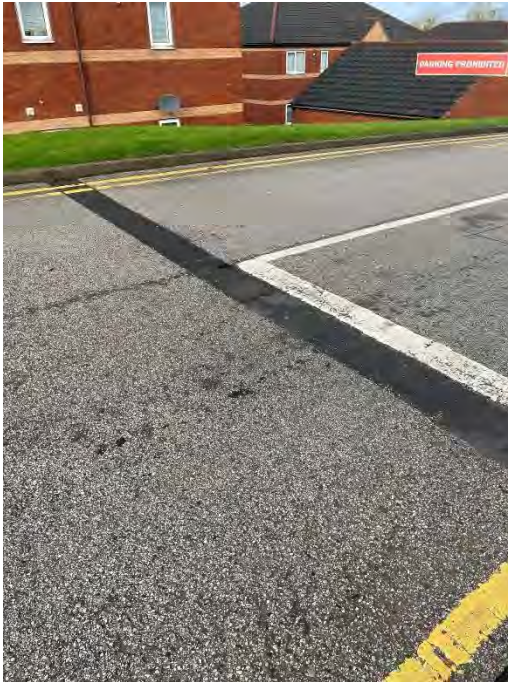
Location: Chainage 6.0 – eastern footway looking west across carriageway

- 2.4 Issue: Service trench along extents of carriageway and some areas broken away and water ponding over trench.

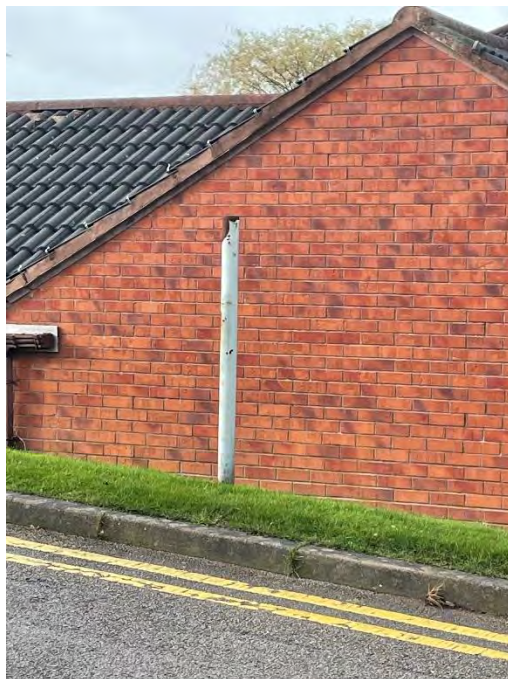
Location: Chainage 35.0 – eastern footway looking across to western verge

- 2.5 Issue: Sign post, without visible sign located in verge. Post has signs of rust where paint has worn off.

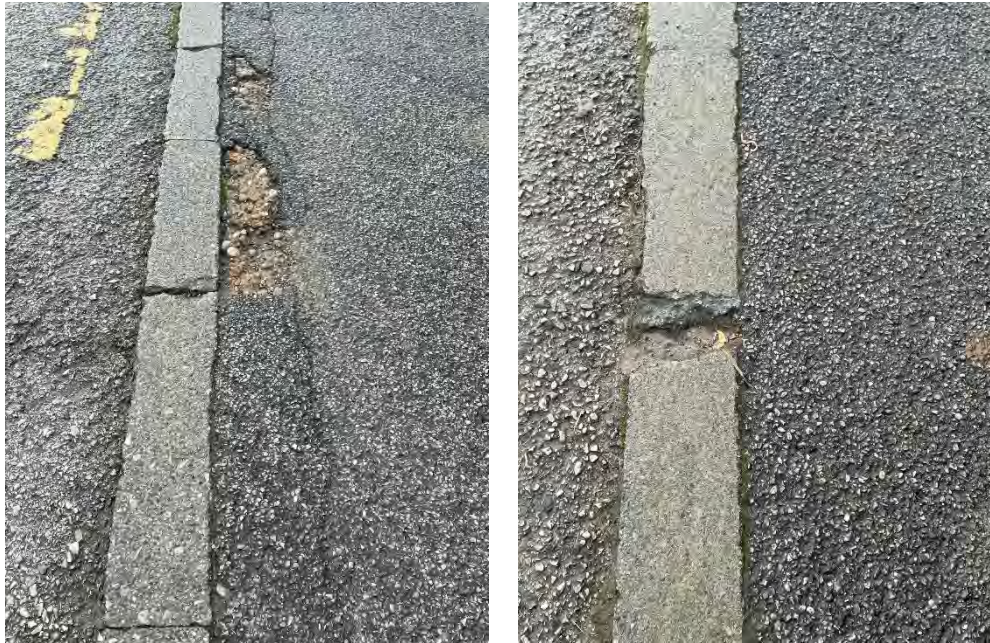
Location: Chainage 60.0 – western side of carriageway at access to Keresforth Court

- 2.6 Issue: Kerbing along access to Keresforth Court chipped away in places with sections of carriageway surfacing also broken away at kerb.

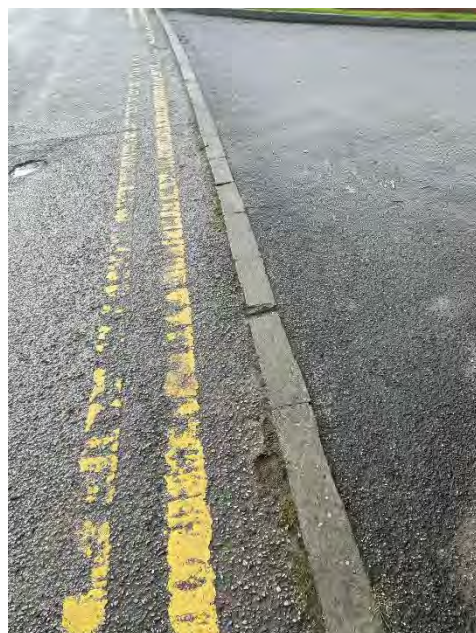
Location: Chainage 64.0 – western side of carriageway looking across access to Keresforth Court

- 2.7 Issue: Kerbing along access to Keresforth Court chipped away in places with sections of carriageway surfacing also broken away at kerb.

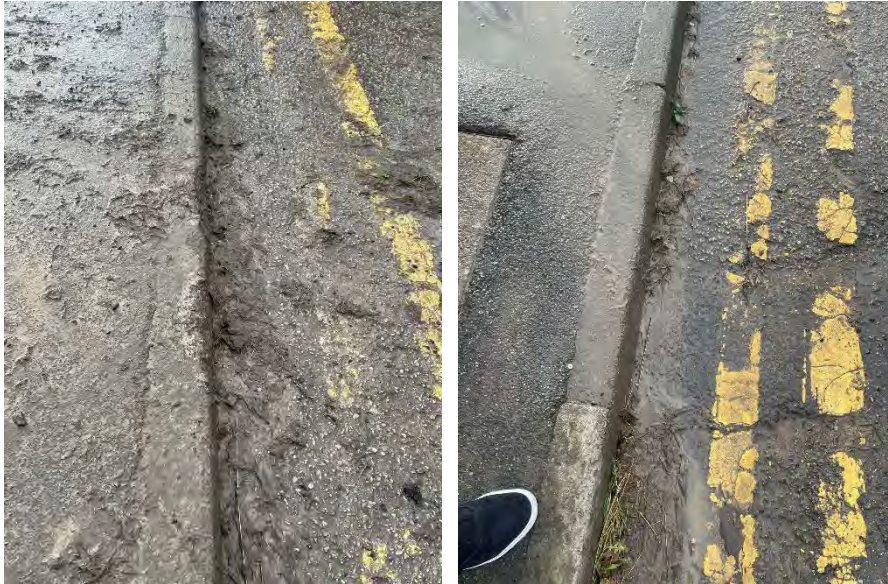
Location: Chainage 66.0 – eastern edge of carriageway looking towards kerb

- 2.8 Issue: Kerbing appears to be driven over with sections of kerbing broken and chipped away. Large amount of mud also poses potential risk with reduced surface grip, areas of carriageway surfacing also cracked or broken away around area.

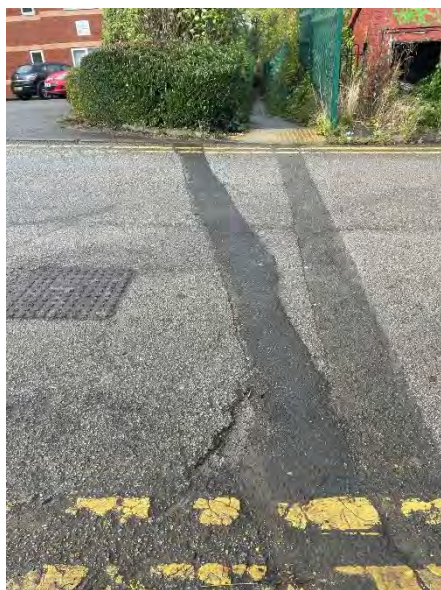
Location: Chainage 70.0 – eastern footway looking west across carriageway

- 2.9 Issue: Two large service trenches visible with some surface cracking and broken away originating from near trenches. Large centre line crack, likely originating before trenches were made also visible.

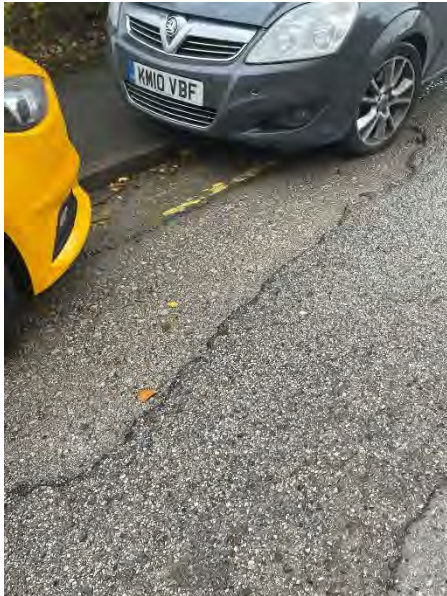
Location: Chainage 80.0 – eastern side of carriageway looking east towards footway

- 2.10 Issue: Large section of carriageway surfacing broken away with road marking painted onto carriageway without surface being relaid.

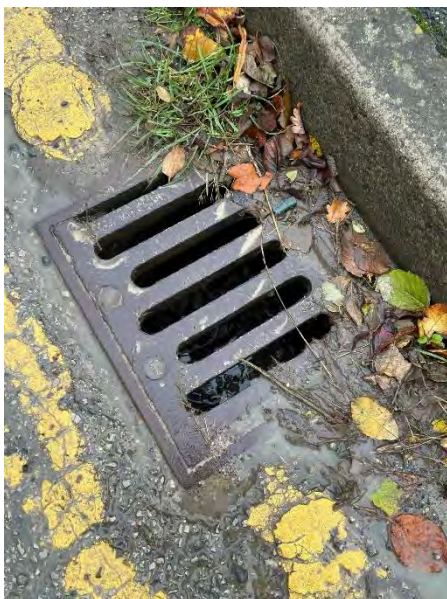
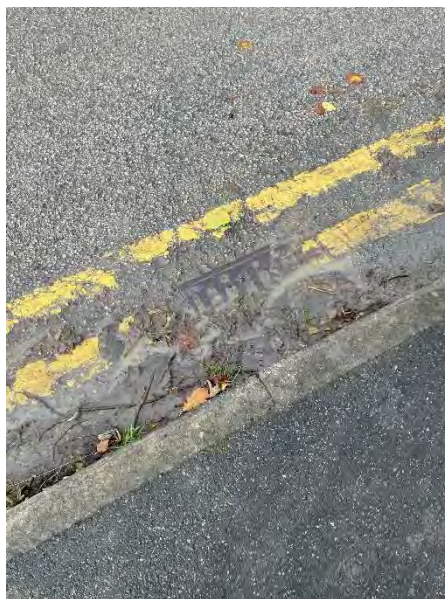
Location: Chainage 85.0 – eastern footway looking towards gully

- 2.11 Issue: Gully appeared in reasonable condition and was not blocked, some debris was visible around the gully. Overall condition of gullies within survey area was mixed with several blocked while others were functional.

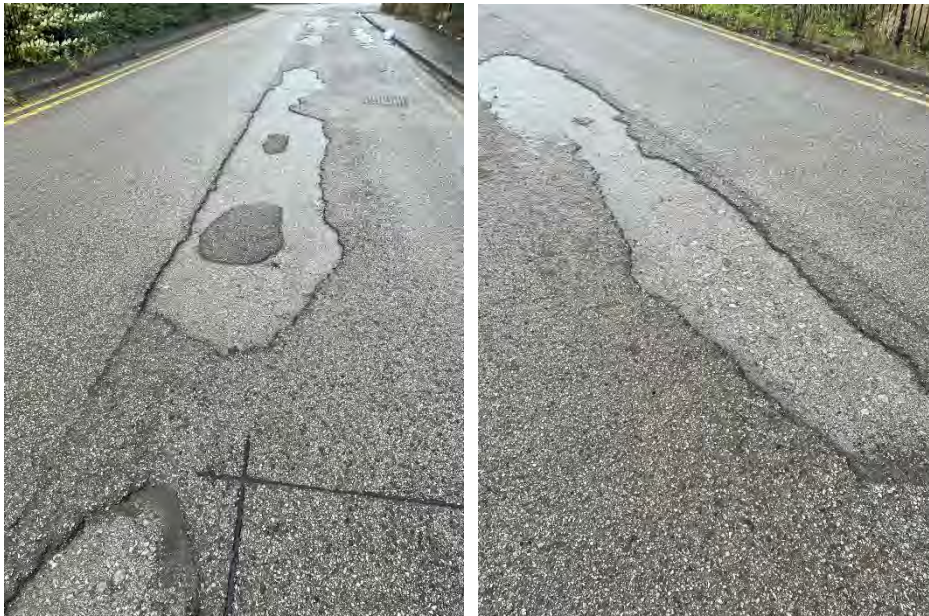
Location: Chainage 96.0 – middle of carriageway facing north along Keresforth Close

- 2.12 Issue: Large areas of carriageway surfacing broken away in large patches with visible surface cracking forming along centreline along nearly entire extents of Keresforth Close.

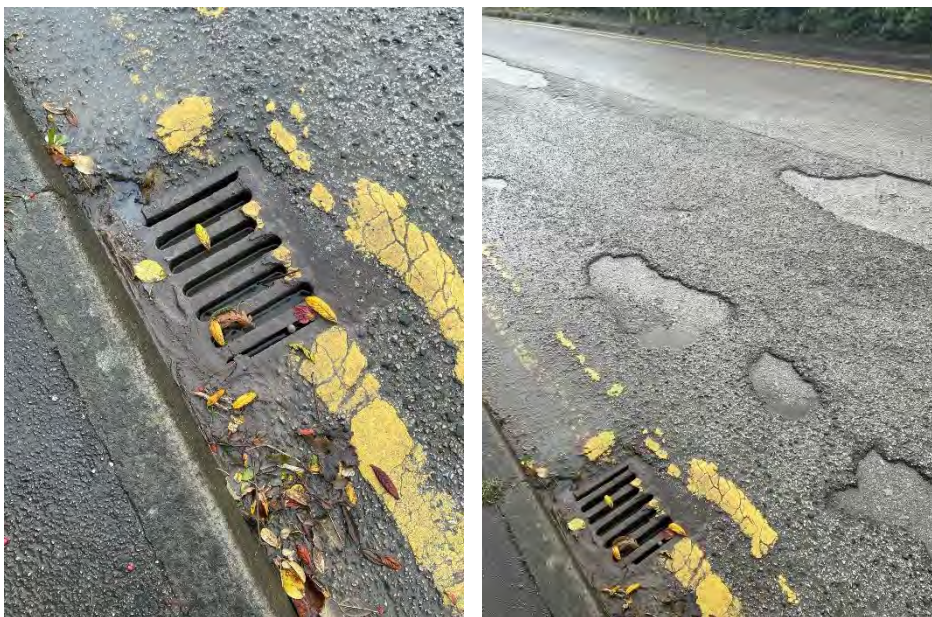
Location: Chainage 109.0 – eastern footway looking towards gully

- 2.13 Issue: Gully appears blocked with water level almost at top of gully grate, some debris also visible with road markings faded.

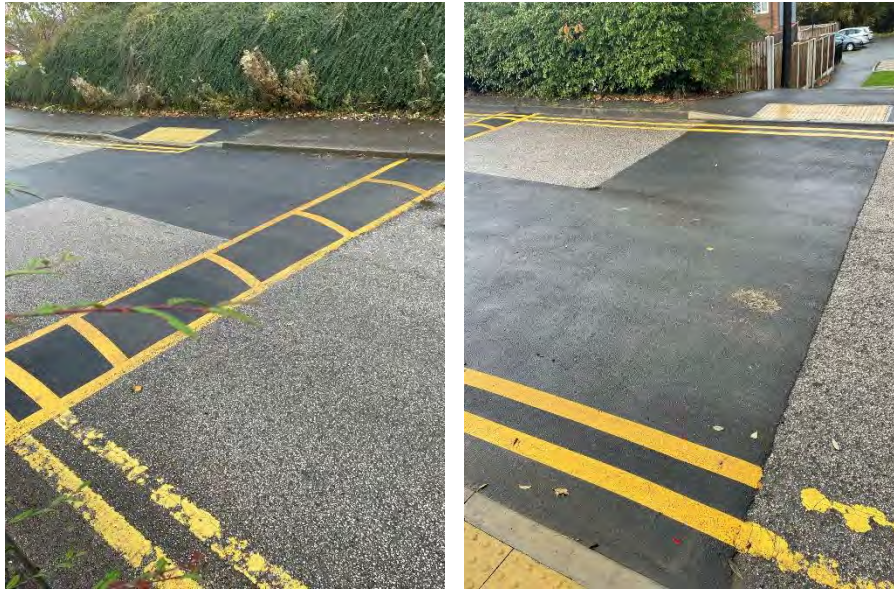
Location: Chainage 136.0 – western edge of carriageway looking at gullies

- 2.14 Issue: Area of carriageway resurfacing with recently constructed pedestrian crossing and speed hump, areas of carriageway broken away near resurfacing and road markings faded.

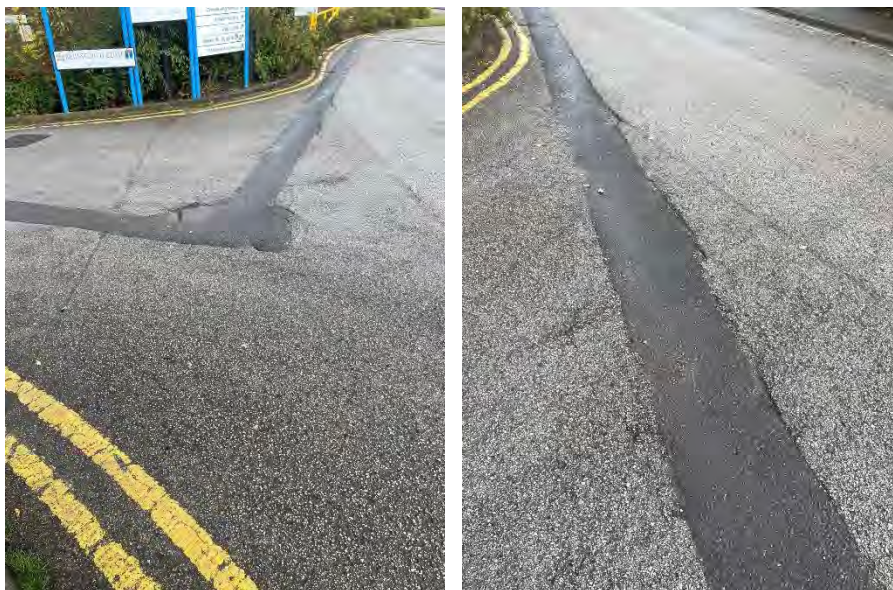
Location: Chainage 146.0 – western edge of carriageway looking across access to residential area

- 2.15 Issue: Large trench along carriageway crossing access to residential area from Keresforth Close and towards Health Centre. Multiple surfacing cracks originating from or near trench and some ponding at joints.

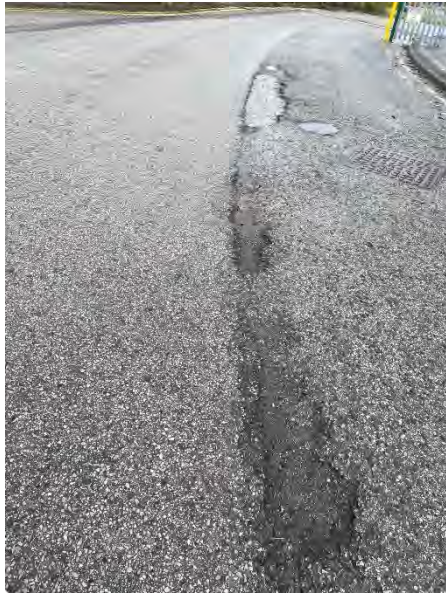
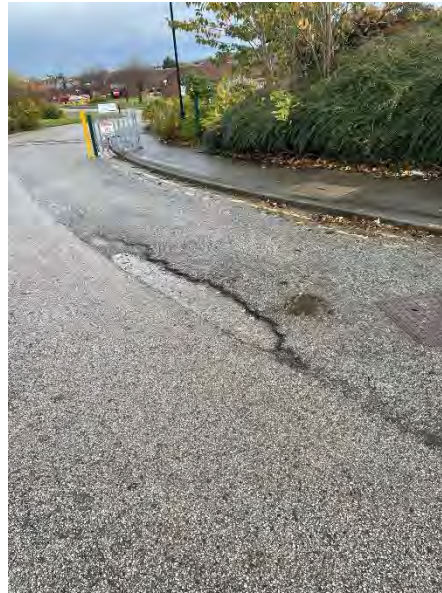
Location: Chainage 150.0 – middle of carriageway looking north along centreline

2.16 Issue: Large areas of carriageway surfacing broken away with some ponding occurring in places.

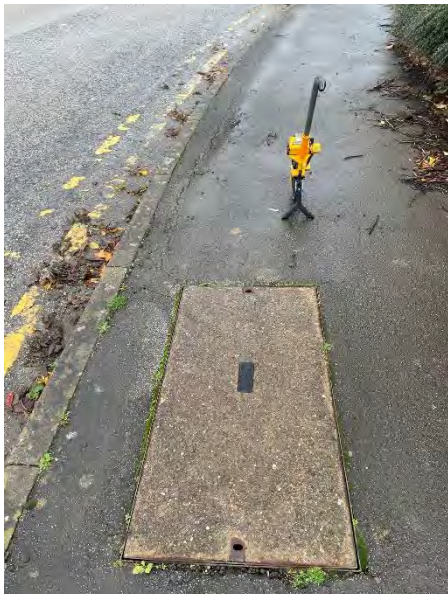
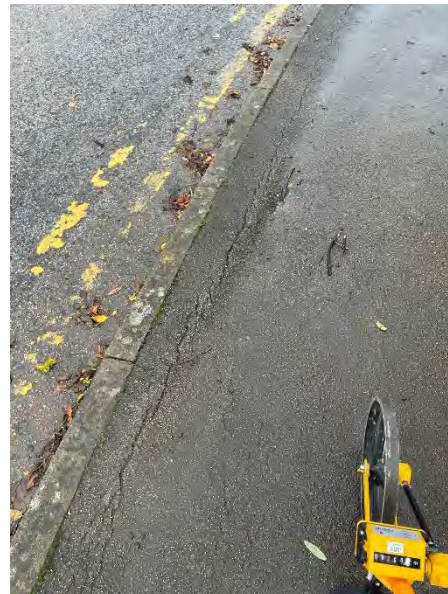
Location: Chainage 159.0 – eastern footway looking along back of kerb

2.17 Issue: Surface cracking visible behind kerbing along footway with some cracking originating from service cover located within footway.

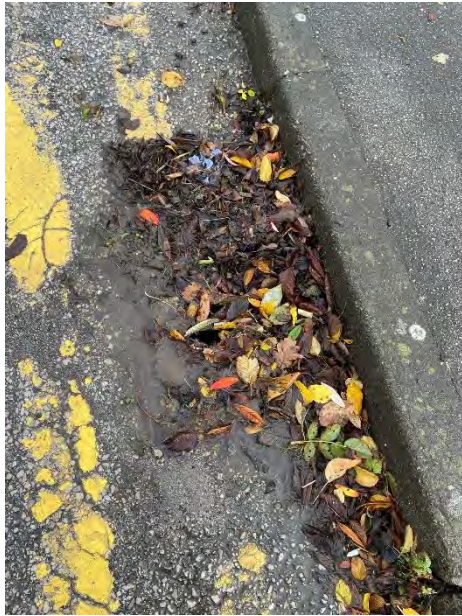
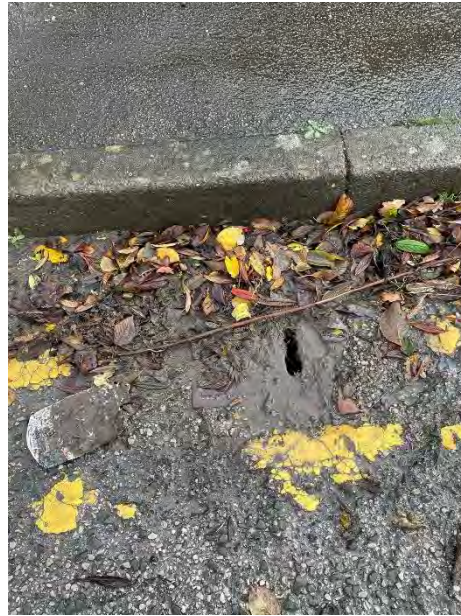
Location: Chainage 165.0 – eastern side of carriageway looking towards gully

- 2.18 Issue: Gully covered by debris and unable to function, other nearby gullies also blocked by debris and faded road markings.

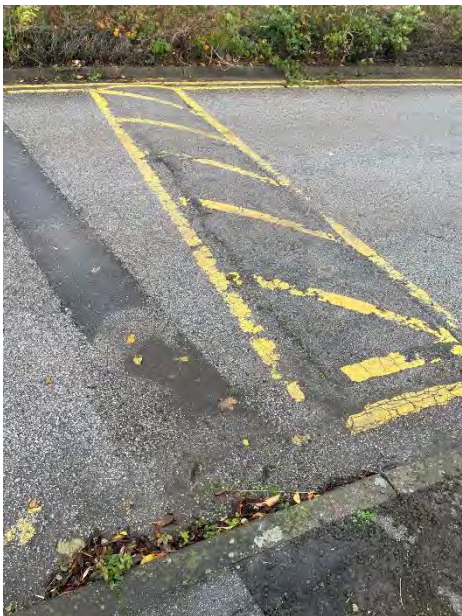
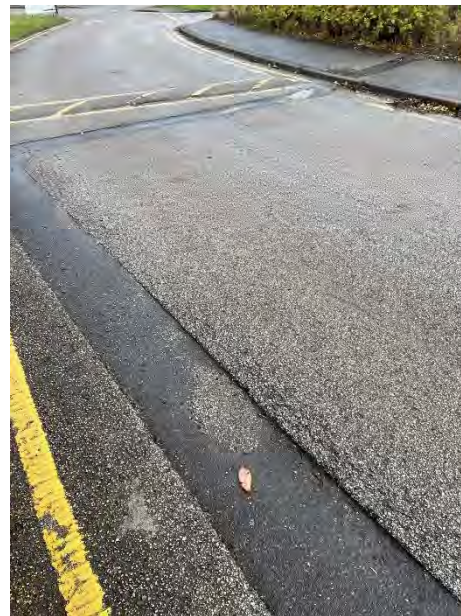
Location: Chainage 168.0 – eastern side of footway facing west across carriageway

- 2.19 Issue: Large trench, originating from residential area crossing in front of speed hump and into footway with some surface cracking forming at joint between trench and carriageway surfacing. Road markings fading with some surfacing broken away from speed hump.

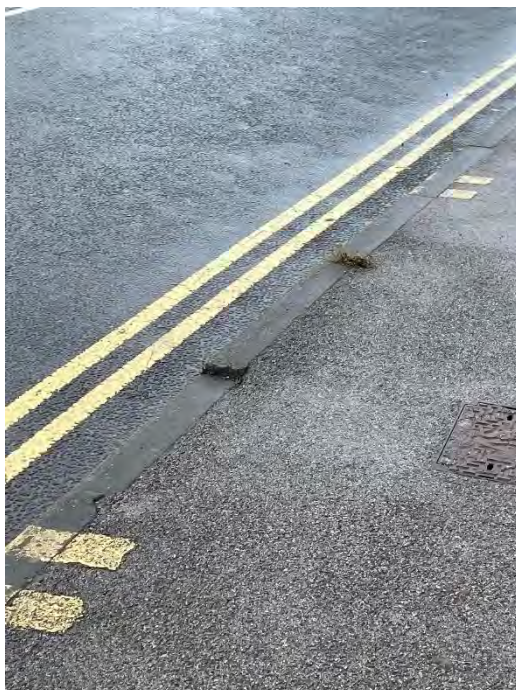
Location: Chainage 0.0 – northern side of footway looking towards kerb

- 3.3 Issue: A section of kerbing appears to have partially sunk with a small area of vegetation growing between two kerbs.

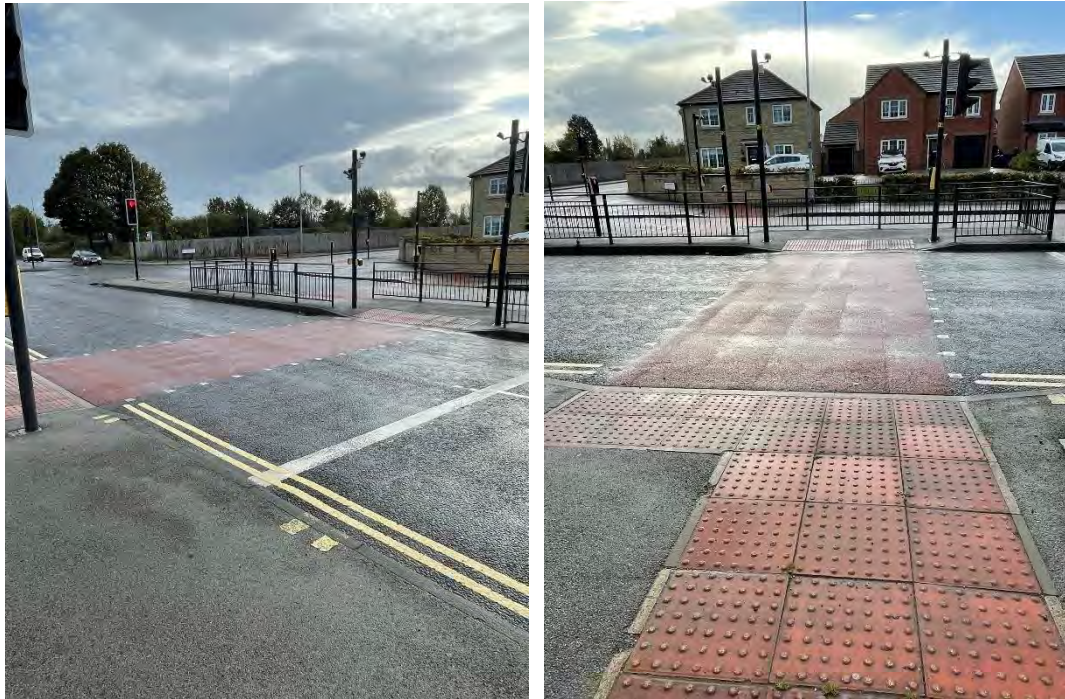
Location: Chainage 28.0 – northern side of footway looking south towards crossing

- 3.4 Issue: Pedestrian controlled crossing appears in good condition overall, some edging kerbs appear chipped and tactile pavings uneven in placed. Road surface appears in excellent condition.

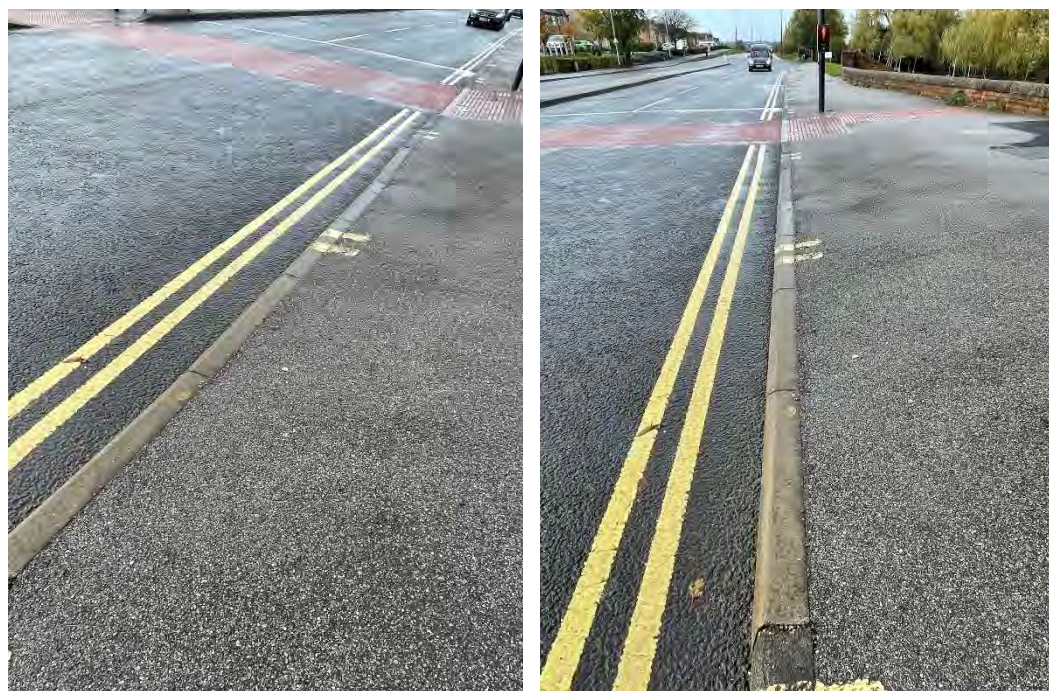
Location: Chainage 33.0 – northern footway looking west along kerb

- 3.5 Issue: Dropped kerb after pedestrian crossing. Overall condition appears good.

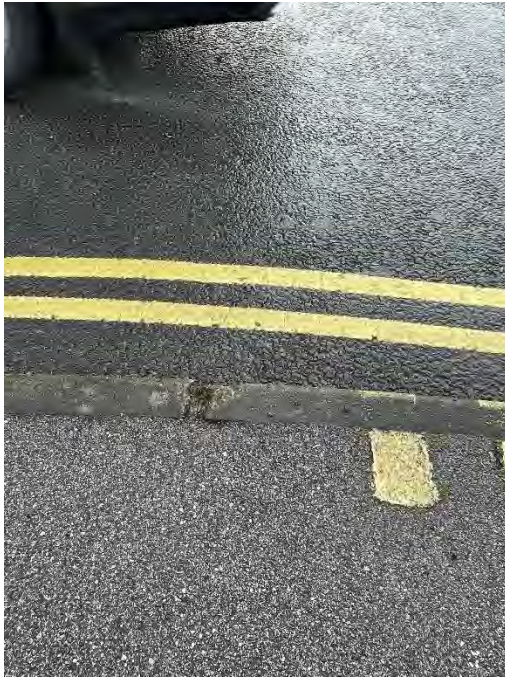
Location: Chainage 39.0 – northern footway looking towards kerb

- 3.6 Issue: Kerbing near pedestrian crossing appears chipped in places.

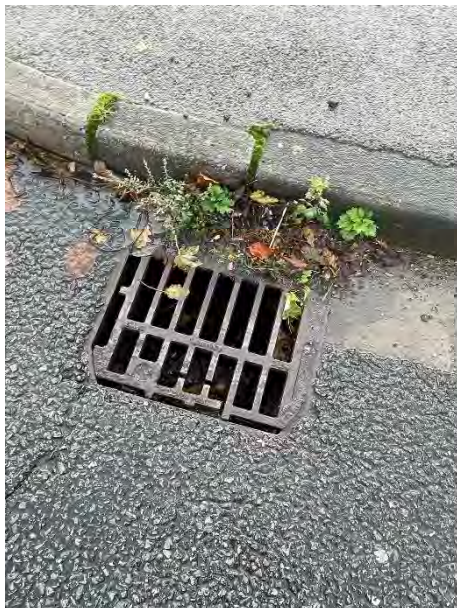
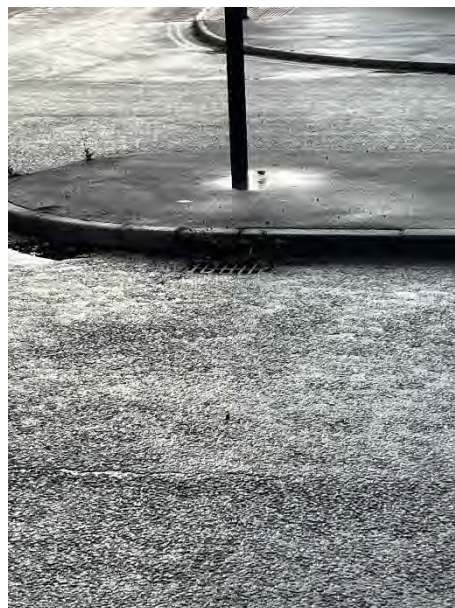
Location: Chainage 42.0 – northern footway looking south towards gully at island

- 3.7 Issue: Gully appears to have some debris within, but is not visibly blocked. However, some debris and vegetation growth has built up between gully and kerbing.

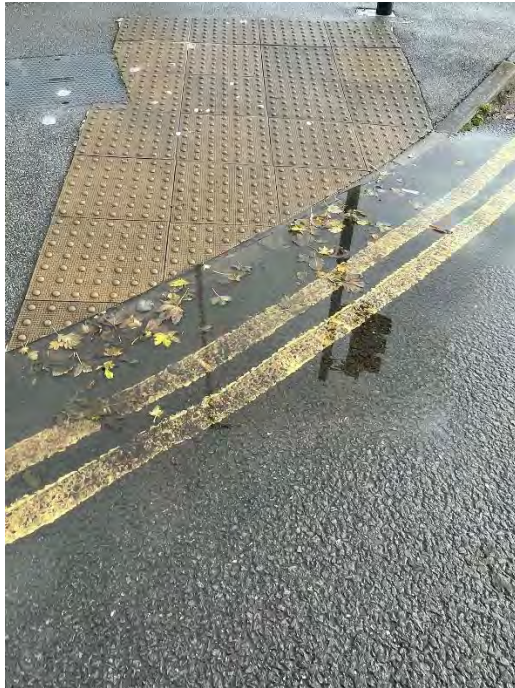
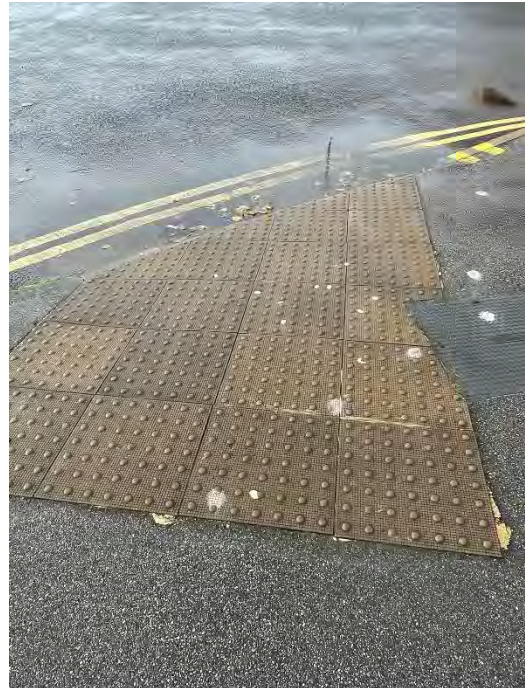
Location: Chainage 55.0 – access to Keresforth Close looking towards southern side of crossing

3.8 Issue: Area of ponding at dropped kerb crossing on southern side of access to Keresforth Close.

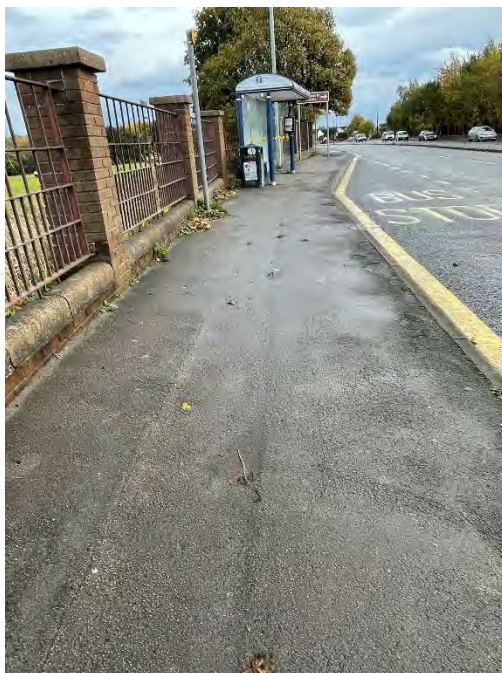
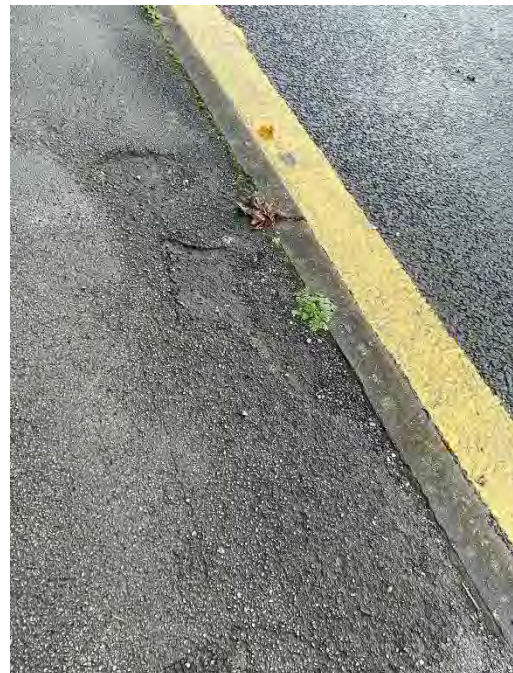
Location: Chainage 63.0 – northern footway looking east along footway

3.9 Issue: Visible trench along middle of footway leading towards bus stop with sections of footway surfacing breaking away from behind kerbing.

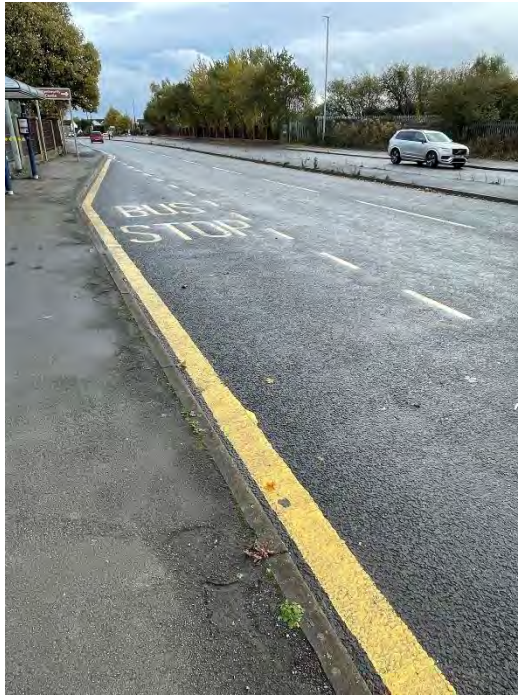
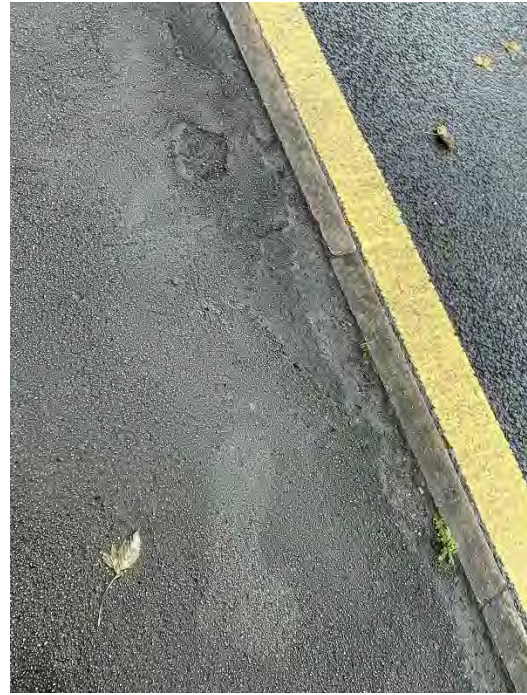
Location: Chainage 72.0 – northern footway looking across bus stop cage

- 3.10 Issue: Carriageway at bus stop appears in good condition with some areas of footway behind kerbing appearing to have broken away.

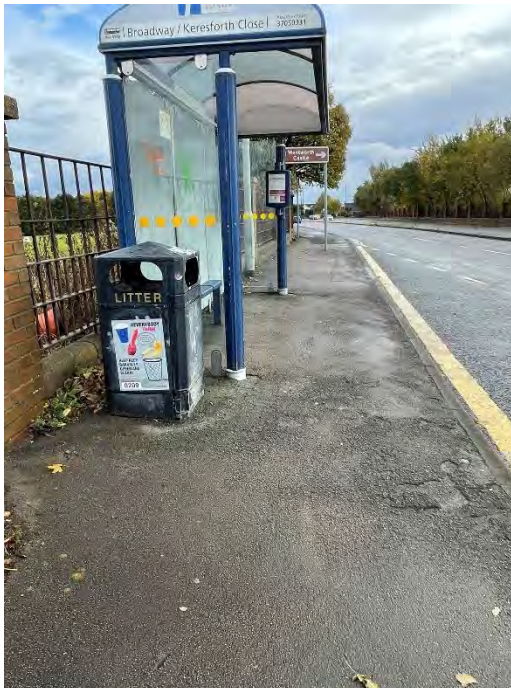
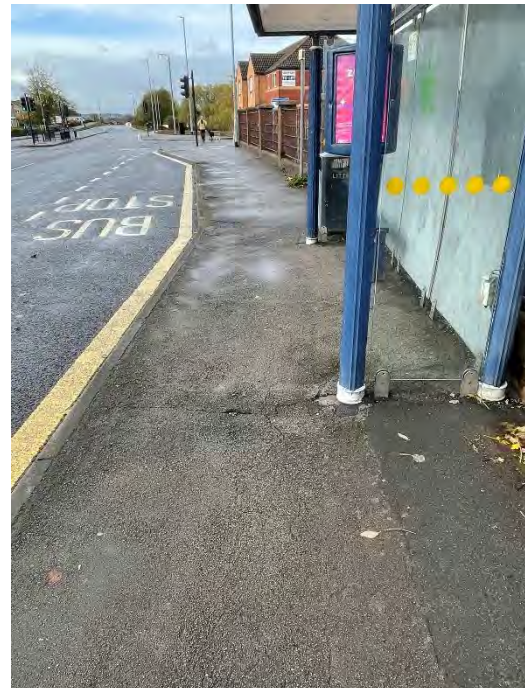
Location: Chainage 82.0 – northern footway looking at bus stop

- 3.11 Issue: Bus stop shelter appears in reasonable condition. However, areas of cracked and broken footway surfacing originating around bus stop shelter is visible.

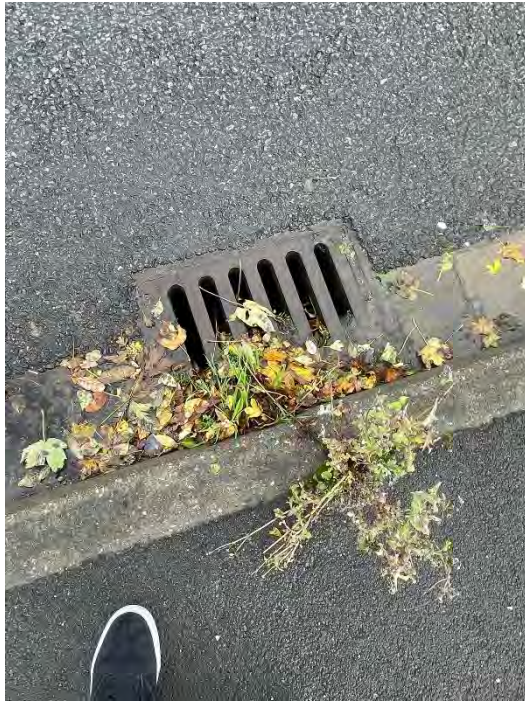
Location: Chainage 90.0 – northern island looking at gully

- 3.12 Issue: Gully appeared partially blocked by debris with some vegetation growing behind kerbing near gully.

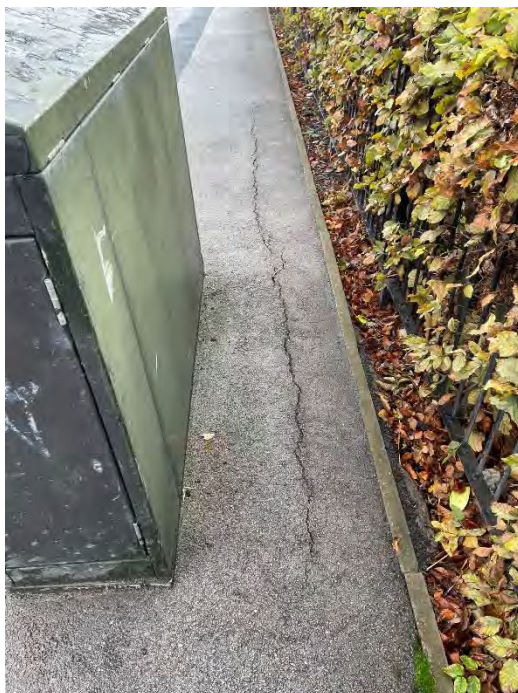
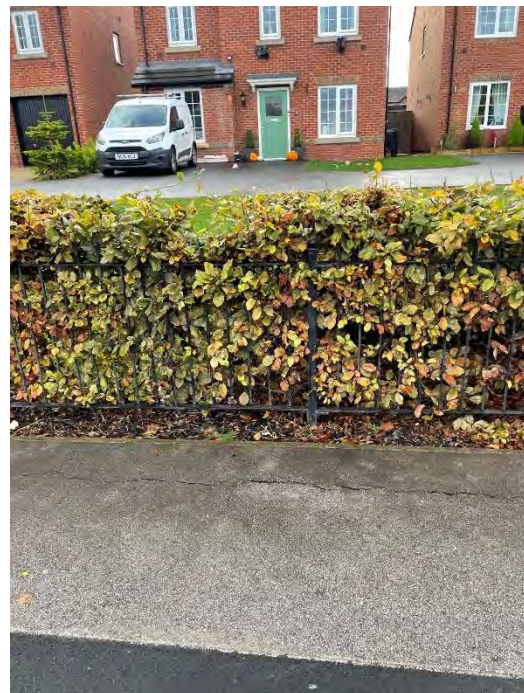
Location: Chainage 6.0 – southern footway looking east along back of footway

- 3.13 Issue: Large section of surface cracking originating at back of footway in front of hedge and behind utilities box.

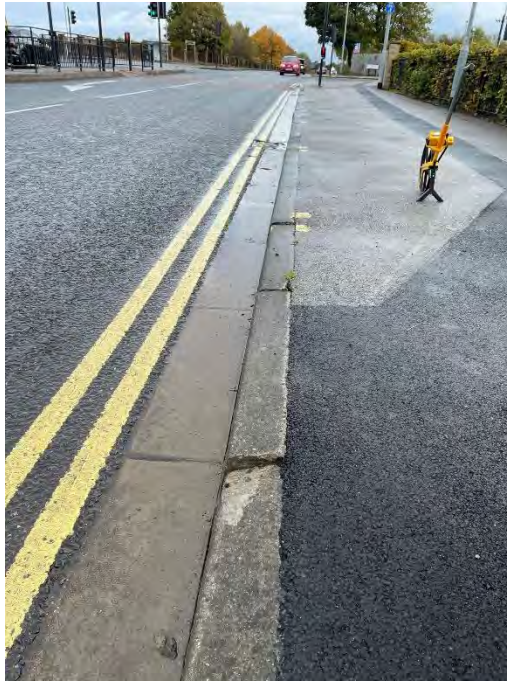
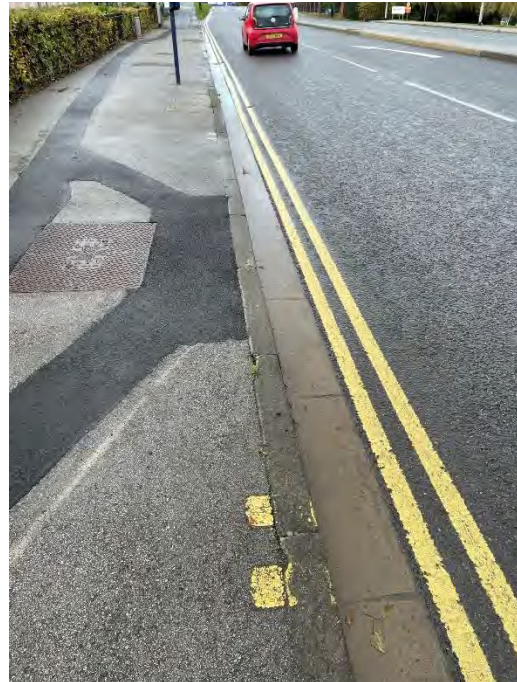
Location: Chainage 9.0 – southern footway looking east along kerb line

- 3.14 Issue: Multiple kerbs appear chipped or otherwise damaged with area of road markings also appearing to have partially faded.

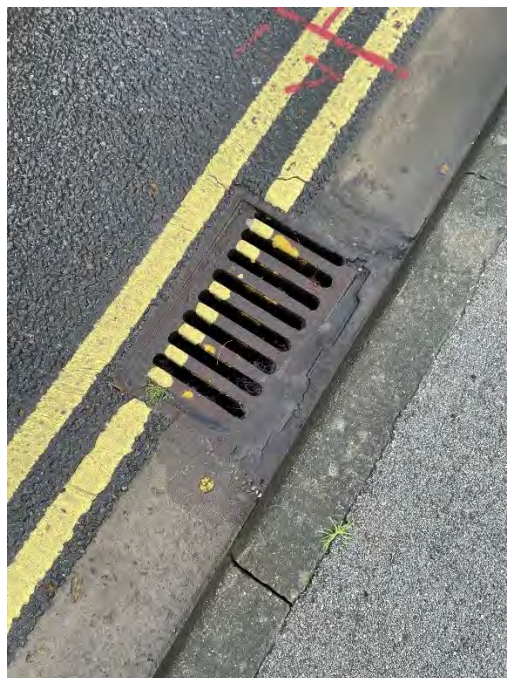
Location: Chainage 18.0 – southern footway looking towards gully

- 3.15 Issue: Gully does not appear blocked. However, a small amount of debris does appear to be blocking some water from entering back of gully.

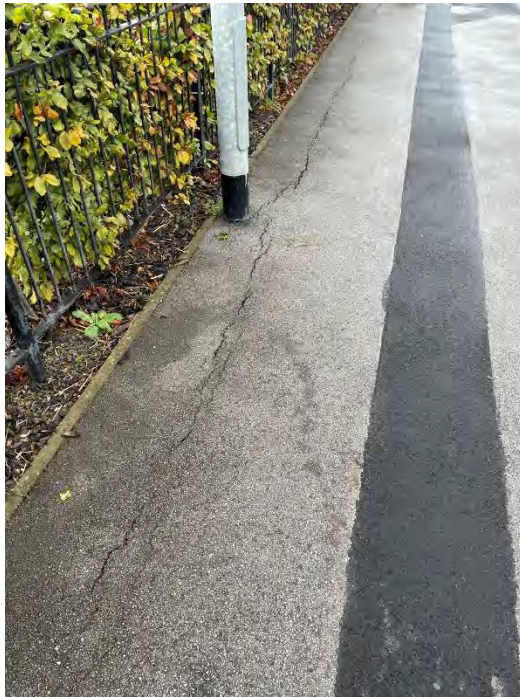
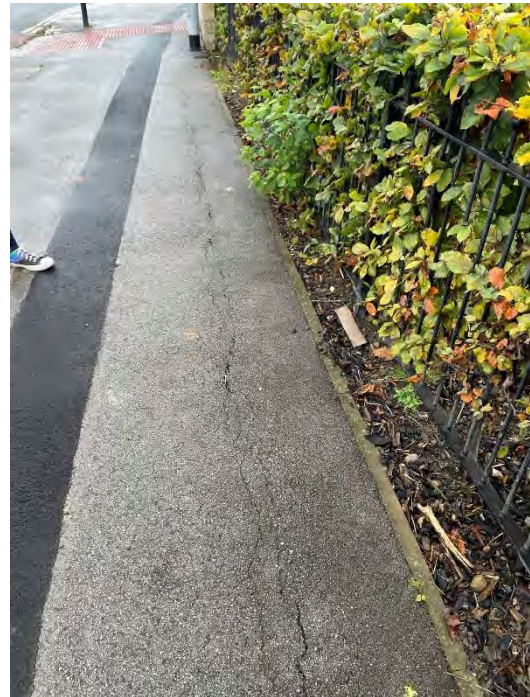
Location: Chainage 28.0 – southern footway looking towards back of footway

- 3.16 Issue: Large surface crack along back of footway connecting with earlier crack and continuing towards lighting column.

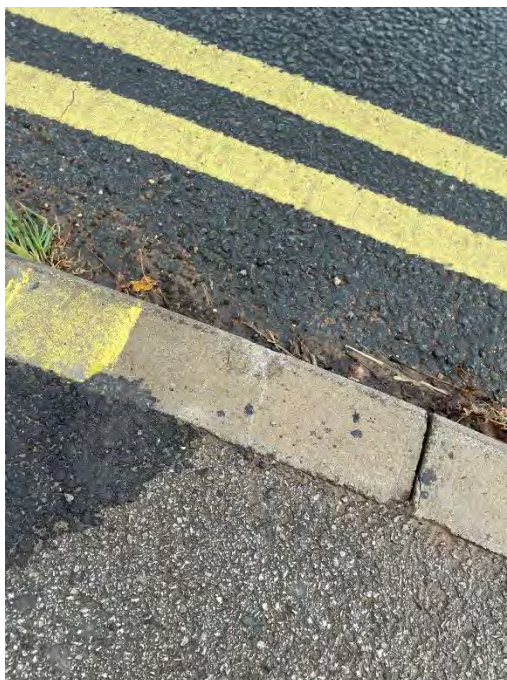
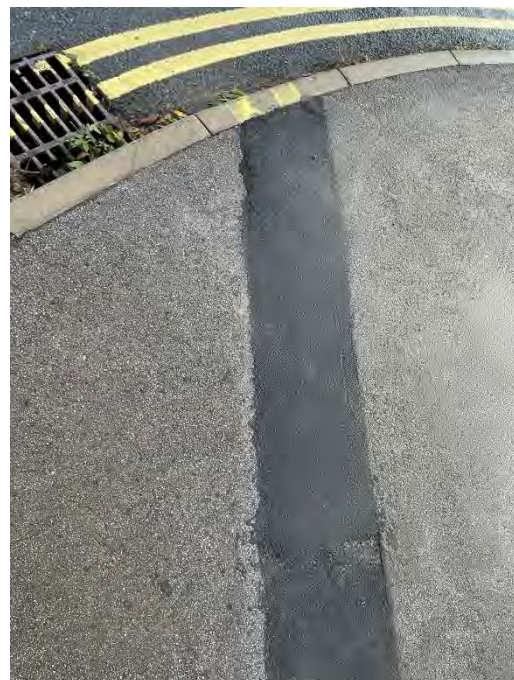
Location: Chainage 40.0 – southern footway looking towards kerb

- 3.17 Issue: Section of kerbing at access to Assembly Way appears chipped in places near trench location.

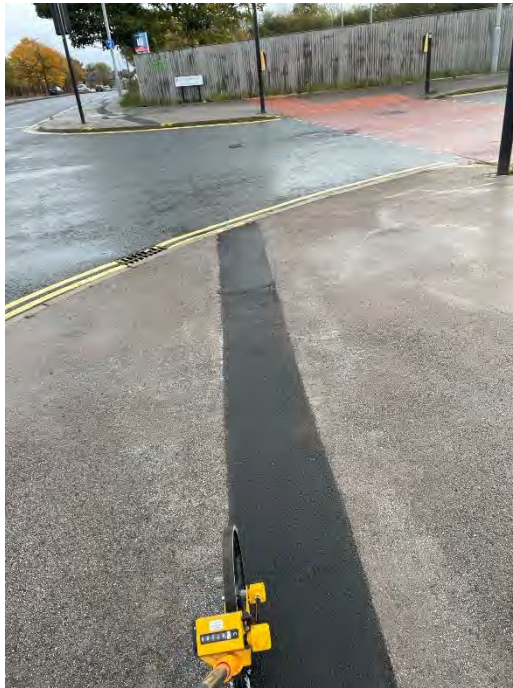
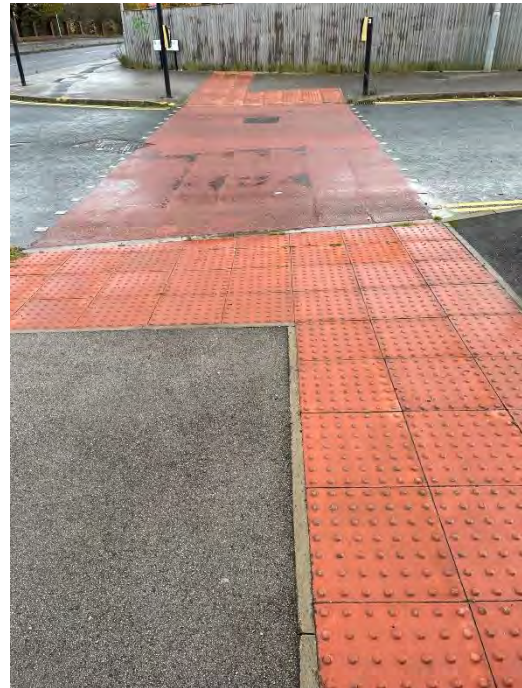
Location: Chainage 44.0 – southern footway looking east towards crossing

- 3.18 Issue: Crossing appears in overall good condition. However, coloured surfacing appears to have begun faded in places.

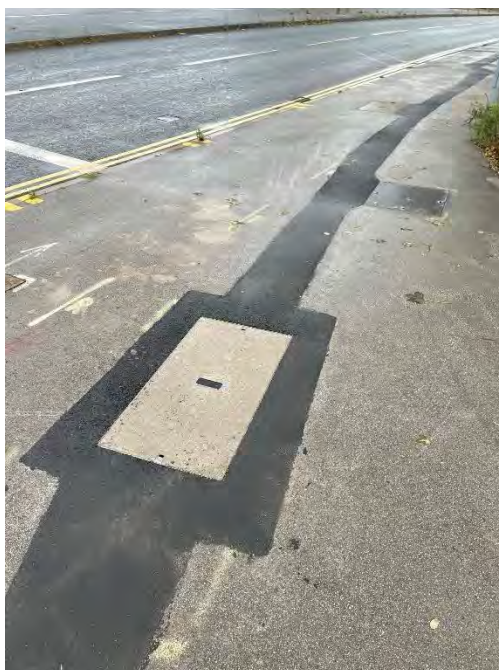
Location: Chainage 59.0 – southern footway looking east across footway

- 3.19 Issue: Large area of resurfaced footway around service covers with some areas of vegetation growing between kerb and footway.

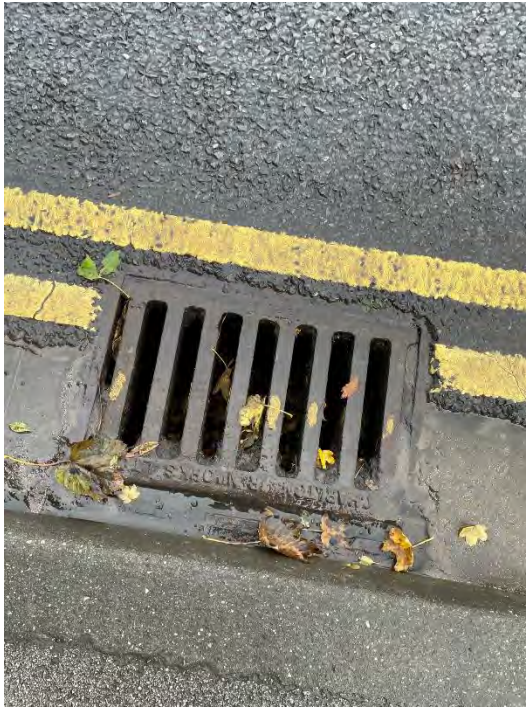
Location: Chainage 66.0 – southern footway looking towards gully

3.20 Issue: Some debris visible within gully, but does not otherwise appears to be blocked.
