## **Tree Survey**

| <b>Survey for trees at site:</b> | Westfield House, 47 Victoria Road, Barnsley, S70 2BU |
| <b>Reference</b> | TreeSurvey <b>0155 (Revised)</b> |
| <b>Survey date(s)</b> | 19/04/2018 |

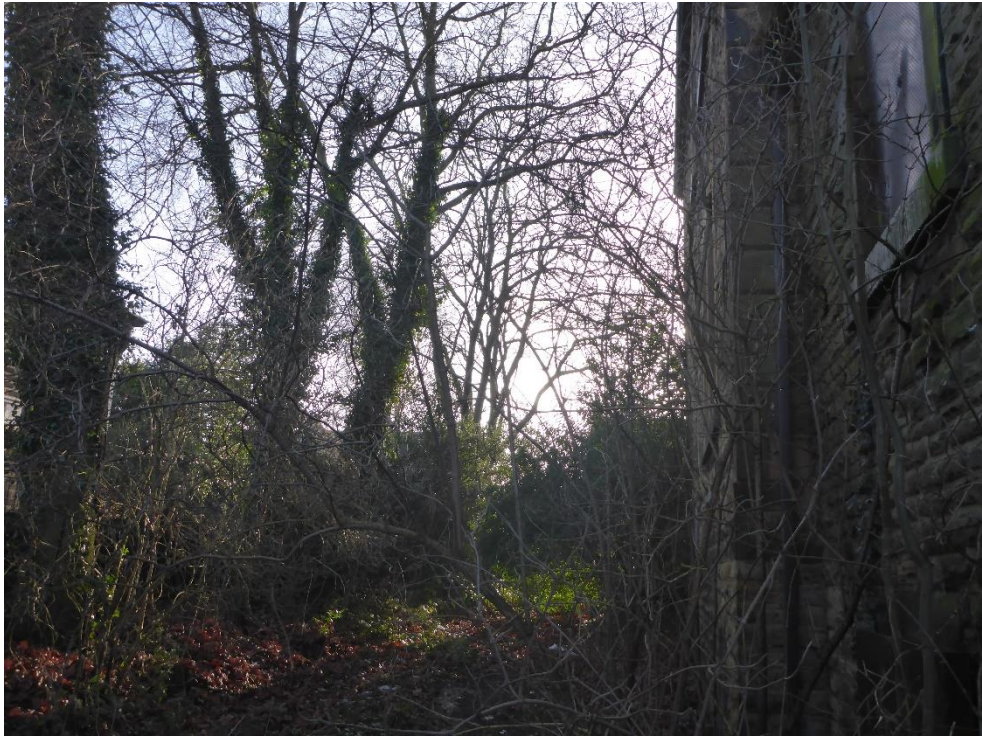
*Photo 3: Trees T3, T4, T5, T6 situated in a line running along the east border, with the existing building to the right.*

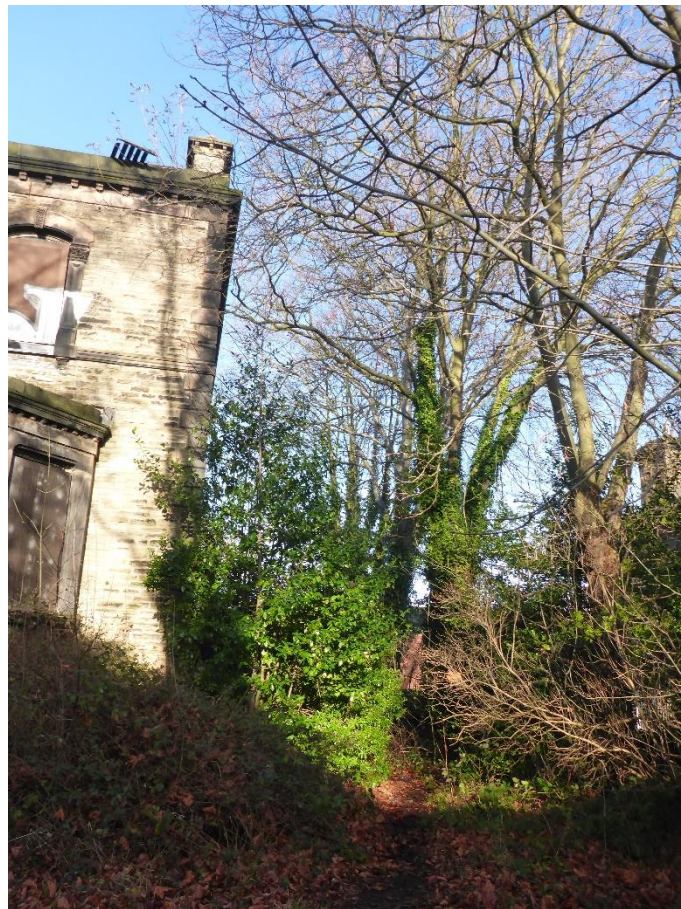
*Photo 4: T5 and T6 on the east boundary situated close to the existing building. The proposed driveway is to run between the existing building and these trees.*
