Bat Survey to  
Burntwood Hall Farm  
Brierley Common

Barnsley  
S72 9HB

# 1. Summary

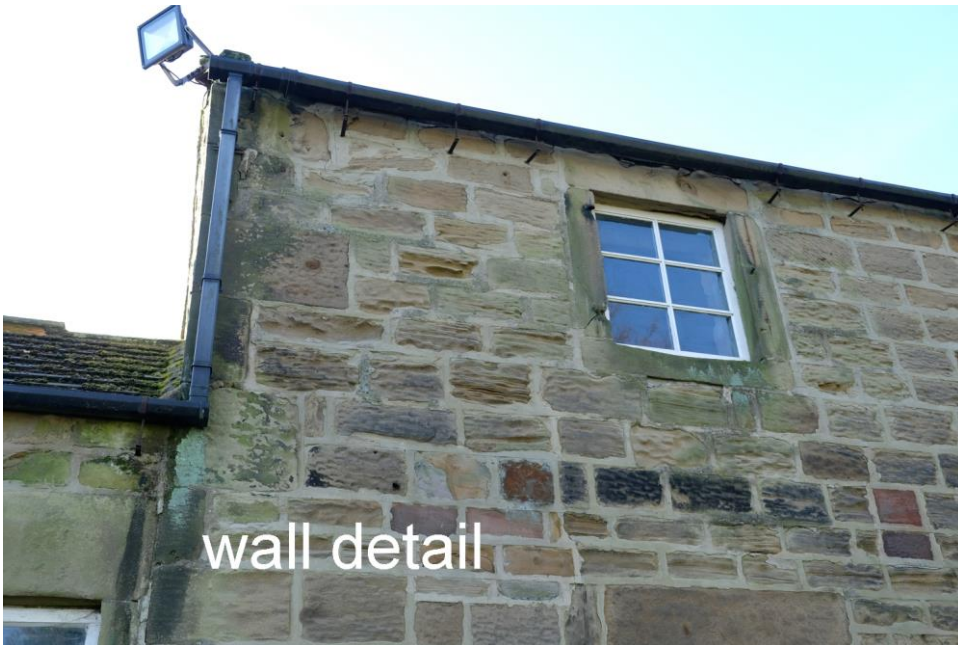
wall detail

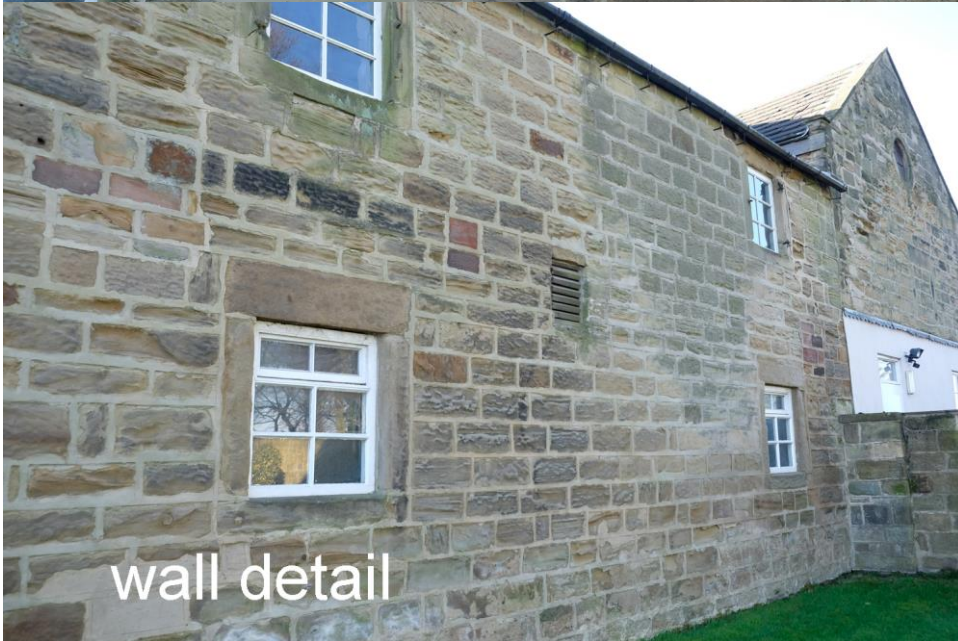
wall detail

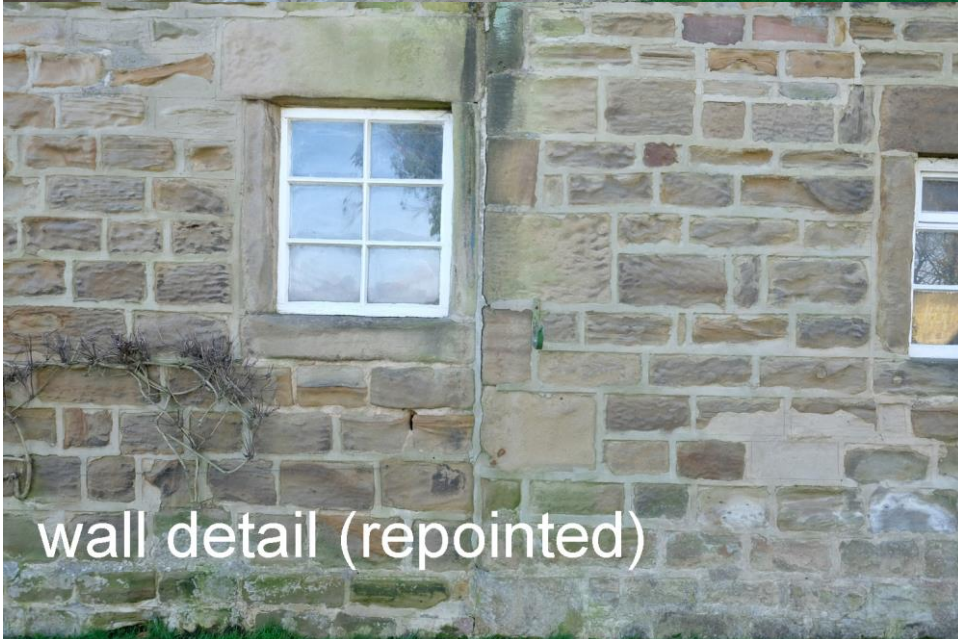
wall detail (repointed)

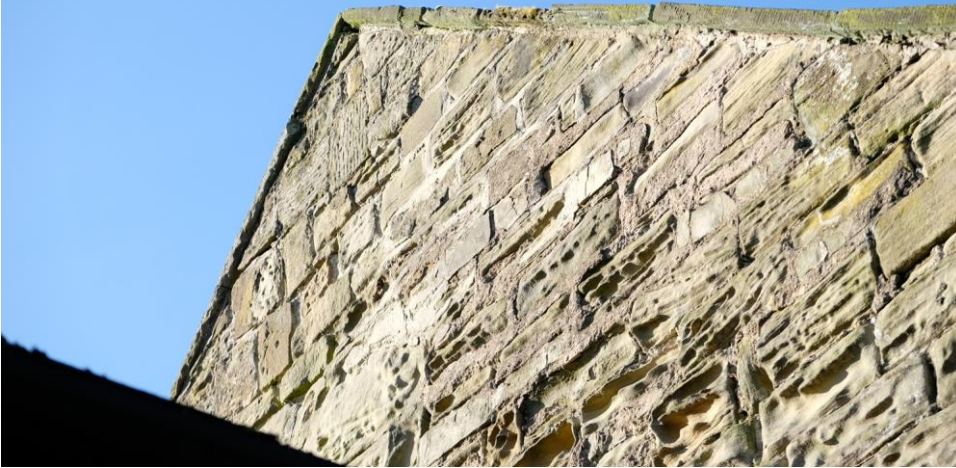
gable wall (barn 1)

**Barn 1:** This barn is a two storey building adjoining an existing residential dwelling. The walls are stone and are very well pointed and do not have gaps or cavities. All walls have been extensively repointed and all verges sealed and the single gable has stone capping which appears well bedded. The roof is sound and has been modified and recovered at some stage and the original York stone tiles have been replaced with a thin, cement fibre tile. Internally, the roof is unlined and the tile structure can be easily seen to be a criss-crossed diamond effect that has no gaps or cavities the would enable bats to roost or entre the barn via the roof. The ridges appear sound and have a heavy build-up of dust webs and dirt and do not show signs of bats. The floor in this section is very clean and inspection did not reveal any droppings or scattered prey remains. There are some stored good that have clearly not been moved in a good while and these did not show any signs of droppings. Both internal walls were inspected for

droppings that may have adhered to the stonework but none were found. There did not appear to be any evidence of bats using this section of the barn and the building is considered to be of **negligible** interest to bats.

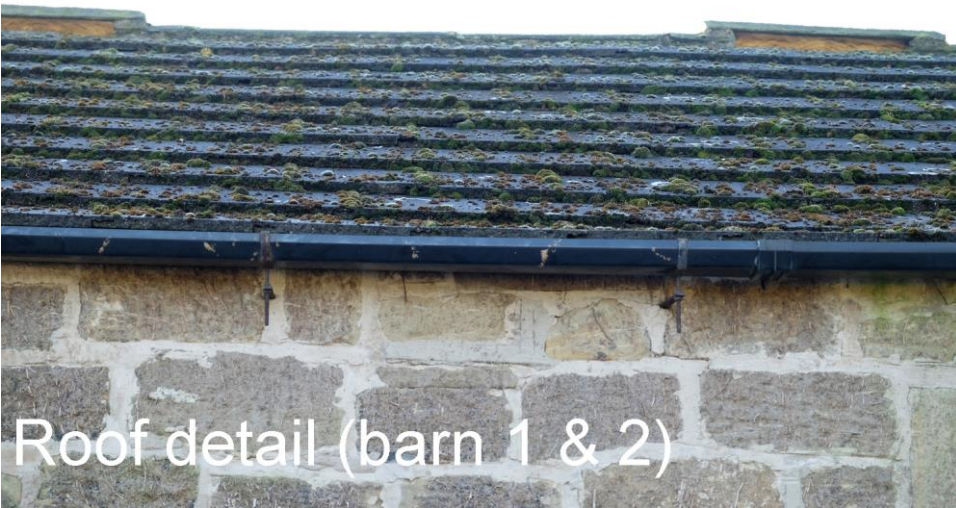
Roof detail (barn 1 & 2)

**Barn 2:** A single storey extension to barn 1 and again, the building has been extensively renovated and repointed resulting in no external cracks or cavities that may be of interest to bats. The roof has also been replaced with Marley tiles and does not have cavities. The ridges are sound apart from one small section that has some pointing missing and the single gable wall has sound heavy stone capping. Internally the roof is lined with traditional hessian and bitumen felt which is sound and has no light ingress. The ridges show a big build-up of cobwebs and do not show signs of bats using the ridges. There was no evidence internally of bats using the building with no droppings to be found on the stored goods. There are no fascia or soffits that would offer potential roosting sites and the dry verge is sound. Overall, the building is considered to be of **low-negligible** interest to bats.

- All contractors to be made aware of the possible presence of bats when removing ridge tiles
- All ridge tiles should be stripped by hand and left off the building for a period of 24hrs
- A Schwegler 1F bat box should be erected on one of the other barns in the yard opposite the proposed development area before building works commence on the site. This bat house should be sited at least 3m above ground and be mounted on a south or west facing wall.

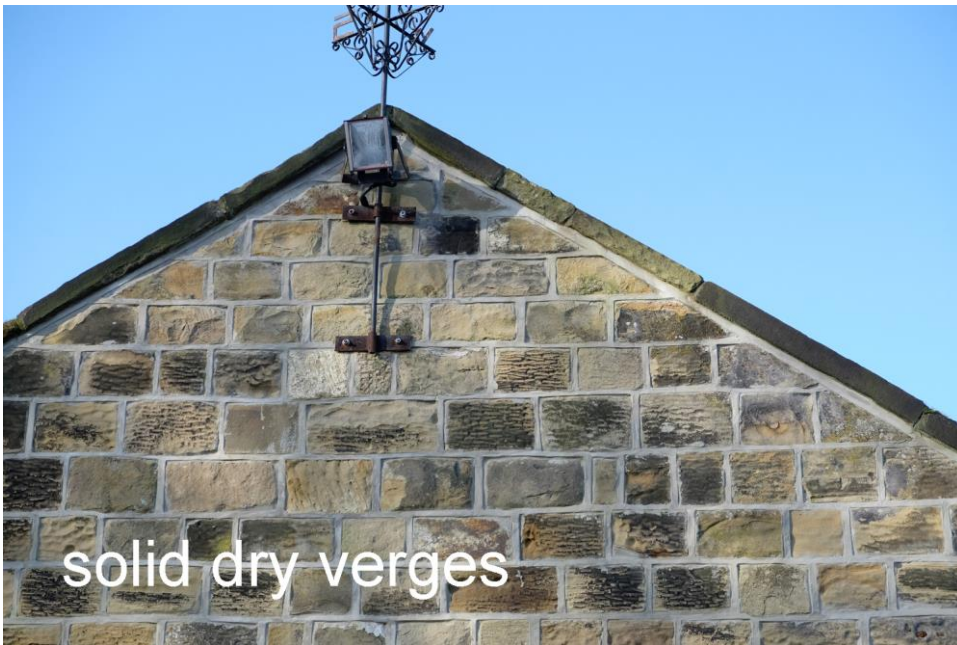
solid dry verges

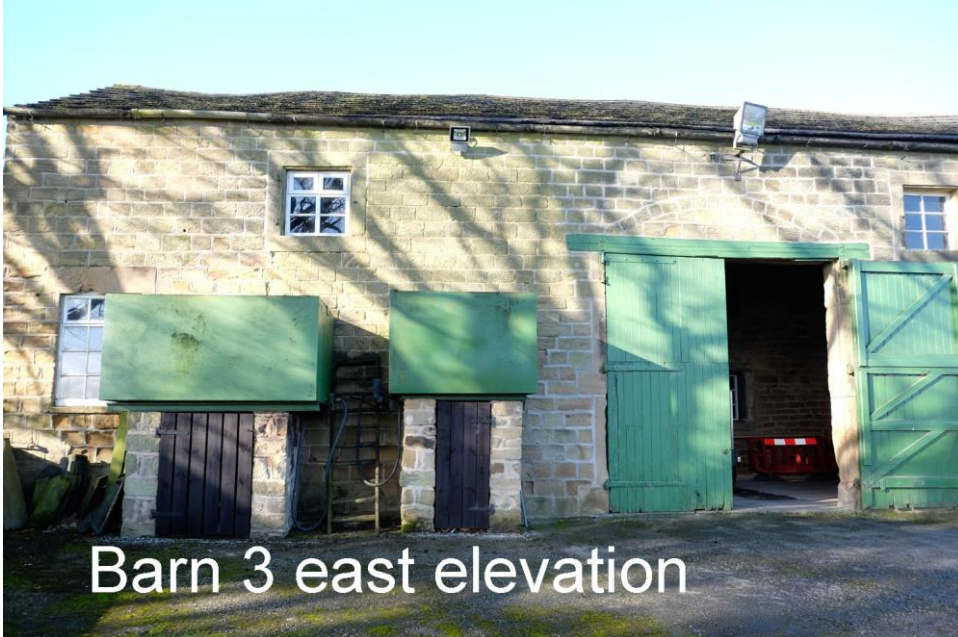
Barn 3 east elevation

**Barn 3:** This is a large two storey stone barn which is one big open space internally having no first floor. The roof has been replaced with a Marley tile which has a tight interlocking pattern and has no access gaps. Internal inspection shows the roof to be lined with traditional felt and in a good condition with no light ingress from the ridges. Although the ridge section is clean internally, there was no evidence to suggest use by bats. There were no droppings adhered to the internal gable walls and no droppings on the large wheat drying device installed inside the barn. The barn has several windows and is therefore subject to a good deal of daylight which would discourage the use by some species of void dwelling bats. All walls have been extensively repointed both internally and externally and all dry verges are sound and very well cemented. There are no fascia or soffits that would allow access to the wall tops and internally, the walls tops have all been heavily cemented to the underside of the roof tiles so it is unlikely there are suitable areas for bats. All windows and doors are wooden but well sealed into the openings. The building is considered to be of **low-negligible** roost potential.
