## A61 Barnsley Dilapidation Survey

10.57hrs, Friday 13<sup>th</sup> January 2023

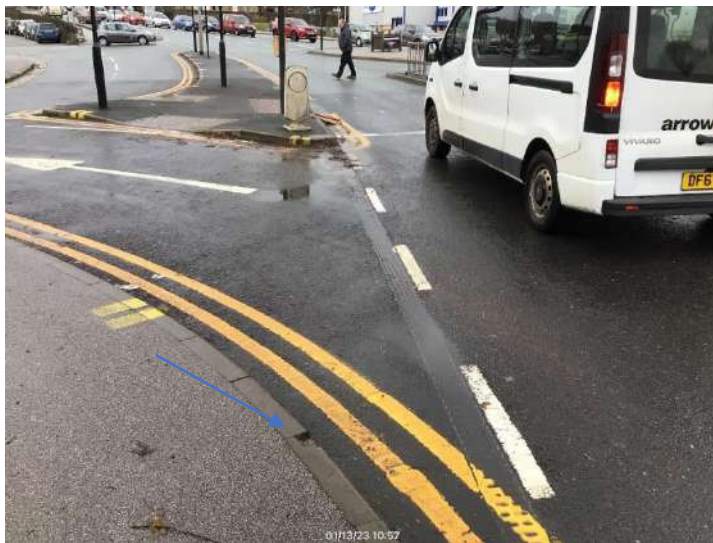
### 1) Northwest tie in: Damaged kerb

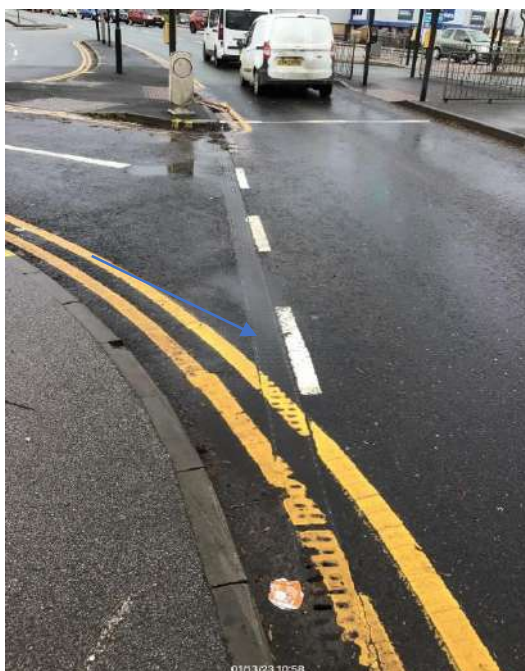
### 2) Northwest tie in: Blocked Aco Drain

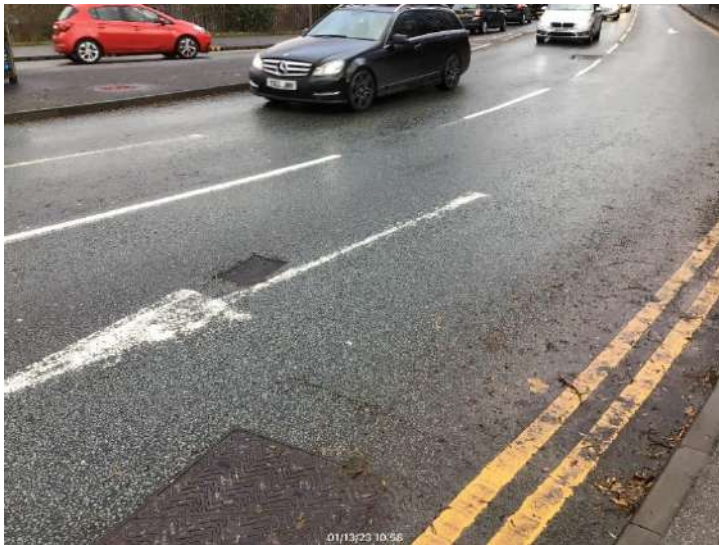
3) Lane 1 Northbound: low chamber/water valve

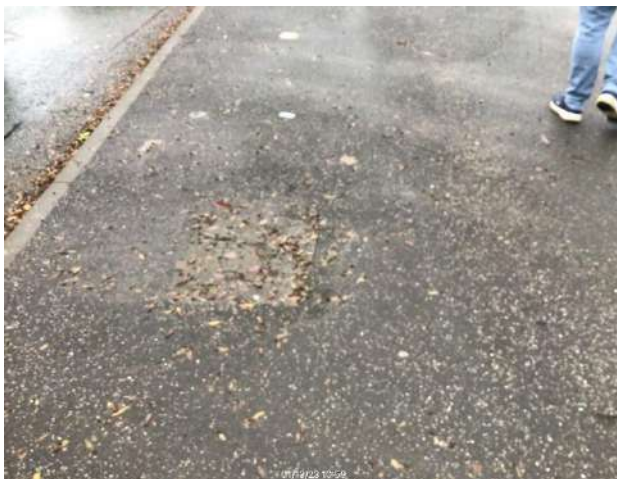
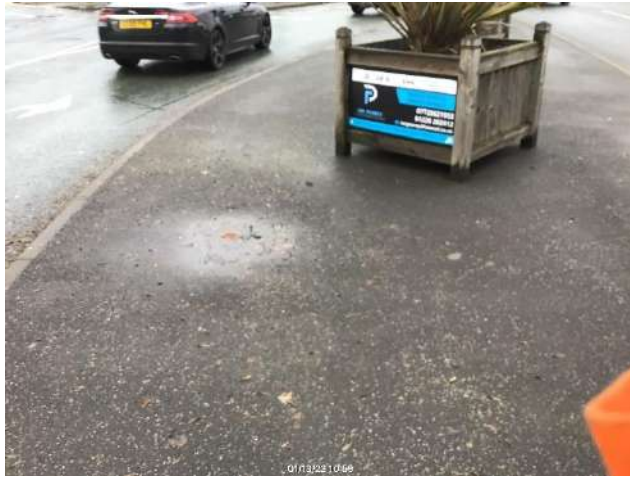
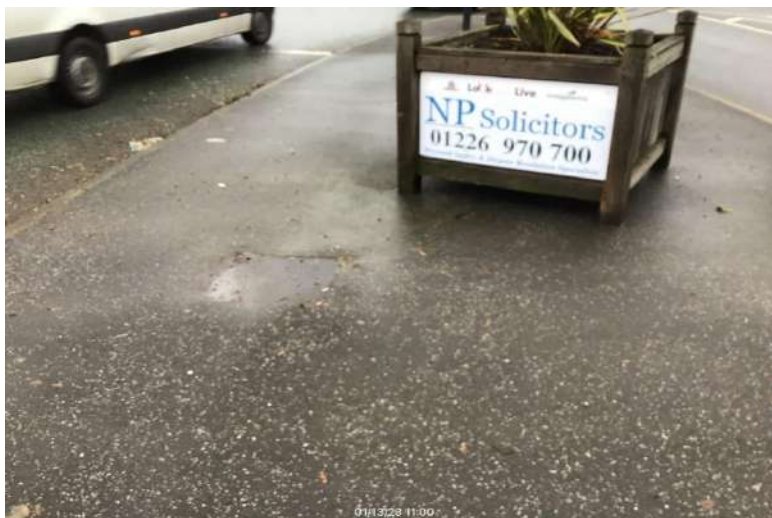
4) North Tie in Island: Low chambers (3no)

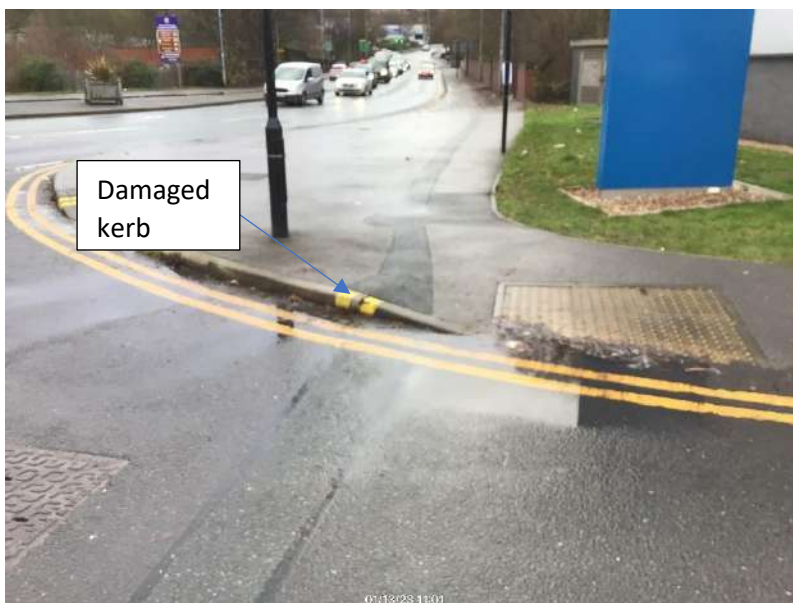
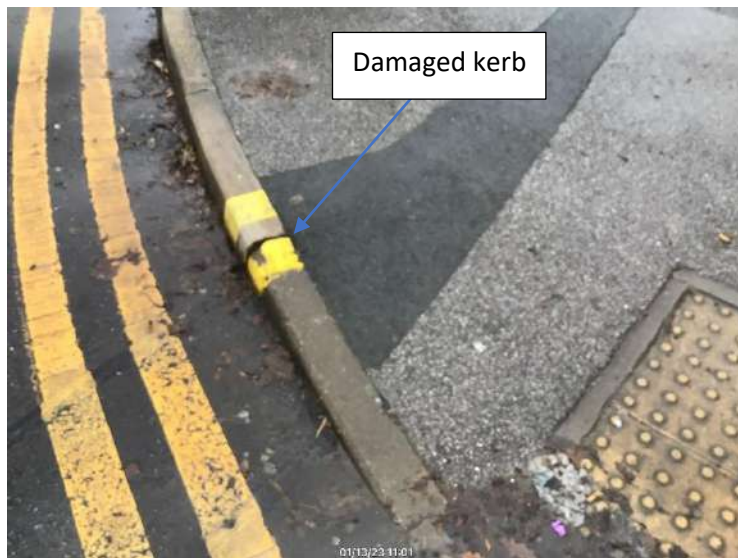
5) Northwest tie in: Damaged kerb/standing water to pedestrian crossing

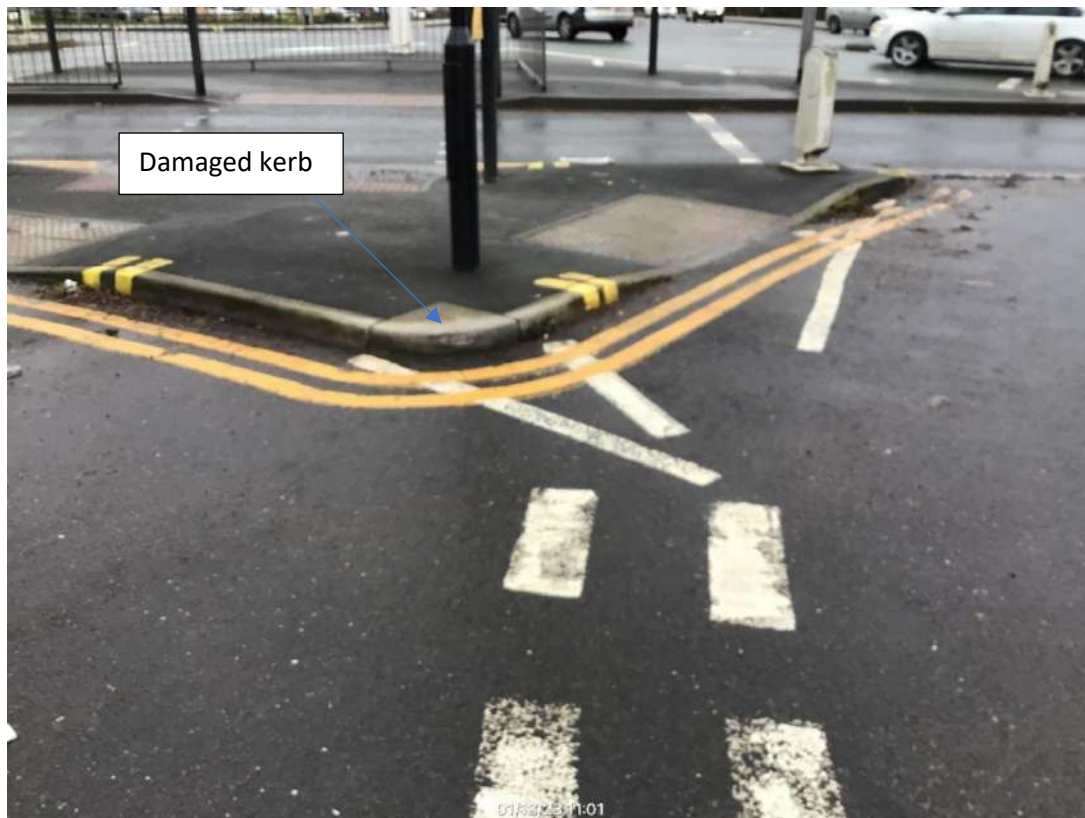
6) Northwest tie in: Damaged kerb

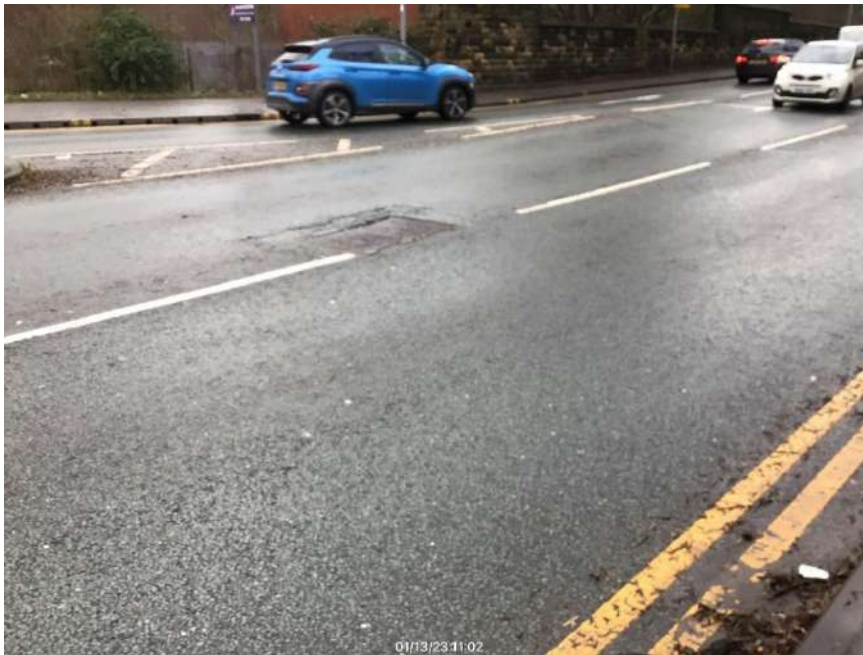
7) Northbound Lane 2: Low chamber with surrounding surfacing course damage

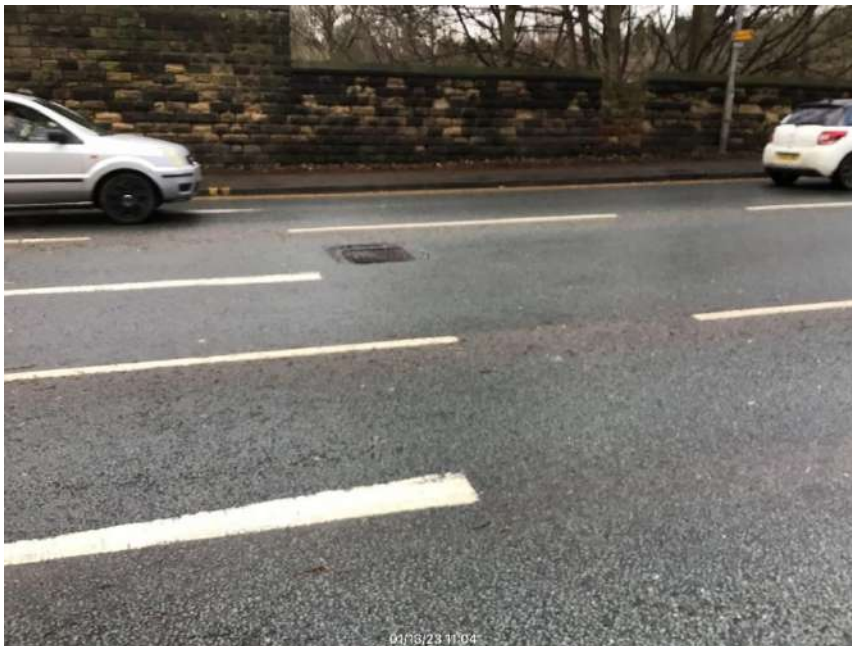
8) Northbound Lane 2 low chamber with surrounding surfacing course damage

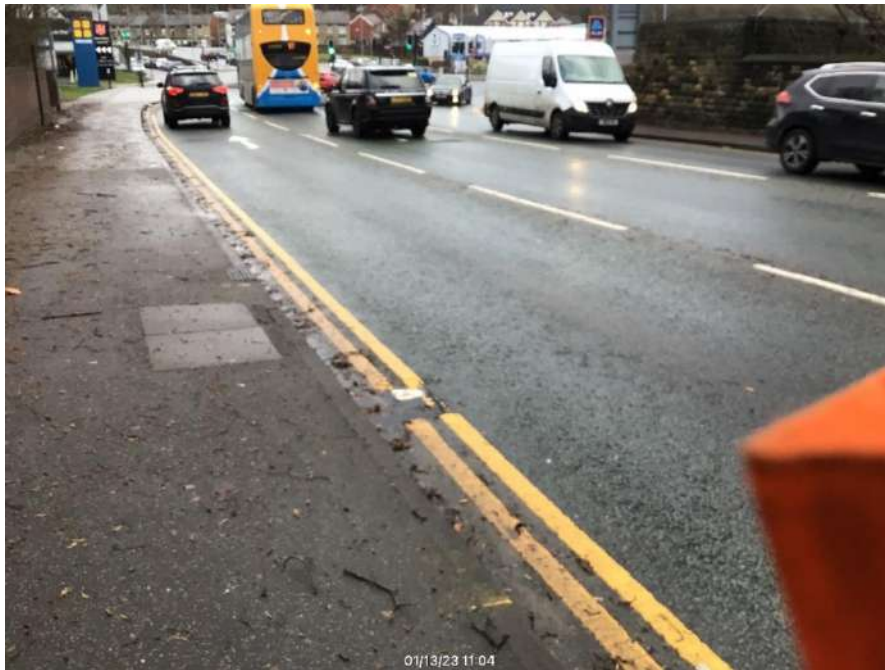
9) North of Bridge, Northbound: Blocked gully

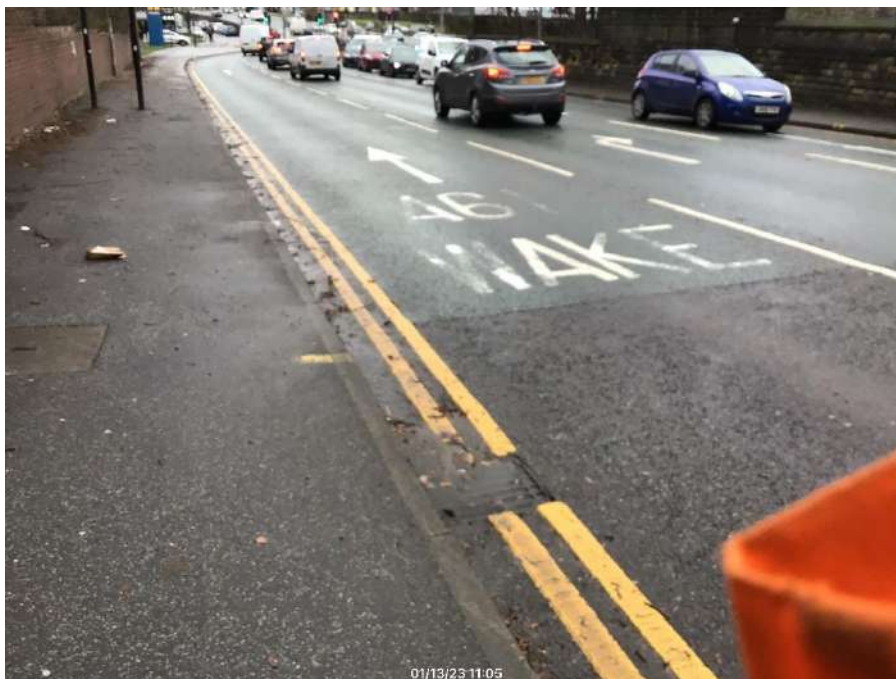
10) North of bridge, Northbound: Blocked gully

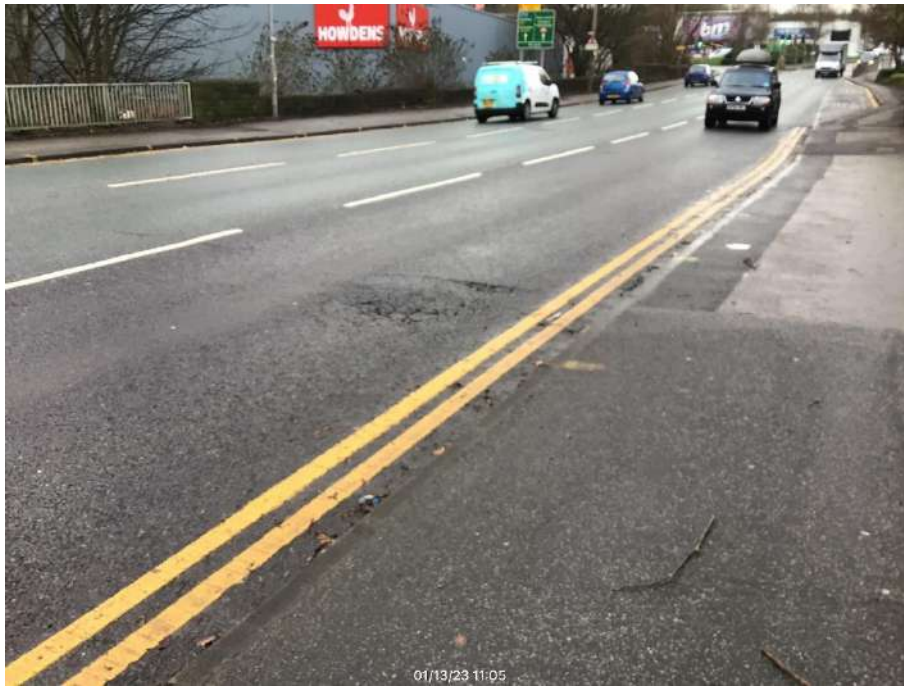
11) North Bridge joint, Lane 1: Failed/cracked surfacing course

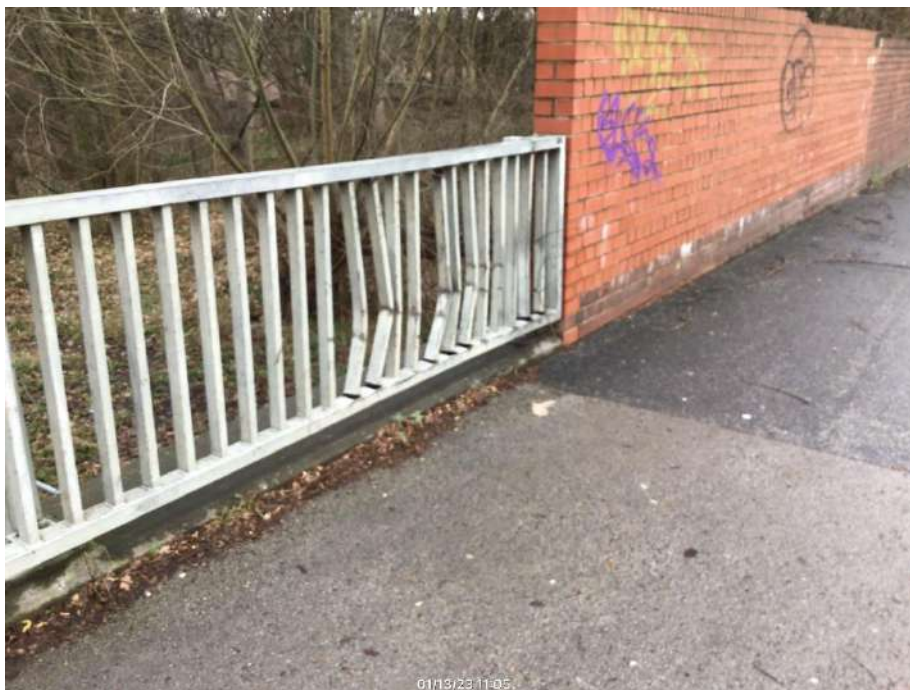
12) Damage to west bridge parapet

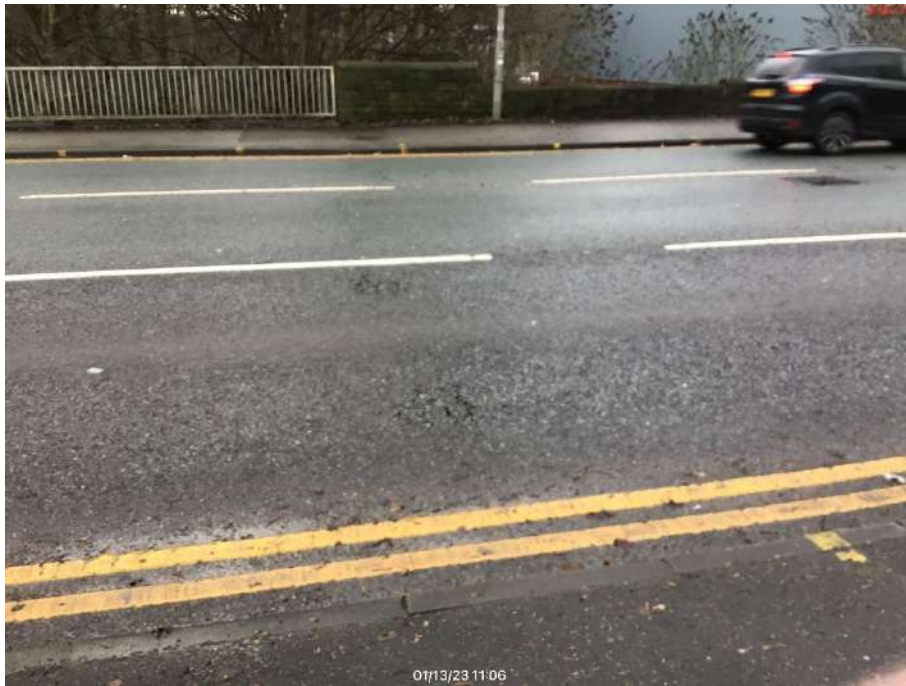
13) South Bridge joint: Failed/Cracked surfacing course

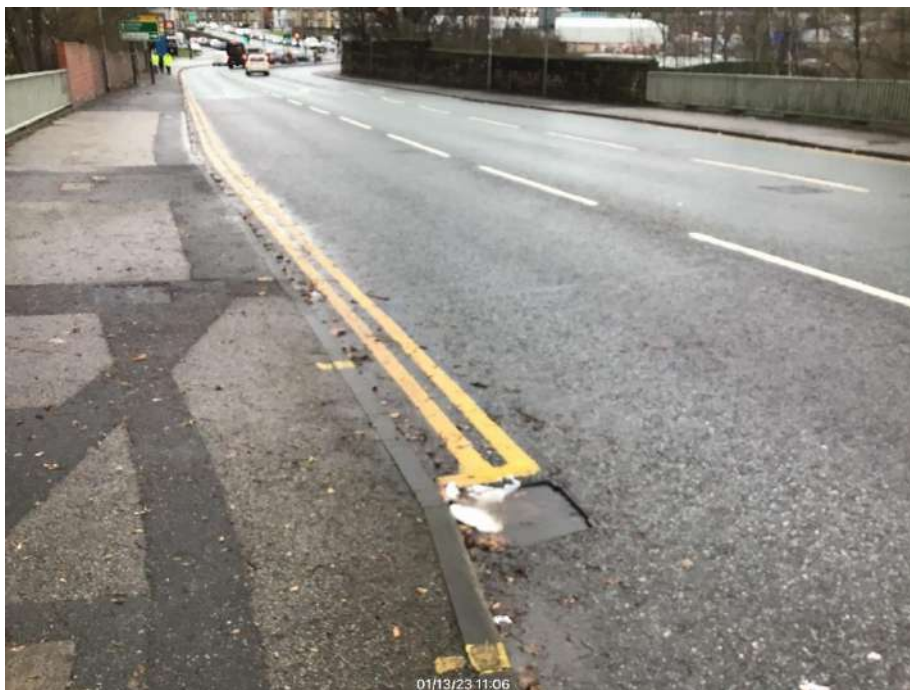
14) South of Bridge, Northbound: Blocked gully

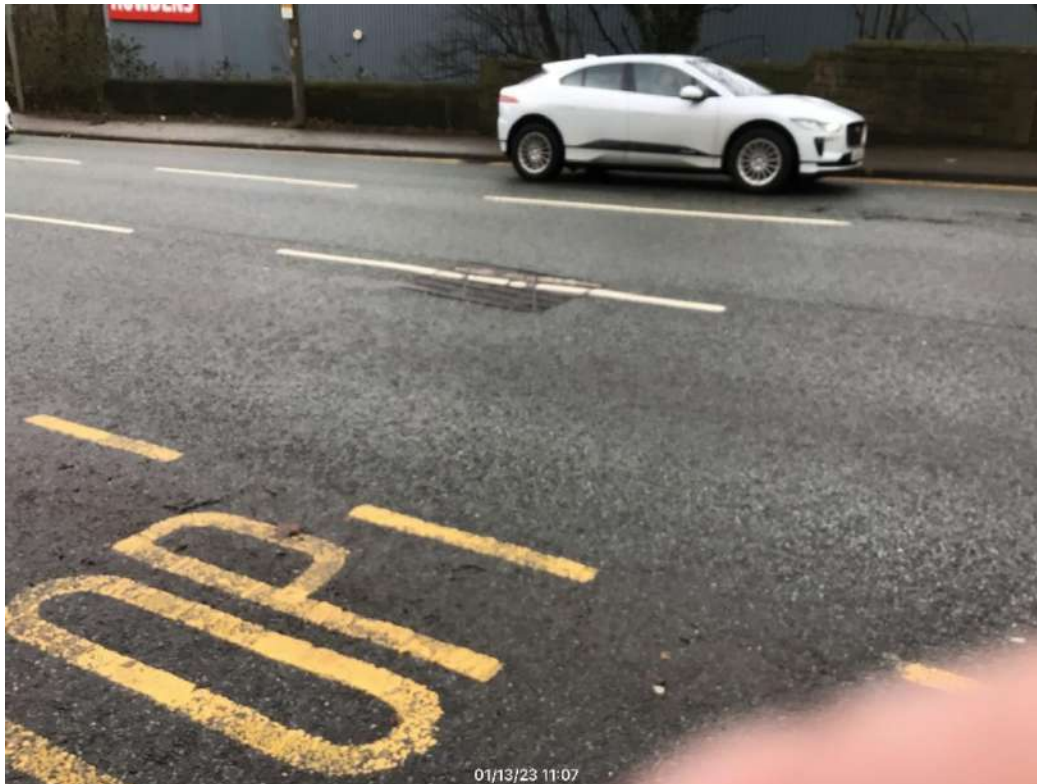
15) South of bridge, Northbound Lane 1 & 2 joint: Low chamber

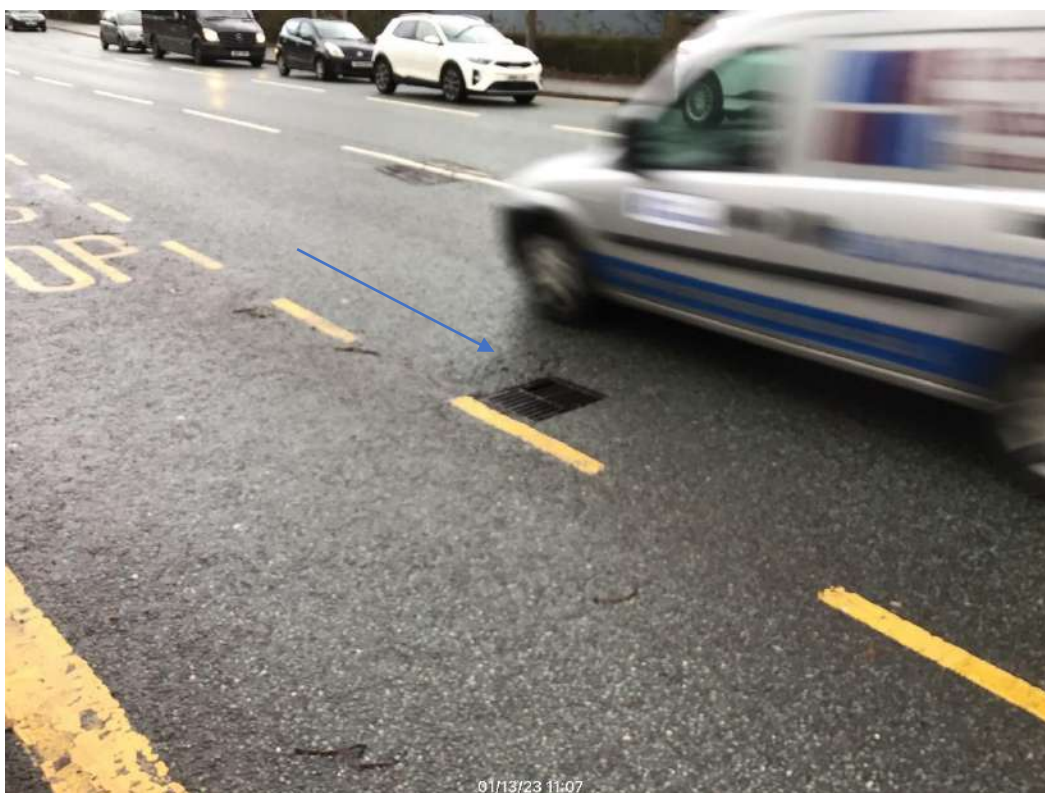
16) South of bridge, Northbound Lane 1: Cracks to surface course nest to gully

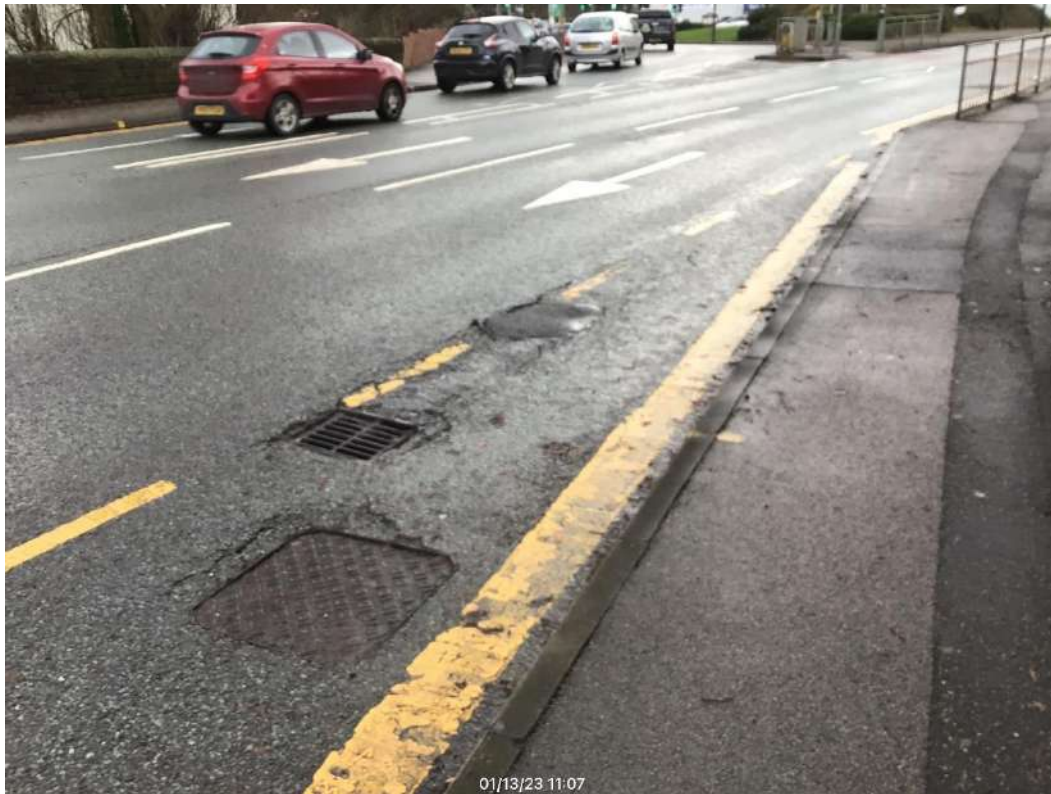
17) South of bridge, Northbound Bus stop taper: failed/cracking to surface course around chamber & gully

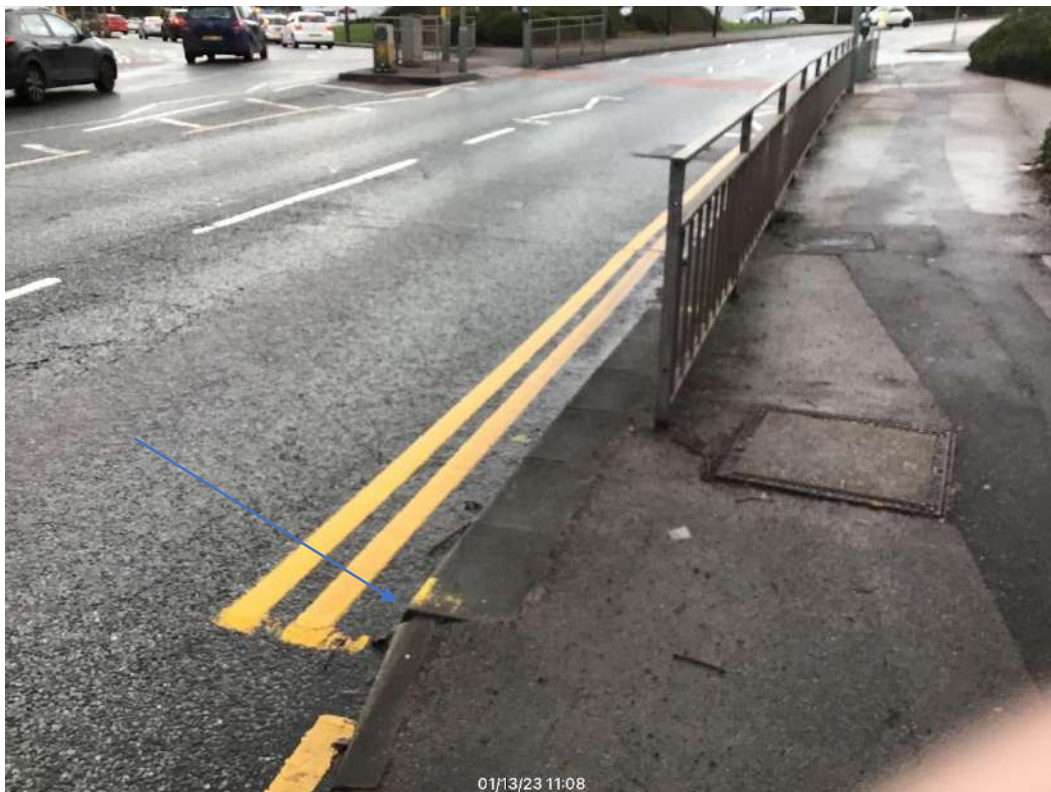
18) South of bridge Northbound/Bus lay by taper: Damaged kerb

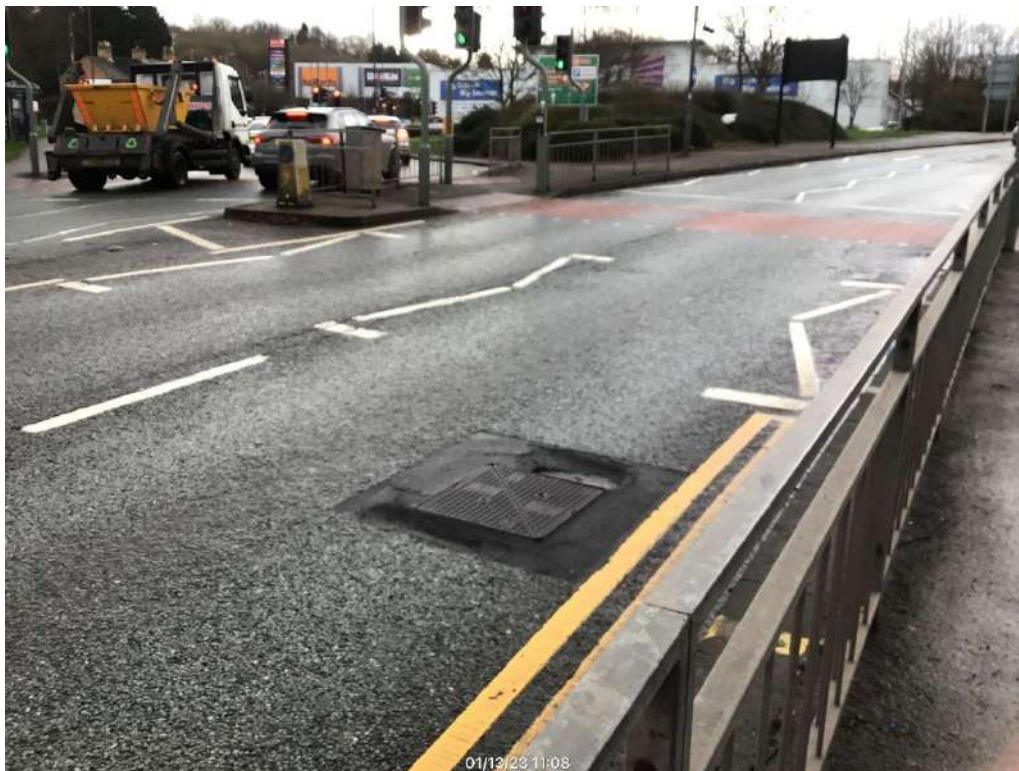
19) South of bridge, Northbound Lane 1: Damage to surfacing around chamber

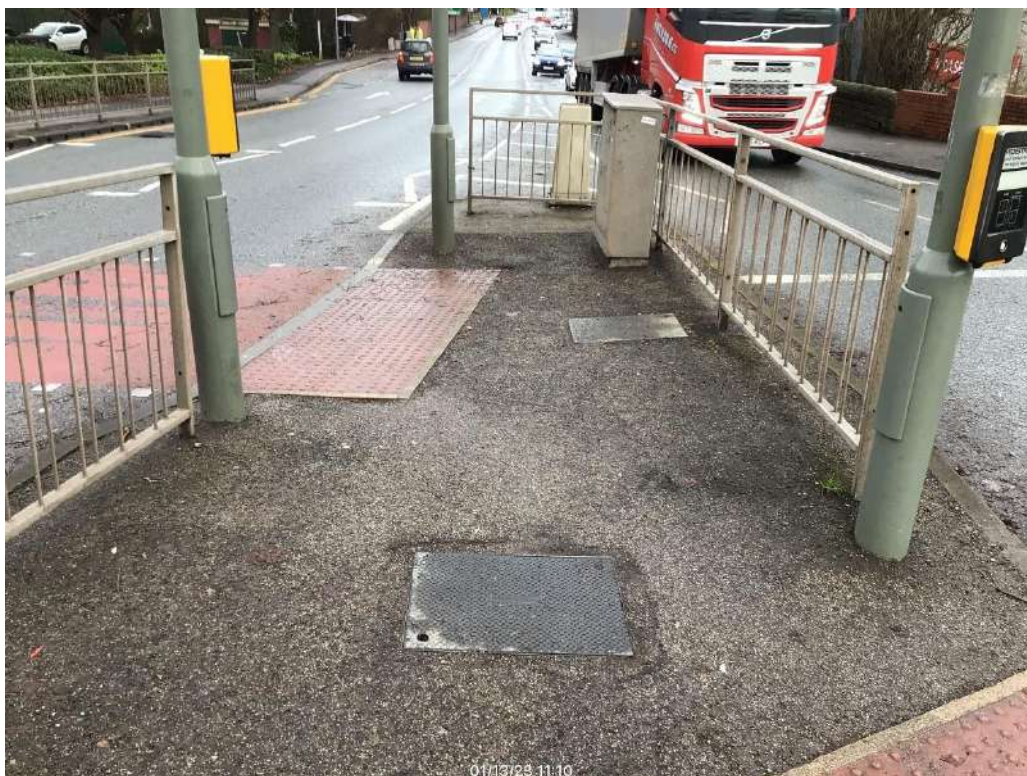
20) South tie in pedestrian crossing island: low chamber with sunk tarmac surround

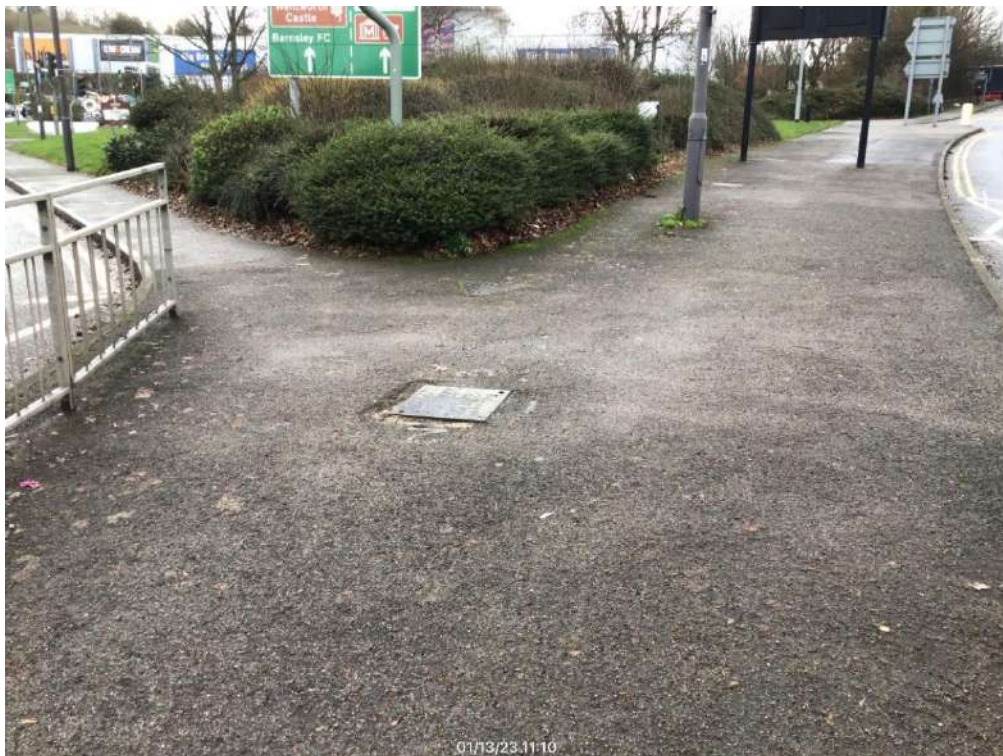
21) South tie in island: low/sunk tarmac surround around chamber

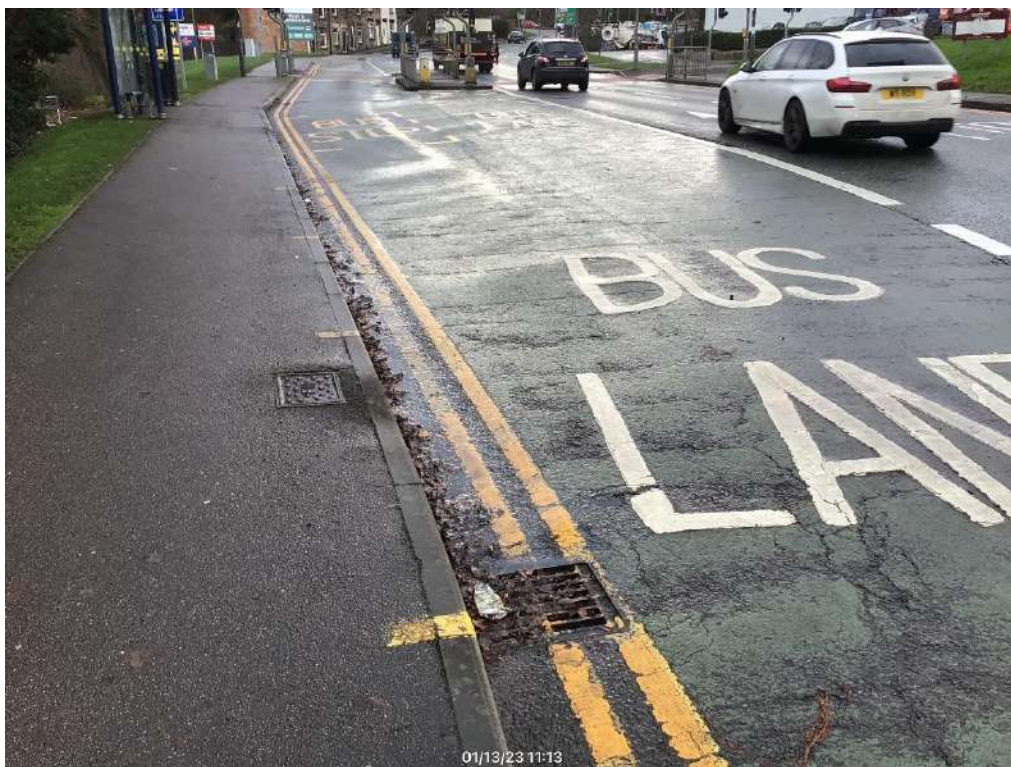
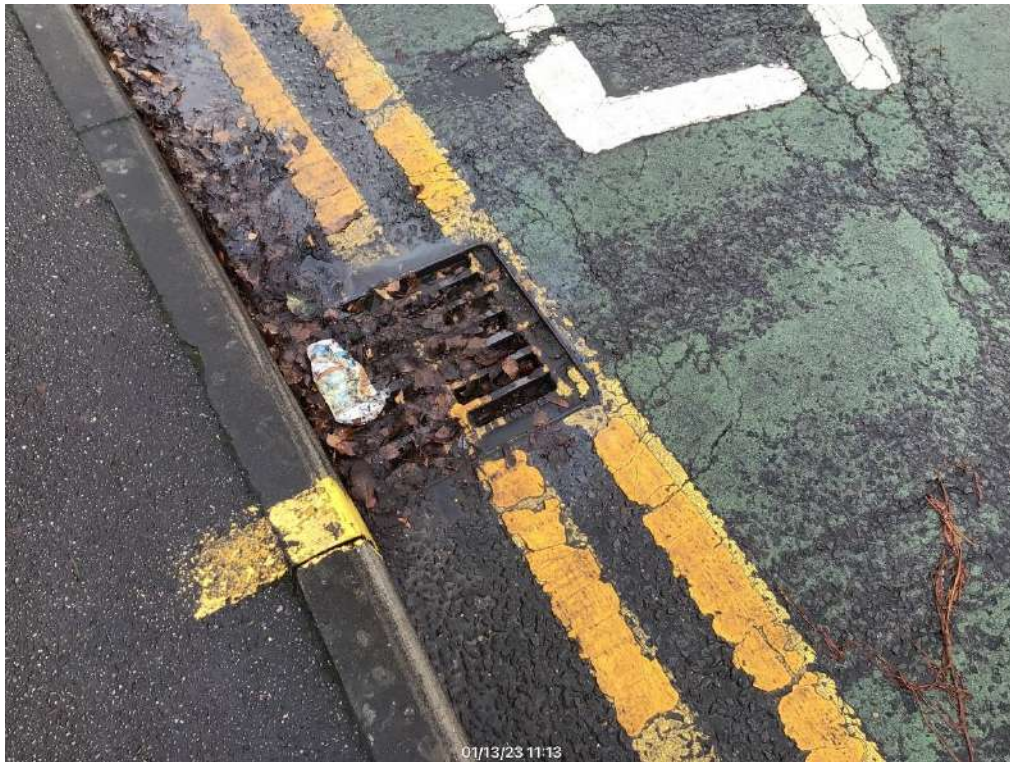
22) South tie in, Southbound bus lane: Cracking to bus lane surfacing & blocked gully

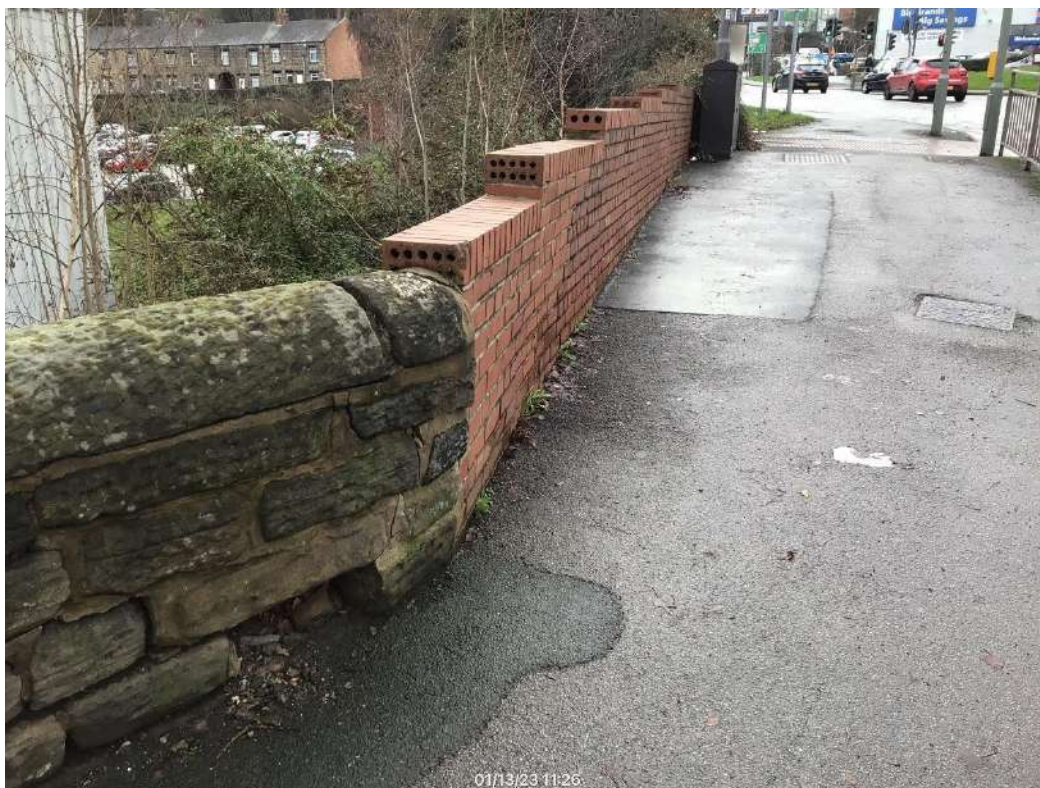
23) South tie in, East footway wall: Condition of existing wall

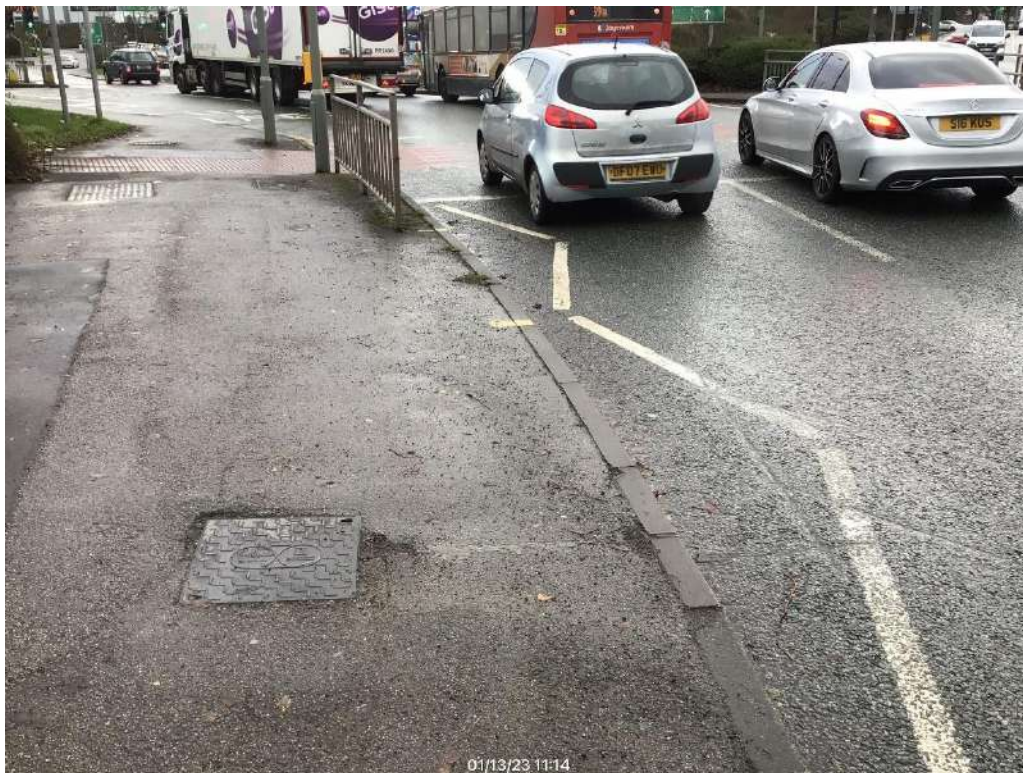
24) South Tie in East footway: low failed tarmac around chamber

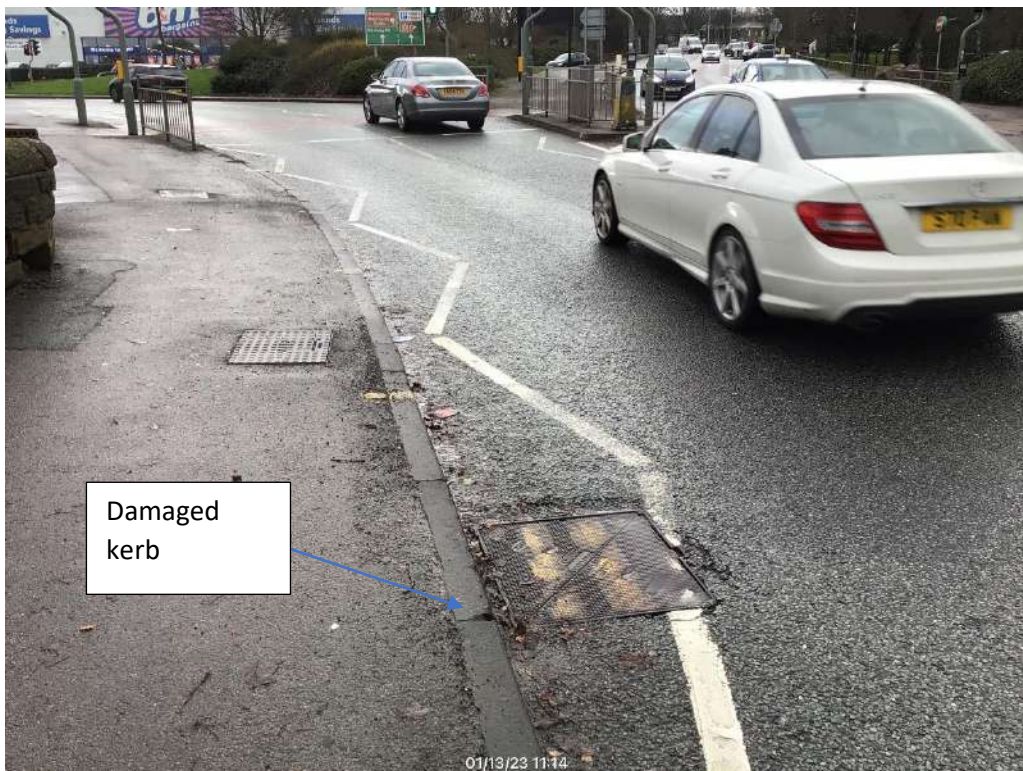
25) South tie in, Southbound: damage to kerbs

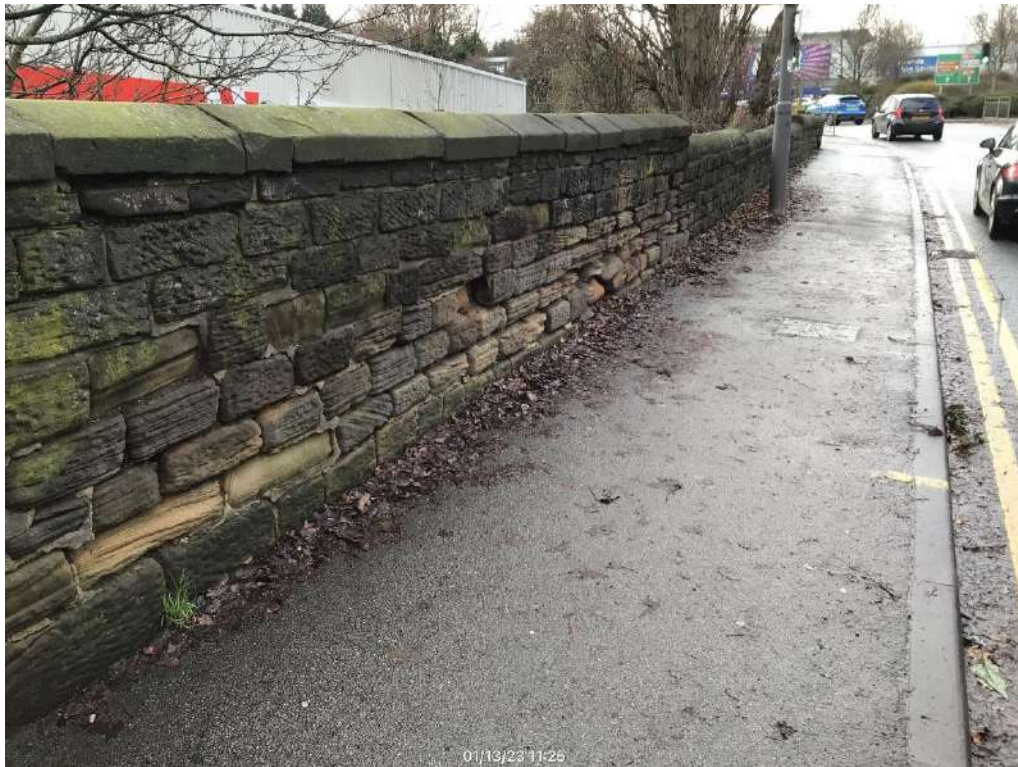
26) South of bridge, East footway wall: Existing condition

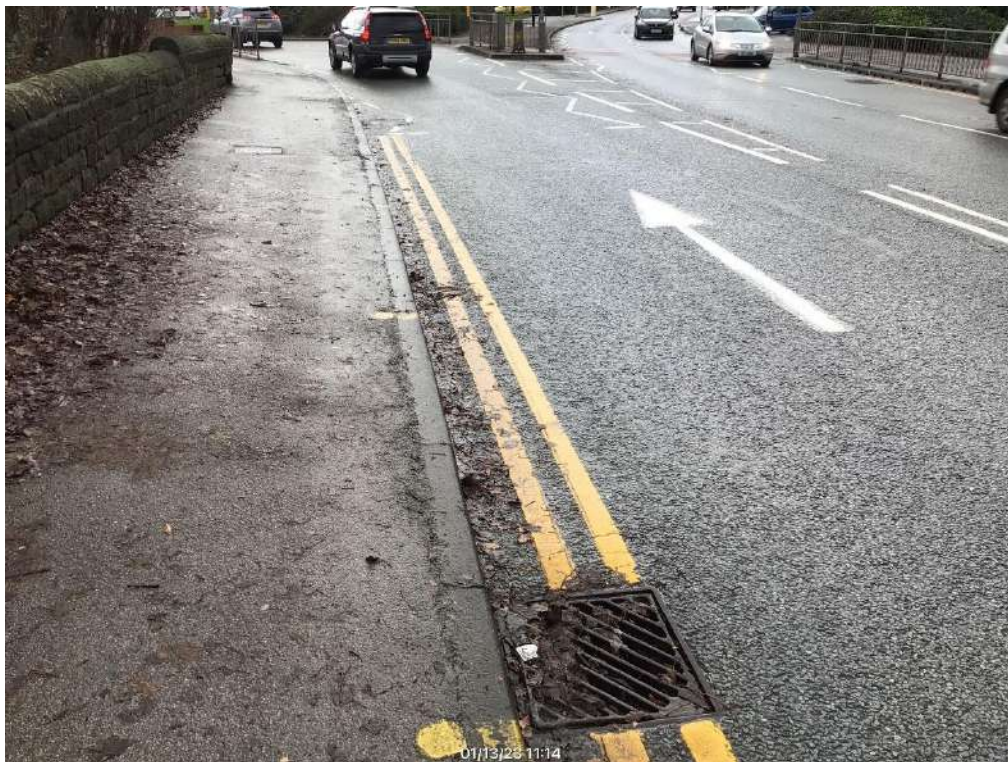
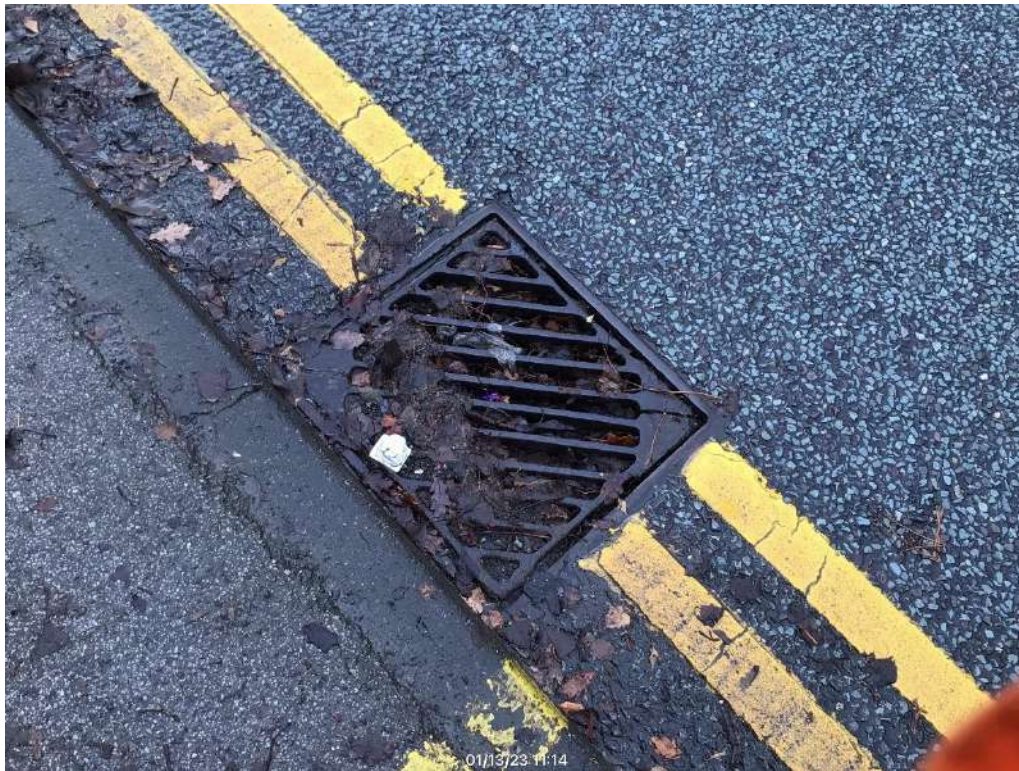
27) South of bridge, Southbound: Blocked gully

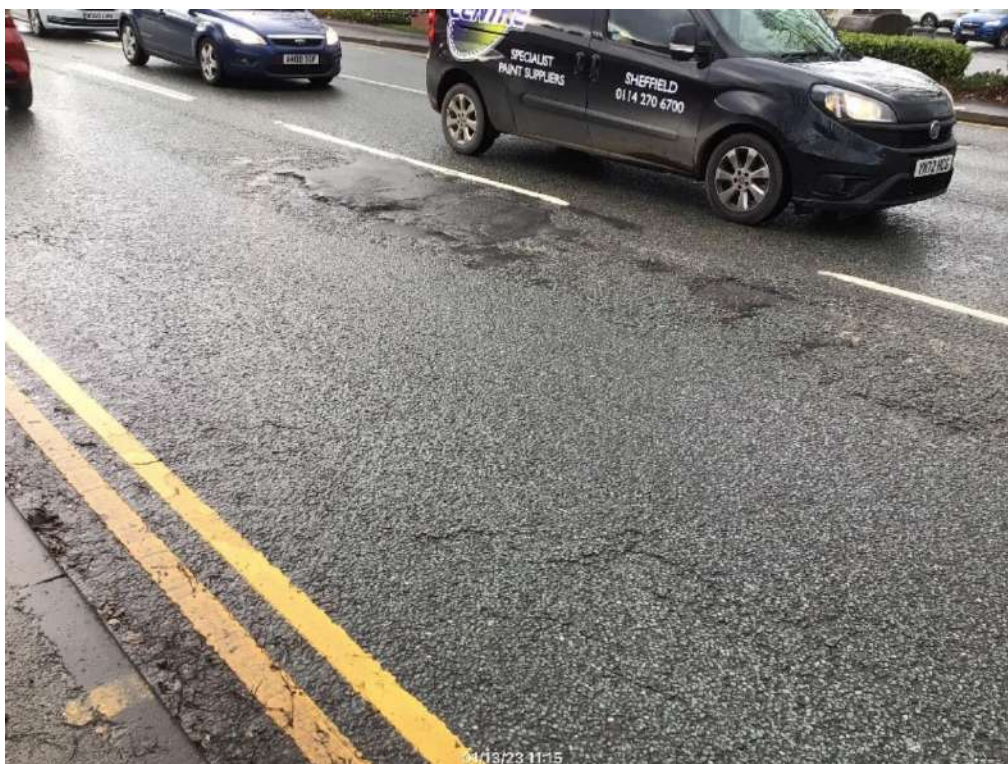
28) South of bridge, southbound: failed surfacing course

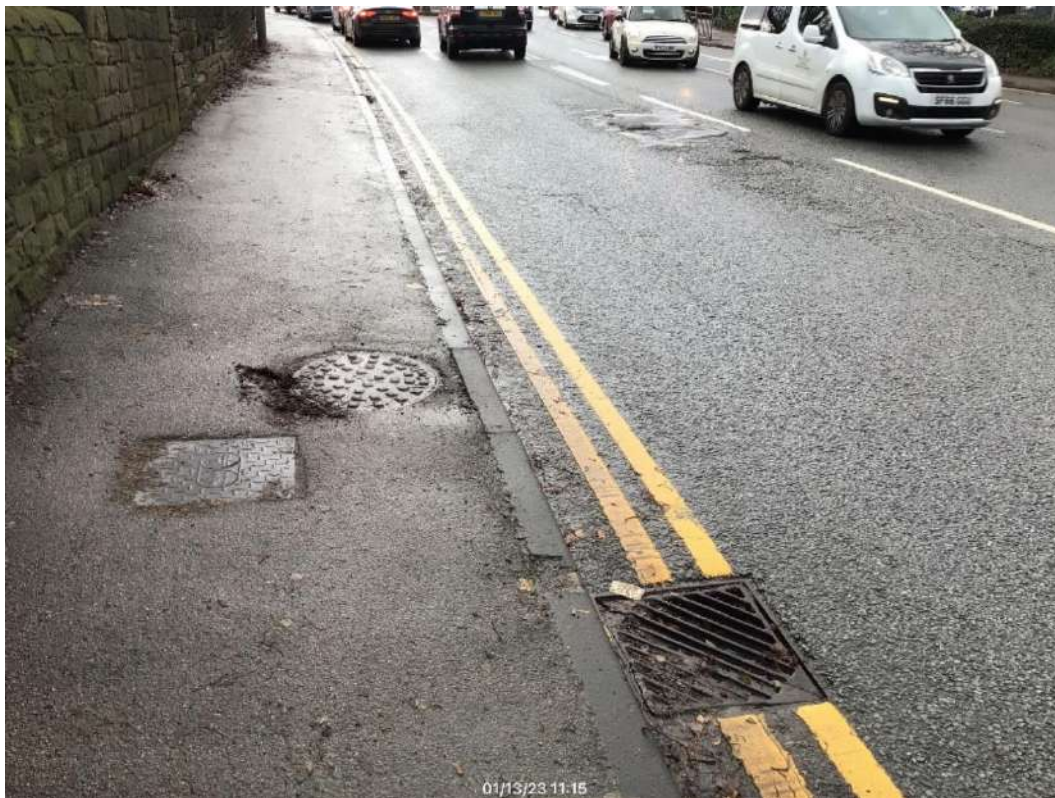
29) South of bridge, southbound: Blocked gully
