## A61 Barnsley Dilapidation Survey

10.57hrs, Friday 13<sup>th</sup> January 2023

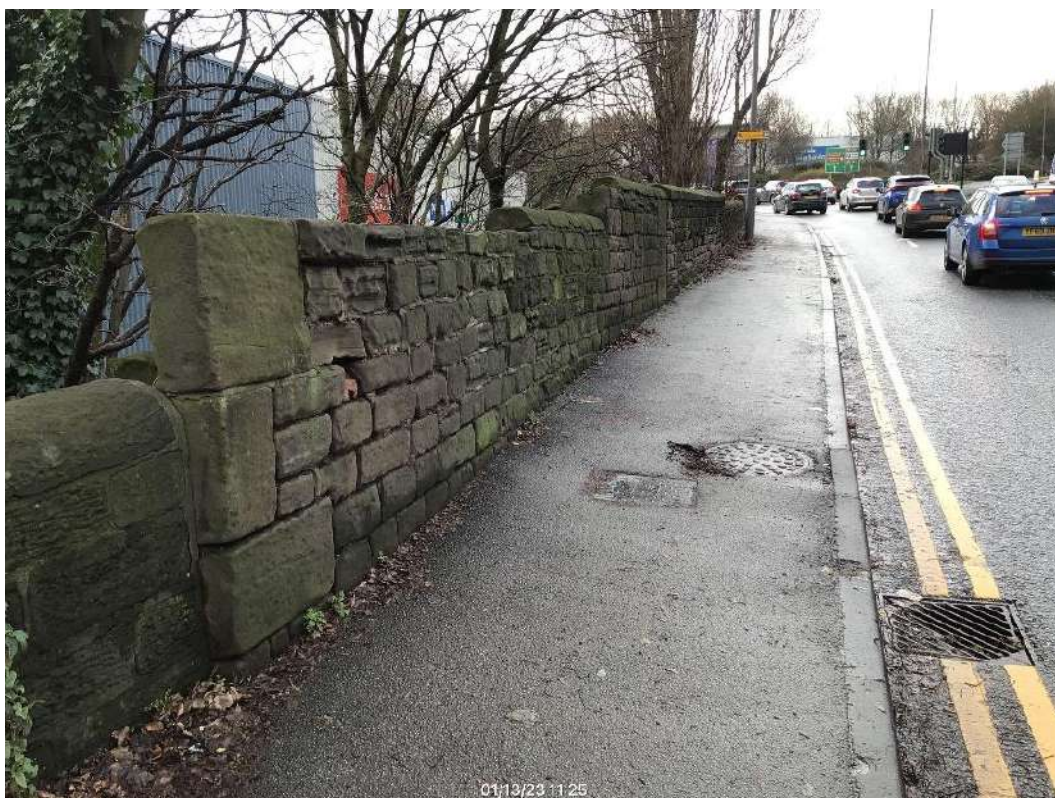
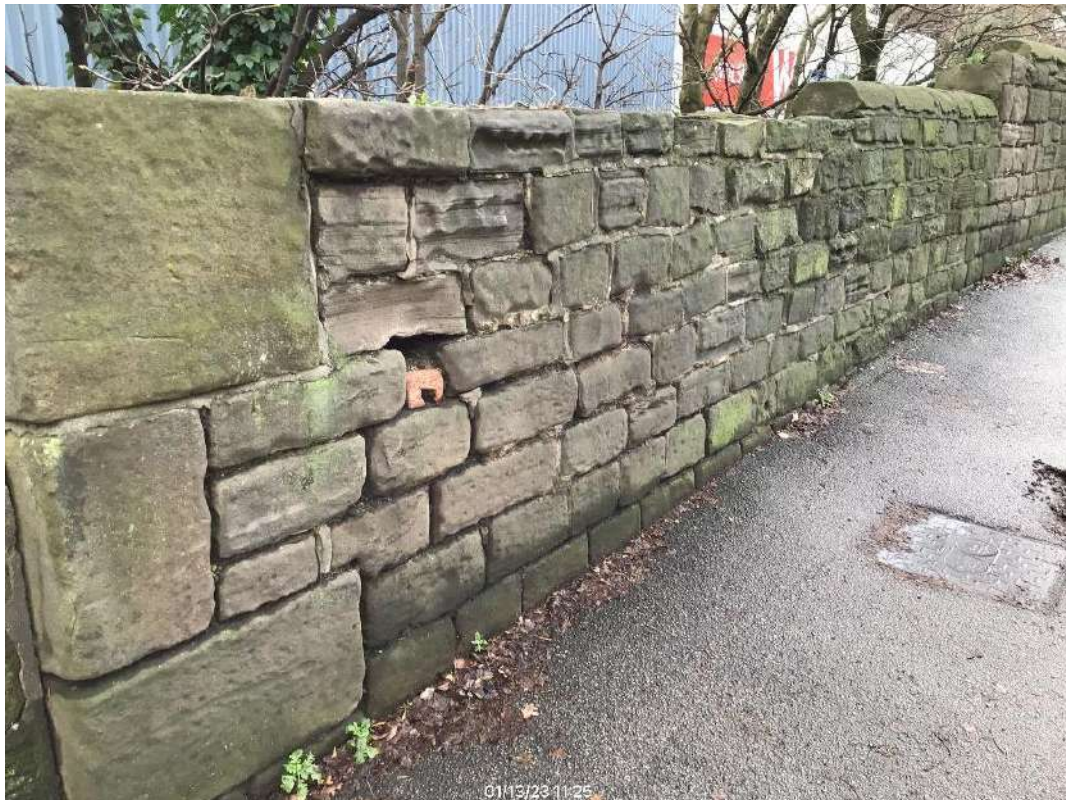
30) South of bridge, East footway wall: Existing wall condition

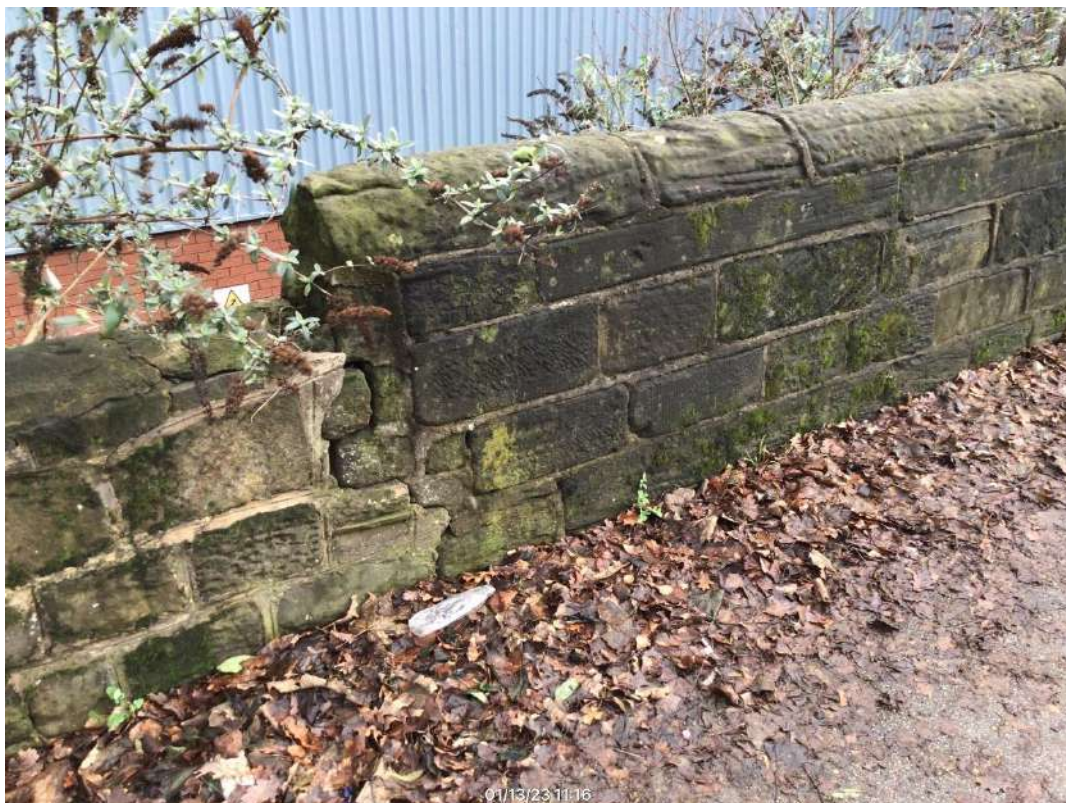
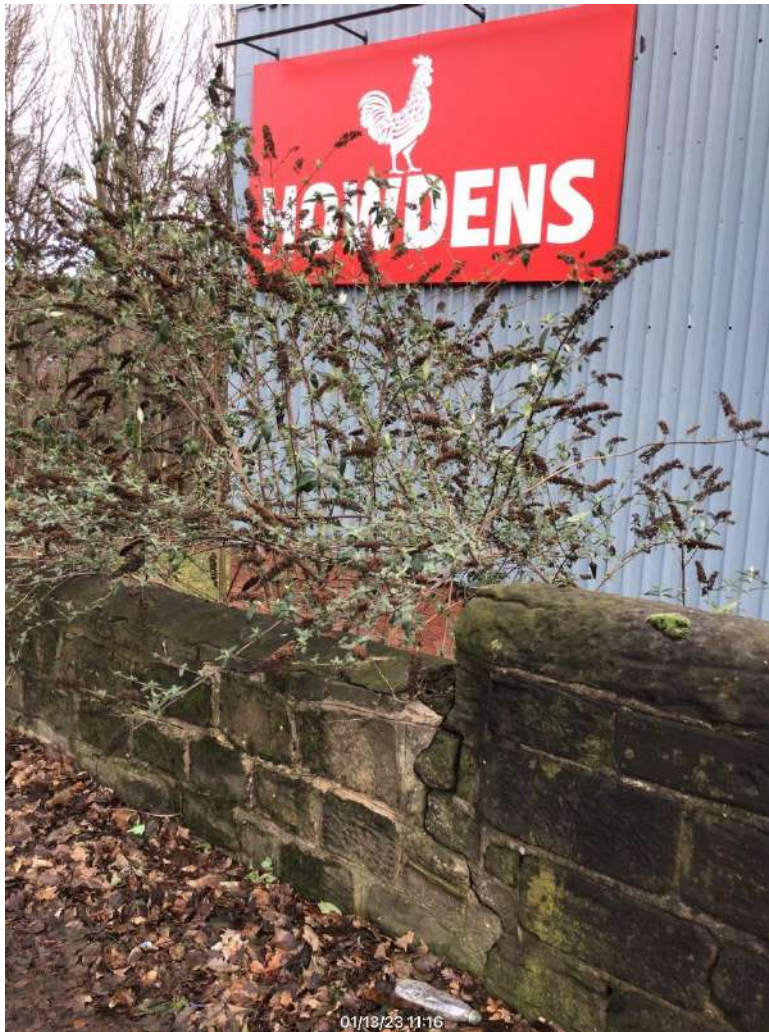
31) South of bridge, East footway wall: Existing wall condition

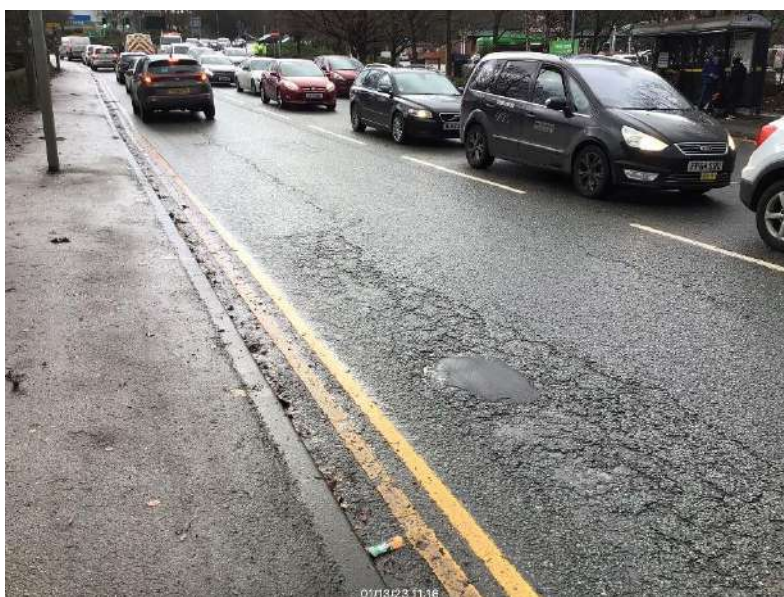
32) South of bridge, southbound: Failed/cracking to surfacing course

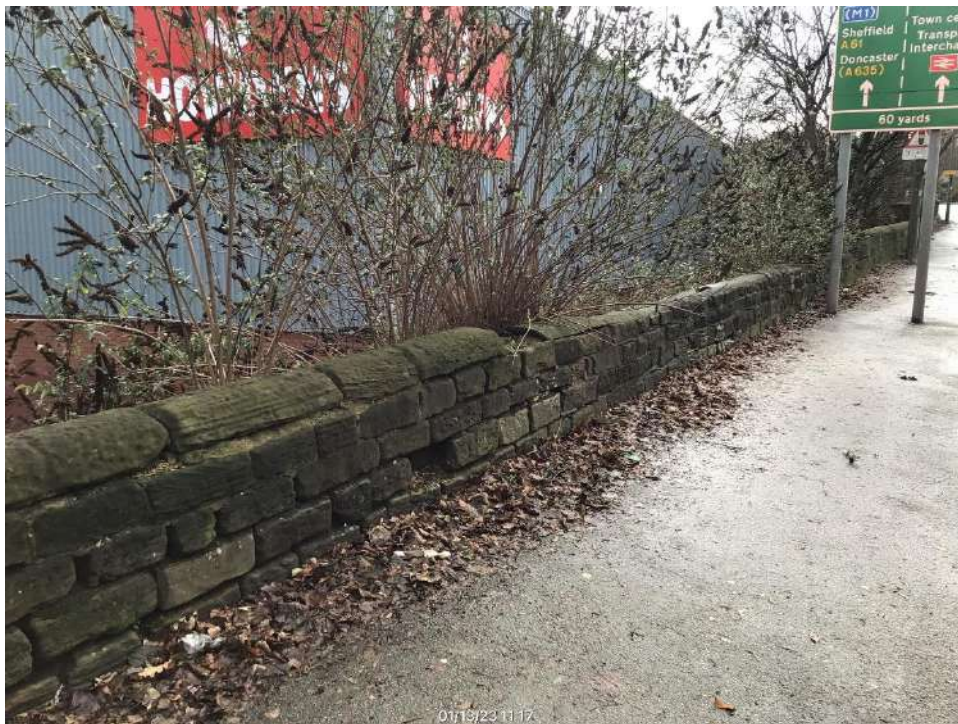
33) South of bridge, East footway: Existing wall condition

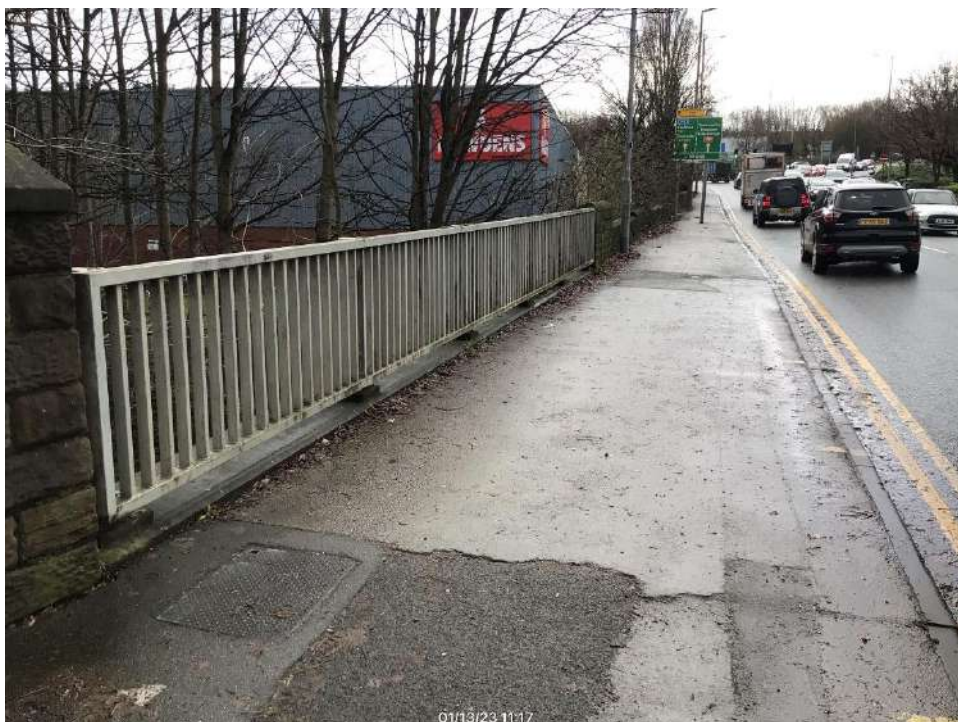
34) North of bridge, East footway: Existing footway tarmac/East Parapet

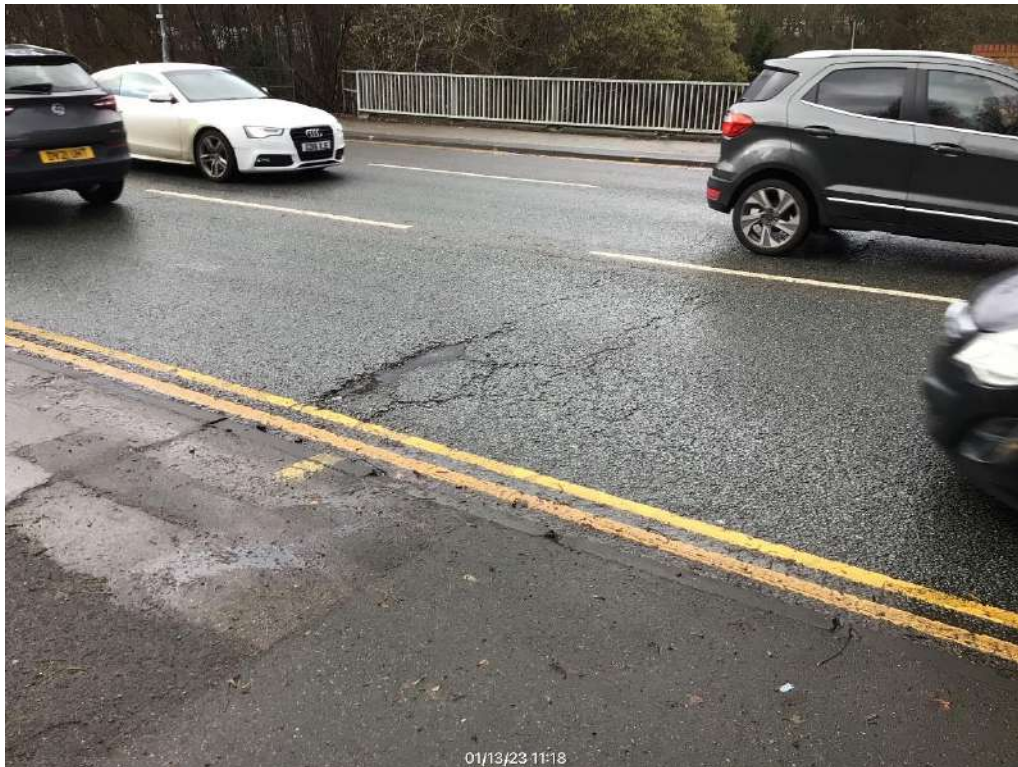
35) Northbridge joint, southbound lane: failed/cracking to surface course

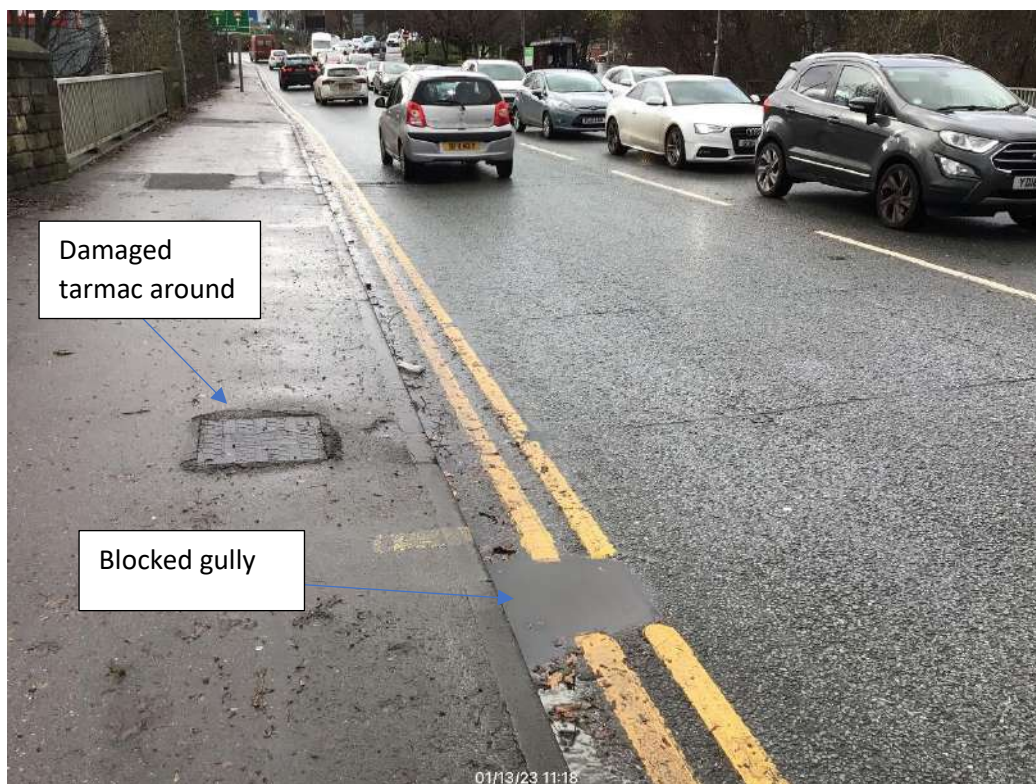
36) North of bridge, Southbound Lane: Blocked gully & damaged tarmac around chamber in footway

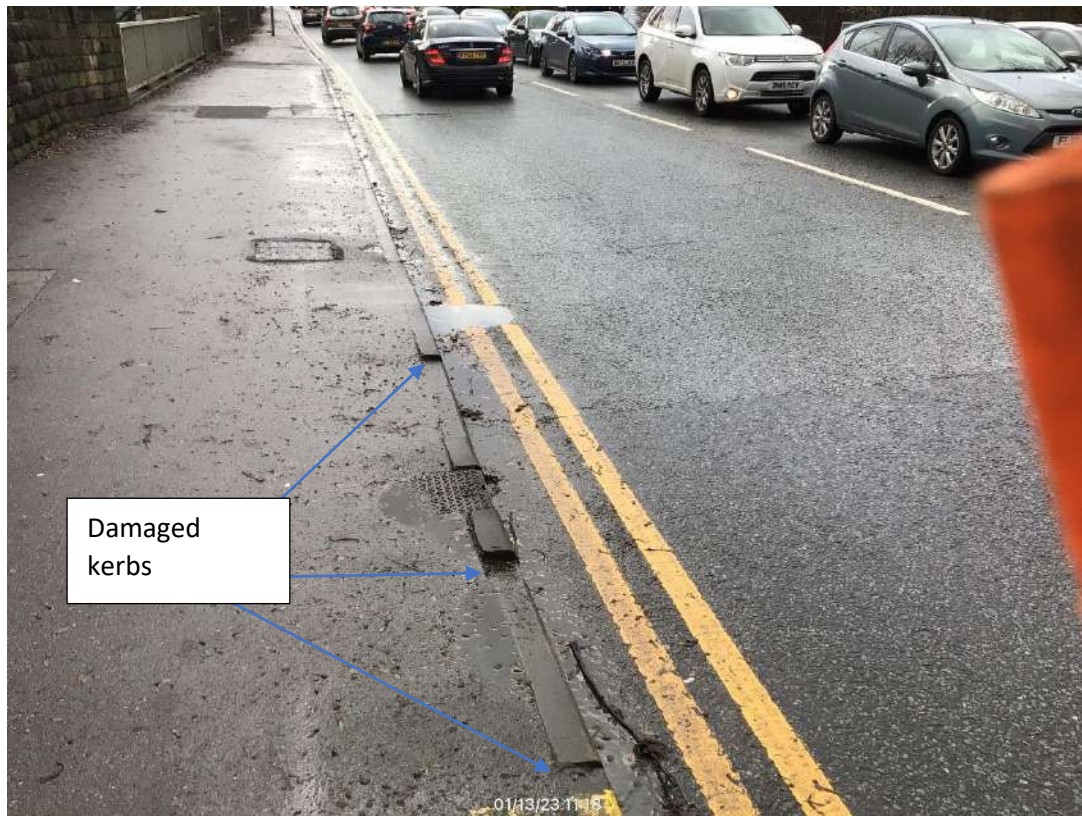
37) North of bridge, Southbound Lane: Damaged kerbs

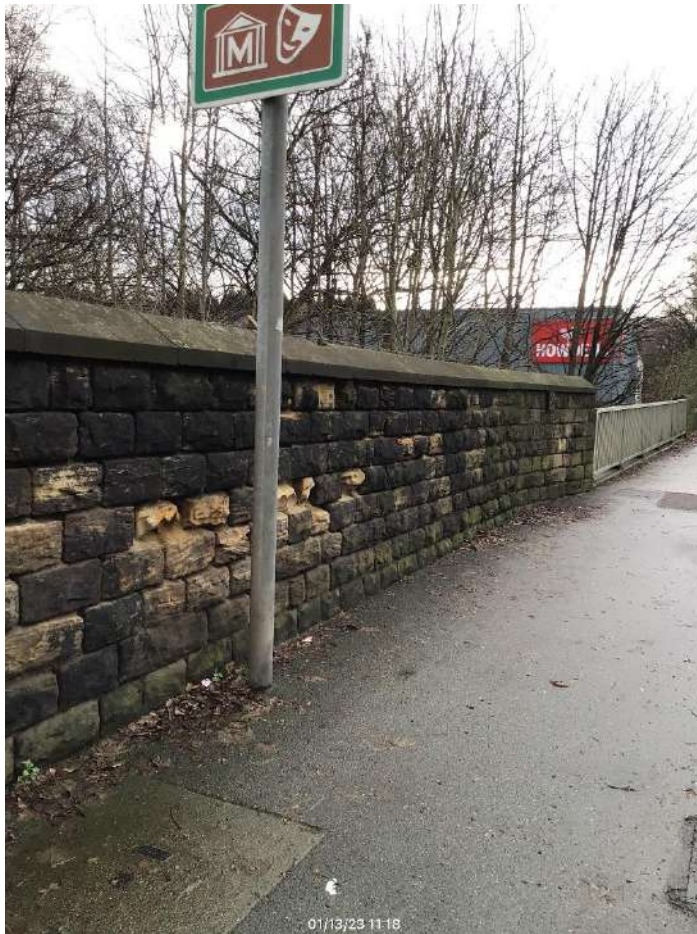
38) North of bridge, East footway wall: Existing condition

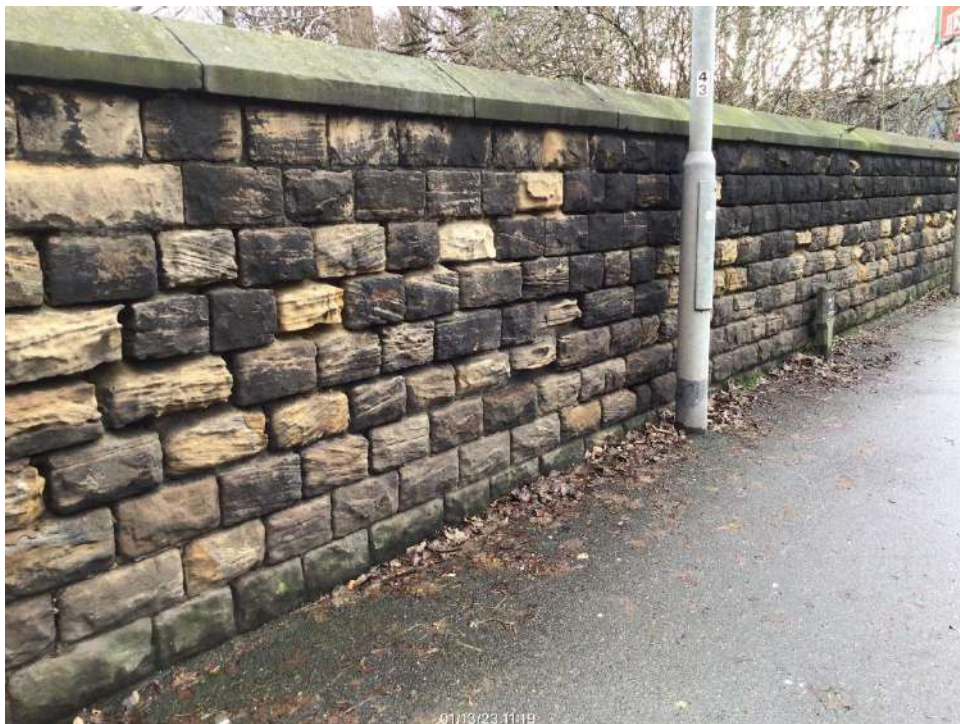
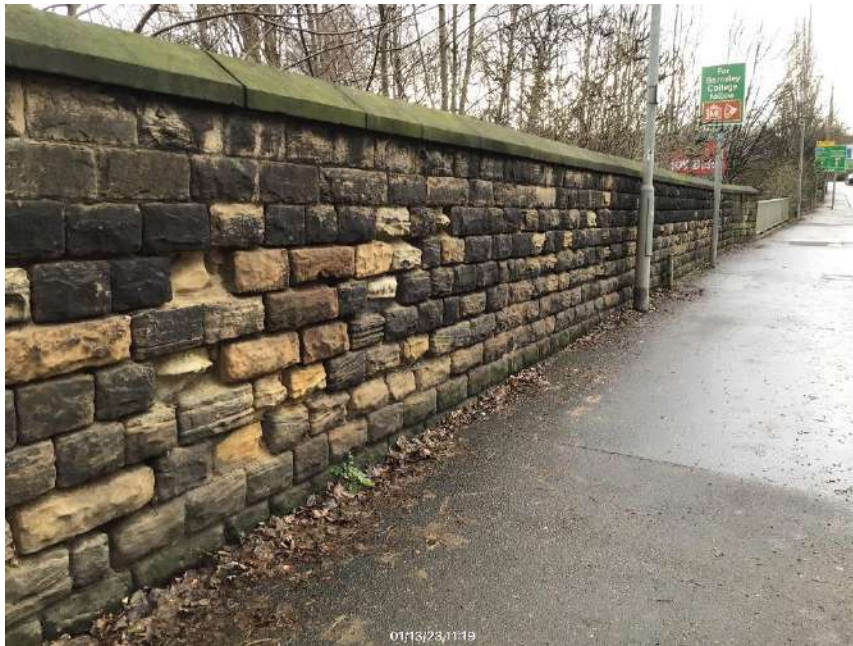
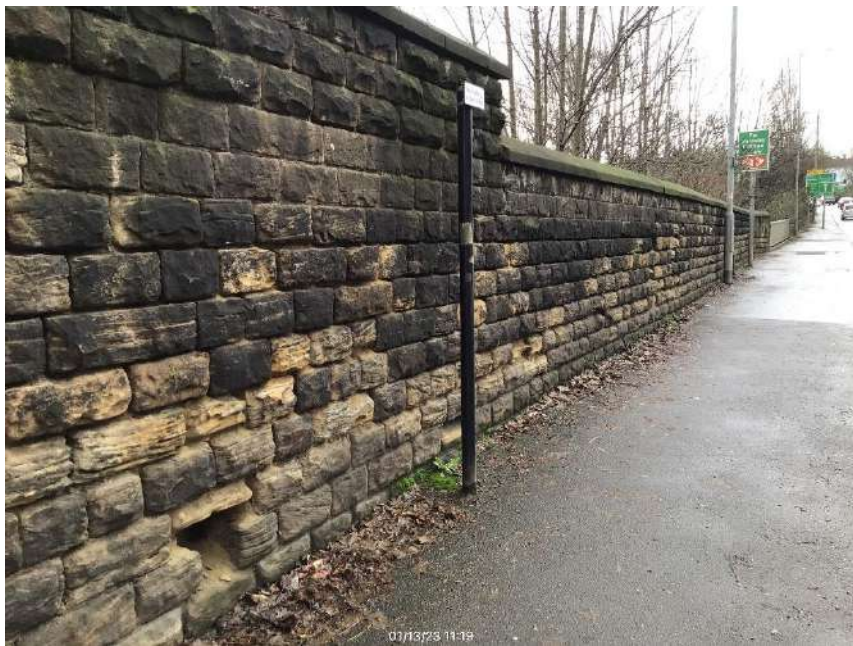
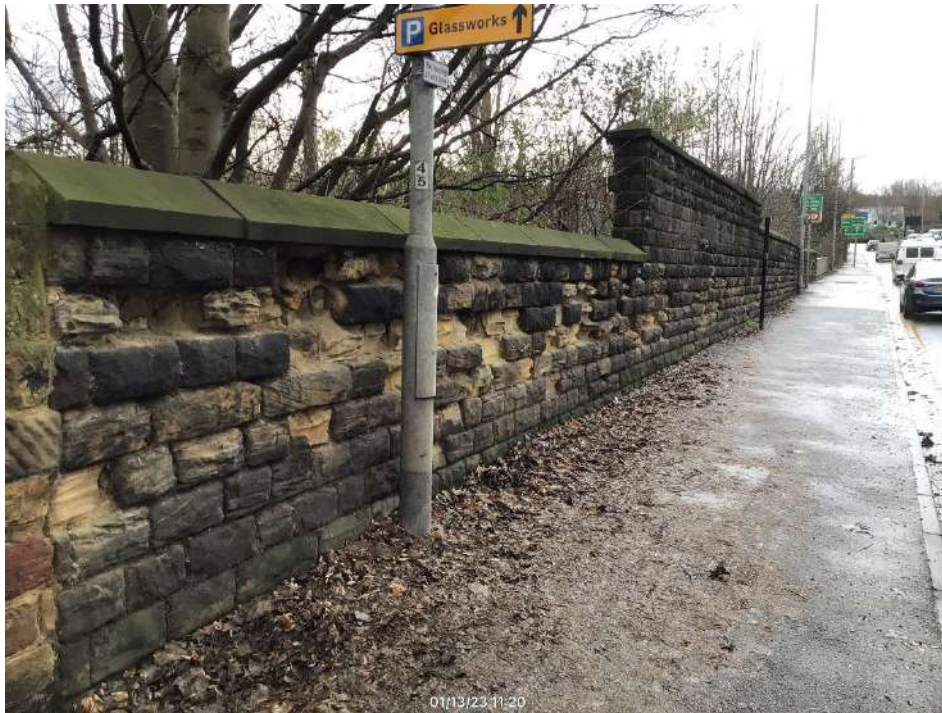
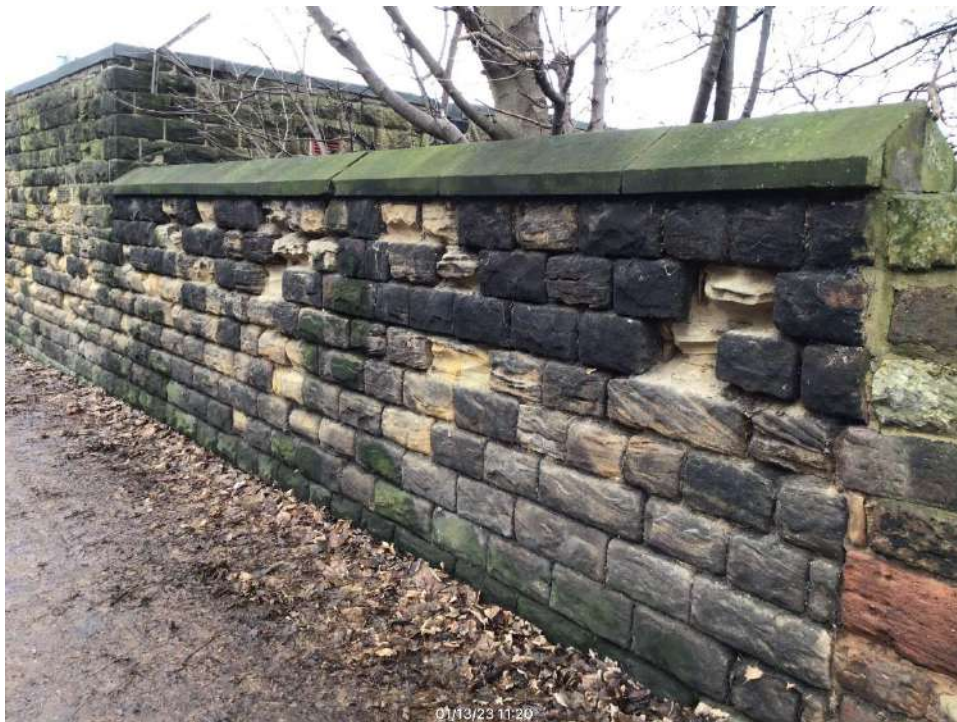
39) North of bridge, East footway wall: Existing condition

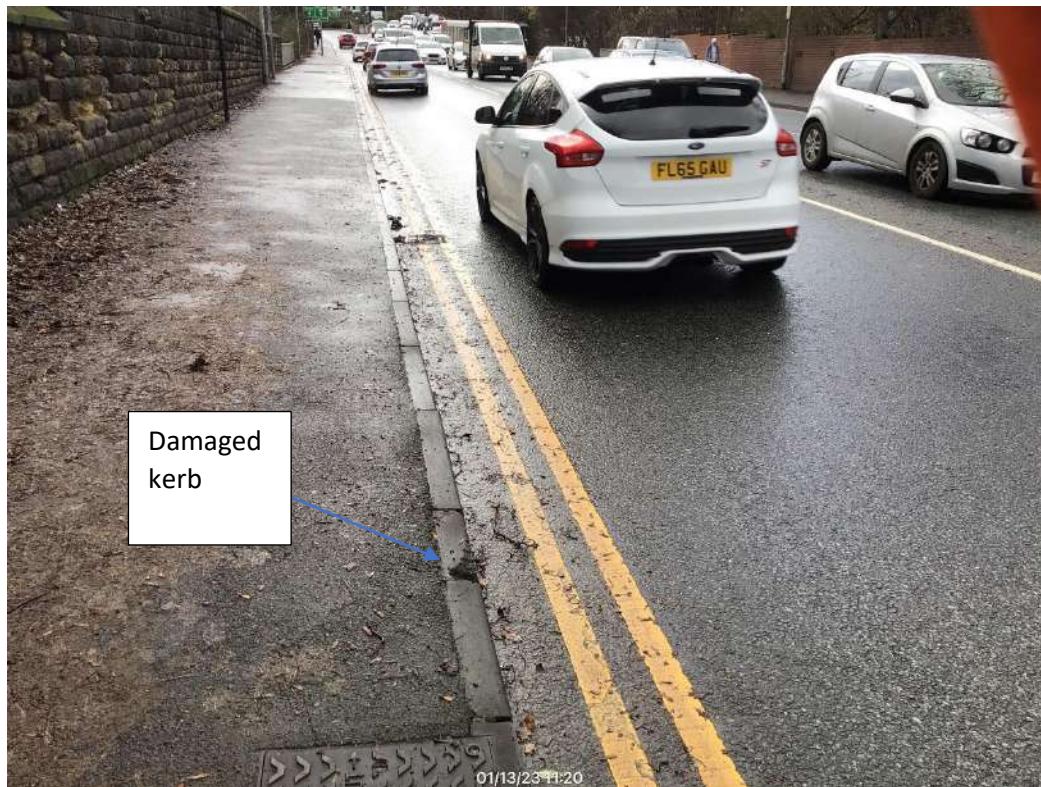
40) North of bridge, Southbound: Damaged kerb

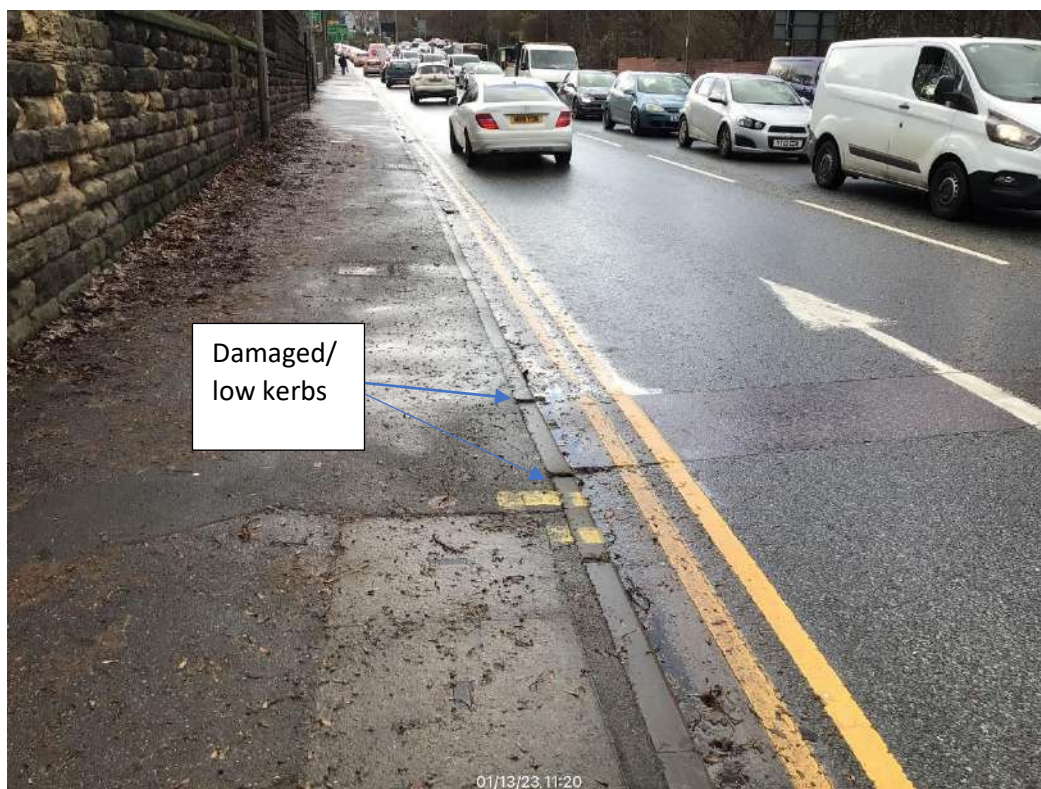
41) North of bridge, Southbound: Damaged/low kerbs from trench reinstatement works

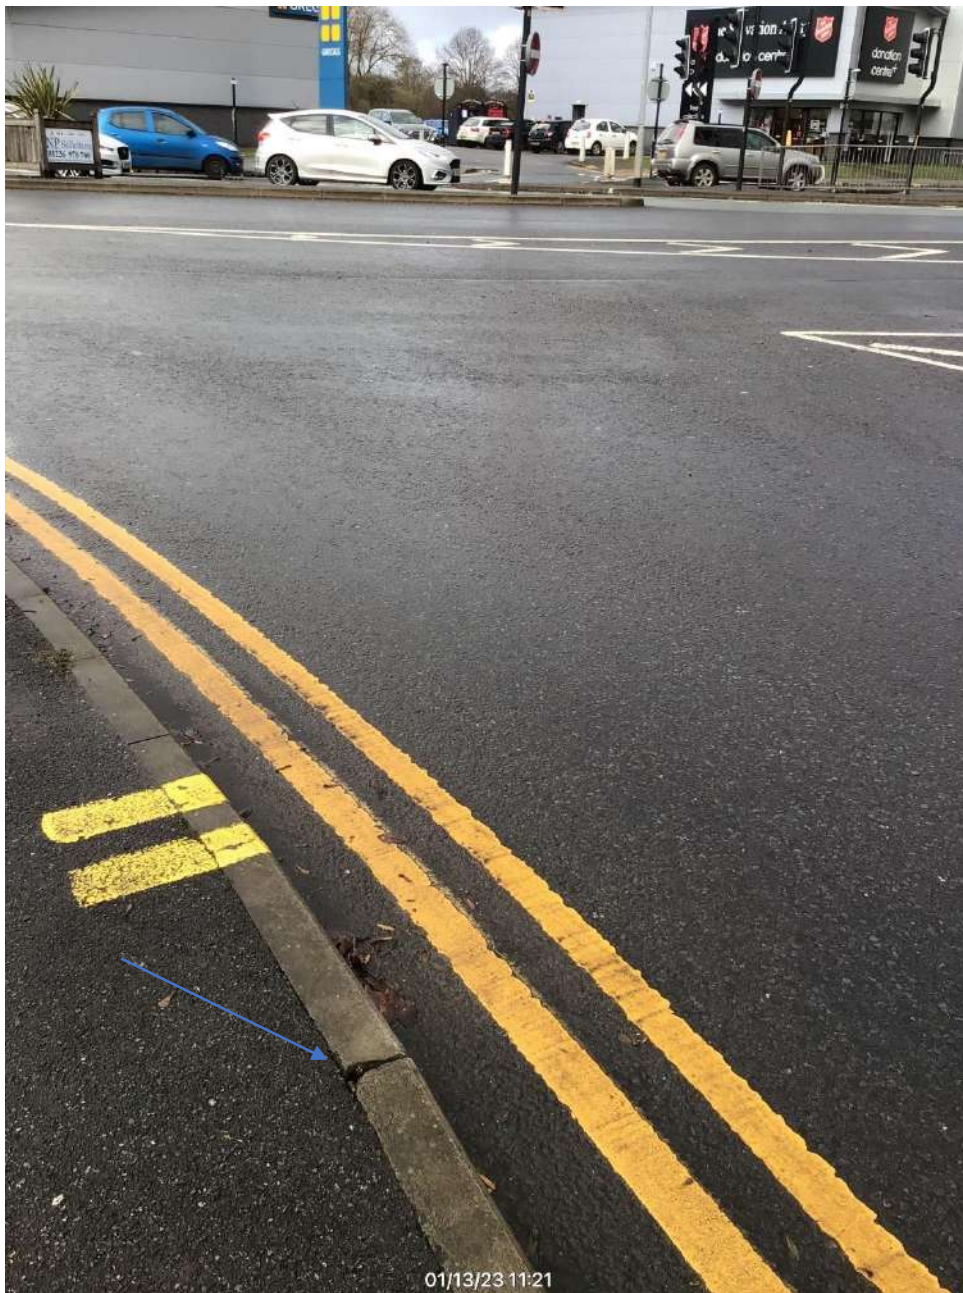
42) Northeast tie in, East kerb line: damaged kerb
