**WENTWORTH CASTLE, STAINBOROUGH, BARNSELEY:  
PROPOSED REPAIR OF STRUCTURE AND CEILING AT  
EAST END OF SOUTH ('PALLADIAN') WING**

**LISTED BUILDING STATEMENT (as submitted December 2011)**

This Statement has subsequently been superseded with regard to the extent of the defective structure revealed in March 2012 when the cracked ceiling was demolished and the floor structure fully examined from below.

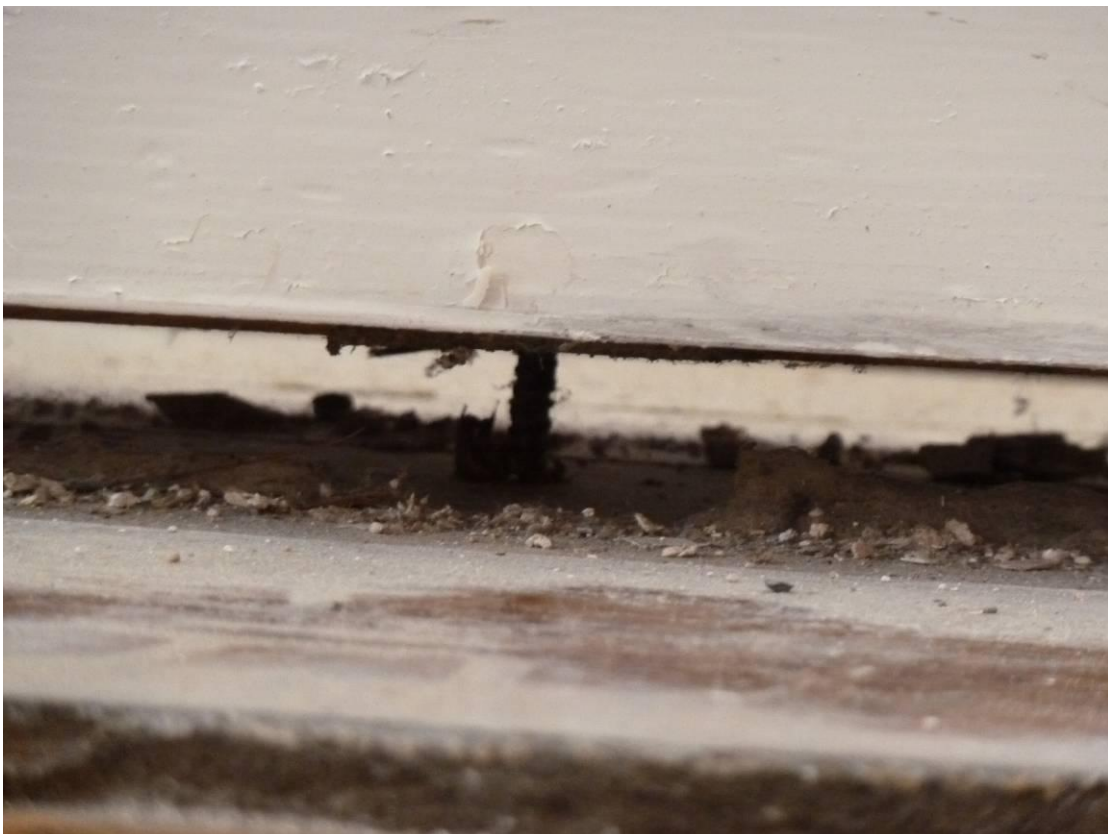
- 2.4 In spring 2011 the crack re-appeared in the ceiling. This was monitored and, over the course of a couple of months it became clear that there was active movement in the second floor structure. The floor was moving at a perceptible rate particularly at the east end of the room and it was clear that this movement had caused the plaster to become detached from the structure.

**3** Second floor structure settling below the second floor partitions pulling screw fixing of partition sole plate away June 2011

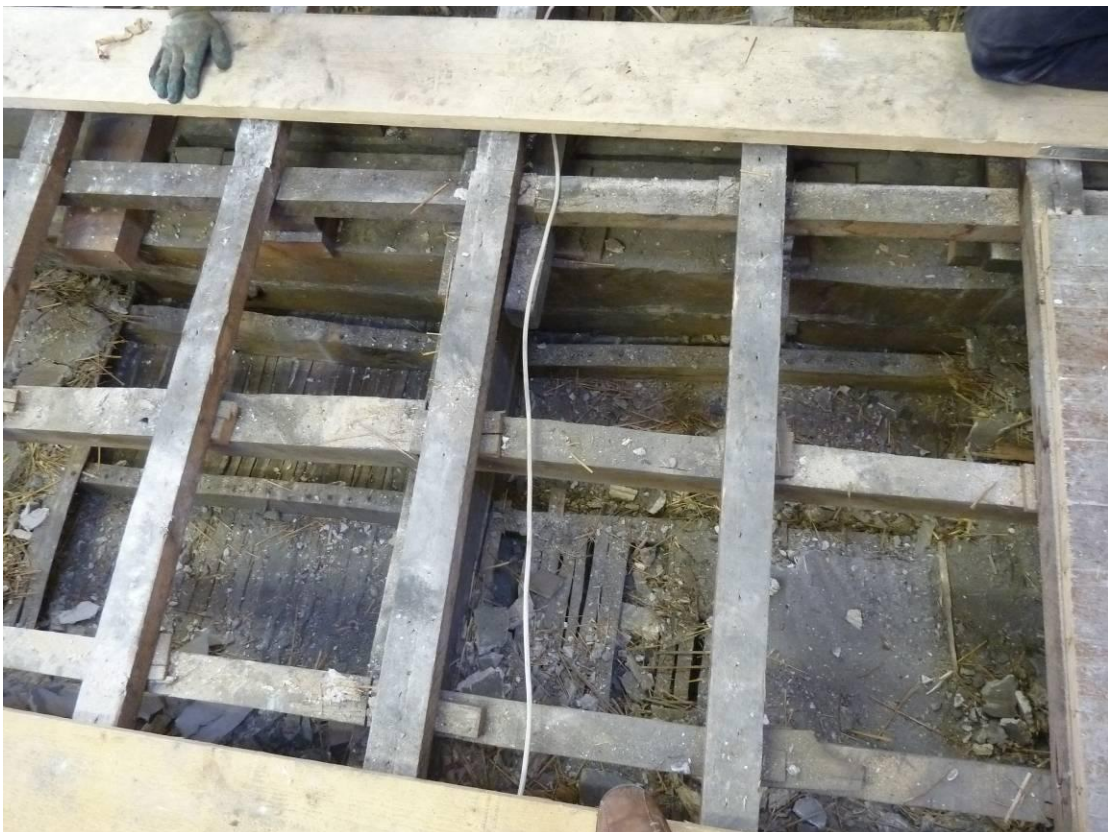
**6** *Photograph of the structure from above. The lime mortar and straw pugging has been partly removed to expose the lath and plaster. The re-used riven or rough-hewn floor joists are apparent at the bottom of the photograph. The one beneath the joiner's knee is modern sawn softwood. The repair to the principal beam is apparent (see below)*

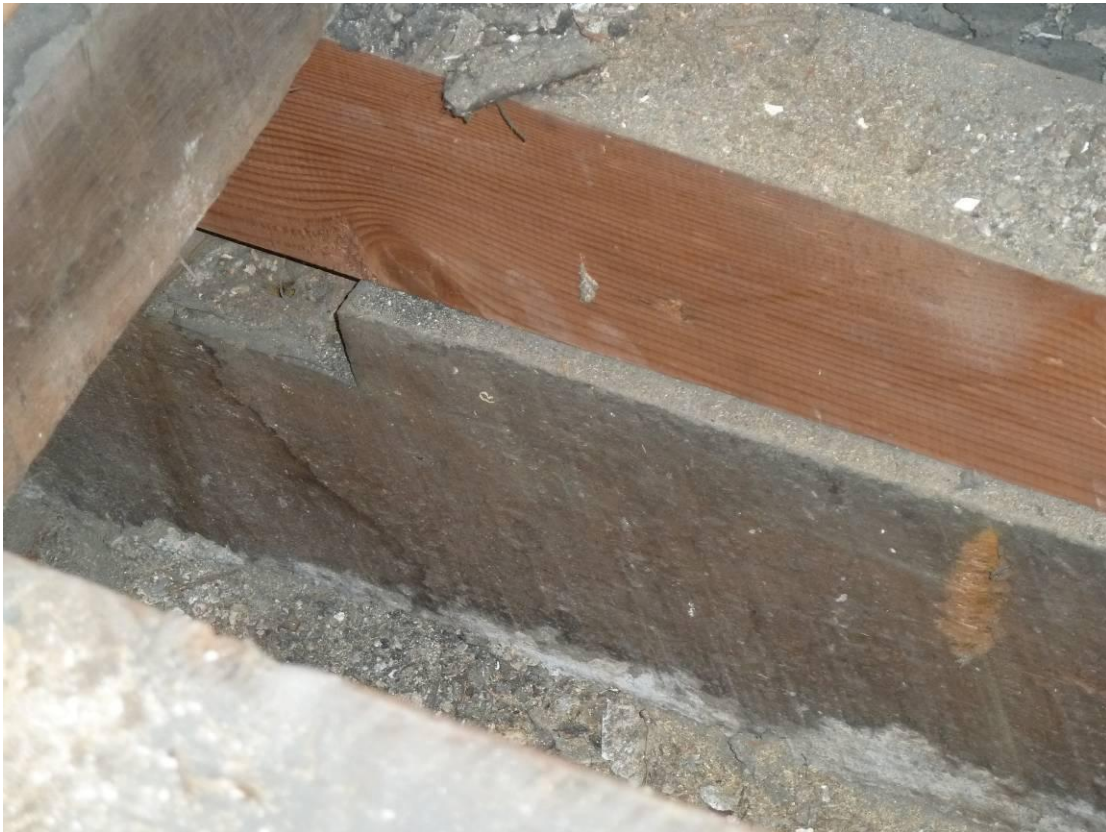
**7** Mortise in secondary beam – former housing of floor joist – and modern levelling member.

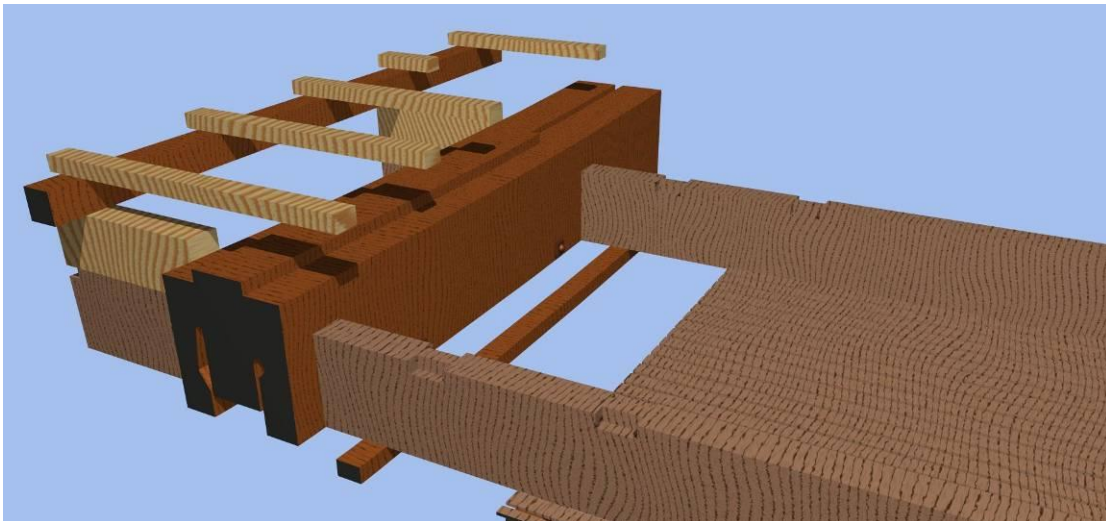
**8** Model of historic repair

The central portion of the beam has been hollowed out over a length of about 1.5 – 2m. Presumably to remove material effected by fungal or insect attack. An oak member has been inserted into the centre of the older beam to resist compression in the top part of the beam. The central flitched portion is held in place with wedges and with bolts towards the bottom edge of the beam. These bolts have square heads and appear to be hand-wrought, suggesting

that the repair might have been made before the second half of the nineteenth century.

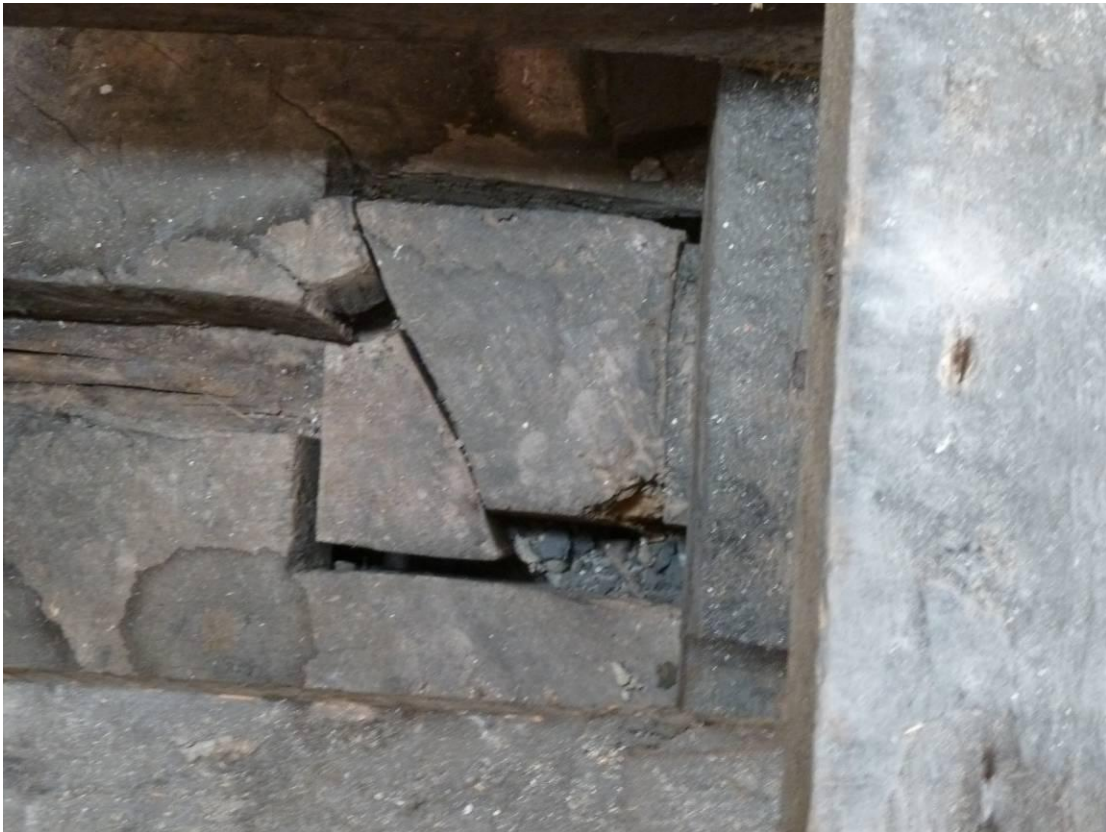
**9** *(Failed) wedge at south end of historic repair*

The wedges holding the repaired member have failed (Photo 9) there is a fresh and continuous crack through the western half of the original beam approximately centrally in the repaired section and the tenon of one of the secondary beams has sheared at its junction with the main beam. It is necessary to support the beam with scaffold to prevent a collapse of the ceiling.

The existing, defective beam will be left in-situ. It has been decided that this approach is in accordance with best conservation practice. The cost of removing the member would, in any case, have been prohibitive. A pair of parallel I section steel beams will be provided one either side of the existing beam. It will be necessary to cut back the secondary beams and remove some floor and ceiling joists to make space. Small bridging members will be provided between these beams and the defective oak beam will be hung from these. 15mm dia stainless steel rods will be inserted through holes drilled in the timber and plates provided under the beam. The existing secondary beams will be supported from the new steel beams. The connection will be formed with new steel shoes.

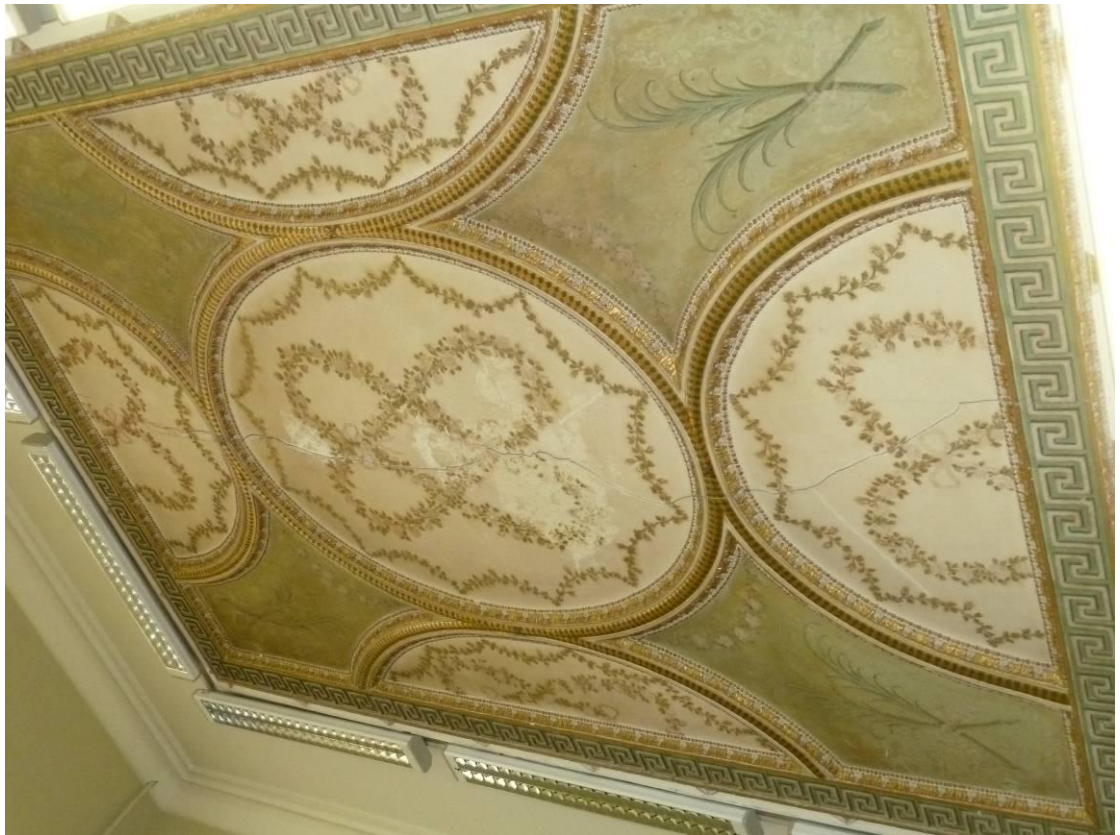
**11** *Ceiling of more westerly room: NB Painted decoration, moulded and gilded radius work within decorated key pattern border. There is a cornice at the wall to ceiling junction- installed after the ceiling was lowered in 1950.*

The central decorative plaster was probably lost when the beam was repaired and made good in the 19<sup>th</sup> C with less expensive work. The 'cornice' was probably lost in 1950 when the ceiling was lowered. The frieze remains intact.

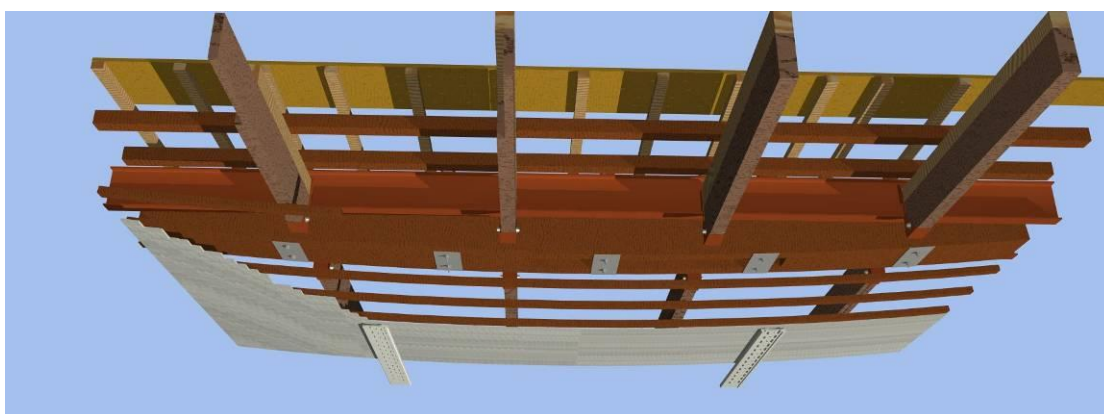
**12** Model of proposed structural repair from below

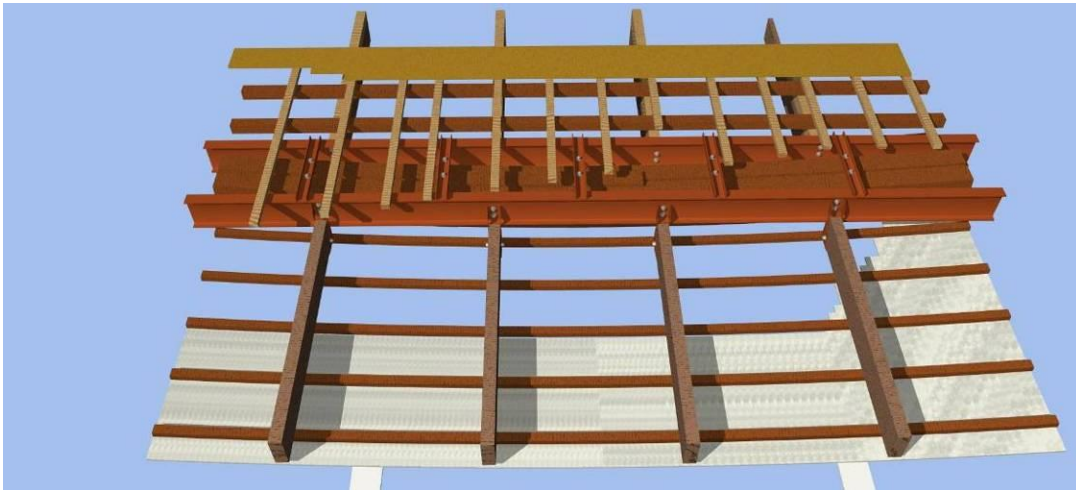
**13** Model of proposed structural repair from above.

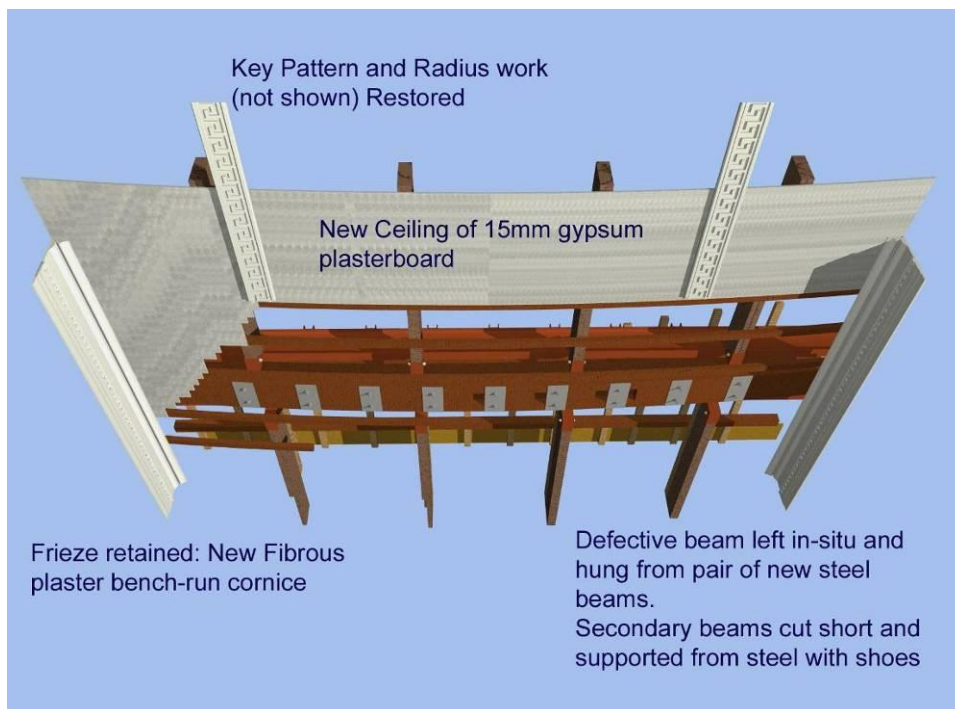
**14** Model of proposed ceiling reinstatement

Sections of the existing decorative sections have been taken down and moulds will be taken after the paint finishes have been stripped. The existing ceiling will be removed completely. The pugging layer will be removed over most of the area to enable a thorough inspection of the remaining structural timbers. It will not be replaced. An area of pugging will be left insitu to the west of the junction between the western secondary and the western principle beams to evidence the original construction. The ceiling will be replaced with 15mm gypsum plasterboard and skim. The embellishment will be replicated and adhesive fixed. The key pattern band will be bench cast to the mould in modern casting plaster. The radius work will be run on the bench in casting plaster in sections. A small new cornice of a pattern to be agreed will be provided at the wall to ceiling junction. This will be fixed as near as possible parallel to the frieze to reconcile the distorted geometry of the room caused by the structural movement.

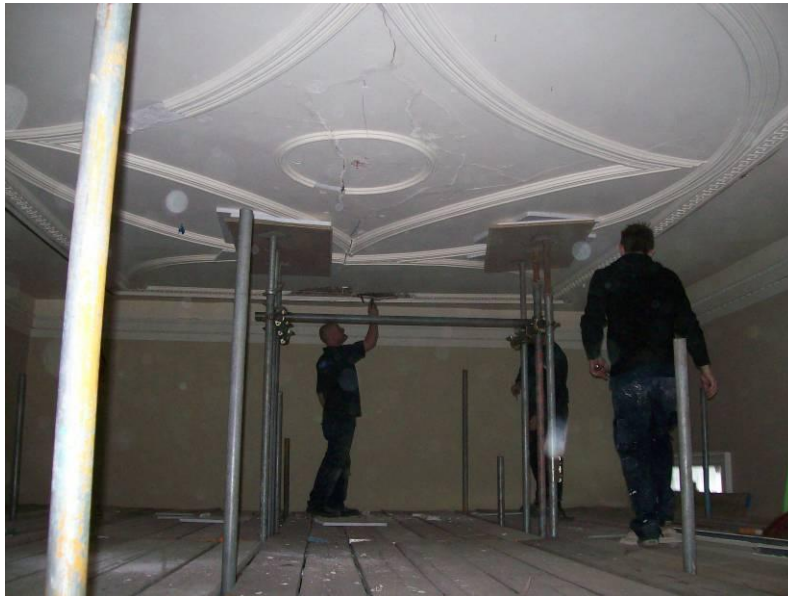
On 20<sup>th</sup> March 2012 following receipt of Listed Building Consent for the works as proposed above, the ceiling of the MBB Room was demolished. This enabled full examination of the timber floor structure from below and led to the discovery of a similar crack at the mid-span point of the second principal beam to that previously found in the first beam. It is clear that both beams had been extensively repaired in the same way and probably at the same time in the 19<sup>th</sup> century.

*15 propped ceiling showing mid line cracking and deflection*

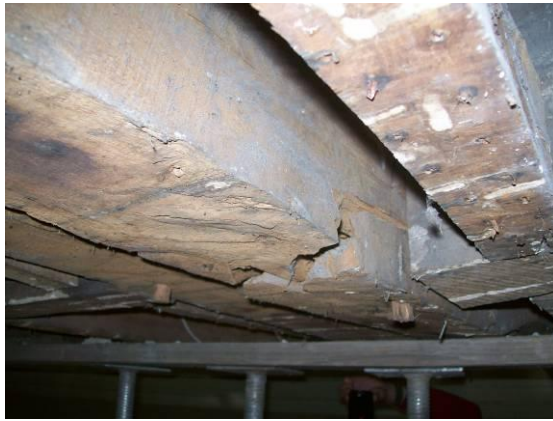
**16** crack through principal beam requiring scaffold propping

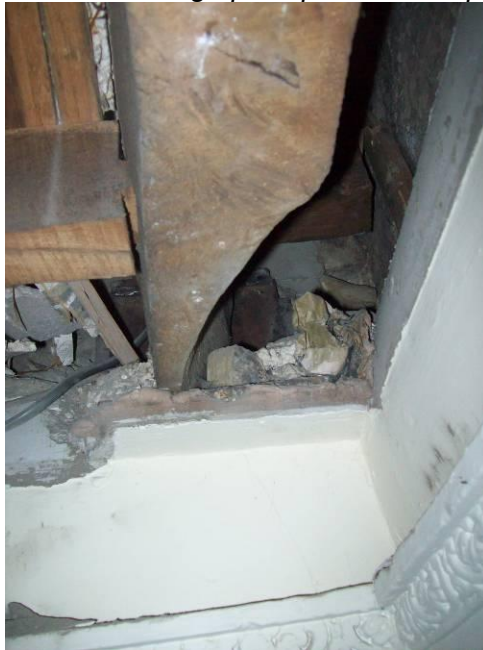
Furthermore wood boring beetle attack to the structural timbers generally was extensive but particularly to the ceiling joists and secondary beams which had been impossible to fully examine from above due the pugging layer above the now removed laths. Multiple other cracks in the secondary beams and patches of worm holes with frass and crumbling wood and loose or broken mortice and tenon joints between the joists and beams were also found. It is now apparent that the full extent of the deflection at over 225mm at the longitudinal midline below the failed principal beams is due to deflection of the structure: the plaster had remained quite tightly attached. The secondary beams were held at the east and west walls with steel shoes let into the masonry but with barely enough timber bearing the load onto the shoe, some had rot at the beam ends. It became clear that the intended repairs would not be enough to rectify these serious defects.

**17** Secondary beam end barely bearing on the masonry at western wall

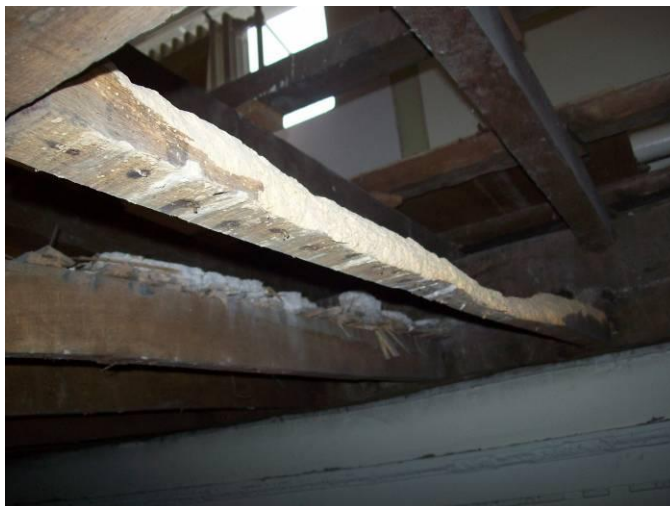
**18** Ceiling joists eaten away by beetle attack

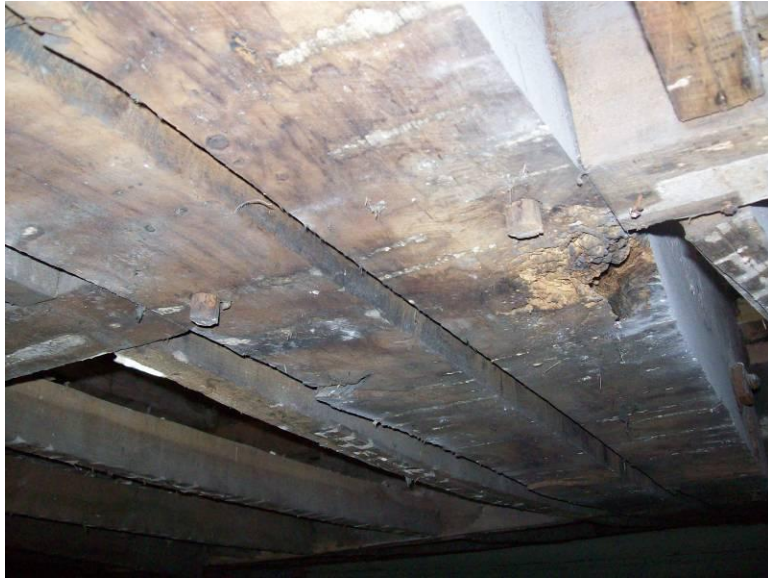
**19** *Cracks through the second principal beam*

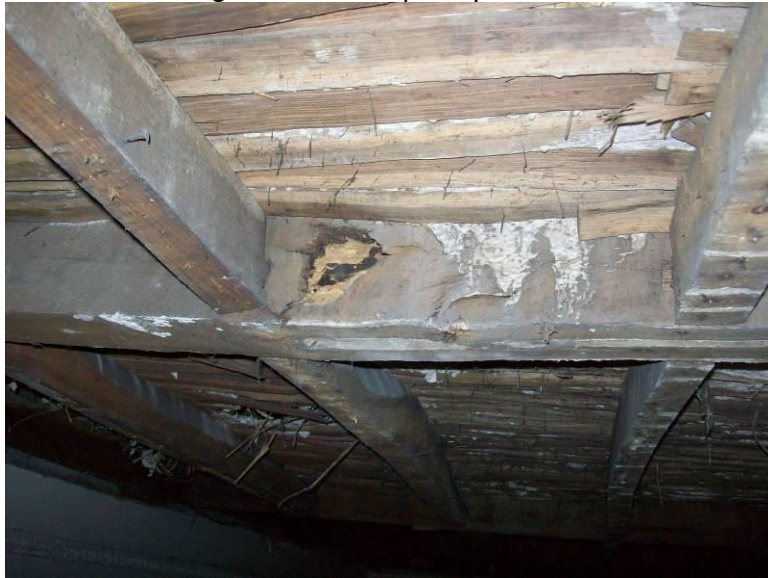
**20** *Deep pockets of soft crumbling decayed wood in secondary beam*

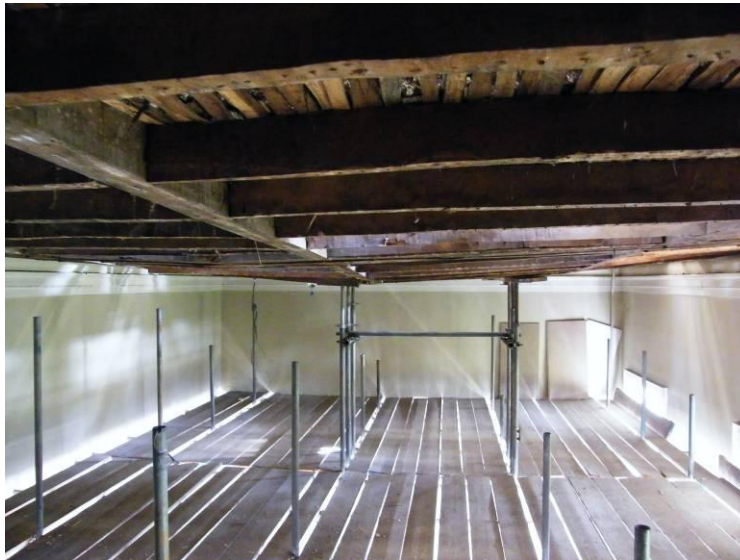
The reinstatement of the ceiling would still have the same extreme deflection unless this was mitigated by allowing the ceiling perimeter to meet the walls lower than the old ceiling. However this would be limited by the position of the surviving C18th frieze which in places was barely 75mm below the old ceiling line. It would be difficult to achieve a good result with the installation of the ceiling enrichments with such a severe sag in the ceiling and the addition of a modestly sized cornice would be impossible.

**21** View of the underside of the propped floor structure showing the severity of the deflection in relation to the wall frieze

The new proposal will require a thinner floor composite steel and timber floor construction to achieve the additional height above the frieze to fit the new cornice. The structural engineer has confirmed that the steel beams can be 305mm deep and the overall construction around 353 mm yielding enough space for a cornice of overall depth of around 236mm. Below is shown an indicative design based on an existing frieze and cornice below the coved ceiling of the Aviary room to the western end of the same wing.

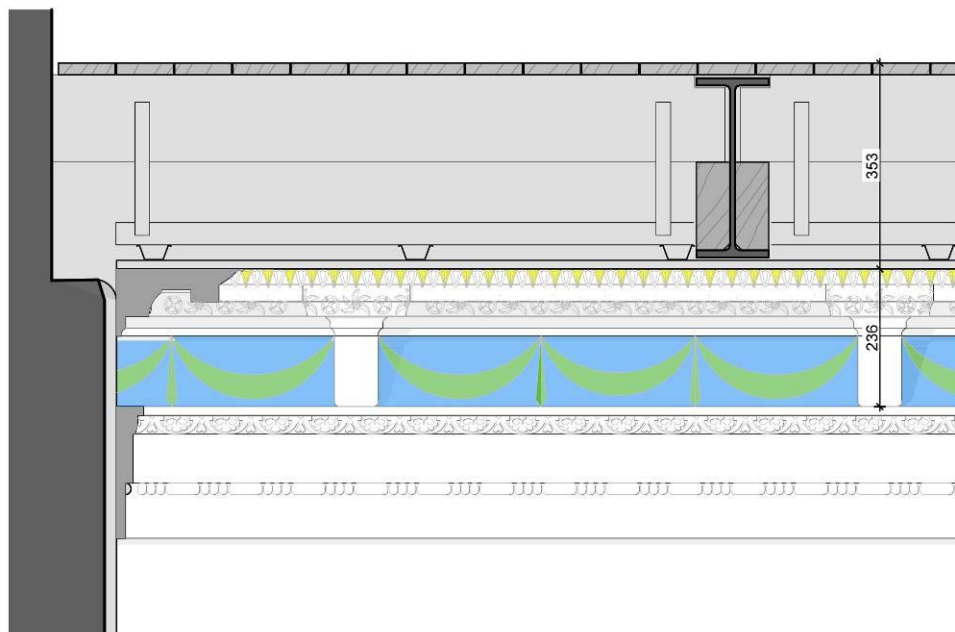
**22** Indicative design for a cornice with hand painted panels above the existing frieze inspired by the existing in the Aviary room as shown below
