## Royd Moor House Farm

L'Arche Developments (Yorkshire) Ltd

## Structural Inspection Report

December 2022

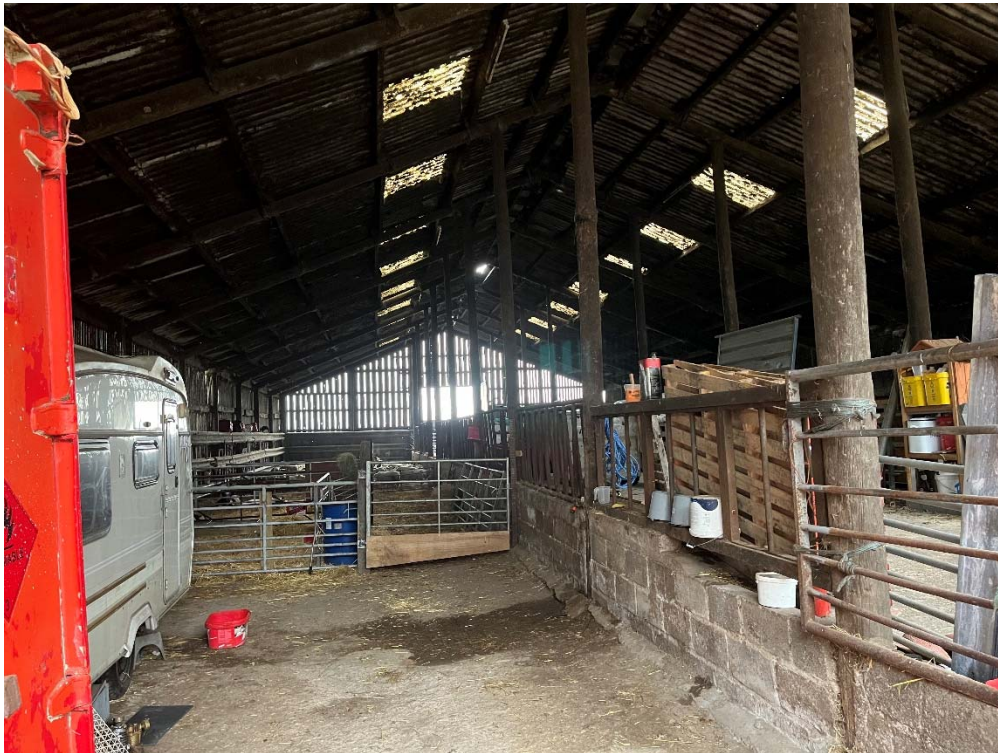
The building is a duo pitched timber frame with two rows of internal timber props to the rafters, which has a precast concrete wall to three sides (**Error! Reference source not found.**). The building is open on the northern elevation.

Photograph 1 Building 8 Internal View

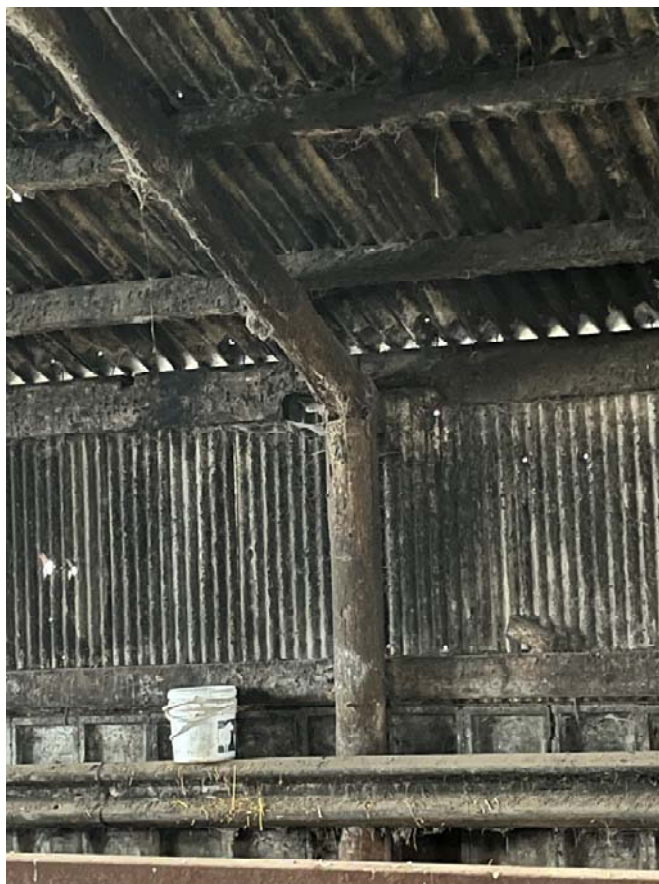
Above the concrete walls, the frame is clad with timber panels with the roof clad using corrugated sheets carried by timber purlins and sheeting rails (Photograph 2).

Photograph 2 Building 8 Typical Cladding

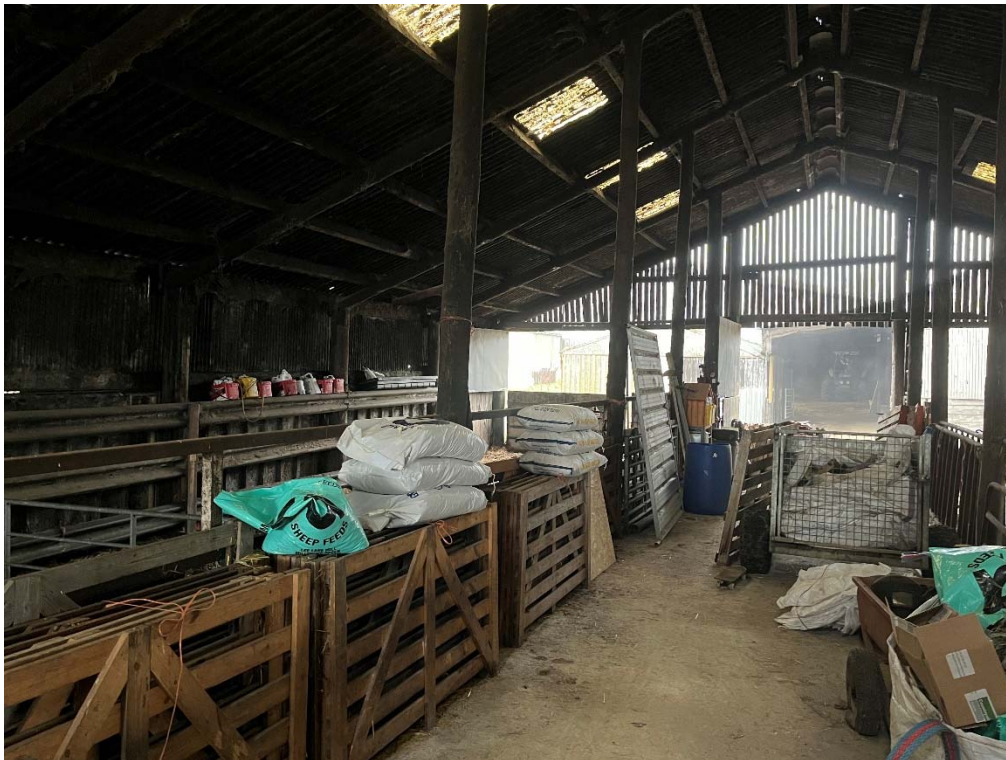
The floor is an unfinished concrete slab (Photograph 3) which has a slight fall.

The floor slab, where open to inspection, was free from damage and degradation

Photograph 3 Building 8 Slab

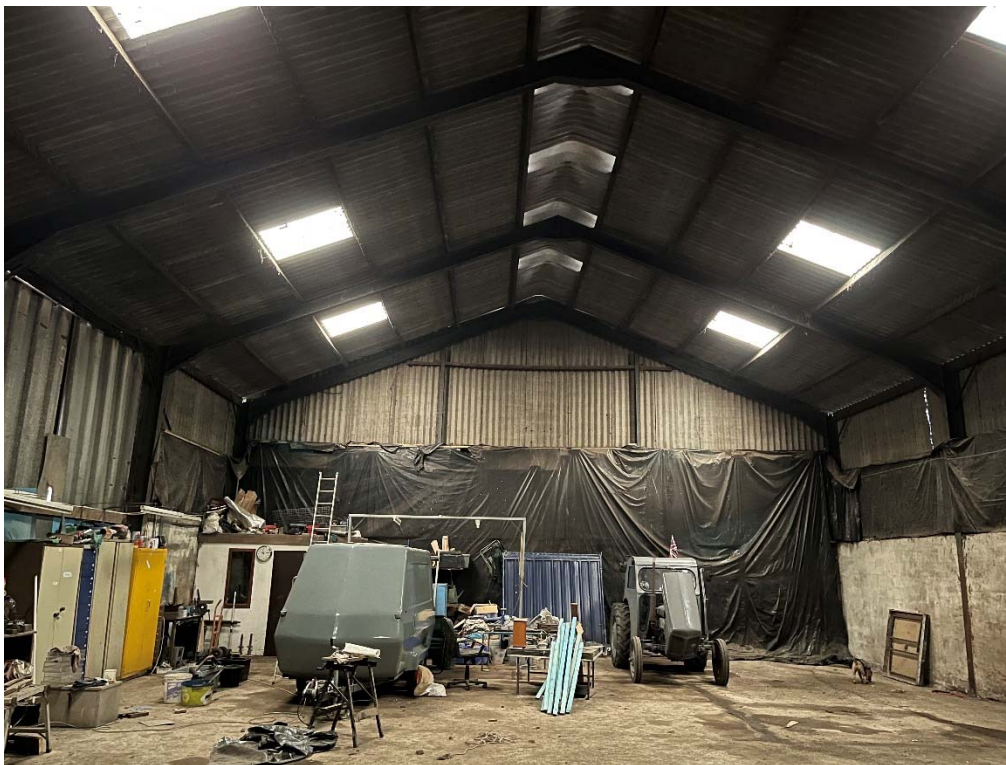
The building is a comparatively modern steel single-bay portal frame which has 2.4m high, concrete blockwork walls to three sides and timber cladding to the remaining gable (Photograph 4).

Photograph 4 Building 14 Internal View

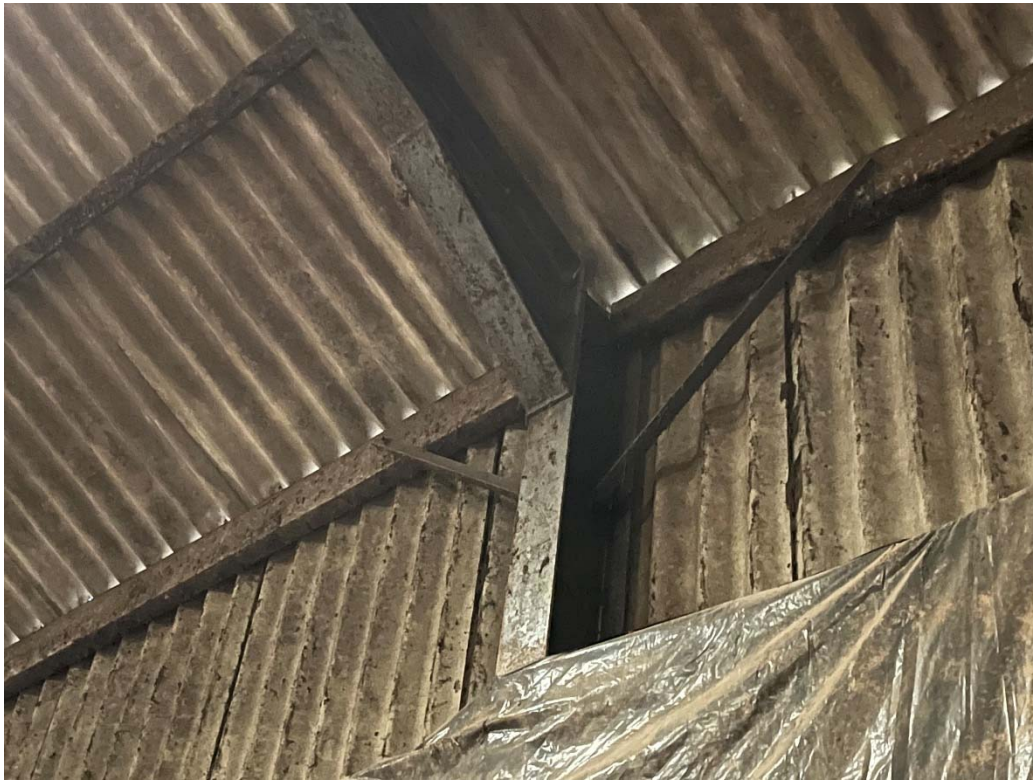
Above the blockwork walls and on the roof, the frame is clad with corrugated cement sheets carried by cold rolled purlins and sheeting rails (Photograph 5).

Photograph 5 Building 14 Typical Cladding

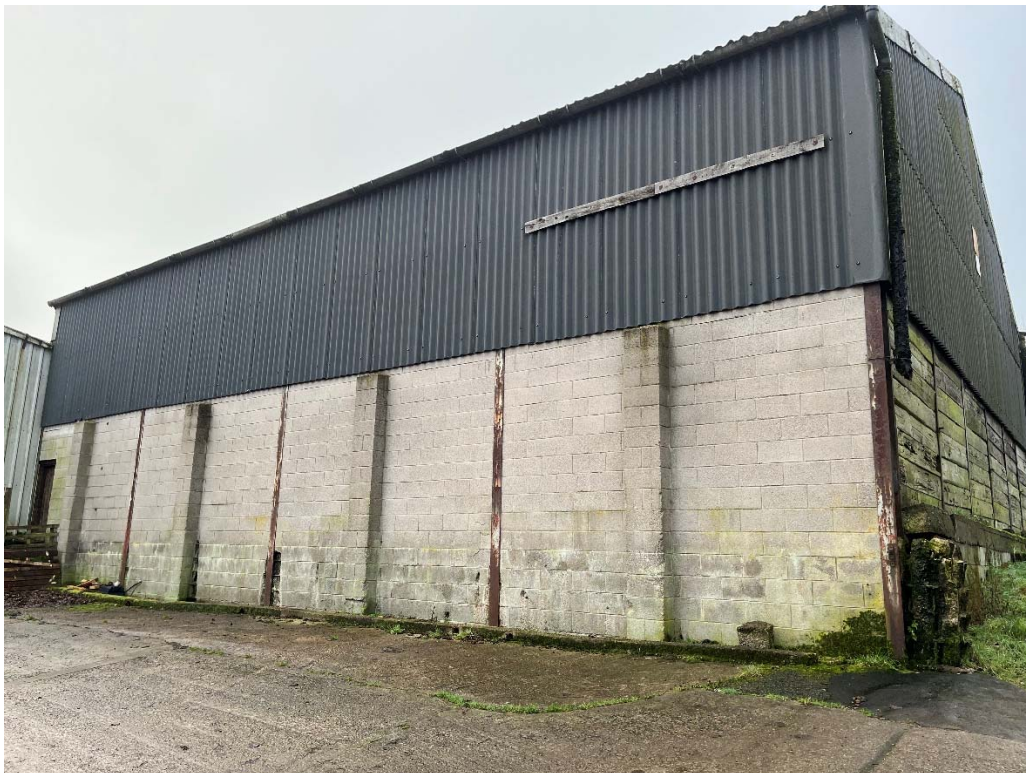
To the west, the ground is lower than the floor slab with the blockwork wall acting as a retaining wall (Photograph 6).

Photograph 6 Building 14 Western Elevation Retaining Wall

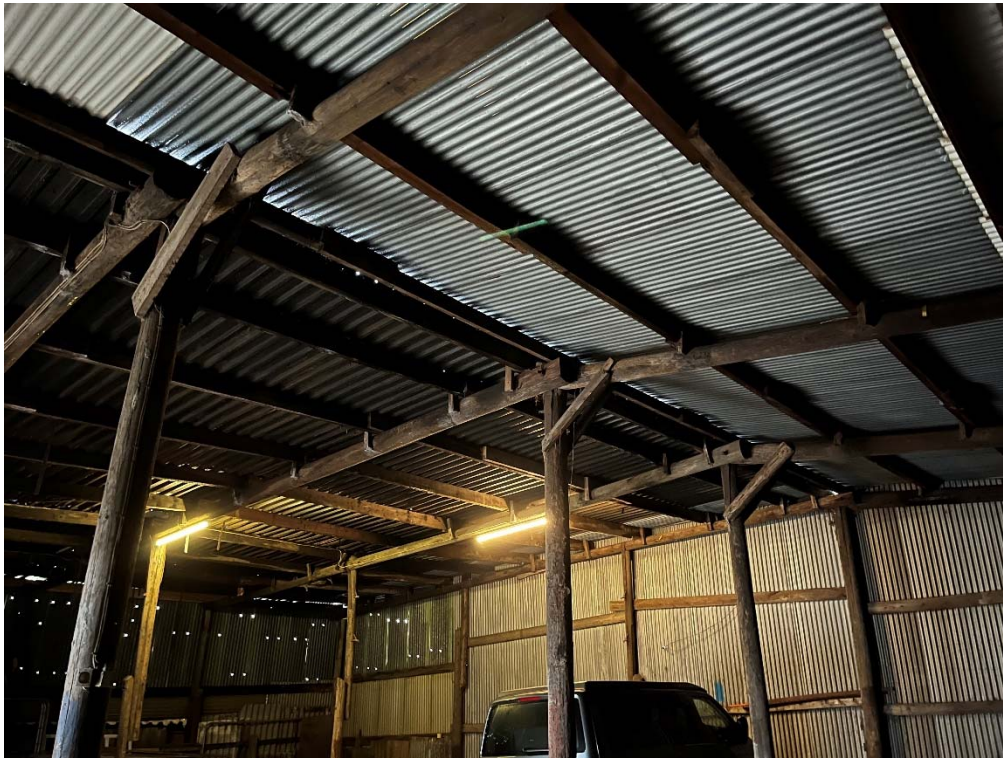
The building is a duo pitched timber frame with three rows of internal timber props to the rafters (Photograph 7). The building is enclosed on all four sides.

Photograph 7 Building 19 Internal View

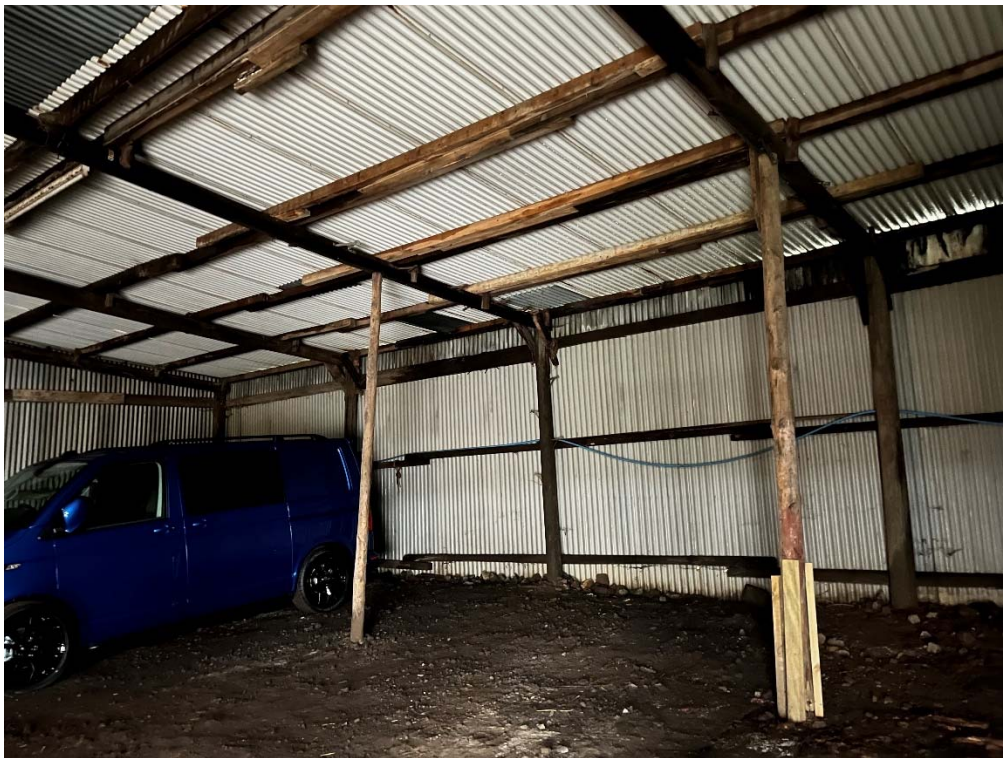
The frame is clad with corrugated sheets with the roof clad using similar sheets carried by timber purlins and sheeting rails (Photograph 8).

Photograph 8 Building 19 Typical Cladding

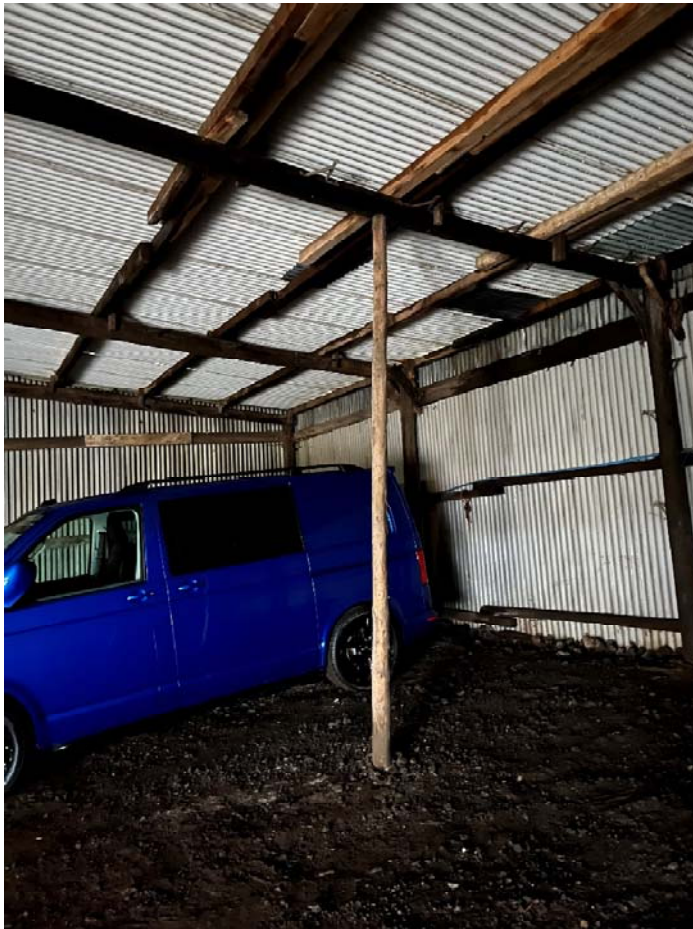
The floor is an unfinished earth / rubble (Photograph 9).

Photograph 9 Building 19 Internal Floor

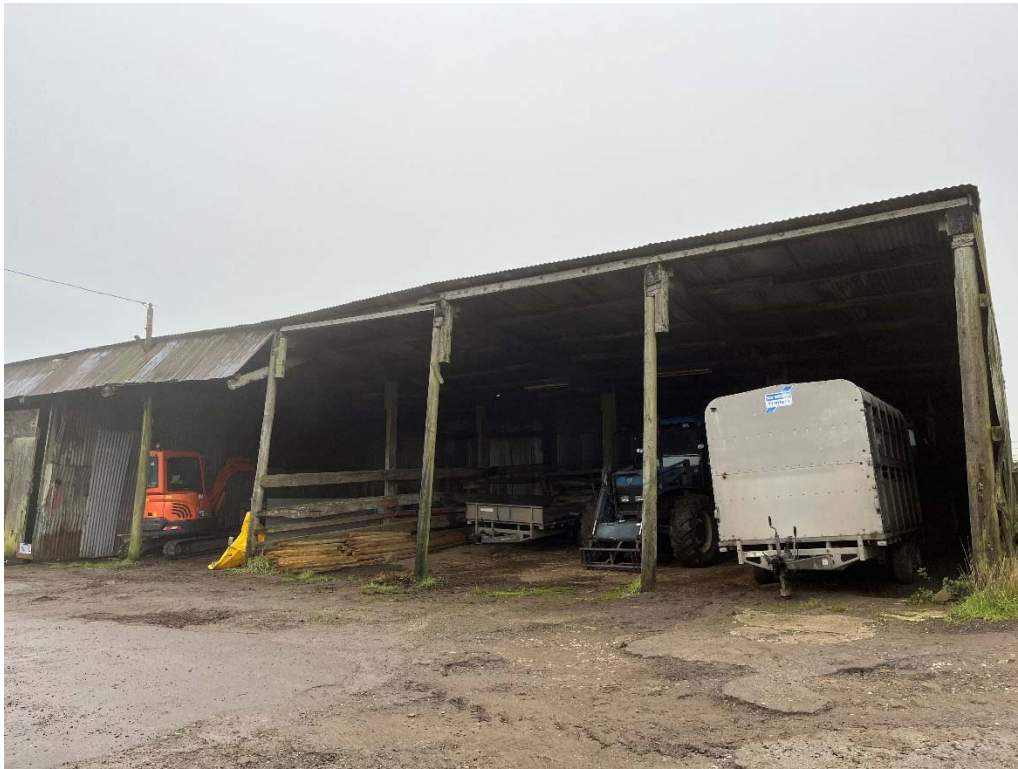
The building is a mono pitched timber frame with a single row of internal timber props to the rafters (Photograph 10). The building is enclosed on all three sides and open to eastern elevation.

Photograph 10 Building 20 Front Elevation

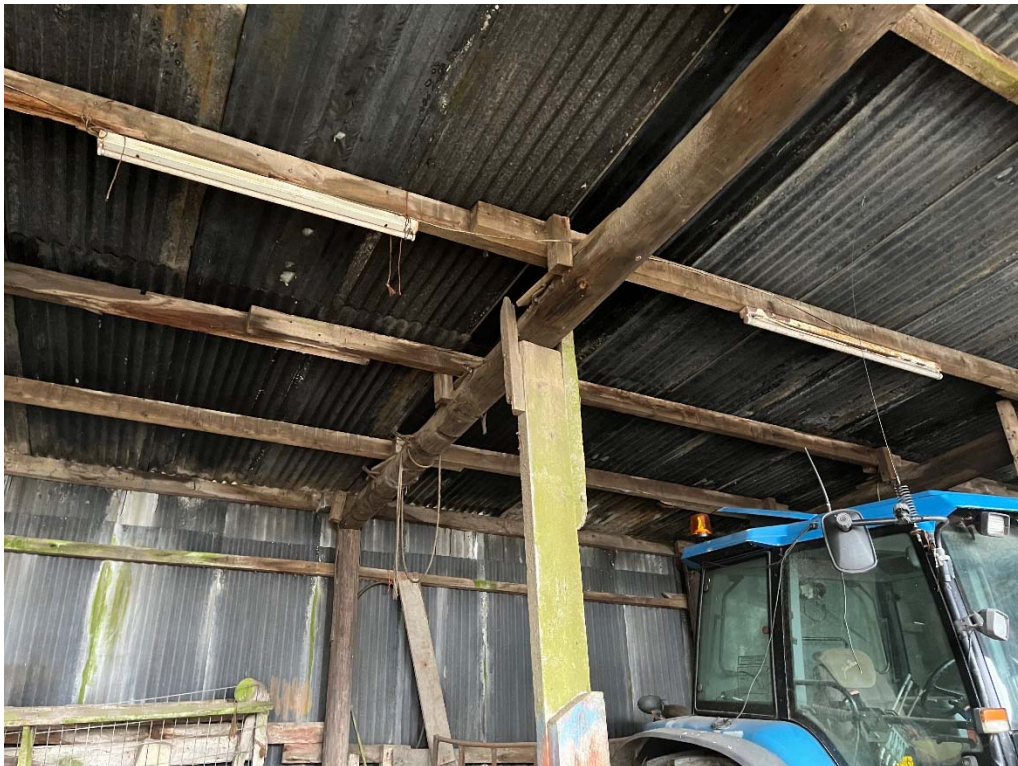
The frame is clad with corrugated sheets with the roof clad using similar sheets carried by timber purlins and sheeting rails (Photograph 11).

Photograph 11 Building 20 Internal Cladding
